Dalgety Bay

Appropriate Person Report

Author	Miss Nina Patton

26 June 2013
Reviewed	Dr James Gemmill

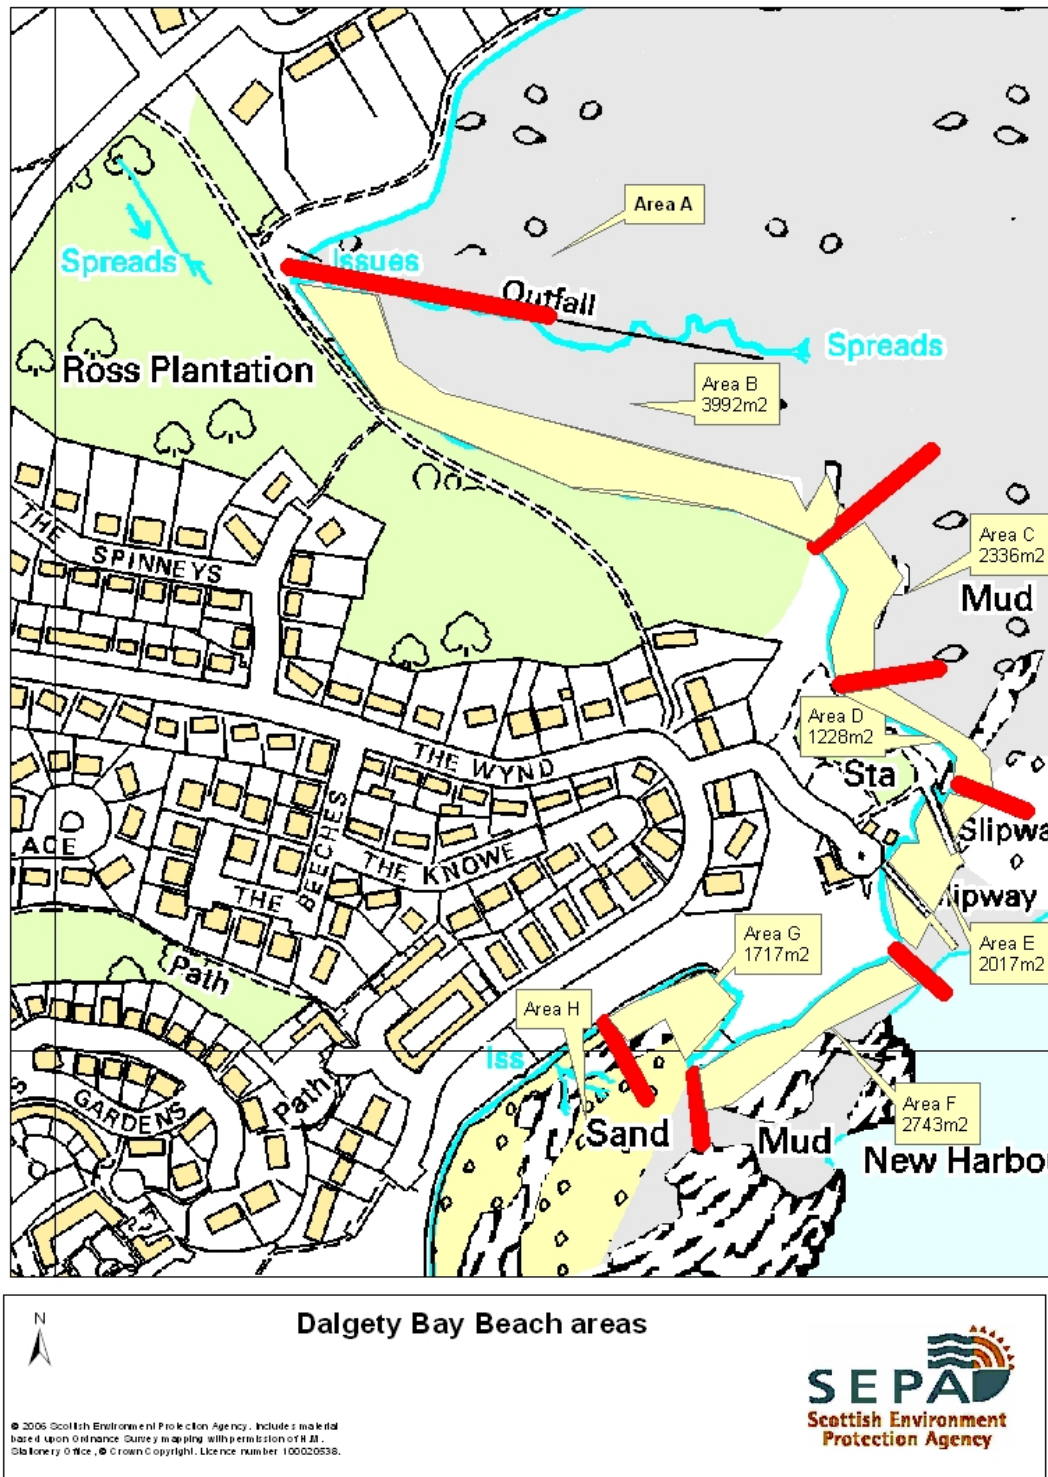
Figure 5: Dalgety Bay Beach Areas

Table 7: Evidence for Significant Pollutant Linkages

The areas referred to in Table 7 are represented on Figure 5.

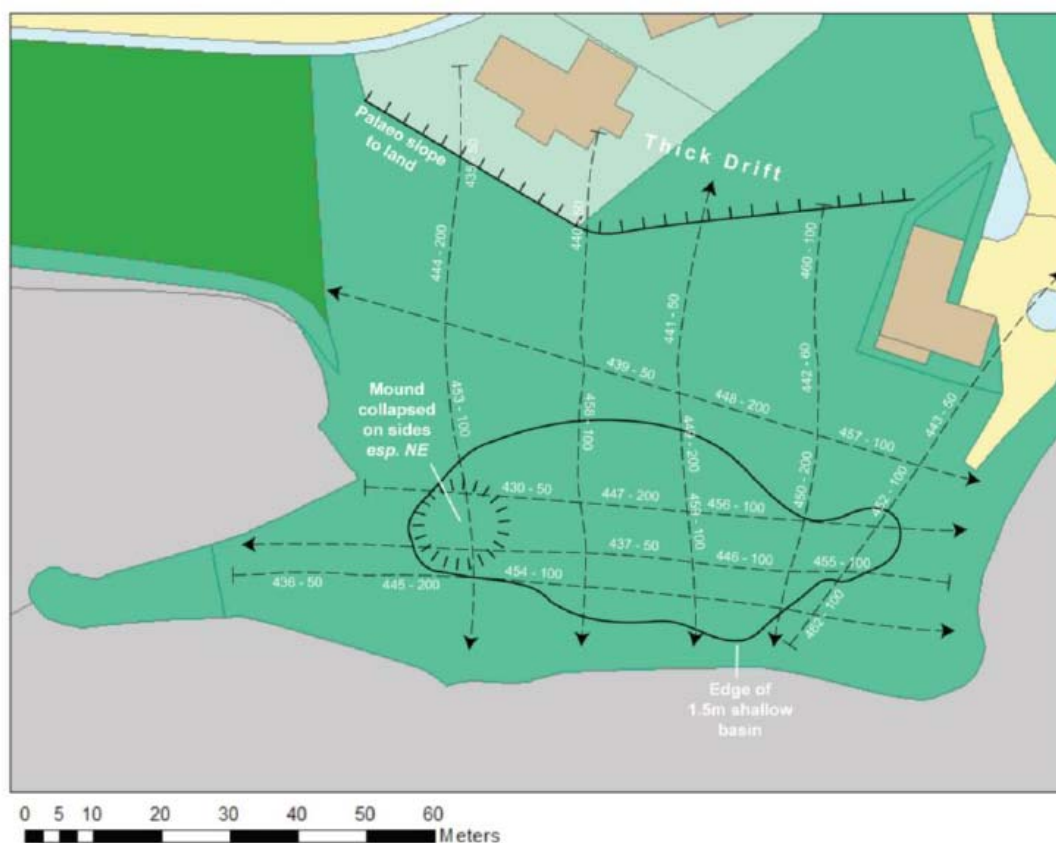
Figure 6: GPR transects and a brief interpretation of the data Dec 2011 (Tyler 2011):

The location of made ground deposits in the Headland area which are predominantly radioactive ash and clinker, mirror the findings of the 2011 GPR survey (Tyler, 2011). Figure 6 shows the 2011 GPR transects and a brief interpretation of the data.

This figure shows an outline of the main basin of the made ground. The basin infill was estimated to be about 2m deep from the surface of the site. The superficial infill material continues to the north under the club house and to the North West which may indicate separate minor basins of infill (around 1.5-2m deep).

The borehole and trial pit logs from the 2012 intrusive investigation (AMEC, 2013c) confirm this, showing made ground in this area generally of the order of 2m deep and up to 5m deep locally. The logs and the cross sections presented in the AMEC Factual Report (AMEC, 2013c) show the 'basin' of made ground shallowing in a south westerly direction towards New Harbour (Appendix 16 Figures B5 and B6) This 'basin' area identified in the GPR survey corresponds with the refuse tip as marked on the 1:2,500 OS map dated 1963/64. This is also consistent with the findings of the Enviro 2007 site investigation (Enviro, 2007b).

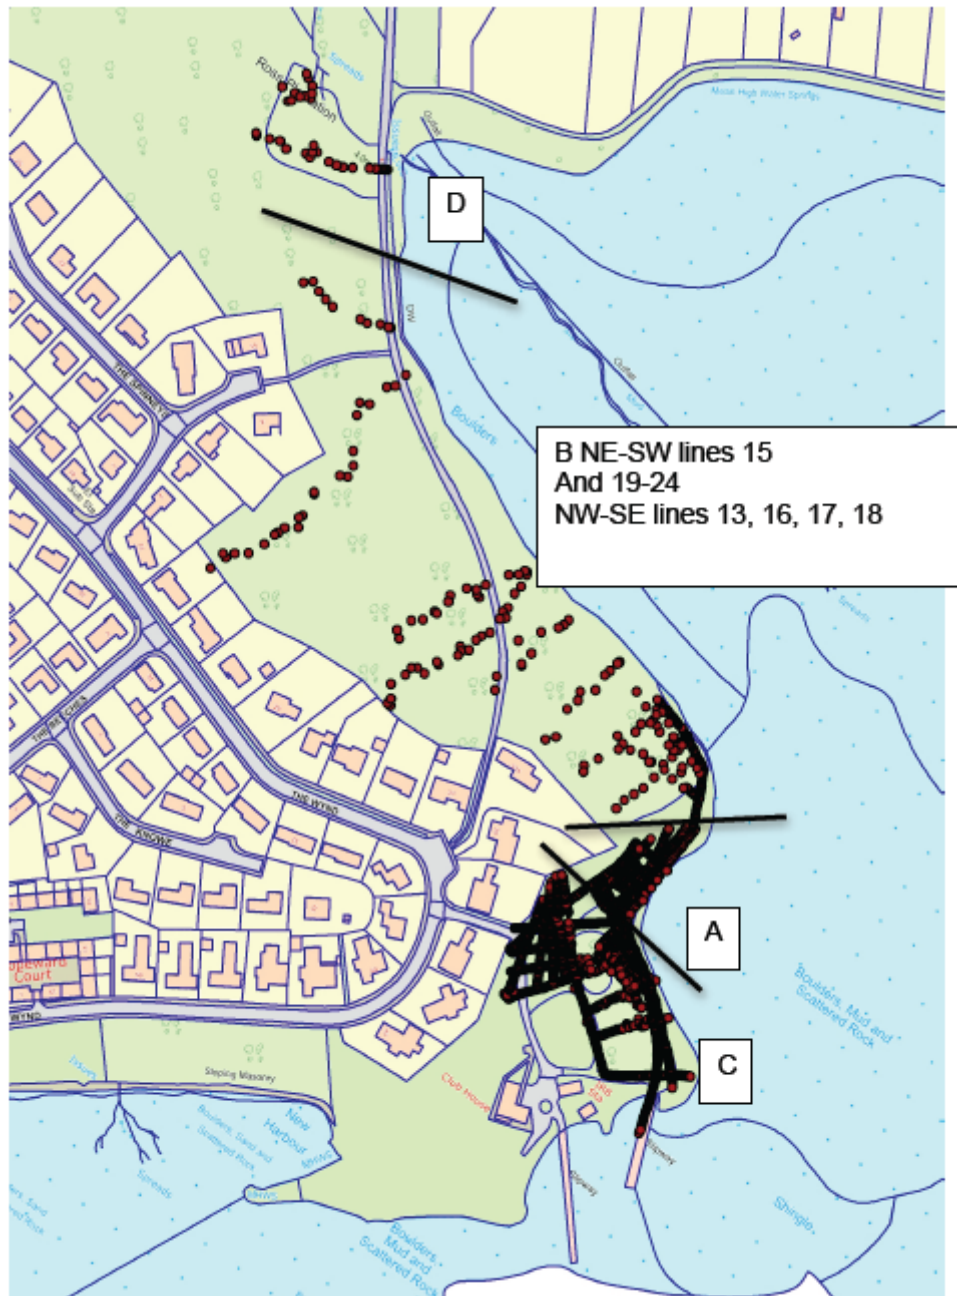
Figure 7: GPR transects at Dalgety Bay (Ruffell & Tyler 2012)

A further GPR survey was undertaken in 2012 (Ruffell & Tyler 2012). The report covers the Ross Plantation area, Demarcated Area and the Boat Park Area. The transects are shown in Figure 7 and Figure 8.

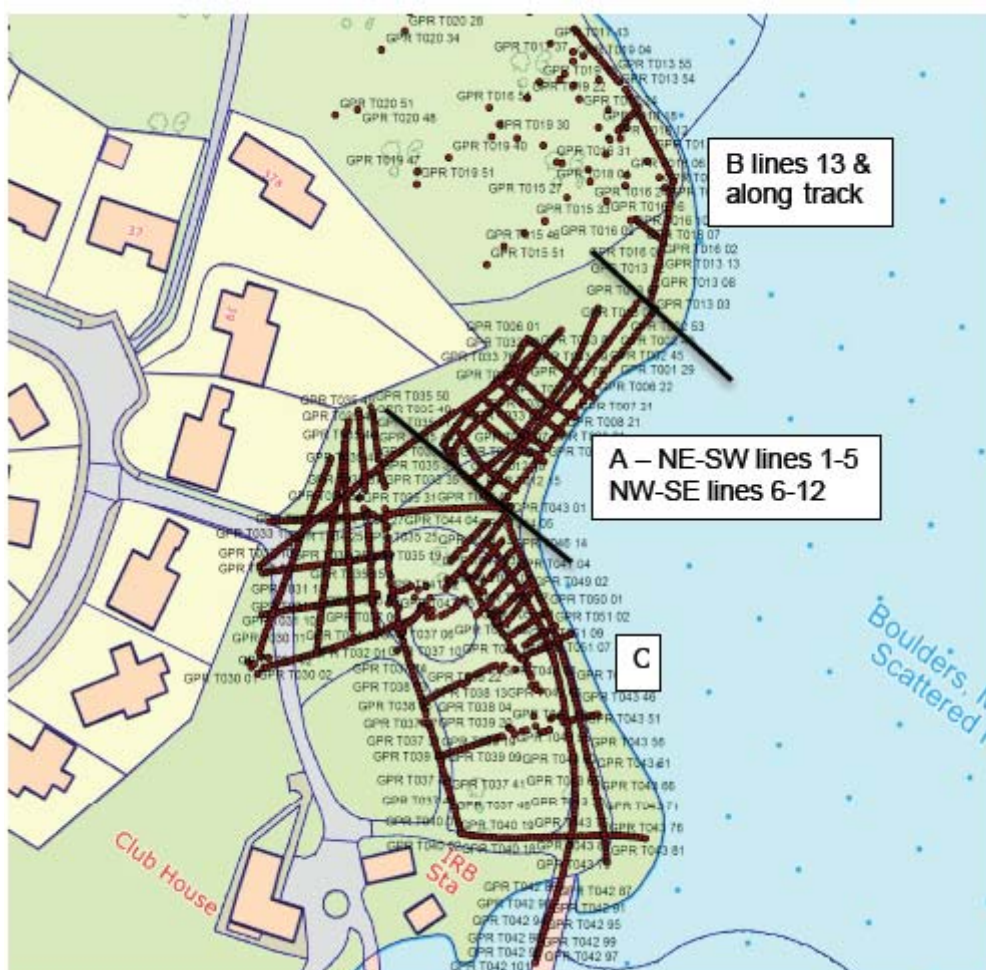
Figure 8: GPR Transects in Areas A & C (Ruffell & Tyler 2012)

The results from the Demarcated Area (Area C) show a transition between a basin of infill material up to 1m thick to the south changing to very different material to the north of this area. This is confirmed by trial pit and borehole logs in the Amec Factual Report (AMEC 2013c) with trial pits in the south of the area (TP3/3/044, TP3/3/045, TP3/3/046, TP3/3/106, TP 3/1/026 TP3/1/025) showing inert made ground up to 1.5m thick overlying made ground of radioactive ash and clinker. The material type changes towards the north of the area where the made ground is predominantly ash and clinker made ground (TP3/1/024, TP3/3/037, BH3/3/005, TP3/2/031B).

The results from the Ross Plantation area along the coastal path, comprises shallow superficial deposits on bedrock. This is confirmed in trial pits TP6/2/063, TP6/2/053 from the AMEC Factual report (AMEC, 2013c) and other trial pit locations in this area where interbedded ash and clinker layers with layers of sandier layers are up to 1m in thickness. Superficial deposits thicken towards the south west which is confirmed by trial pits TP5/2/049, TP5/2/052 in the AMEC Factual Report (AMEC, 2013c) as well as trial pits TP6 to TP8 and other locations in this area from the Enviro 2007 investigation (Enviros, 2007b) where mainly natural deposits thicken towards the south west.
