**APPENDIX C**

RECONNAISSANCE SURVEY FINDINGS

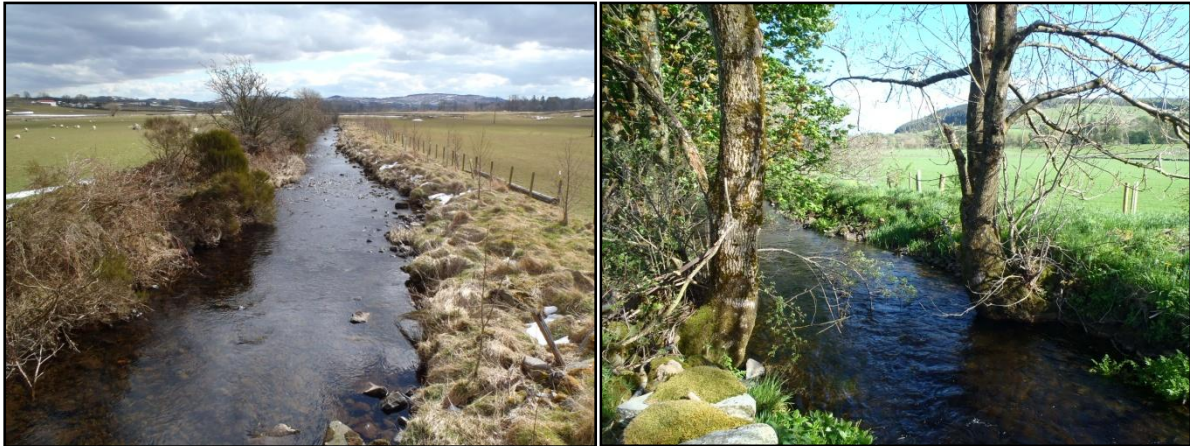
Morphological pressures for this water body within SEPA's morphological pressures database are restricted to several bridges. The reconnaissance survey indicated the presence of additional pressures. Embankments were found intermittently between approximately NX 805 841 (near Whiteside) and NX 836 843 (near Milton) (Figure C2, C5). Evidence of high impact realignment was also observed in some locations within this extent.

**Figure C2 Glenesslin Burn – Embanked and possibly realigned channel in central part of water body.**

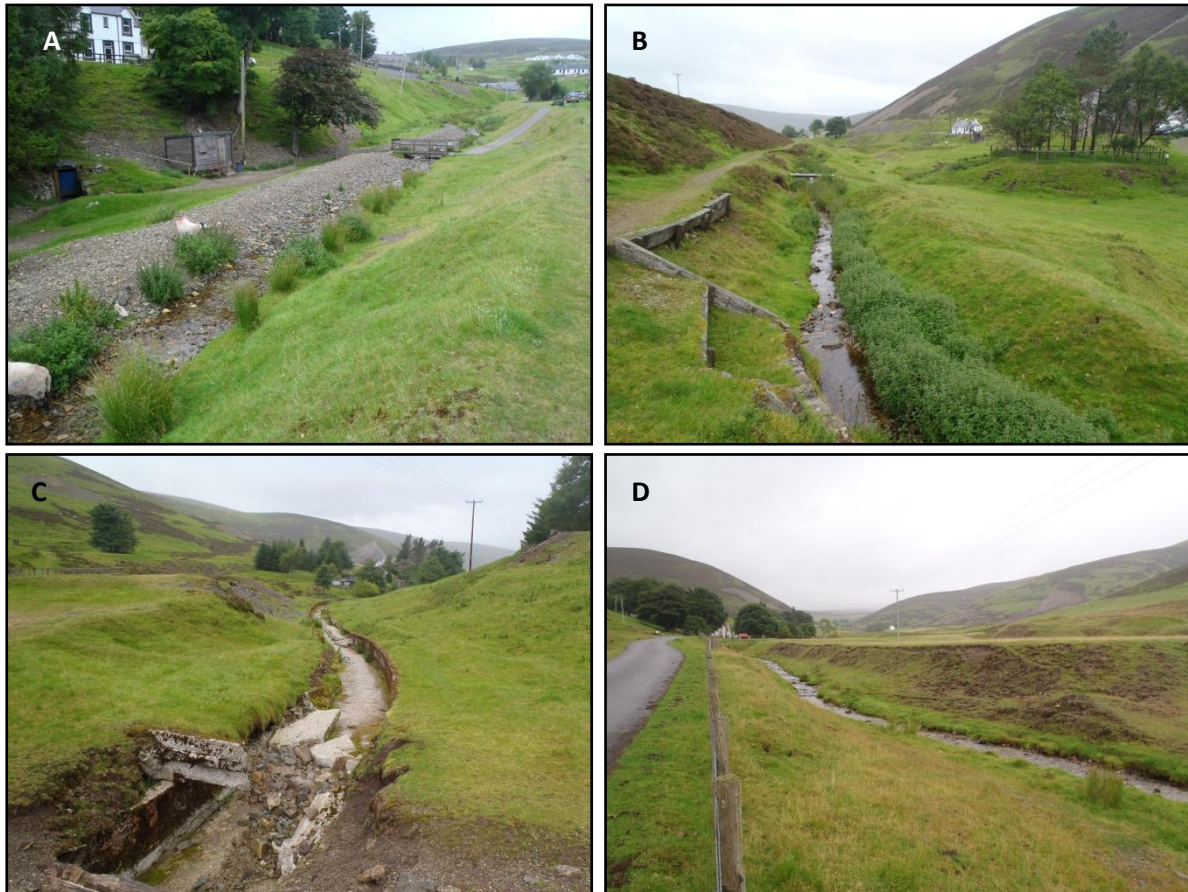
- The burn flowed through a culvert beneath the road through Wanlockhead and a short open culverted section then led to a second closed culvert.
- Downstream of here the reach type became plane riffle. The burn had been realigned to the left hand side of the valley (high impact realignment) and embanked on its right bank (Figure C3). (There appeared to be some recent alteration to the upstream end of the embankment.) Further downstream the burn had been diverted around the valley side (Figure C3).

- Much of the dry channel downstream was an open culvert (Figure C3). The channel remained dry for approximately 500 m until a significant input of flow from a tributary. The origin of the tributary was unclear as the flow emerged from a subsurface channel in a hillslope on the left side of the valley.

- Downstream of the tributary input was a further section of high impact realignment for about 400 m (ending at NS 854 143), through old mine spoil (Figure C3).

Figure C3 Wanlock Water – A: recently modified embankment; B: upper realigned section; C: dry, open culvert channel; D: lower realigned section through mine spoil.
