## Boghead Burn Hydromorphic Character and Restoration Opportunities

**FINAL**

June 2012

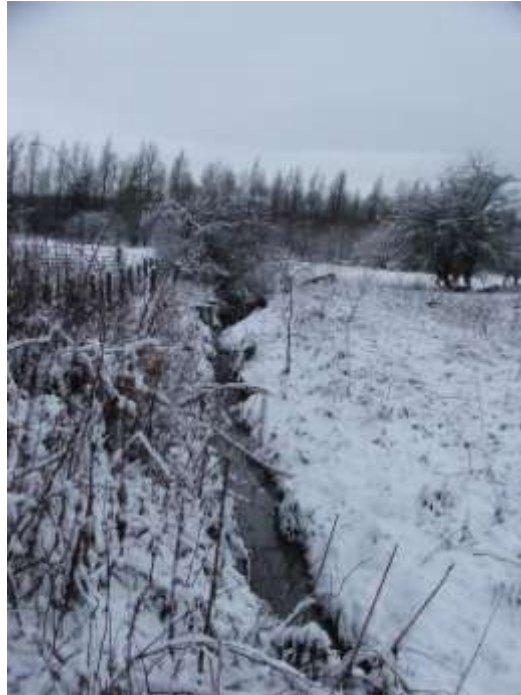
Here the burn flows through a pastoral agricultural landscape with suckler cow herds and sheep stratification farming systems. These systems are characterised by a mixture of improved and unimproved pastures and this area is no exception. Once again in this area there are a number of lochans although none of these are connected directly to the burn as above and these are probably the result of mining subsidence, due to their shallow nature and disconnection from the surrounding drainage systems. In addition to the lochans, the main feature of this part of the river is the main Whitburn to Falkirk road (A801) which is situated on a high embankment over the surrounding low-lying floodplain (see Figure 1-1).

**Figure 1-1: Boghead Burn looking west near Half Loaf Pond showing the raised A801 road**

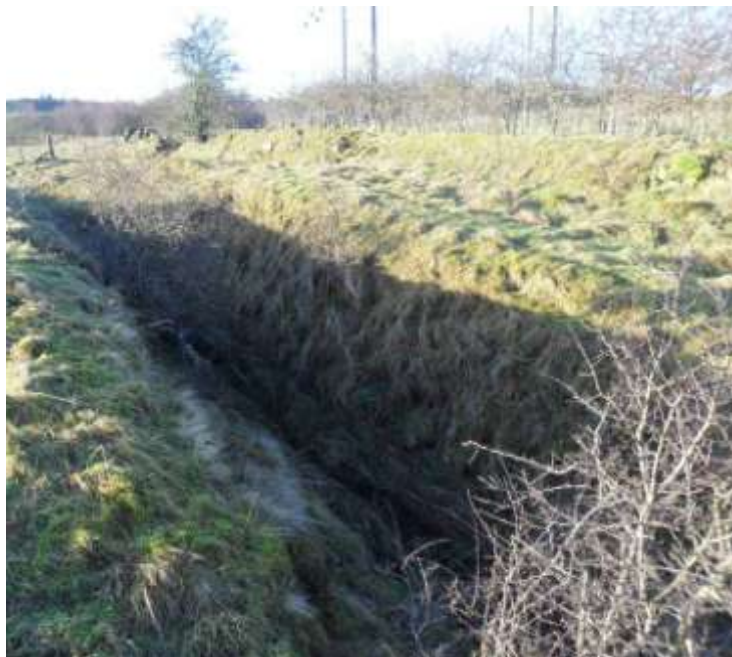
The upper reaches of the Boghead Burn are characterised by a series of engineered ditches (Figure 1-3), many of which run dry (Figure 1-4). The featureless over-deep trapezoidal channels are generally straight and generally suffer from aggradation linked to excessive diffuse fine sediment inputs from surrounding tracks and farmland and the multiple channelling of flows along artificial watercourses.

**Figure 1-3: The heavily modified over-deep upper Boghead Burn**

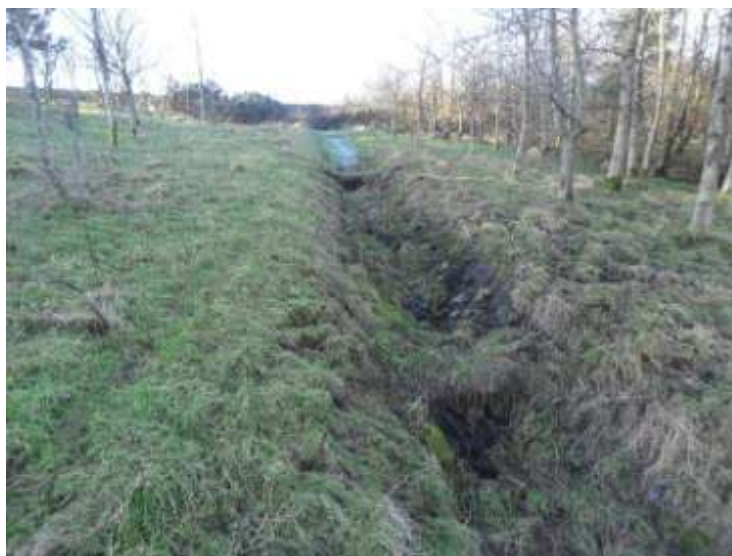
**Figure 1-4: Dry channel network of the upper Boghead Burn**

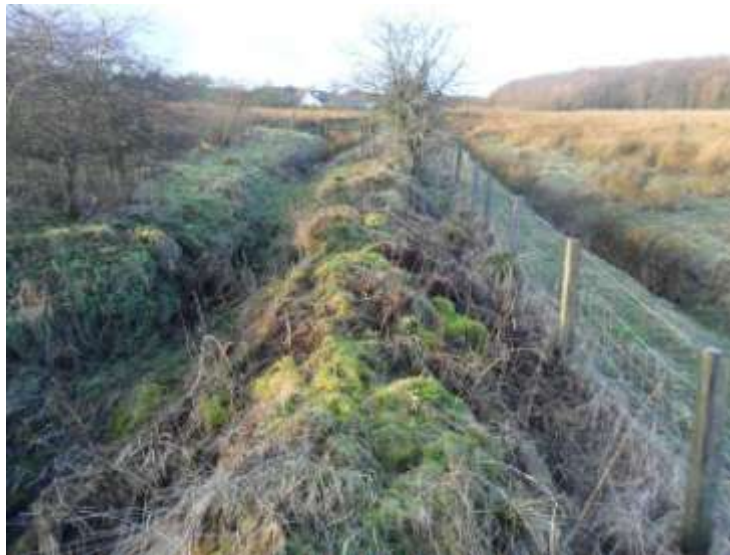
**Figure 1-5: Sedimenting dry channel at Hall Torbane Farm**

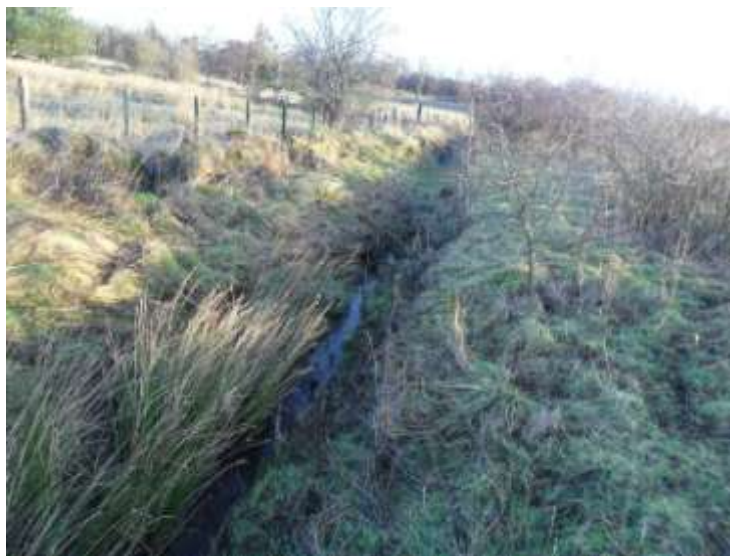
**Figure 1-6: Infilled channel downstream of abstraction culvert**

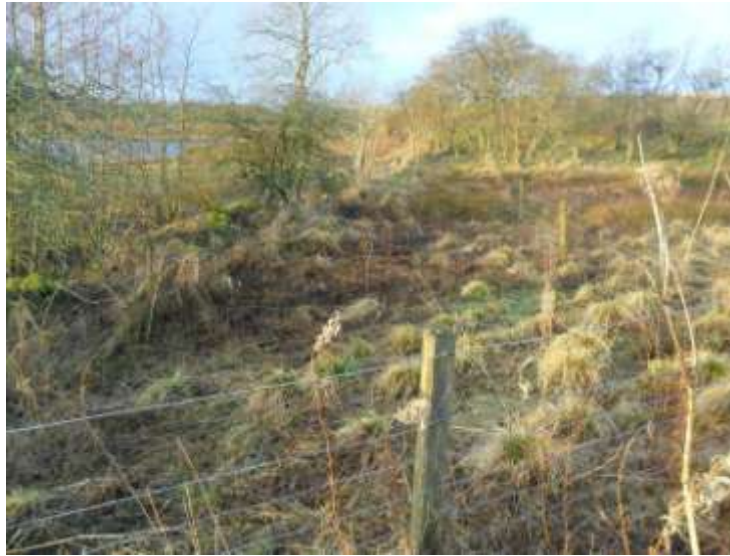
straightened channel and a Birch and Willow riparian woodland has developed on the left bank close to the A801 (Figure 1-7). This is a useful analogue on which to model the restoration of riparian margins across the farmland in the area.

**Figure 1-7: Naturalising wet floodplain upstream of the A801**

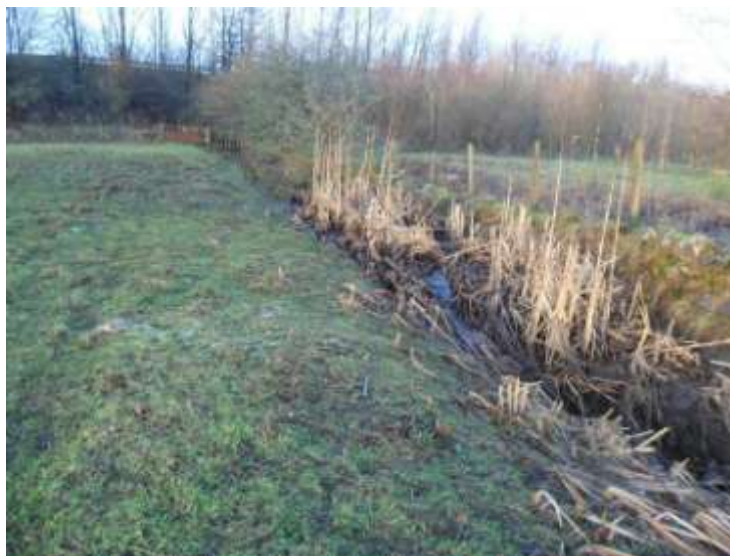
The Burn flows through a culvert under the A801 into a straight engineered channel subject to intense sedimentation (Figure 1-8). A low floodwall and earth flood bank runs along much of the left bank reducing the connectivity of the watercourse with the floodplain (Figure 1-9).

**Figure 1-8: Reed covered in-channel sediment downstream of the A801 culvert**

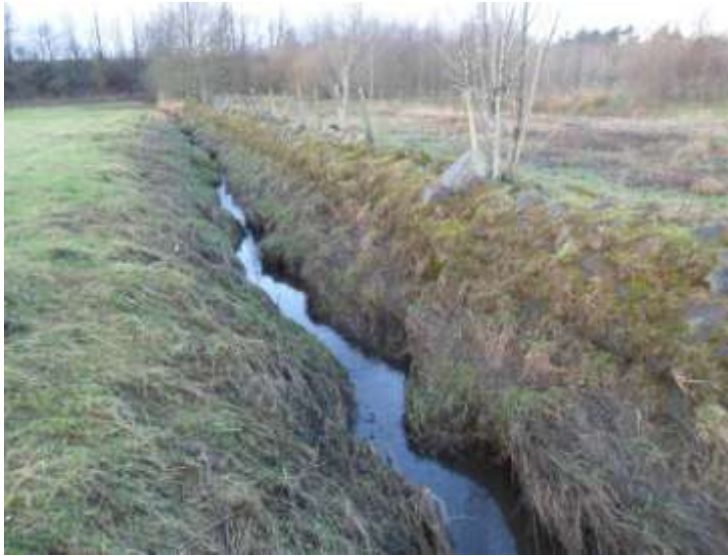
**Figure 1-9: Low flood bank and wall opposite Half Loaf Pond**

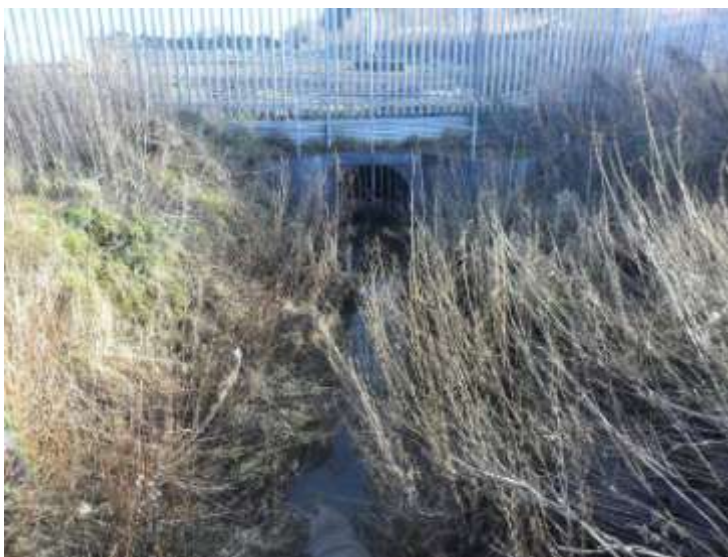
The river flows through a culvert under Standhill Depot (Figure 1-10) before entering a more confined reach after the B7002 through Standhill. The channel gradient steepens here and is brick lined (Figure 1-11). Much of the brick lining is in poor condition.

**Figure 1-10: The culvert under Standhill Depot**

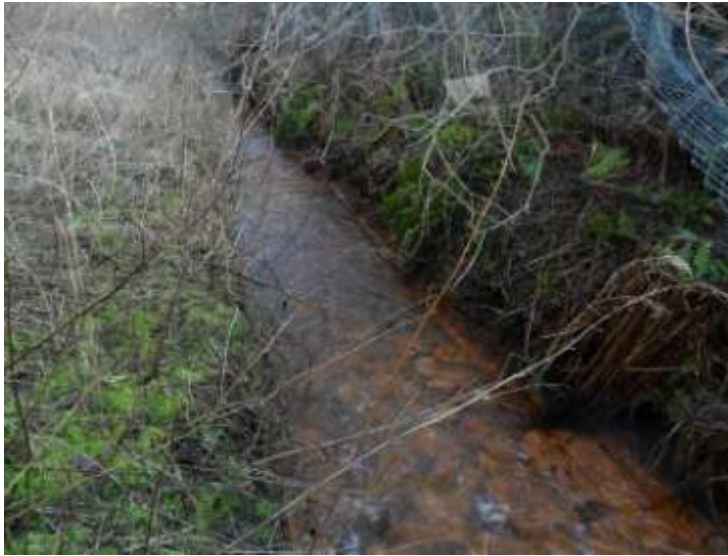
**Figure 1-11: Brick lined channel through Standhill.**

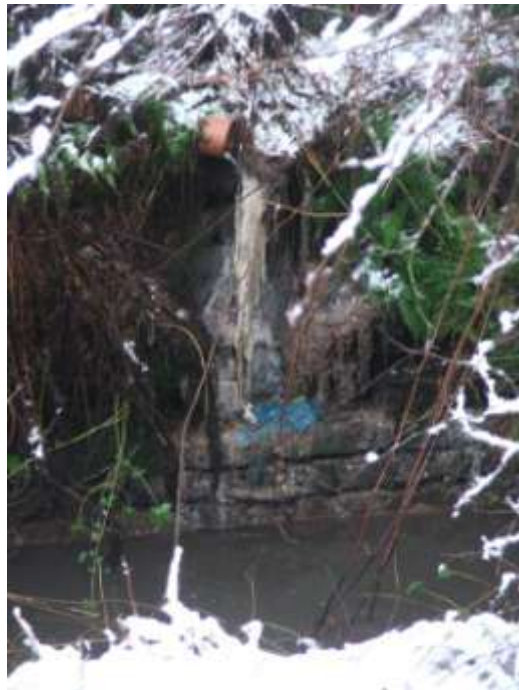
**Figure 1-12: Unidentified congealed discharge from a small pipe in the Standhill Industrial Estate**

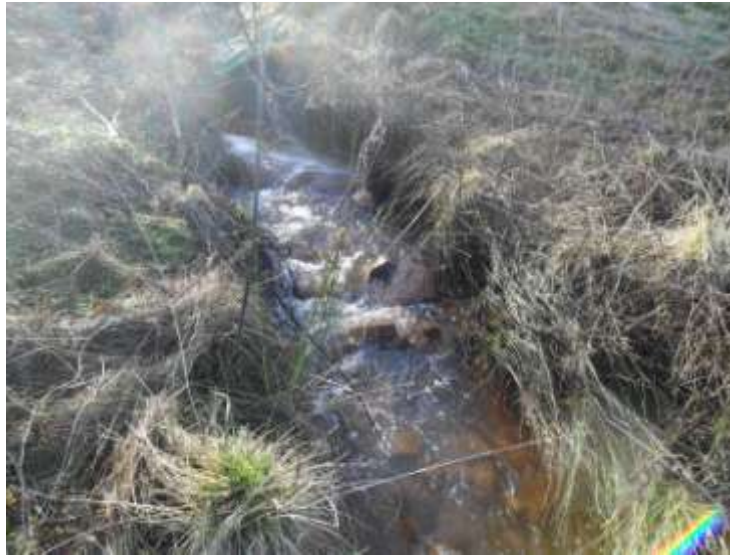
The river becomes less confined after Inchcross Road and assumes a more natural alluvial state. There is some morphological development with masonry debris organised into steep rapid areas with lower energy pools behind (Figure 1-13).

**Figure 1-13: Masonry rapids in the channel after Inchcross Road.**

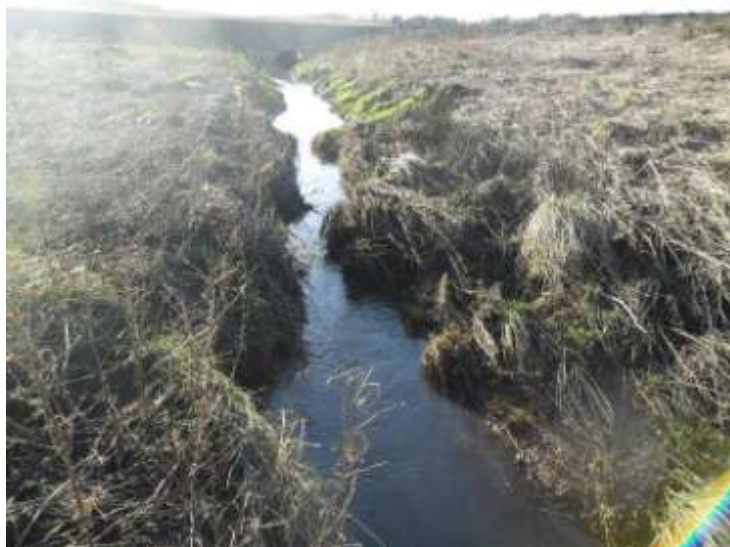
The river enters a wide floodplain area shared with the Bog Burn. There is generally good connectivity (Figure 1-14); however, floodplain processes are disrupted by a complex set of high flood banks running parallel and perpendicular to the channel and by a new road crossing of the floodplain interrupting the downstream continuity of flow processes. Local channel instability has already been triggered at the culvert under the new road (Figure 1-15).

**Figure 1-14: Channel - floodplain connectivity on Boghead Burn**

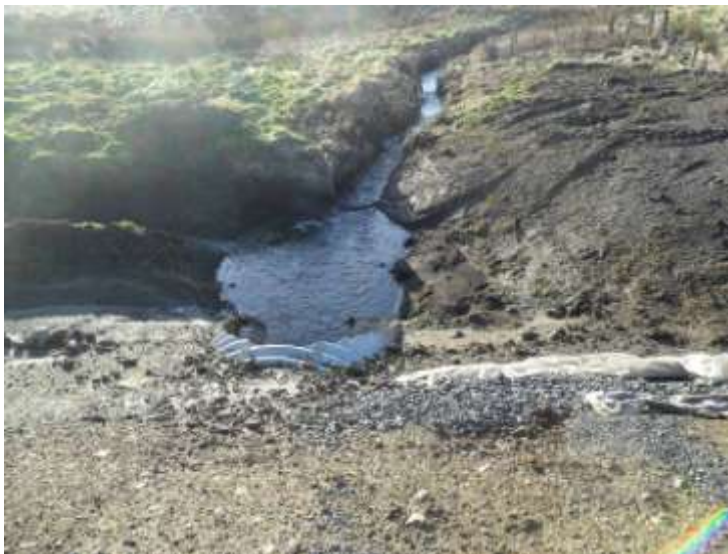
**Figure 1-15: Morphological instability at the new road crossing of the Boghead Burn**

Downstream of Standhill there are a number of opportunities for improvement, in particular where the new road crosses over the burn at the confluence between the Bog Burn and the Boghead Burn. The road here has cut across the least altered part of the floodplain and is constricting the burn and causing a scour hole to develop upstream. Consideration should be given to investigating whether this road can be removed.

| ISSUE 10: New road and culvert across burn and floodplain – splitting floodplain and restricting movement of flood flows | Bog_RdRe_1, Bog_CRe_1 | Remove road and culvert | Downstream of Standhill Road, road connecting Whitburn Road and Leyland | 296770E 667730N to 297134E 667534N – Bog_RdRe_1<br>296933E 667612N to 296961E 667658N – Bog_CRe_1 | Morphology | Flood attenuation downstream; re-establishment of floodplain dynamics; rare floodplain habitats reconnected, likely improvement to riparian margins; flood concentration zones removed. | Local flooding frequency increase (duration may reduce), potential drop in geomorphic activity in channel promoting sedimentation locally; road and culvert recently constructed to unlikely to be removed. | Not costed | No capacity info |

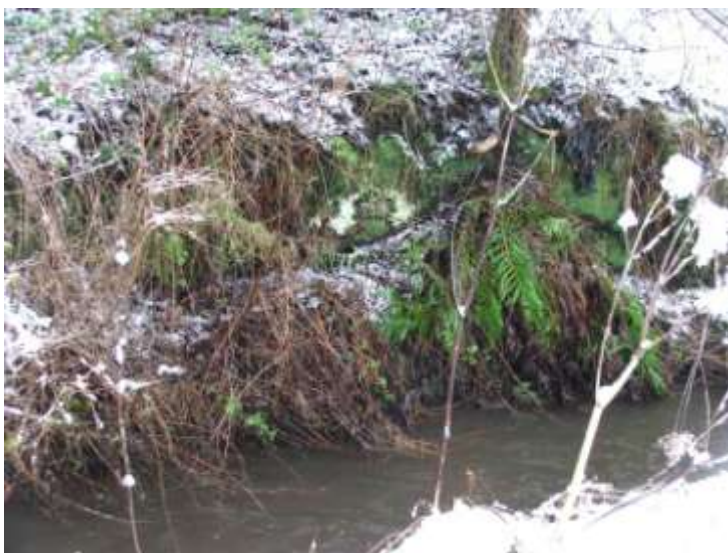
In terms of landuse east of Inchcross Road the burn emerges into a more rural landscape, although this can be misleading. The land on the left bank of the river is made up of tipped bing materials and is covered by recent forestry plantations. The right bank is made up of semi-improved grassland that is summer grazed by cattle: the only grazing stock at the time of the visit were roe deer *Capreolus capreolus*. The sides of the channel are lined with bricks that are falling away and this is home to a number of plant species, including male fern *Dryopteris filis-mas* (see Figure 1-16).

**Figure 1-16: Male fern and bryophytes growing on the eroding brickwork channel sides**

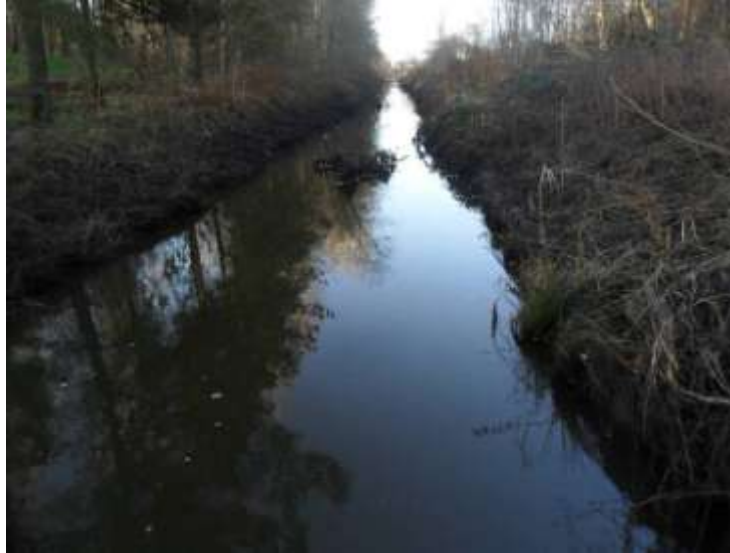
The Bog Burn is a heavily modified alluvial single thread channel devoid of any significant in-channel morphology apart from narrow lateral fine sediment berms (Figure 1-17). Flow is sluggish and ponded, being influenced at low flow by a pipe crossing at Boghead Bridge (Figure 1-18).

**Figure 1-17: Hydromorphically degraded reach of the Bog Burn**

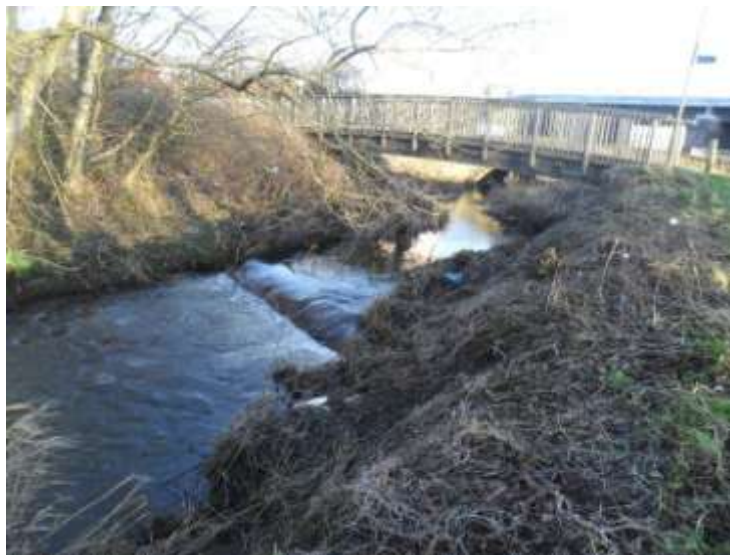
**Figure 1-18: Low flow control on Bog Burn**

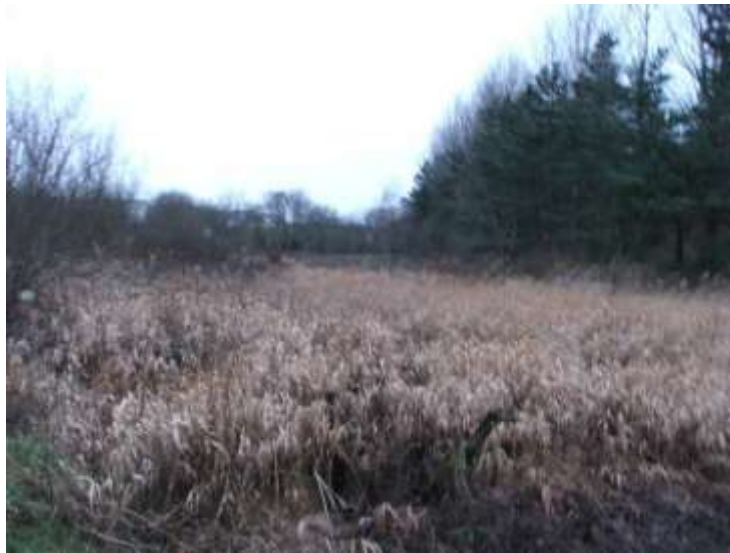
**Figure 1-19: Poor reed canary grass fen bordering forestry adjacent to the Boghead Burn**

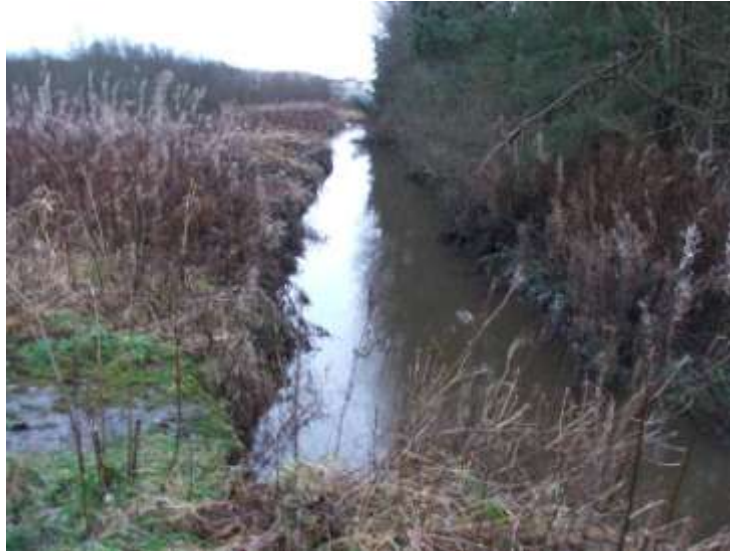
The artificial looped section near Whiteside is entirely man-made and the river is completely canalised and isolated from its floodplain by the numerous old railway lines and the height of the made land to the north of the channel (see Figure 1-20 ). In order to reconnect the river with its floodplain and improve the overall ecology of this area, consideration should be given to excavating the old bing material between Boghead Bridge and the ancient hedge line to create a lower lying area of floodplain through which the burn can flow. A new sinuous course could be created and the burn allowed to work the existing material and create its own in-channel features. The outflow from the pumping station on the right bank should be redirected northwest along the present channel of the Bog Burn until it reaches the old hedgeline where it

**Figure 1-20: Canalised section of Bog Burn with poor fen on the left hand side and forestry on the made ground on the right**

can join the new channel. This will allow the areas of fen in this area to be fed by the water from this source. The current straight course of the Bog Burn can then be allowed to become a backwater and silt-up, This will in time become colonised by alder and willow trees and this process can be helped on the right bank when the works there are completed.

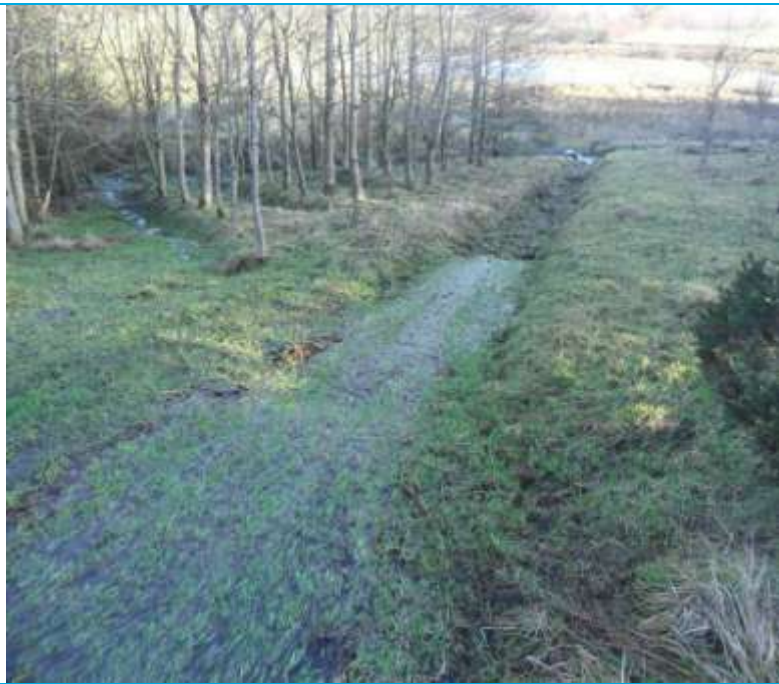
| | <p>Location : 1</p> <p>Description: Flow off of roadway disappears underground drying the surface channel</p> <p>OS NGR: 29460 66676</p> <p>Notes:</p> |

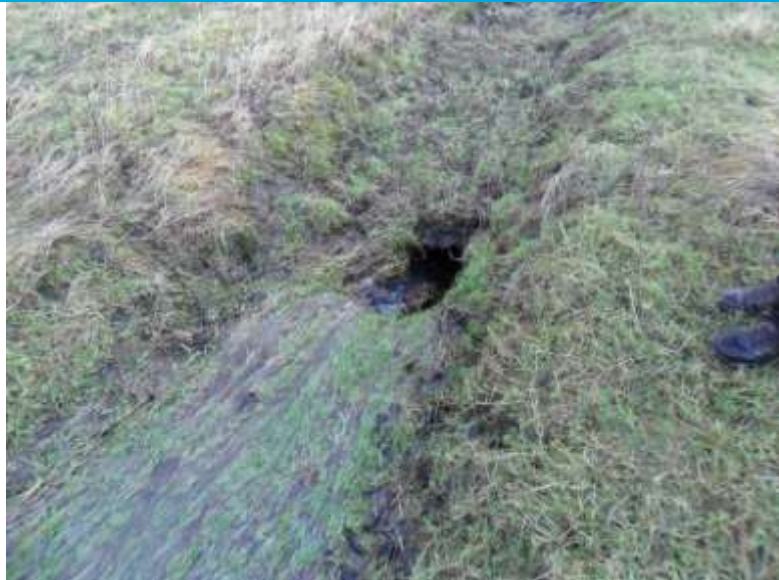
| | <p>Location : 1</p> <p>Description: Underground flow path</p> <p>OS NGR: 29460 66676</p> <p>Notes:</p> |

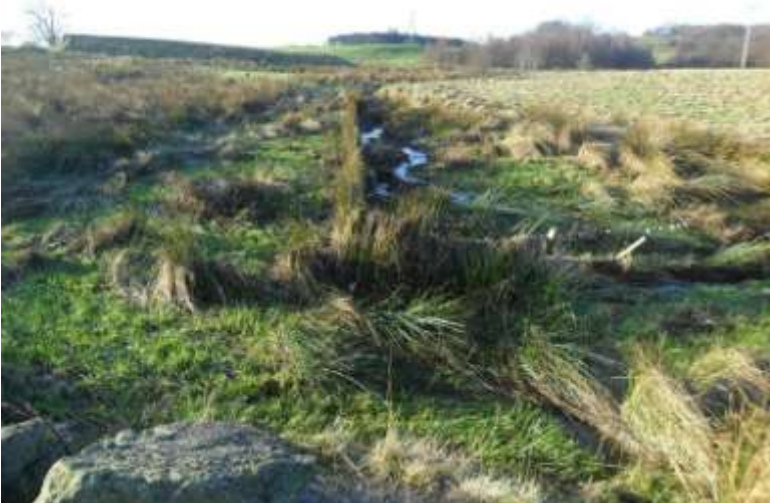
| | <p>Location : 2</p> <p>Description: poorly defined drainage channel</p> <p>OS NGR: 29475 66680</p> <p>Notes:</p> |

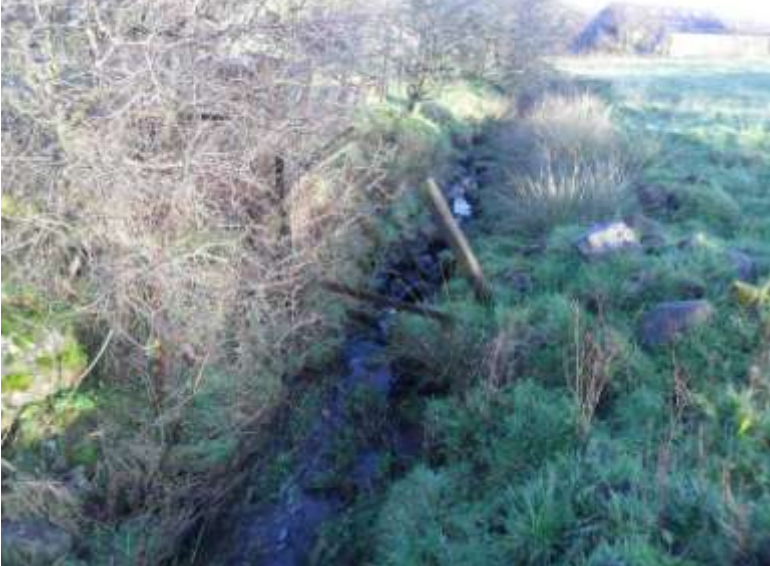
| | <p>Location : 3</p> <p>Description: Poor cobble plane-bed – riffle channel</p> <p>OS NGR: 29496 66683</p> <p>Notes: Channel remains engineered and over-deep</p> |

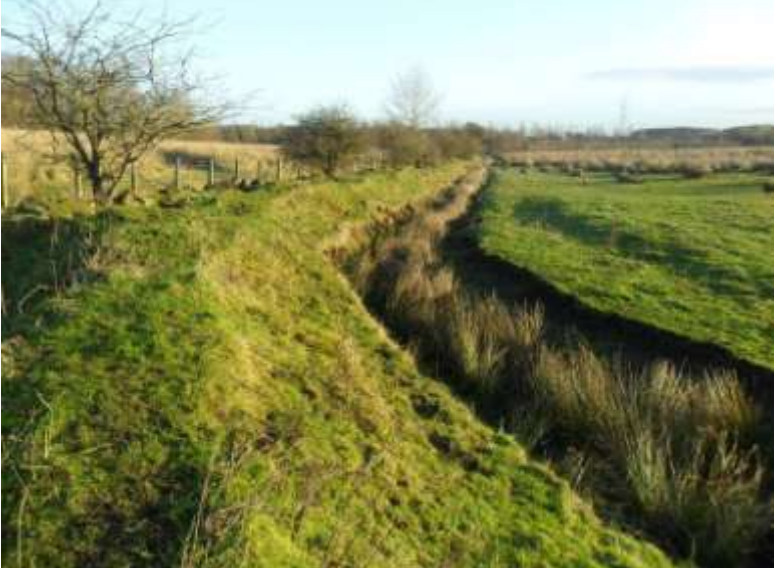
| | <p>Location : 6</p> <p>Description: Heavily sedimented engineered channel</p> <p>OS NGR: 29541 66684</p> <p>Notes:</p> |

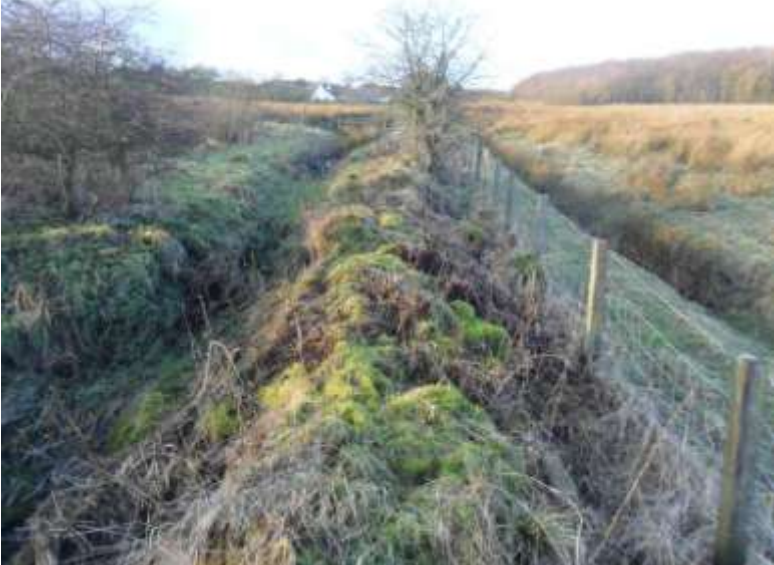
| | <p>Location : 7</p> <p>Description: Dry additional drainage channel</p> <p>OS NGR: 29557 66691</p> <p>Notes:</p> |

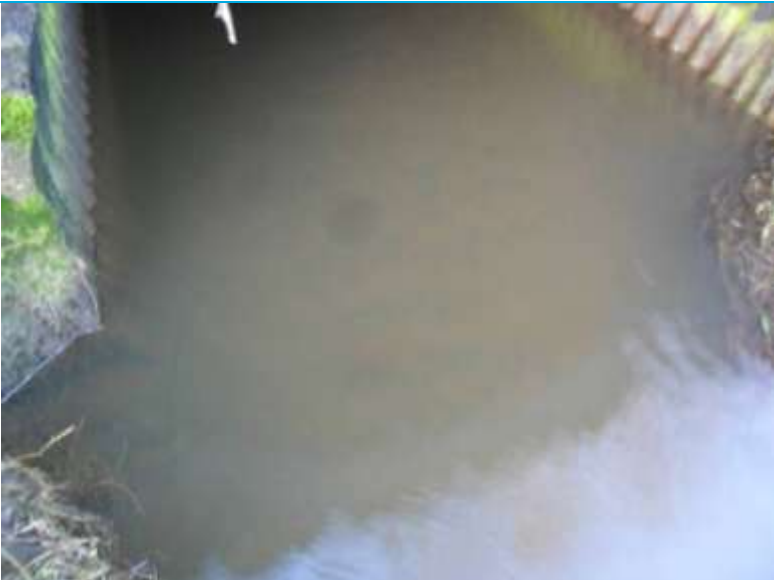
| | <p>Location : 10</p> <p>Description: A801 Road Culvert</p> <p>OS NGR: 29575 66694</p> <p>Notes: Note heavy fine sediment bed load</p> |

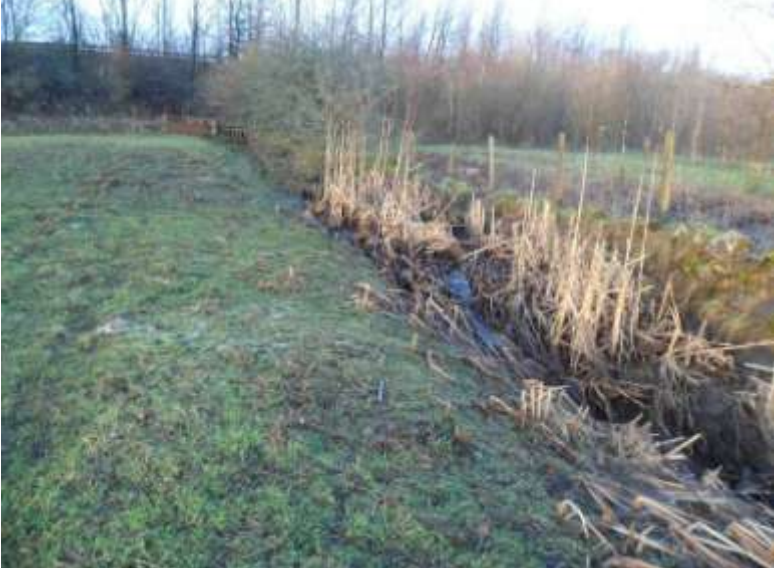
| | <p>Location : 11</p> <p>Description: Heavily sedimented straightened channel</p> <p>OS NGR: 29580 66694</p> <p>Notes: Strong reed growth controlling upstream water levels</p> |

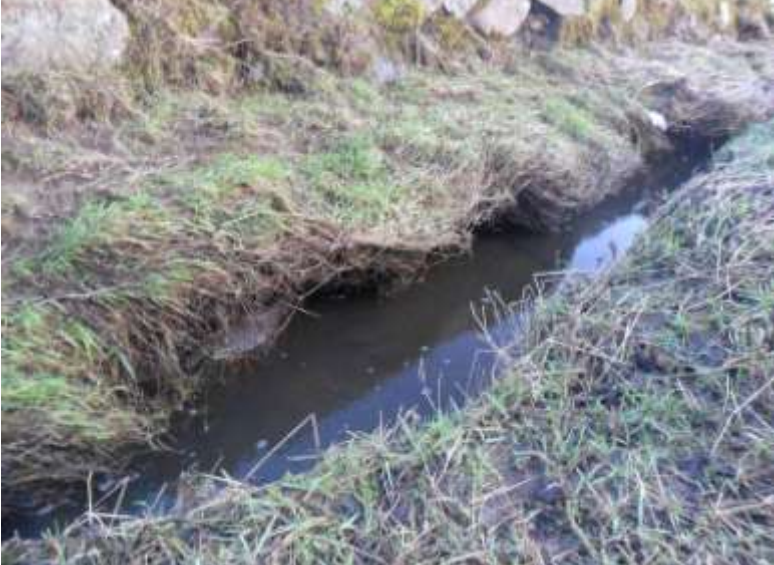
| | <p>Location : 12</p> <p>Description: Local channel bank undercutting</p> <p>OS NGR: 29583 66694</p> <p>Notes:</p> |

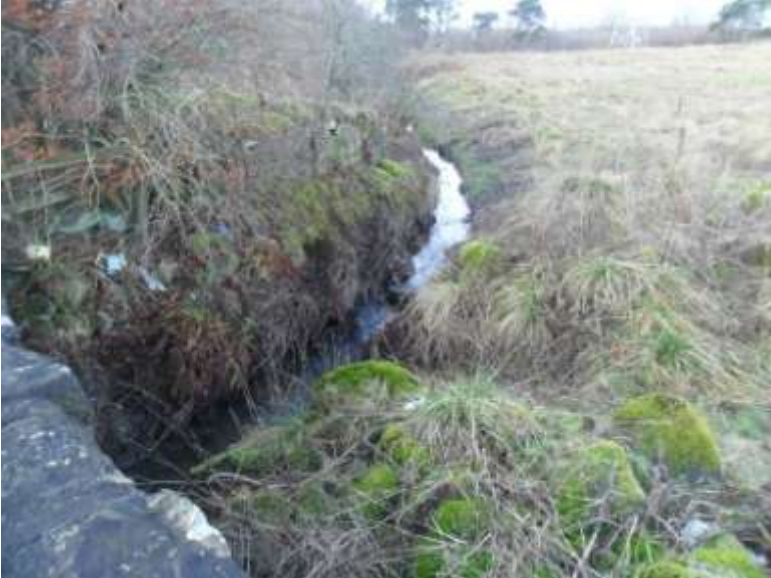
| | <p>Location : 17</p> <p>Description: Over-deep alluvial single-thread channel</p> <p>OS NGR: 29609 66703</p> <p>Notes: Heavily engineered with disconnected floodplain</p> |

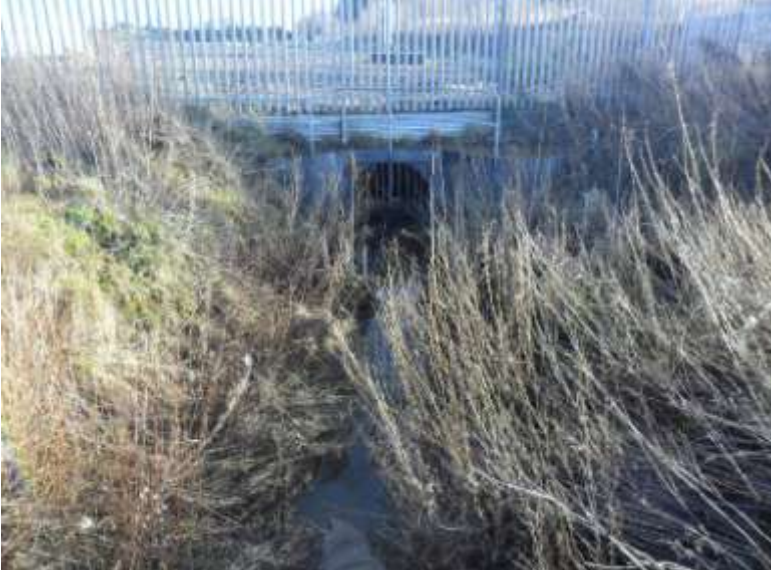
| | <p>Location : 18</p> <p>Description: Flow into culvert under Standhill Depot</p> <p>OS NGR: 29611 66702</p> <p>Notes: Majorly sedimented channel</p> |

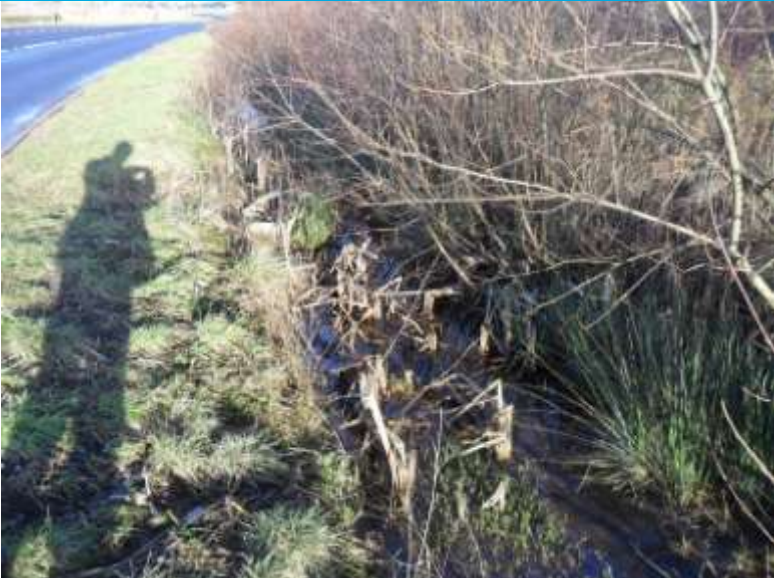
| | <p>Location : 19</p> <p>Description: Sedimented tributary</p> <p>OS NGR: 29611 66699</p> <p>Notes:</p> |

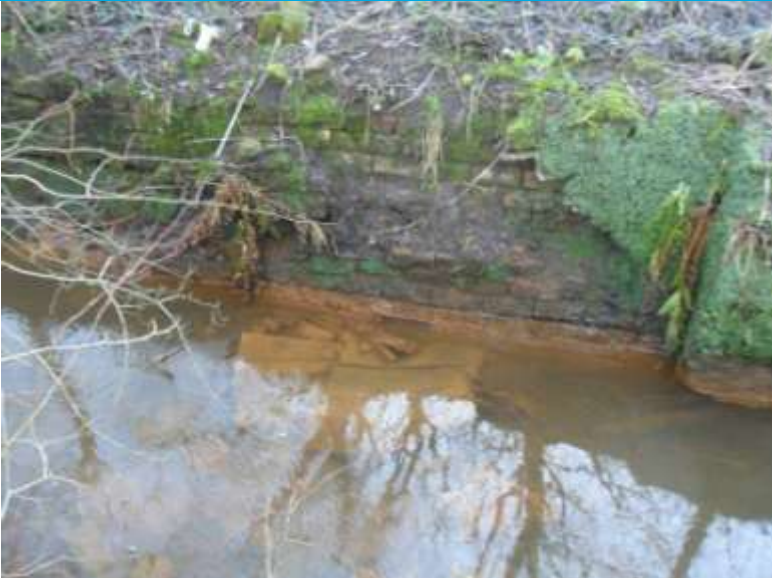
| | <p>Location : 22</p> <p>Description: degraded masonry bank protection</p> <p>OS NGR: 29663 66706</p> <p>Notes:</p> |

| morphology, degraded masonry bank protection, bank erosion, rapids formed from out of eroded masonry material | | remove masonry material, restore rapids | downstream of Standhill Road | 296720E 667294N | Source Pollution | reinstatement will improve bed morphology, hydraulics and sedimentology, fisheries and invertebrate improvements, necessarily restored channel dynamics. | may lead to adverse public reaction. Hydraulics must be appropriate with restored morphology otherwise restoration will fail in the long term. May need to create temporary site access. | | fully covered capacity dataset) |

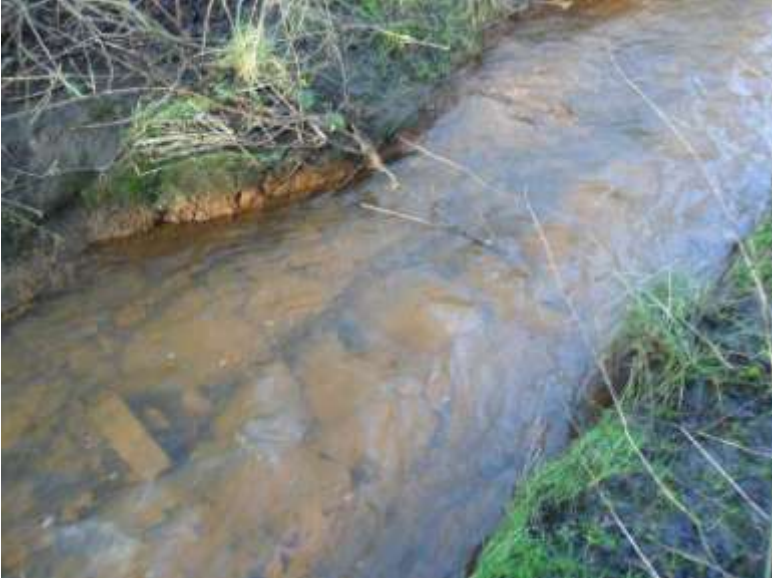
| | <p>Location : 23</p> <p>Description: Bank erosion along failed protection</p> <p>OS NGR: 29668 66708</p> <p>Notes:</p> |

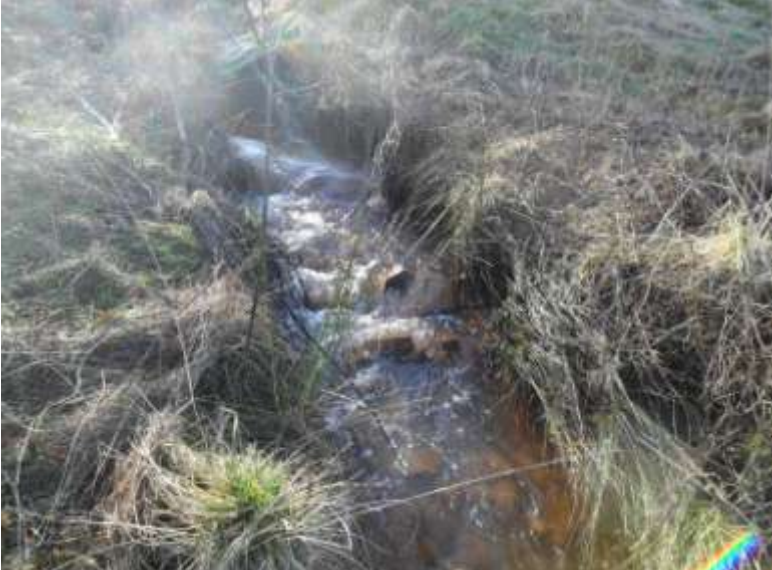
| | <p>Location : 24</p> <p>Description: Rapids formed from masonry</p> <p>OS NGR: 29670 66712</p> <p>Notes:</p> |

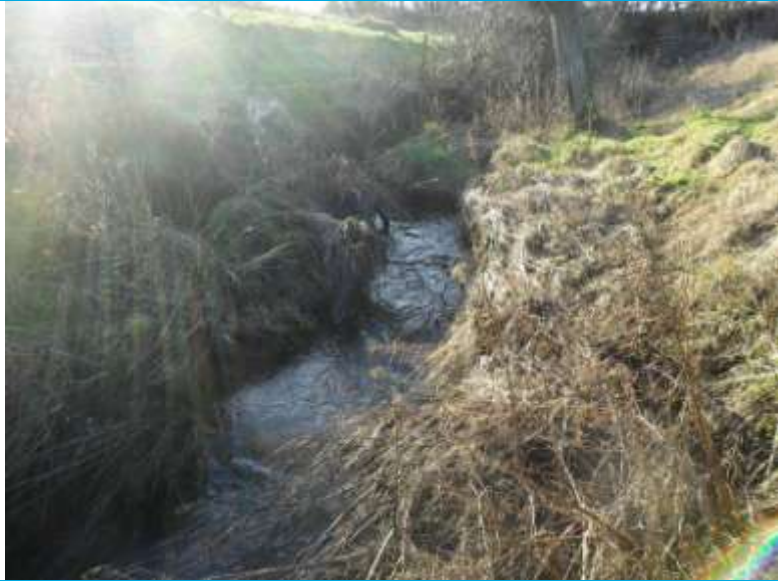
| | <p>Location : 25</p> <p>Description: developing low level berm features</p> <p>OS NGR: 29682 66754</p> <p>Notes: Channel remains over-deep</p> |

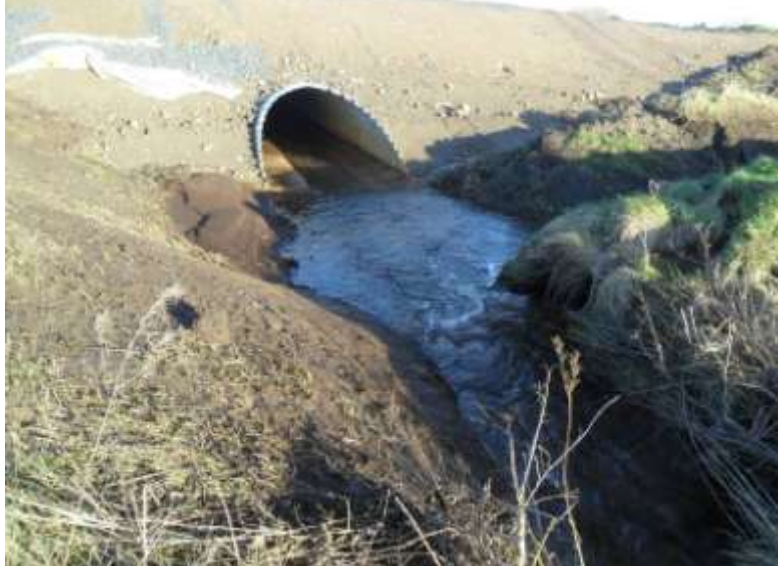
| | <p>Location : 26</p> <p>Description: Culvert for new road crossing</p> <p>OS NGR: 29697 66765</p> <p>Notes: Exit erosion occurring</p> |

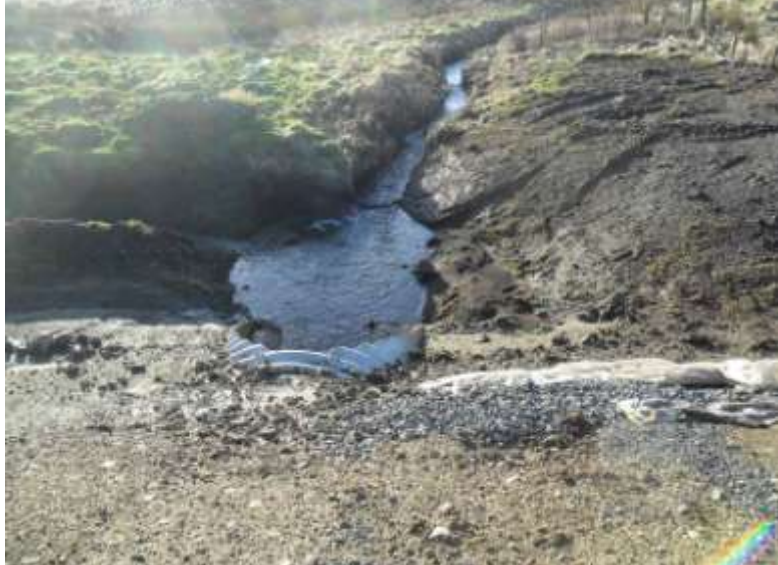
| | <p>Location : 26</p> <p>Description: Culvert under new road</p> <p>OS NGR: 29697 66765</p> <p>Notes: Erosion at culvert exit</p> |

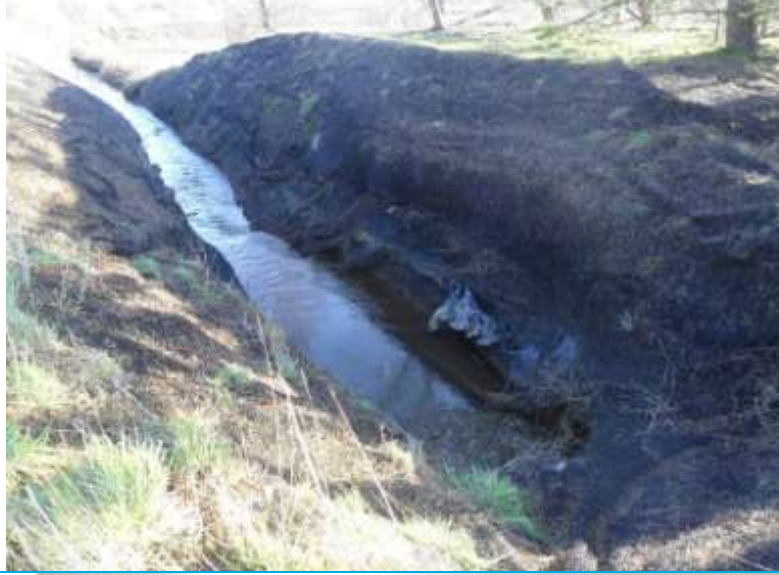
| | <p>Location : 28</p> <p>Description: Failed geotextile protection through dissected embankment</p> <p>OS NGR: 29722 66774</p> <p>Notes:</p> |

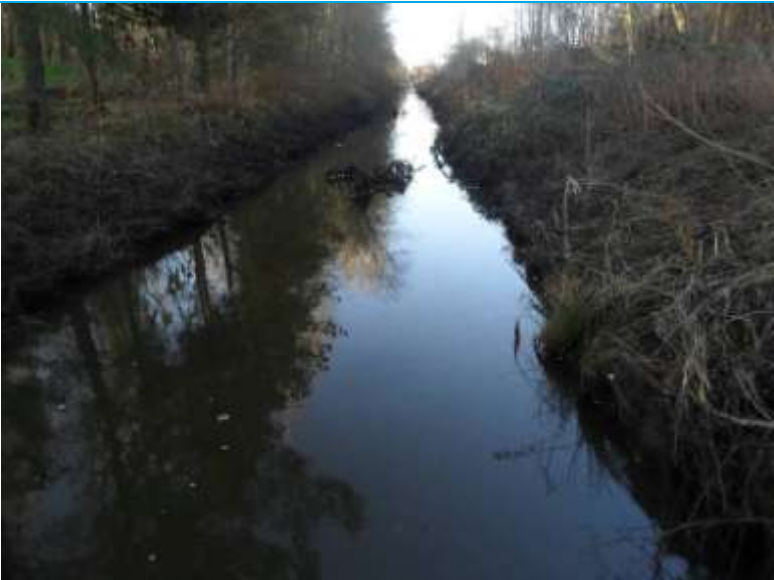
| | <p>Location : 30</p> <p>Description: Bog Burn</p> <p>OS NGR: 29739 66792</p> <p>Notes: Straightened artificial channel</p> |

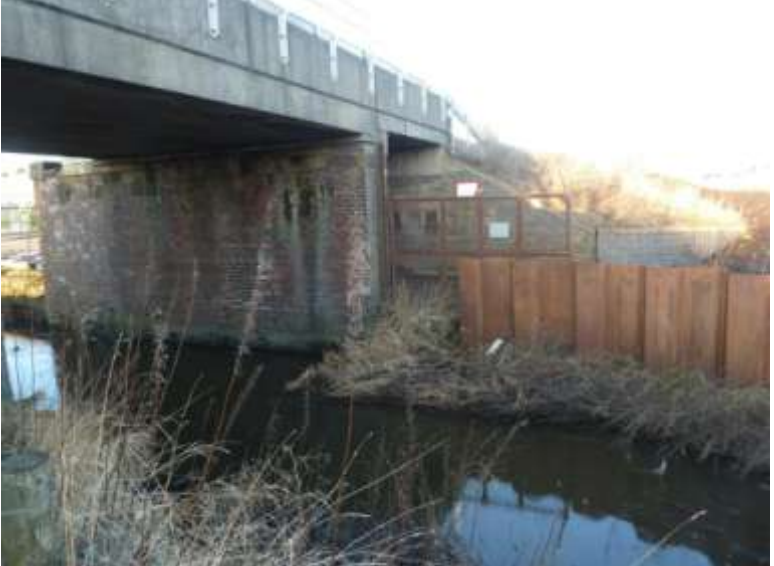
| | <p>Location 31: Boghead Bridge</p> <p>OS NGR: 29725 66798</p> <p>Notes: Sheet piling on channel bank</p> |

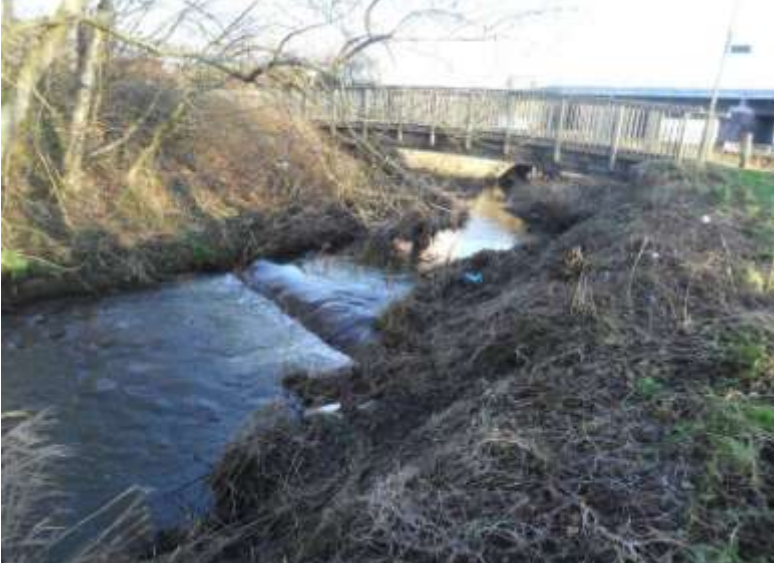
| | <p>Location : 32</p> <p>Description: Pipe structure at Boghead Bridge</p> <p>OS NGR: 29709 66829</p> <p>Notes:</p> |
