Back Burn Hydromorphic Character and Restoration Opportunities

FINAL

June 2012

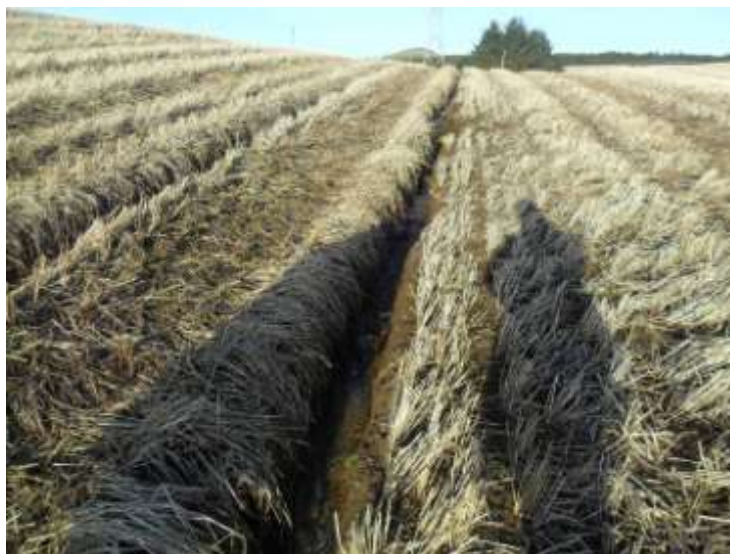
Figure 1-3: Significant farmland mixed sediment inputs

Current farming practice in the area is generating significant mixed sediment (Figure 1-3) and this is being transferred to the channel through surface water flows and minor gullyng.

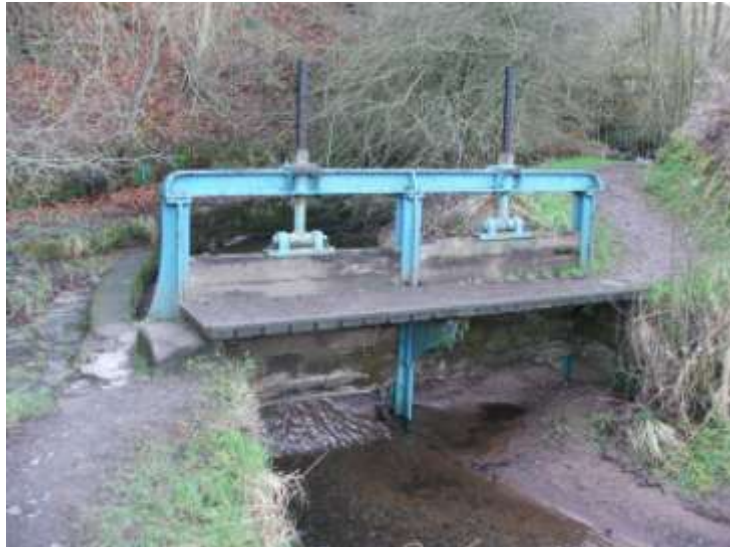
Figure 1-5: Victorian cast iron sluice gate used to direct water out of the natural course of the burn and into a raceway

The most interesting restoration project for the burn would be at the Coul Reservoir. Here it is a recommendation that the existing cast-iron sluice gate at the start of the raceway be removed (or if protected, closed) to allow water to once again flow into the former channel occupied by the burn. This would dramatically improve the ecology of this steep valley and would increase the throughput of water into the reservoir and ensure that the outflow channel flows all year round.

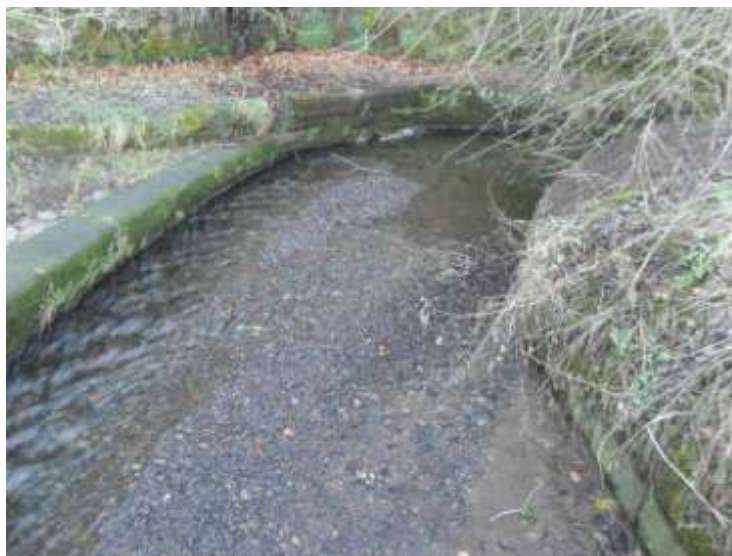
Figure 1-10: Mixed sediment deposition upstream of the weir controlling flow into Coul Reservoir

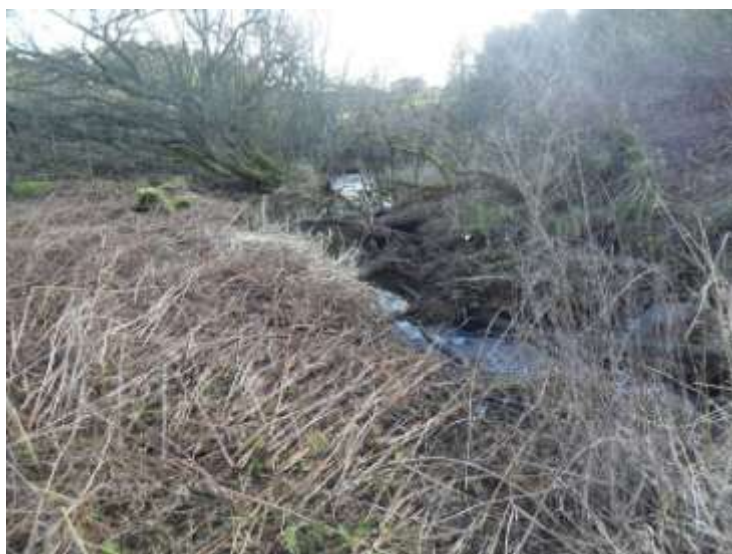
Figure 1-17: Woody Debris Dam across the channel

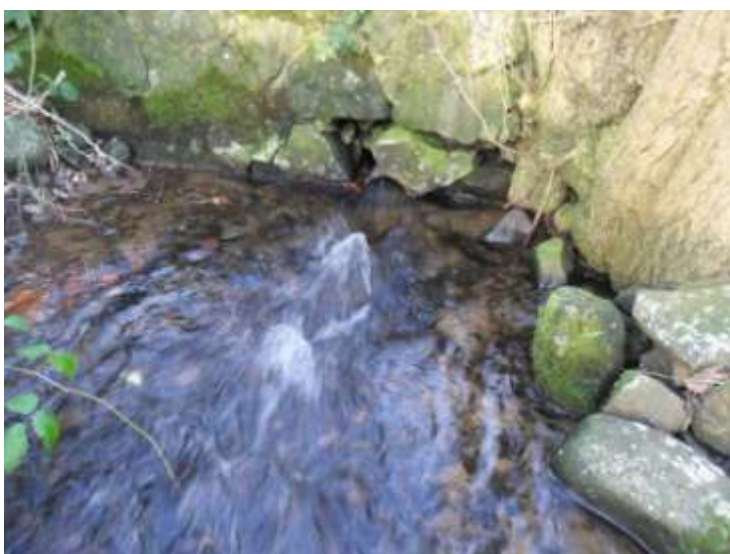
Immediately after the B969 road flow exits from the culvert through a restricted pipe into an area of woodland with a small patch of improved grassland. The pipe (Figure 1-19) allows only a fraction of the flow to enter the channel with the rest being diverted underground around Balfarg to rejoin after the A92(T). The impact of flow loss on the channel has been significant and severe with extensive sedimentation in the original channel immediately downstream of the culvert exit (Figure 1-20).

Figure 1-19: Reduced flow piped exit after the B969

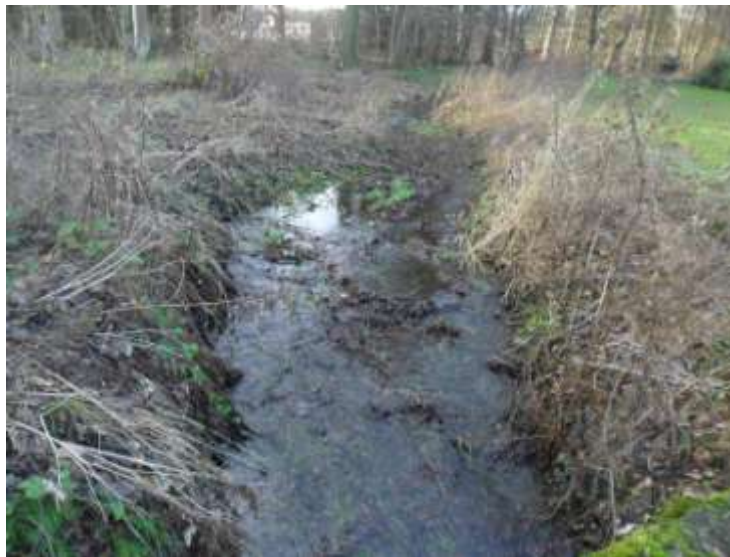
Figure 1-20: Strongly sedimented alluvial plane bed channel

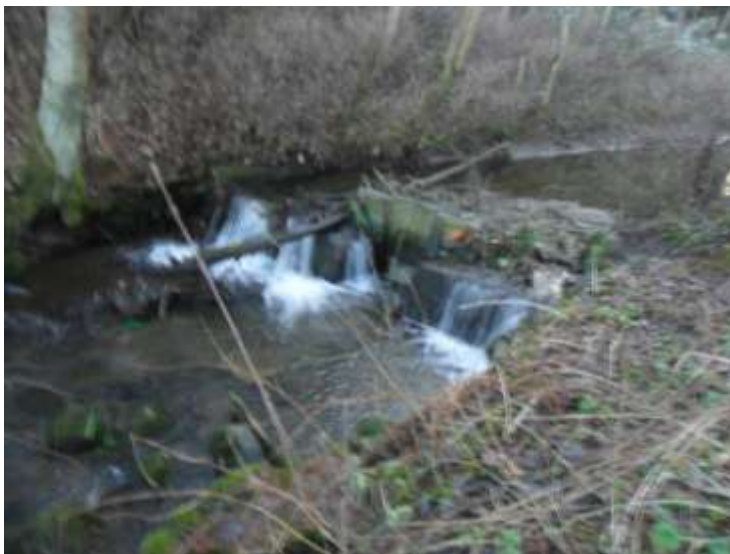
Figure 1-24: Redundant structure in the channel.

On the other side of the A92 the burn is once again in good health with its flow restored. Here there are a number of obstructions in the watercourse, such as weirs, culverts and a redundant gauging weir. These structures and the associated gabion baskets should be removed so that the stream can have a more natural relationship with the surrounding woodland. In one place defences are required due to the presence of a buried water main, which forms a bank with manholes parallel to the burn. This has become infested with snowberry, a non-native species, and this should be removed to restore the woodlands to a more natural state and promote the growth of ground flora.

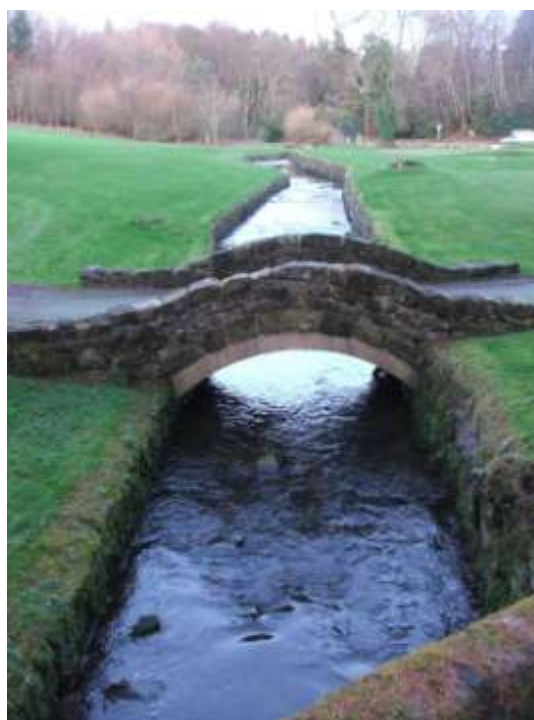
Figure 1-25: Heavily modified and engineered stream near Balbirnie House

The next opportunity is near Balbirnie House. Here the burn is straight and confined within artificial walls. The bank protection should be removed where practicable and the river allowed to alter naturally. This will allow a greater variety of natural features to develop (with a corresponding increase in the numbers of ecological niches available) and the colonisation of the banks with a riparian flora.

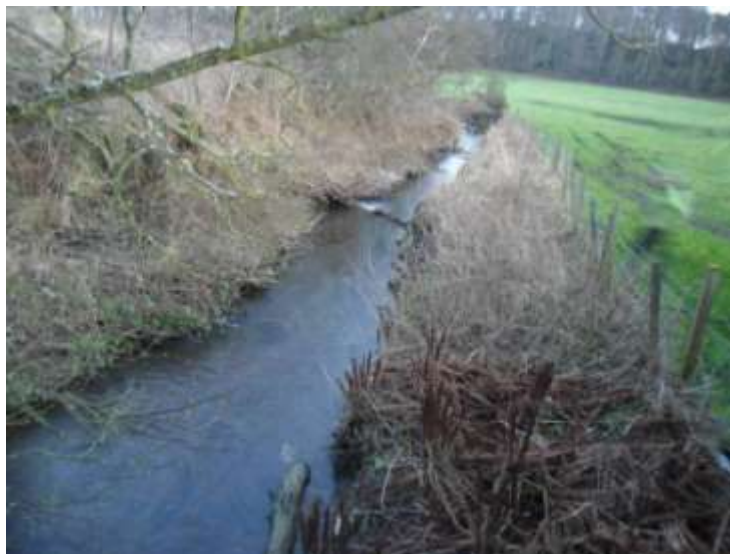
The character of the channel changes again as it exits the confined wooded valley close to Stob Cross Road. Here the river has been straightened (Figure 1-27) having originally flowed in channels to the south and north of the current river. The channel route to the south, although older than the northern channel, is evident from line of rush (Figure 1-28) and offers a significant opportunity for restoration and wetland creation close to the railway crossing.

Figure 1-27: Straightened section of the Back Burn through Markinch.

The final reach from Stob Cross Road to the railway embankment is again engineered straight although there is evidence both north and south of the man-made channel or older channels. It is a recommendation of this report that the burn be redirected in a sinuous, multi-threaded channel to the south of its present location, through the existing area of rushy pasture until it meets the railway embankment. Here a new wetland should be created to allow the water draining down the embankment somewhere to go before eventually flowing under the bridge to the east. This wetland would be fenced-off from the remainder of the field to prevent excessive poaching and should be grazed by cattle for a week or two in August or September, depending on ground conditions. This will prevent the colonisation of the area by trees and ensure that the herbage does not become too rank. This will benefit amphibians, flowering plants and wading birds such as snipe *Gallinago gallinago*.

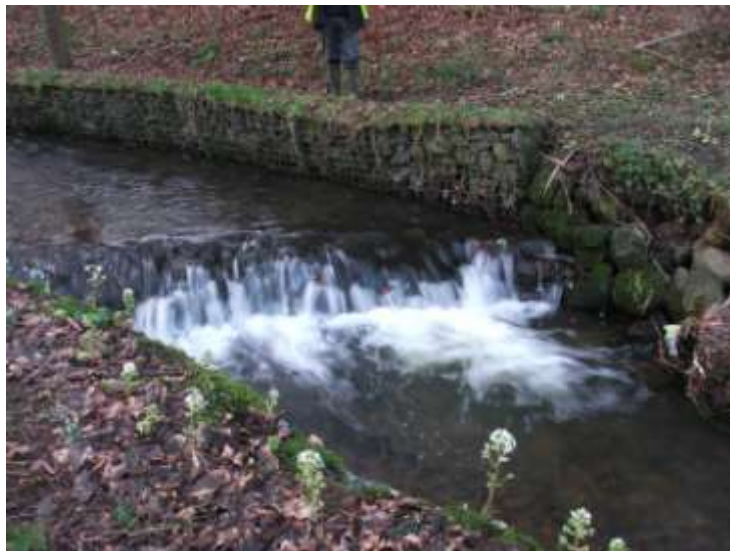
Figure 1-29: Gabion baskets and cobble weir hindering fish passage and the development of a riparian margin

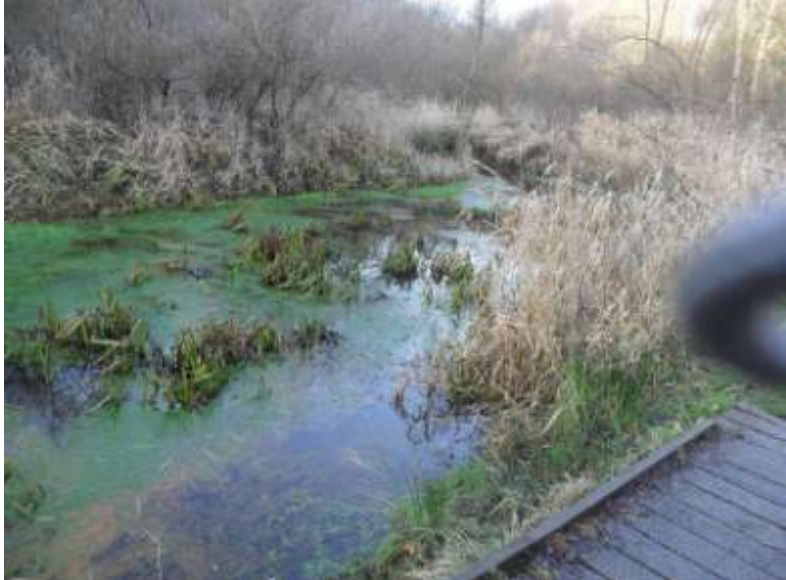
<p>Location : 11</p> <p>Description: Anastomosed sub-channel</p> <p>OS NGR: 32685 70387</p> <p>Notes: One of several sedimenting sub-channels</p>

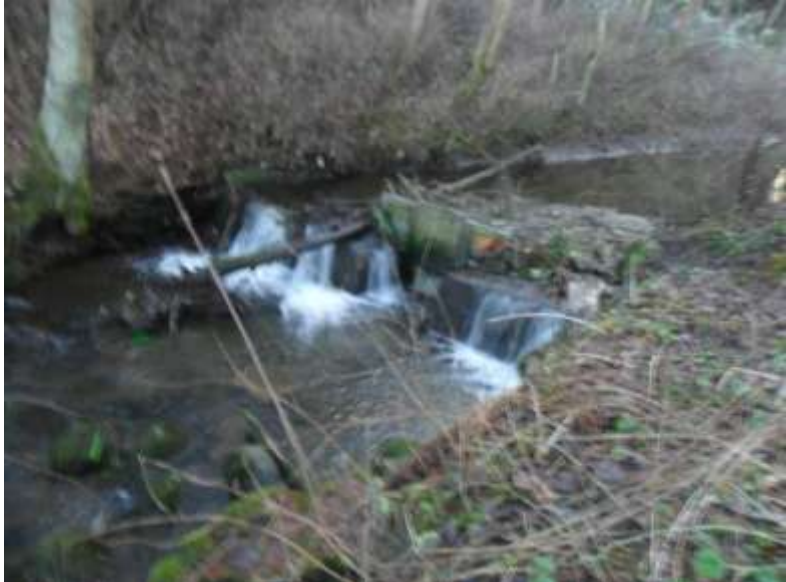
<p>Location : 38</p> <p>Description: Boulder weir structure</p> <p>OS NGR: 32869 70268</p> <p>Notes: Extend boulder area downstream if removal not possible</p>

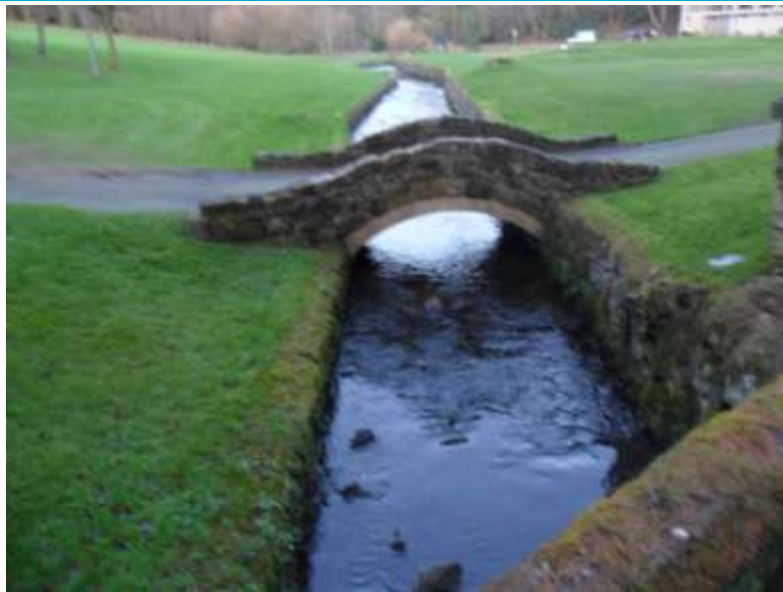
<p>Location : 39</p> <p>Description: Redundant notched weir</p> <p>OS NGR: 32873 70256</p> <p>Notes:</p>
