Catchment Scale Restoration on the River Peffery

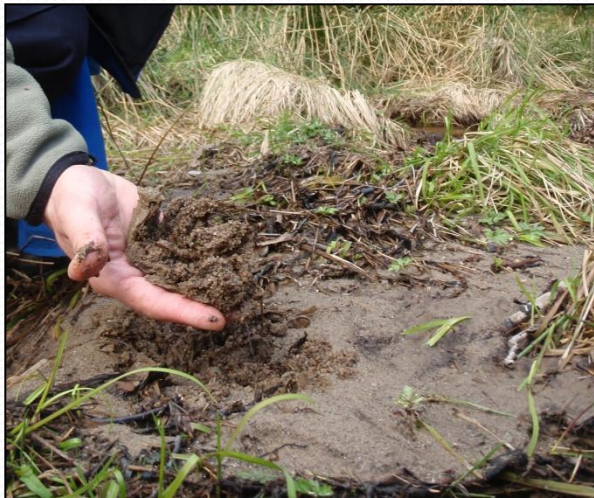
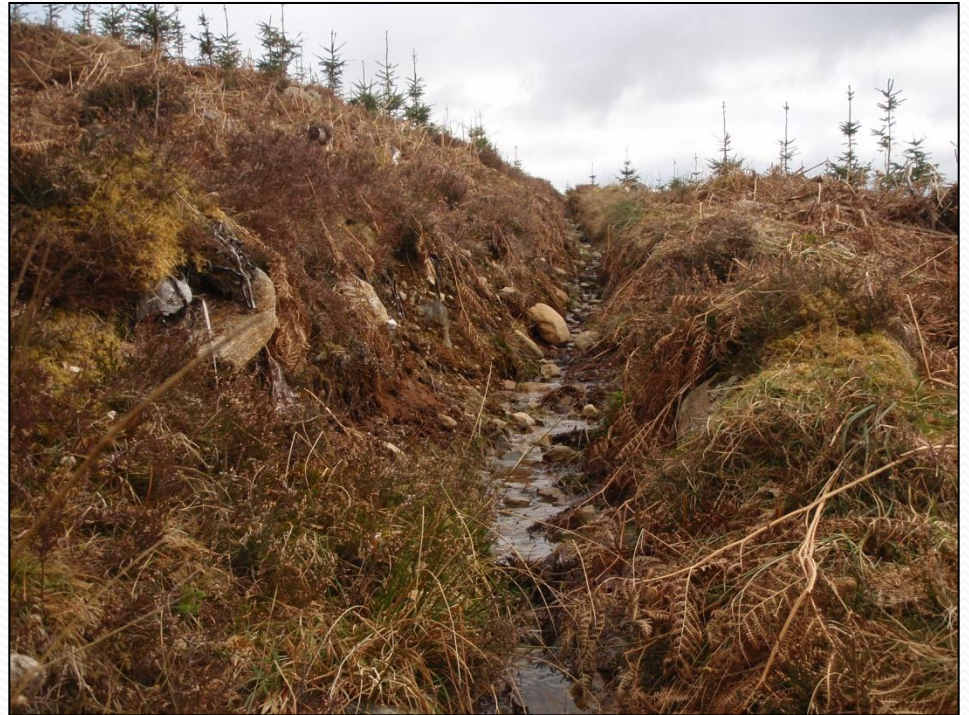
Forestry Pressures

- Acidic run off
- Source of silt
- Flash flooding
- Limited diversity

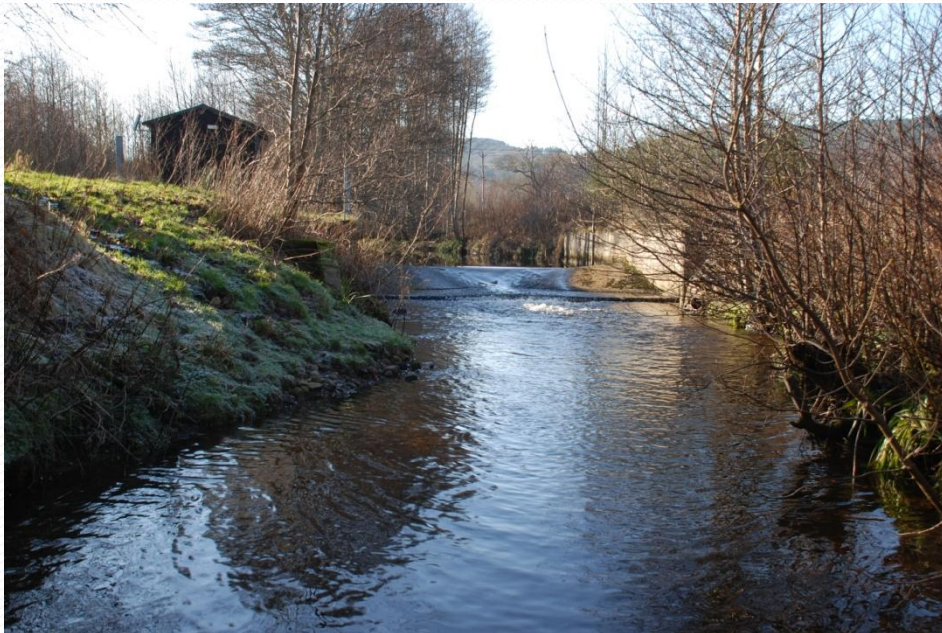
Barriers

- Scottish Water gauging weir (sewage works)
- Negotiated via SEPA for barrier easement in 2013

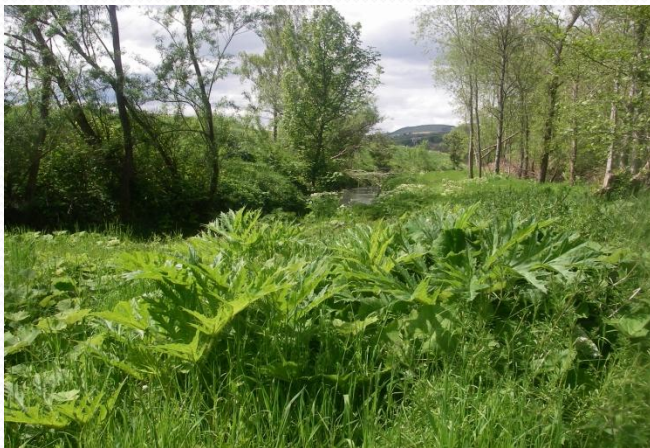
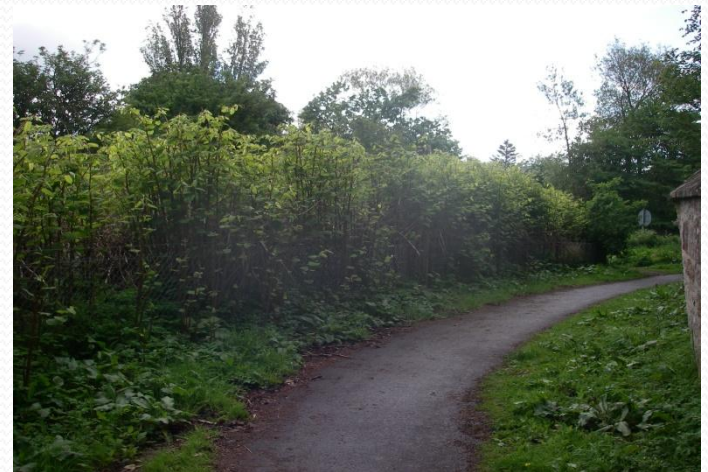
Invasive Non Native Species

- Limiting bank side biodiversity
- Reducing amenity value
- Removed as part of larger RAFTS project
- Followed by bank side planting with local willow cuttings and alder saplings

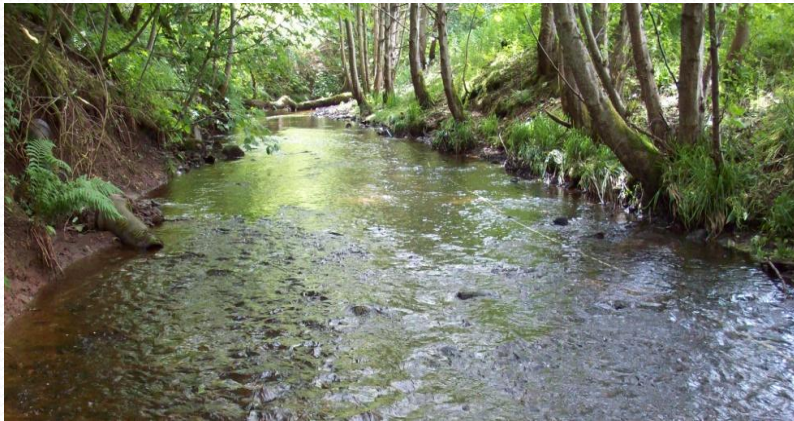
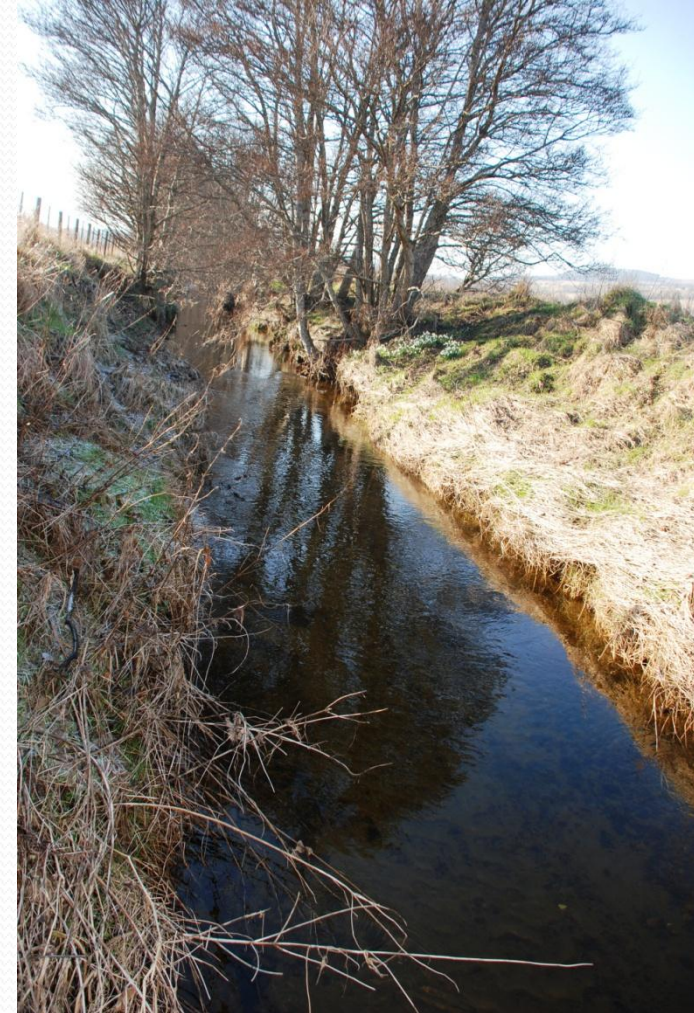
Morphology

- Historically straightened (1740s ?)
- Constrained between flood banks
- Limiting natural river processes
 - Over widened / incised
 - Shallow uniform depth
 - Compacted bed
 - Lacking in stream diversity
