Some thoughts on channelized streams, salmonid fish and their management in arable eastern Scotland.

David Summers

Tay District Salmon Fisheries Board

September 2013

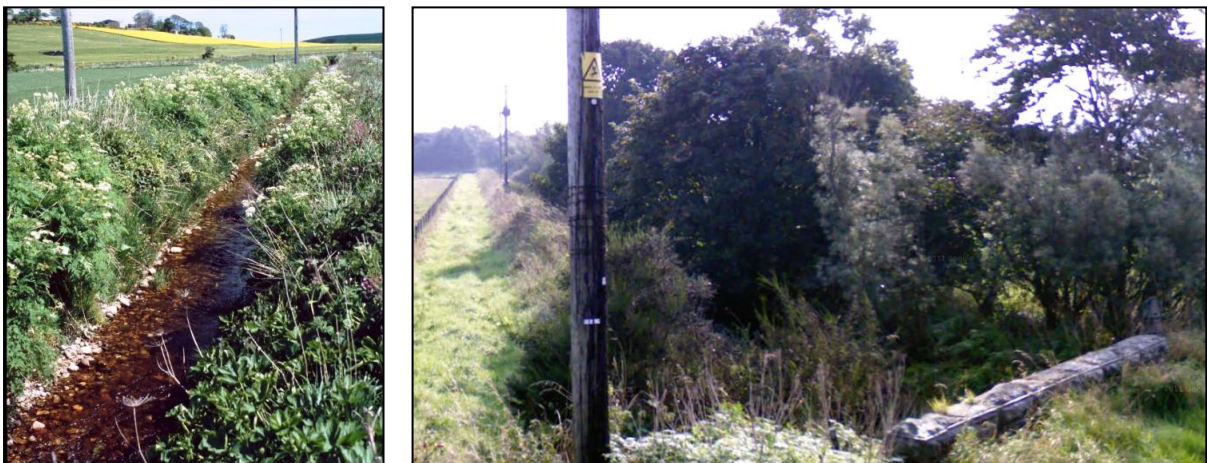
Figure 1.1. Adziel Burn, tributary of North Ugie Water, Aberdeenshire. Photo on left taken *ca* 1990 relatively soon after maintenance dredging of historically straightened channel. Despite having recently been dredged, the banks had effectively re-vegetated. Note the riffle nature of stream and clean gravel substrate. Recent photo on right from Google Street View. It is not really possible to see the stream, but there has been a major growth of planted trees on south side and establishment of dense grassy vegetation on the north bank which appears to be part of some buffer strip scheme. In 1991, densities of 0.04 salmon fry and 1.05 trout fry per square metre were found here on a semi quantitative electrofishing survey. In 2001 the figures were 0.44 and 0.89 respectively.

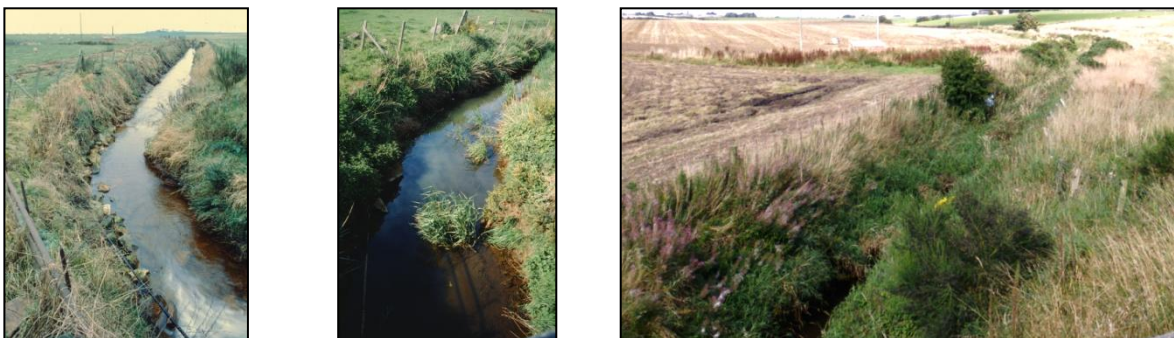
Figure 1.2 Faichfield Burn, tributary of River Ugie, Aberdeenshire. Left and centre photos taken *ca.* 1990 in different seasons. Left photo was taken just after some maintenance dredging. Right photo, recent image from Google Street View. Note dense grassy vegetation and stable channel which has not significantly changed over the period.

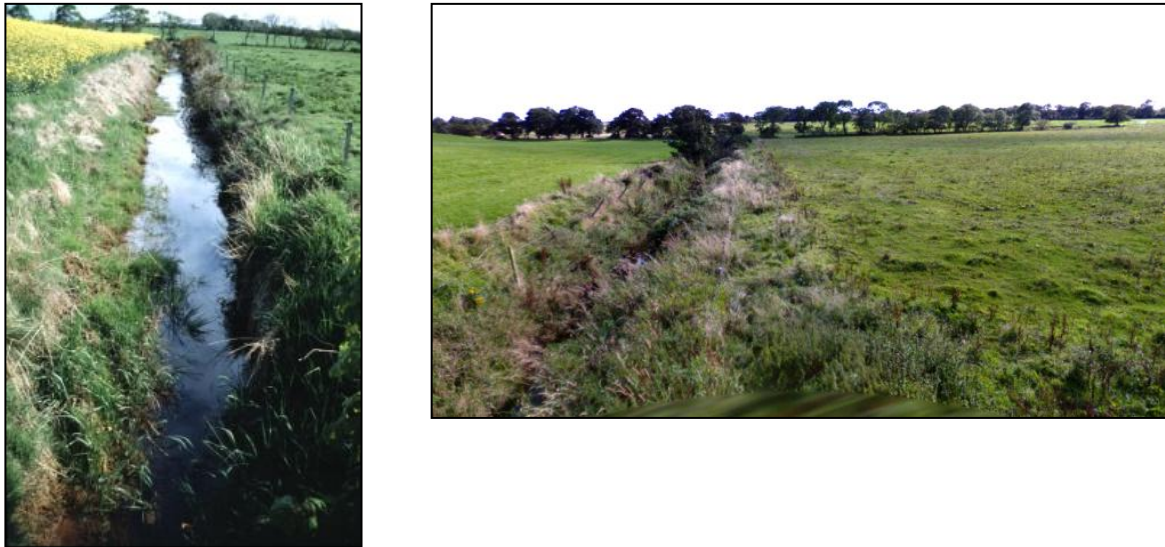
Figure 1.3 Faichfield Burn, tributary of the River Ugie, Aberdeenshire. Photo on left taken *ca.* 1990, right photo recent from Google Street View. This channel again appears highly stable over this period.

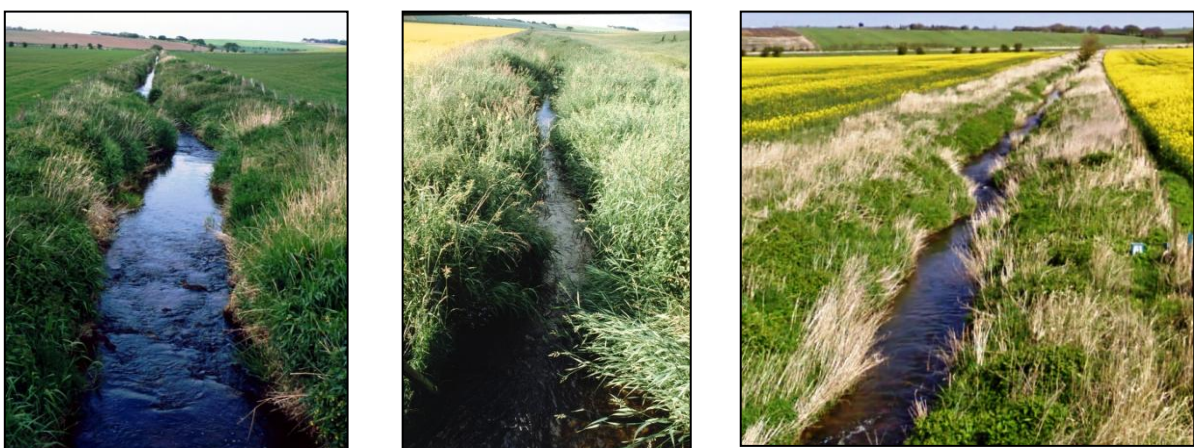
Figure 1.4 The Quhomery Burn, (tributary of the South Ugie Water, Aberdeenshire). Photo on left late spring *circa* 1990. Middle photo, late summer *ca.* 1990, right photo late spring recent Google Street View image. After around 20 years there has clearly been no change in this very stable channel. Note also, there is some degree of riffle / pool variation in this channel. Semi quantitative electrofishing surveys found trout fry densities to be 0.32 per square metre in 1991, 0.92 in 1992, 2.22 in 2001 and 0.91 in 2002. One year old trout densities were 0.38, 0.49, 0.47 and 0.21 respectively.

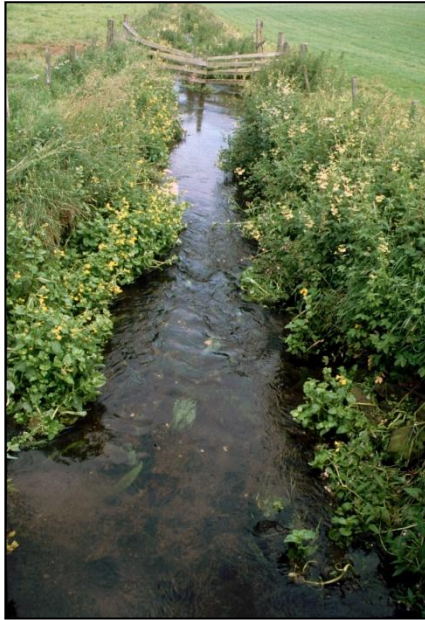
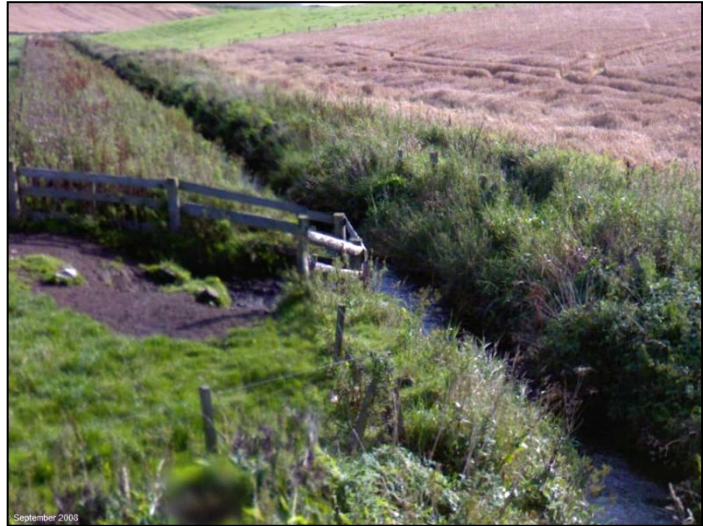
Figure 1.5 Auchreddie Burn, tributary of South Ugie Water, Aberdeenshire. Photo on left taken *ca.* 1990 and, on right, recent image from Google Street View. Note the degree of flow speed / depth variation, dense bankside vegetation and stability which has been maintained. Semi quantitative electrofishing surveys found trout fry densities to be 2.11 per square metre in 1991, 0.6 in 2001 and 0.75 in 2002. One year old trout densities were 0.34, 0.36 and 0.5 respectively.

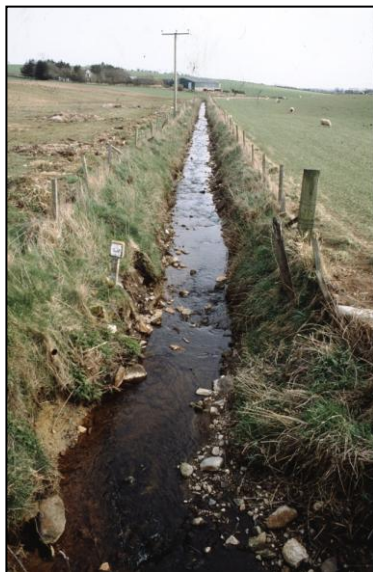
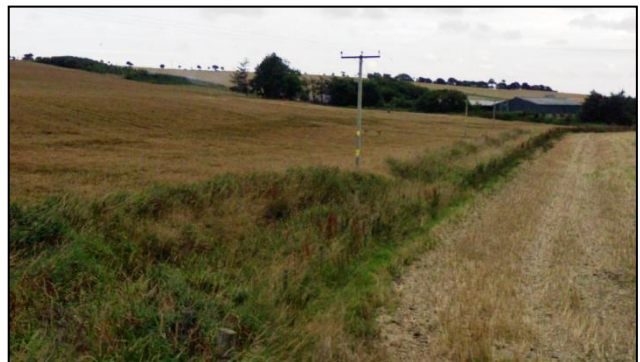
Figure 1.6 Redbog Burn, tributary of North Ugie Water, Aberdeenshire. Photo on left taken *ca.* 1990 shortly after burn was subject to maintenance dredging of historically straightened channel. Note the generally riffly / stony nature of the stream after dredging, indicative of its gradient. The dense growth of summer grasses etc apparent in recent Google Street View photograph clearly show this stream to be stable in the absence of human intervention. No doubt encroachment of grasses resulted originally in the dredging shown.

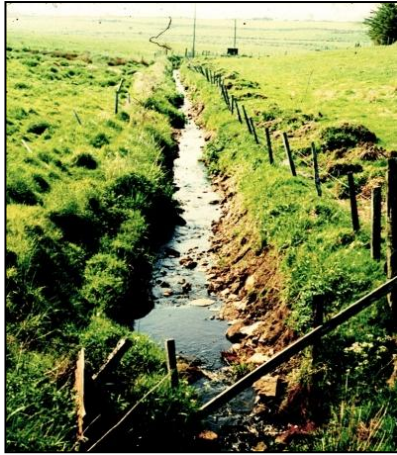
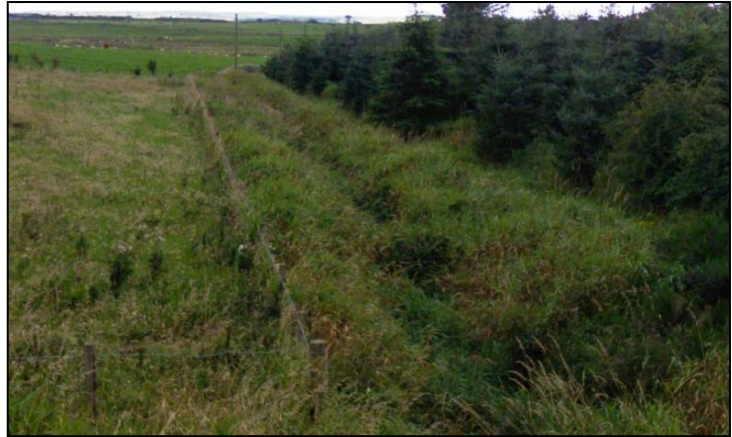
Figure 1.7. Cuttyhill Burn, tributary of North Ugie Water, Aberdeenshire. Photo on left was taken *ca.* 1990, immediately after maintenance dredging. Banks are bare and eroding following the dredging. Recent photograph on right from Google Street View, shows stream has been fenced and is now densely vegetated, clearly very stable and unlikely to be eroding.

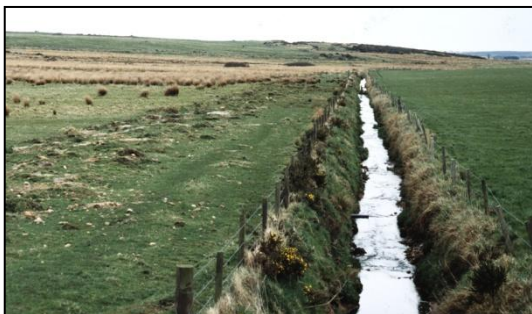
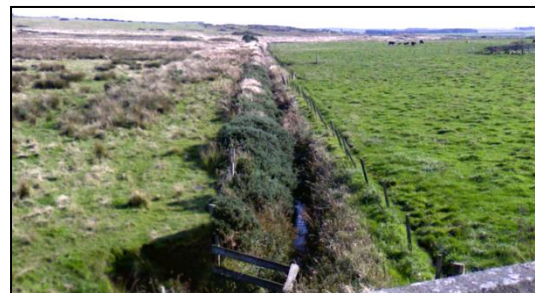
Left photo taken *ca.* 1990 following maintenance dredging. Right photo recent image from Google Street View. Again this channel appears highly stable in the absence of maintenance dredging.

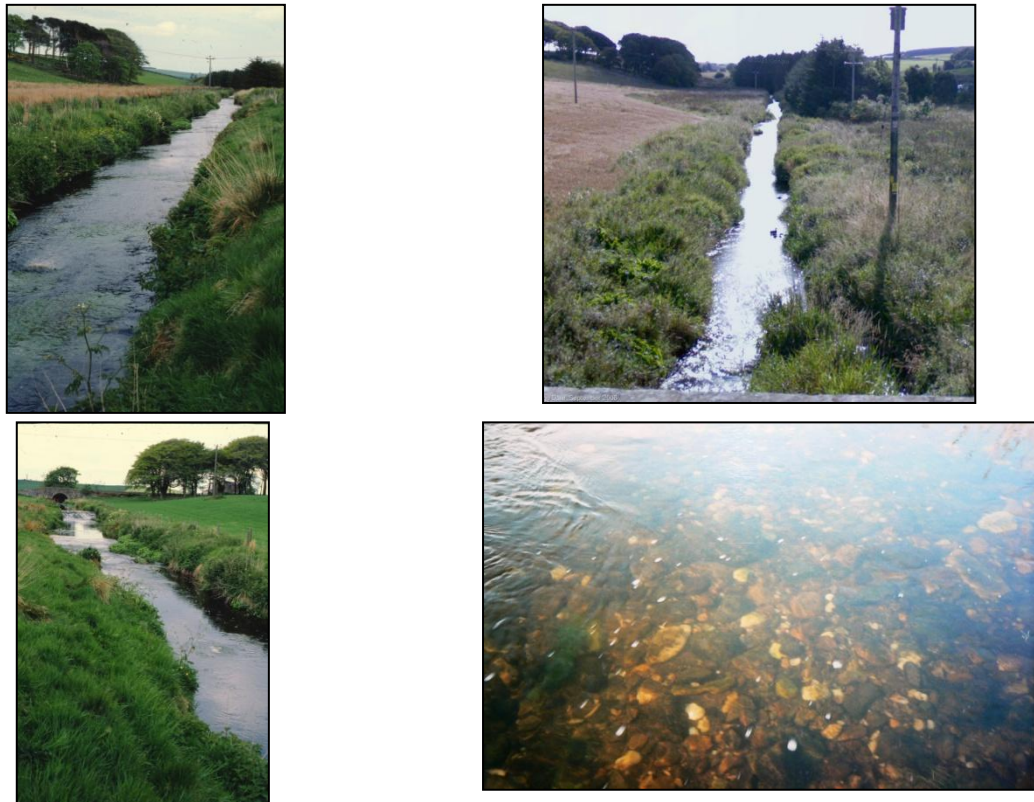
Figure 1.11. South Ugie Water at Maud, Aberdeenshire. Two photos on left, taken *ca.* 1990, downstream and upstream views. Bottom right photo is of the substrate *ca.* 1990. Top right photo, recent Google Street View image. Again this is a very stable channel. The substrate is coarse and there is no evidence of channel erosion. Semi quantitative electrofishing surveys found trout fry densities to be 1.09 per square metre in 1991, 1.14 in 1992, 0.22 in 2001 and 0.93 in 2002. One year old trout densities were 0.05, 0.07, 0.13 and 0.25 respectively. Salmon fry densities were 0 per square metre in 1991, 0 in 1992, 0.14 in 2001 and 0.3 in 2002. One year old salmon densities were 0, 0.11, 0.15 and 0.10 respectively.

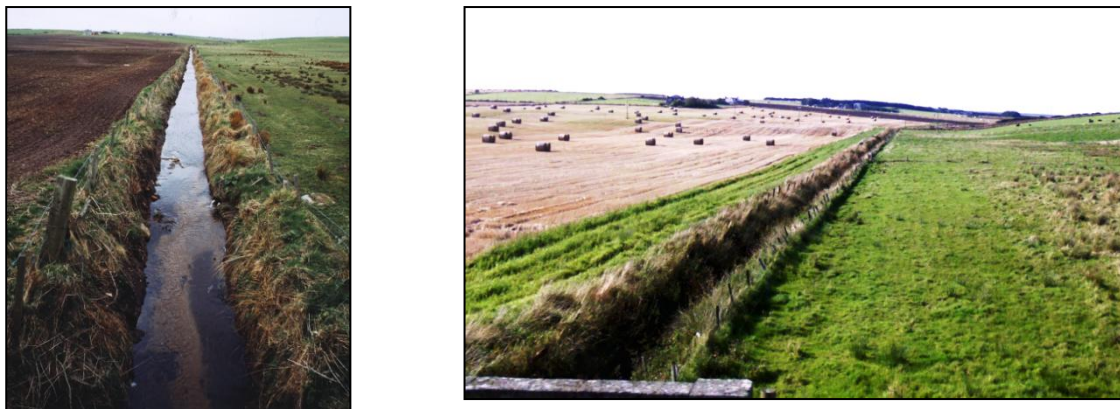
Figure 1.12. Tributary of North Ugie, Aberdeenshire. The photo on the left taken *ca.* 1990 immediately after maintenance dredging. Right photo, recent Google Street View image. Again a clearly stable channel.

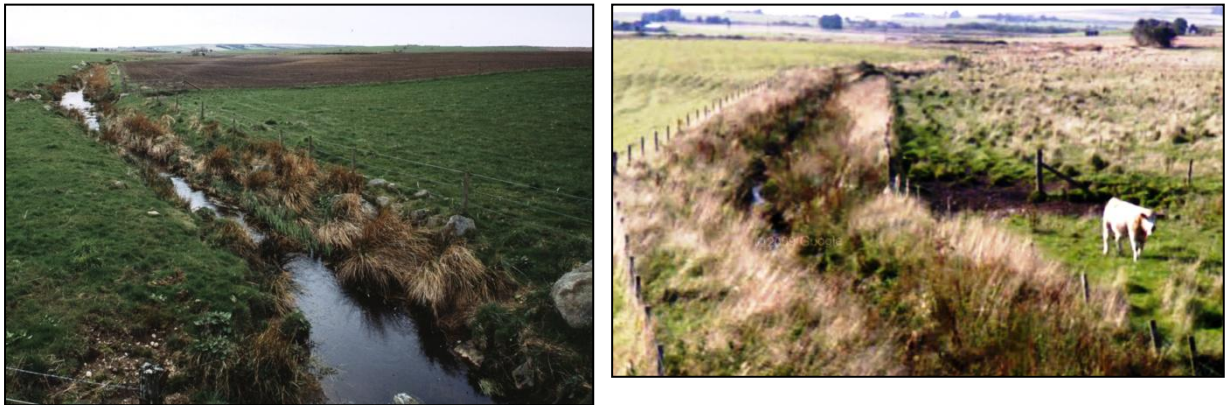
Figure 1.13. Loan Burn, tributary of North Ugie Water, Aberdeenshire.

The photo on left taken *ca.* 1990. Photo on right recent image from Google Street View. Stream has been fenced in interim. Banks clearly very stable and not eroding. A semi quantitative electrofishing survey found the trout fry density to be 0.422 per square metre in 1991 and the one year old trout density to be 0.633.

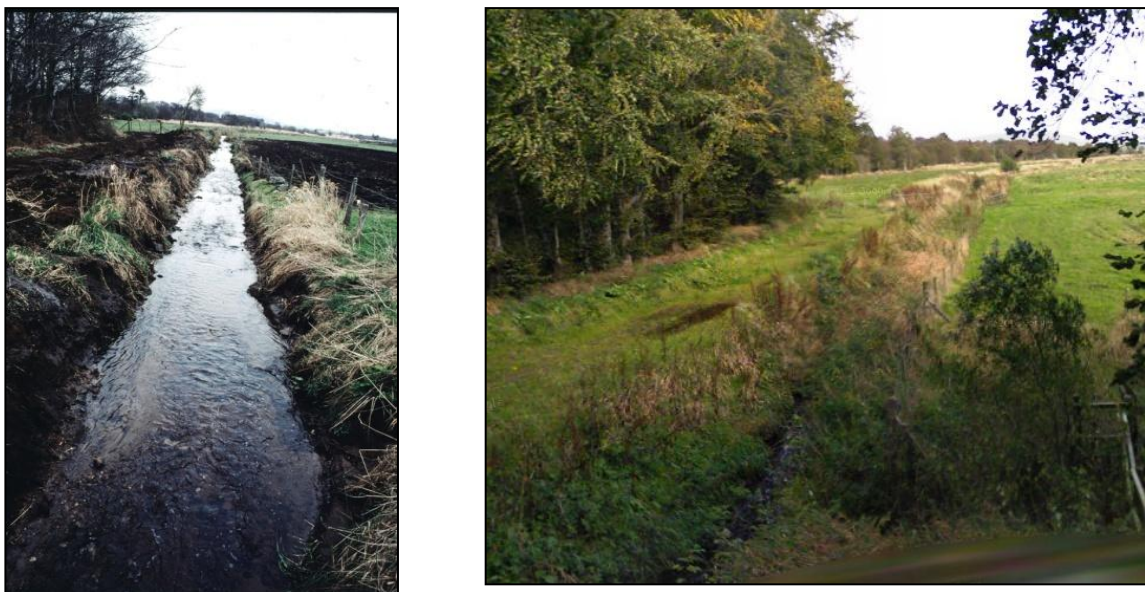
Figure 1.14. Greenspeck Burn, tributary of North Ugie Water, Aberdeenshire.

Photo on left taken *ca.* 1990, following maintenance dredging. Right photo, recent image from Google Street View. Again, in the absence of dredging, clearly a stable channel. Semi quantitative electrofishing surveys found trout fry densities to be 0 per square metre in 1992, 0.34 in 2001 and 0.26 in 2002. One year old trout densities were 0, 0.08 and 0.17 respectively.

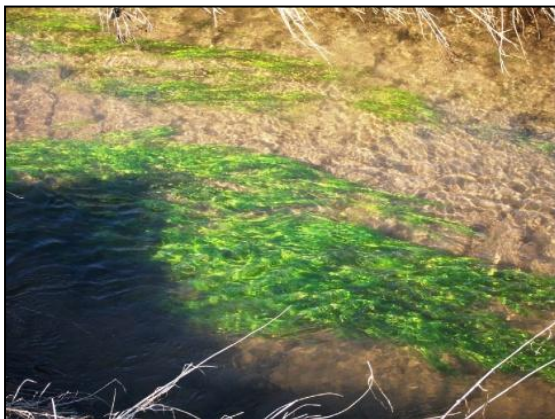
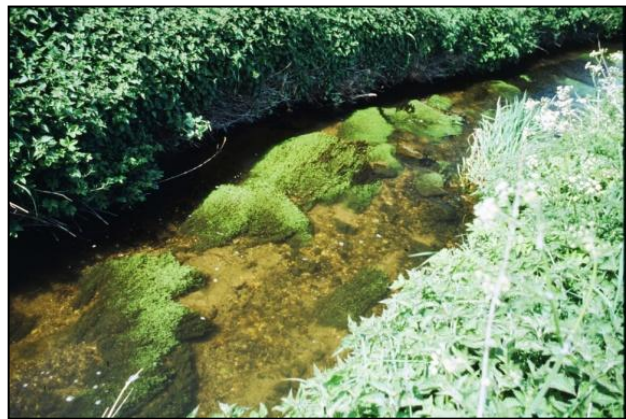
As shown in the two photos below, sediment gets deposited among and around macrophytes and emergent vegetation. This can then be a self reinforcing process. As more sediment accumulates, more plants grow trapping more sediment and so on. Eventually this results in a reduction in channel capacity which creates a desire for dredging to restore the level of channel capacity farmers believe they need.

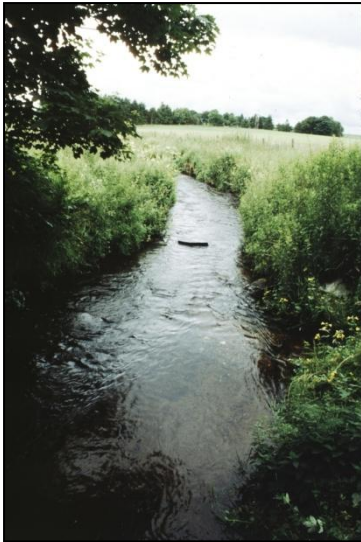
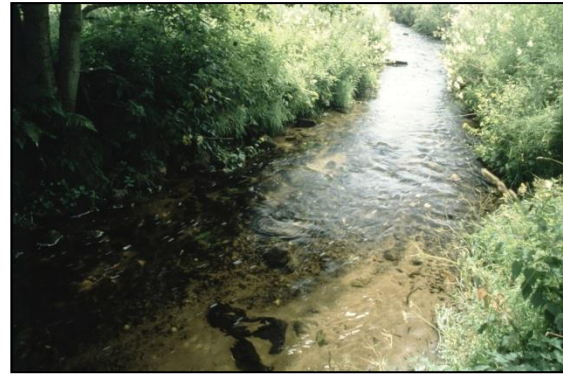
Maintenance dredging has several effects. It can result in sediment release which then affects downstream reaches, as is shown in the following example. The left photo overleaf shows the Fedderate Water, Aberdeenshire, *ca.* 1990 in a reach where velocities generally preclude deposition of fines. However, at the same location, one year later, following maintenance dredging that took place upstream (see Figs 1.8 and 1.9), sandy sediment is clearly visible on the bed, dislodged by the dredging work. The sediment deposited on the bed in this example, though 1 km+ downstream from its source, would have had negative ecological consequences.

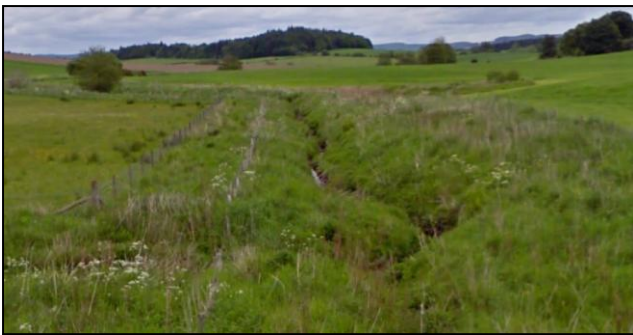
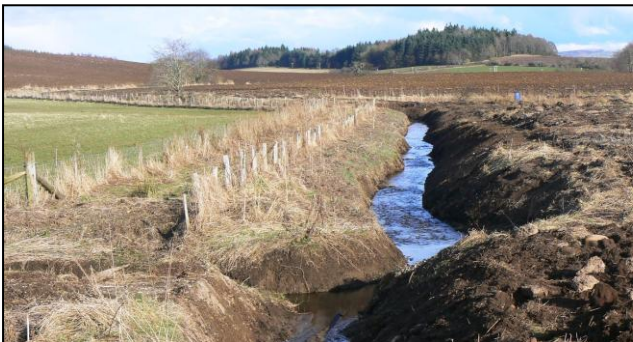
In dredged reaches themselves, there is a much more dramatic impact on the ecology. This is shown by the following example on a small tributary of the Shochie Burn, near Moneydie, Perthshire.

This is a Google Street View image taken a few years ago. The stream appears to have been part of an environmental scheme. It is well buffered etc with grass encroaching and no local erosion likely. Comparing with the small burn in 4.1.6 (p. 30), it is quite possible this stream, albeit small, might have been a trout nursery.

This photo shows that in early 2013, the stream was dredged, presumably because the encroaching vegetation was deemed to be reducing channel capacity. The recovering habitat has clearly been destroyed

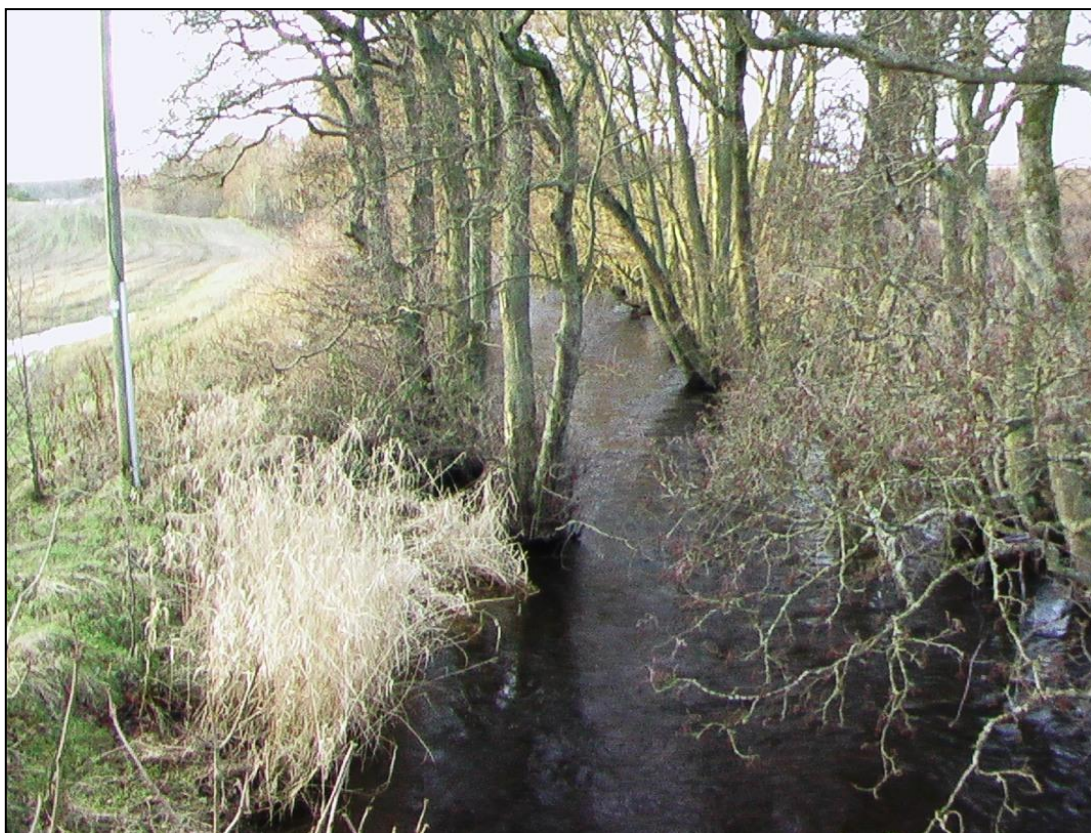
5.1 Lunan Burn

It can be seen from the photo below that where there are trees, there is no reedy grass growth. However, in the short section on the left which is kept open below a power line, reed canary grass is growing. Elsewhere, reed canary grass has been shaded out. In the absence of trees, reed canary grass would flourish along this stream.

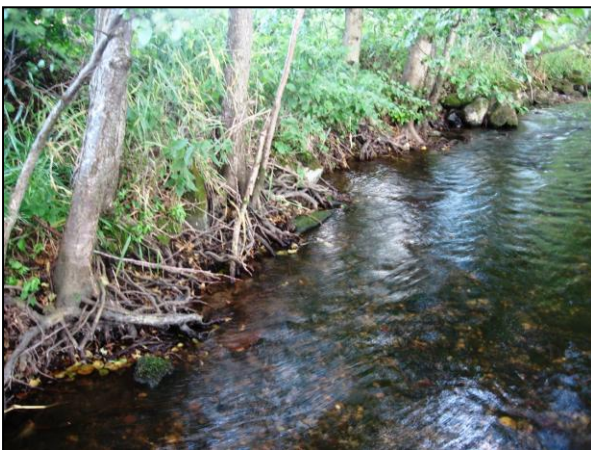
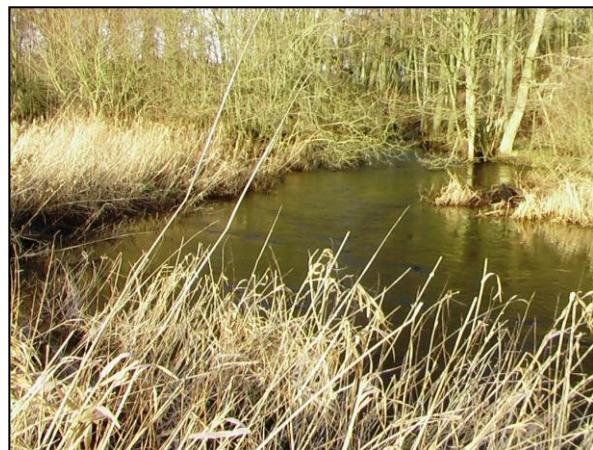
The left photo below further emphasises that there is a lack of marginal cover for fish. The right photo below shows that on another short section of the Lunan Water where the trees have been suppressed to protect another power line, a very different vegetation dominates. In the absence of trees this stream would be wholly fringed by reed canary-grass and would be narrower and deeper.

We have found that over years of annual electrofishing surveys at precisely this shaded location, the mean size of salmon fry particularly has been consistently considerably smaller than other lowland Tay tributaries (see Figure 7.4 in the [attached report](#)). Perhaps this reflects a reduced abundance of invertebrates.

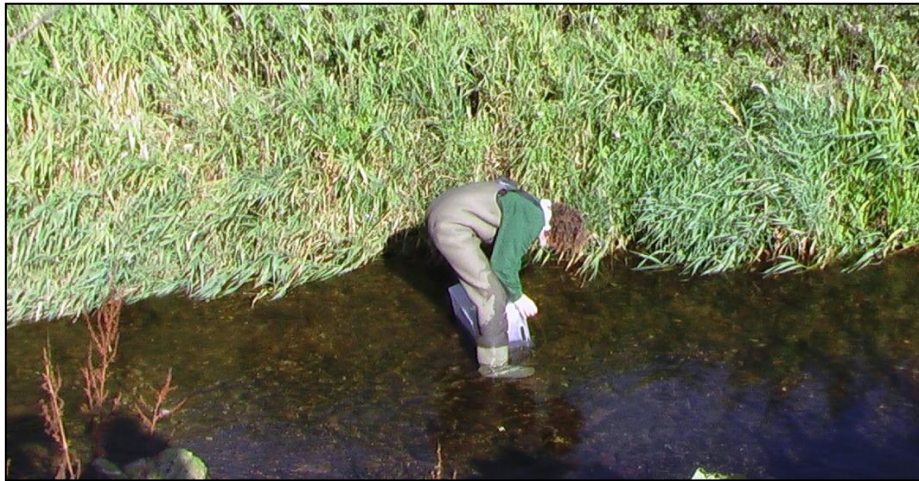
5.2 Kerbet Water, tributary of River Isla, Perthshire.

The Kerbet Water is a channelized stream draining a largely arable catchment near Forfar. The section of stream shown below has been electrofished several times. In each year a very high density of juvenile salmon, principally 0+, has been found (see pages 50 – 52 of [attached report](#)). Despite the high density of juvenile salmon, their growth rate in this generally unshaded stream is much greater than in the shaded Lunan (see 5.1). With a relatively poor substrate, the salmon mainly took refuge under the trailing reed canary-grass mat, which was undercut by up to one metre.

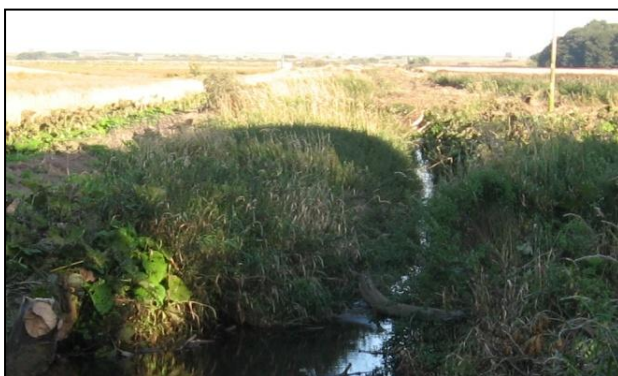
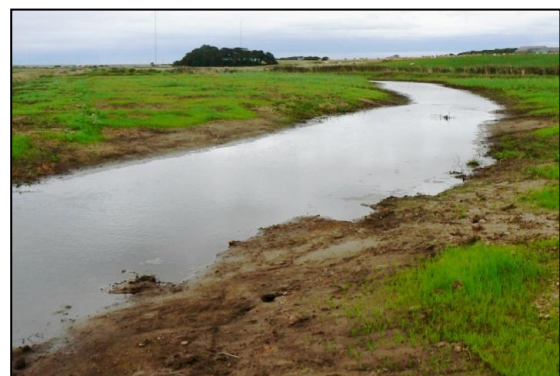
Indeed, another unforeseen consequence of channel “restoration” might make streams more prone to heating. The two photographs below are of the Savoch Burn, Aberdeenshire. The left photo shows the burn prior to “restoration”. It was a typical incised stream with dense encroaching grasses. Following the remeandering work that was done a few years ago, the stream channel has a much greater width to depth ratio and has lost the shading from the bank. Such a channel configuration would clearly be more prone to heating. In addition, by lengthening the channel, the surface area exposed to the sun has increased and the mean water velocity decreased, another two factors which could lead to more heating.
