Tarbolton Landfill – Report

Monitoring plan and update of potential for environmental impacts resulting from consolidated ash waste deposition and lack of operational management

Scottish Environment Protection Agency (SEPA)

August 2018

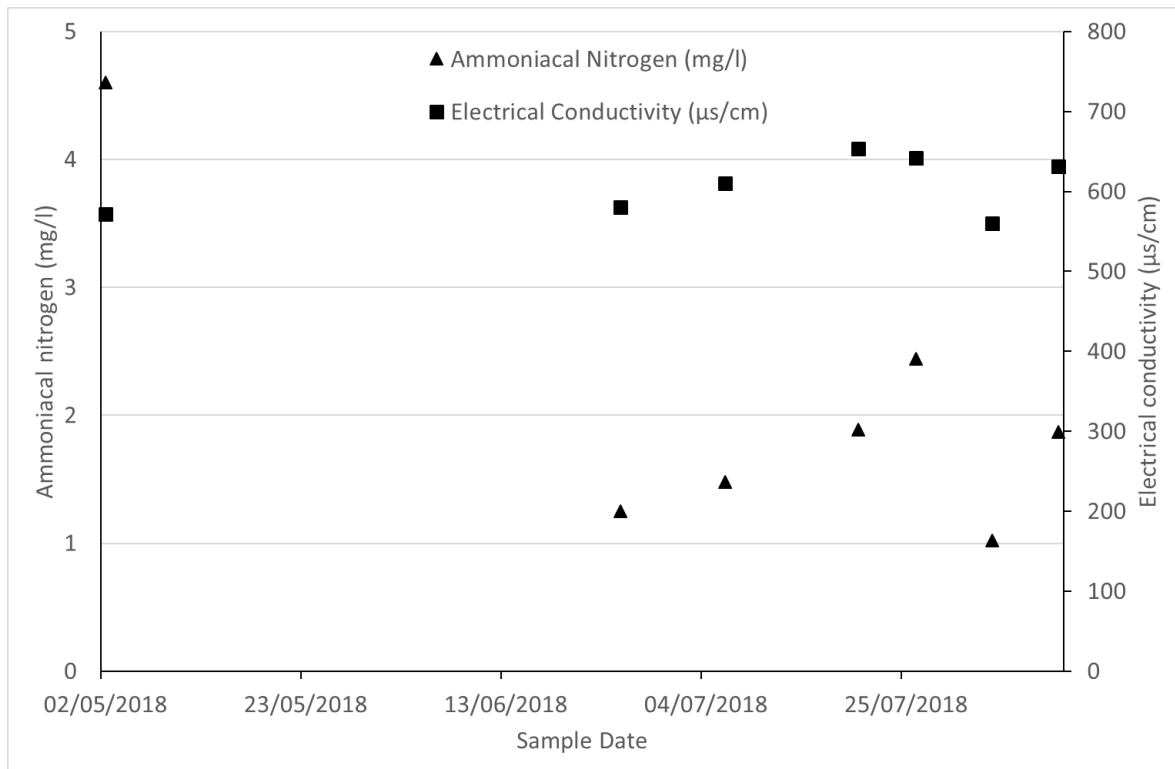
Figure B11 Trends in Ammoniacal nitrogen (mg/l) and electrical conductivity (µs/cm) in the Water of Fail downstream of Tarbolton Landfill (ref 554745)

Comparing the data from May with that obtained recently there is no obvious deterioration in the Water of Fail downstream of the landfill with respect to ammoniacal nitrogen and electrical conductivity (Appendix B Figure B11).
