## Review of Restoration Achievements at two Scottish Opencast Mines

Prepared for: **SEPA**

Prepared by: **Bill Crooks &  
Audrey Litterick**

Date: July 2018

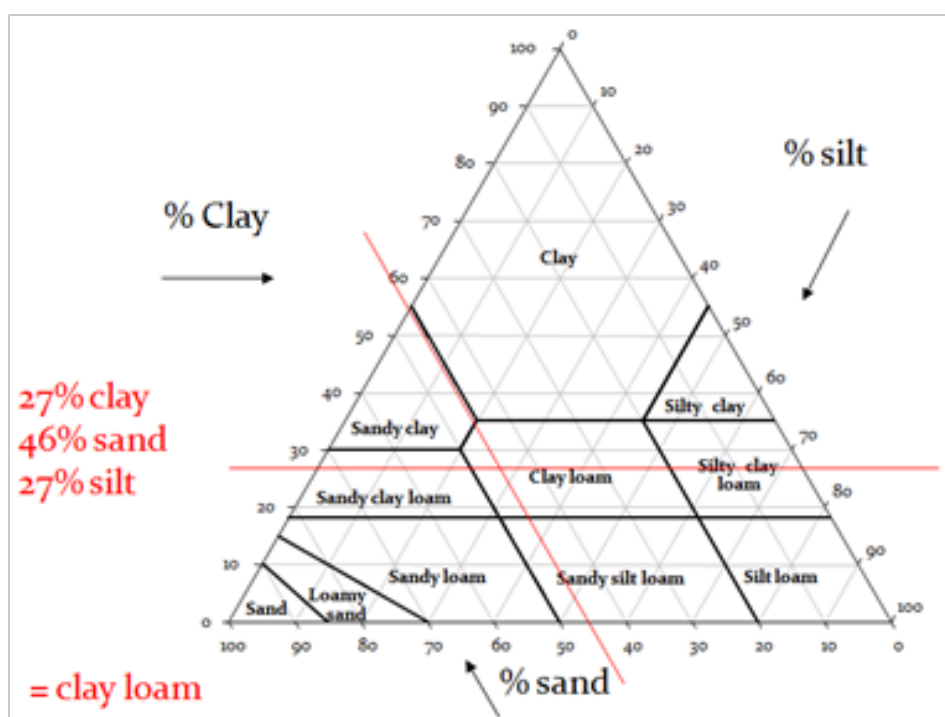
Figure 1. The soil texture triangle used in the UK

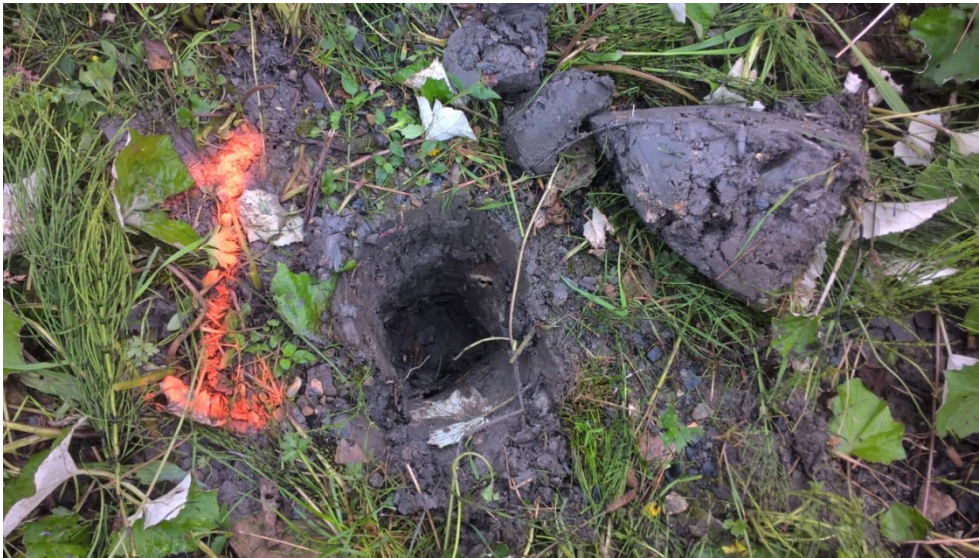
Dense mixed vegetation with clearly identified boundary's between untreated and untreated areas.

Plate 1: Area 1, showing evidence of soil formation and weed species.

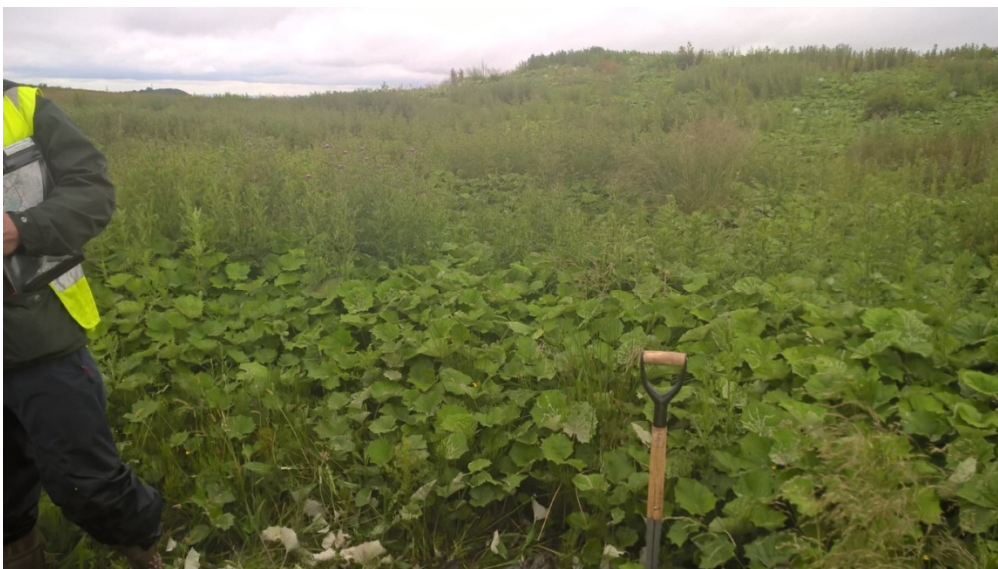
Plate 2: Vegetation in Area 1.

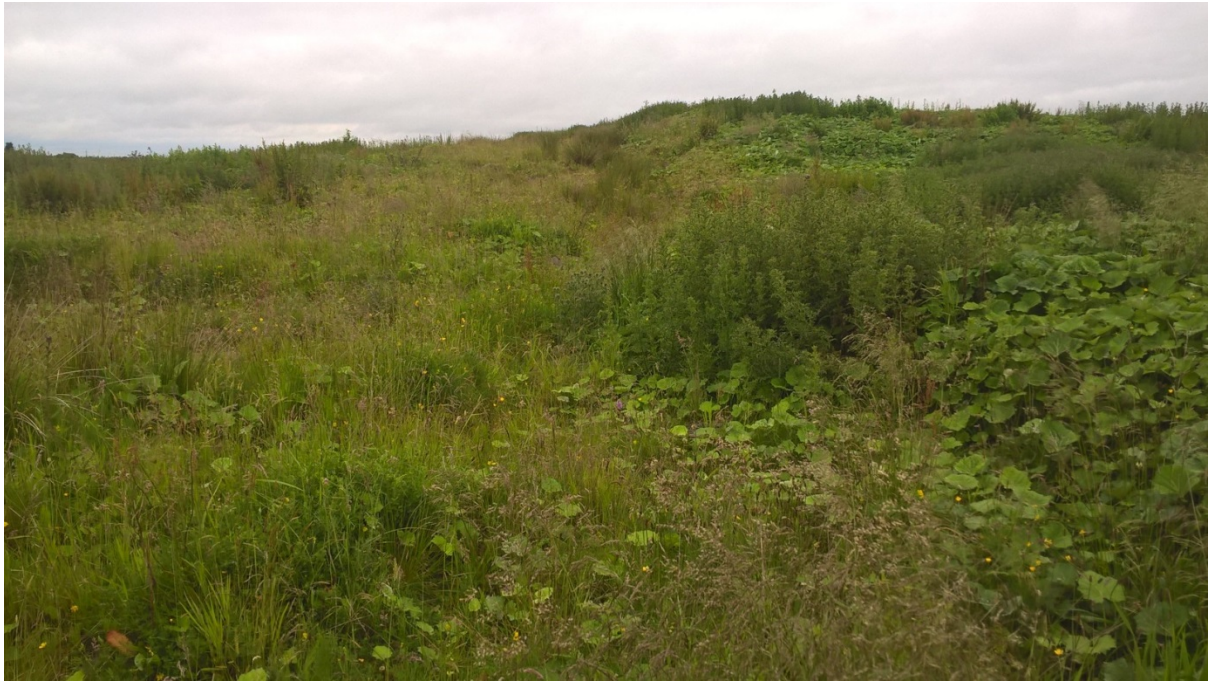
Plate 3: Demarcation between treated and untreated (or less treated) parts of Area 1.

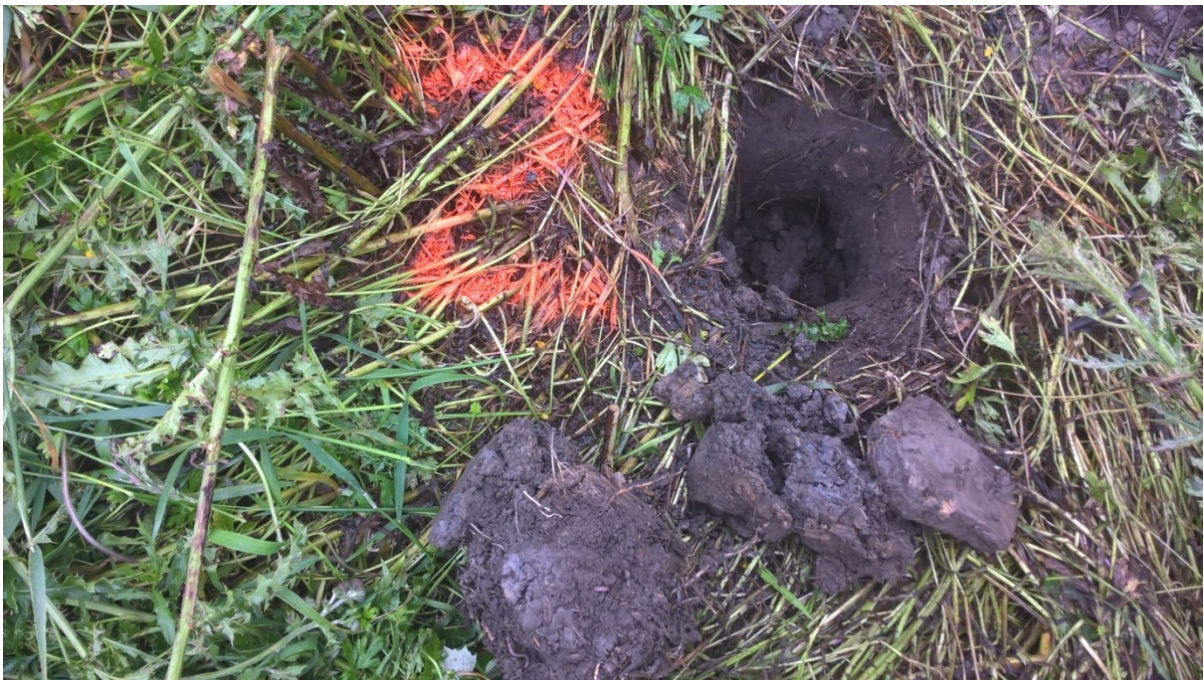
There was a clear boundary surrounding the treatment area in terms of vegetation and soil surface conditions. Good evidence of soil formation.

Plate 4: Area 2, showing some evidence of soil formation and some evidence of organic matter at 20 cm depth.

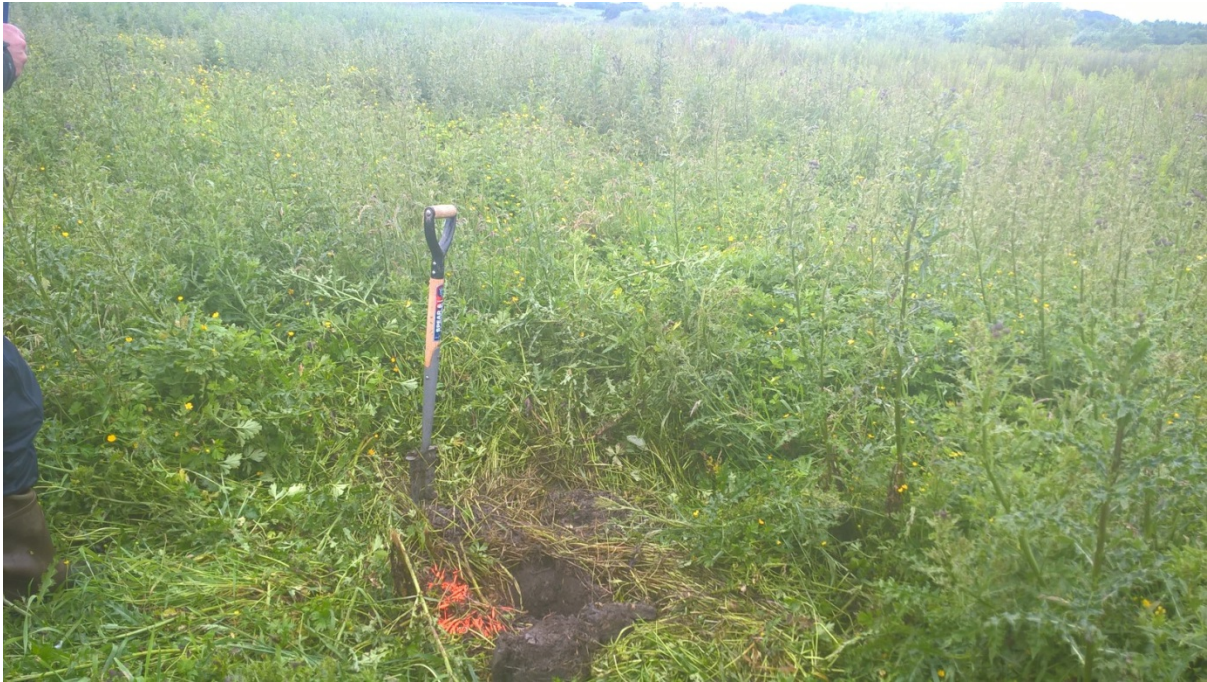
Plate 5: Area 2, showing weedy vegetation. There was a clear boundary around the treatment area in terms of vegetation type and soil surface conditions.

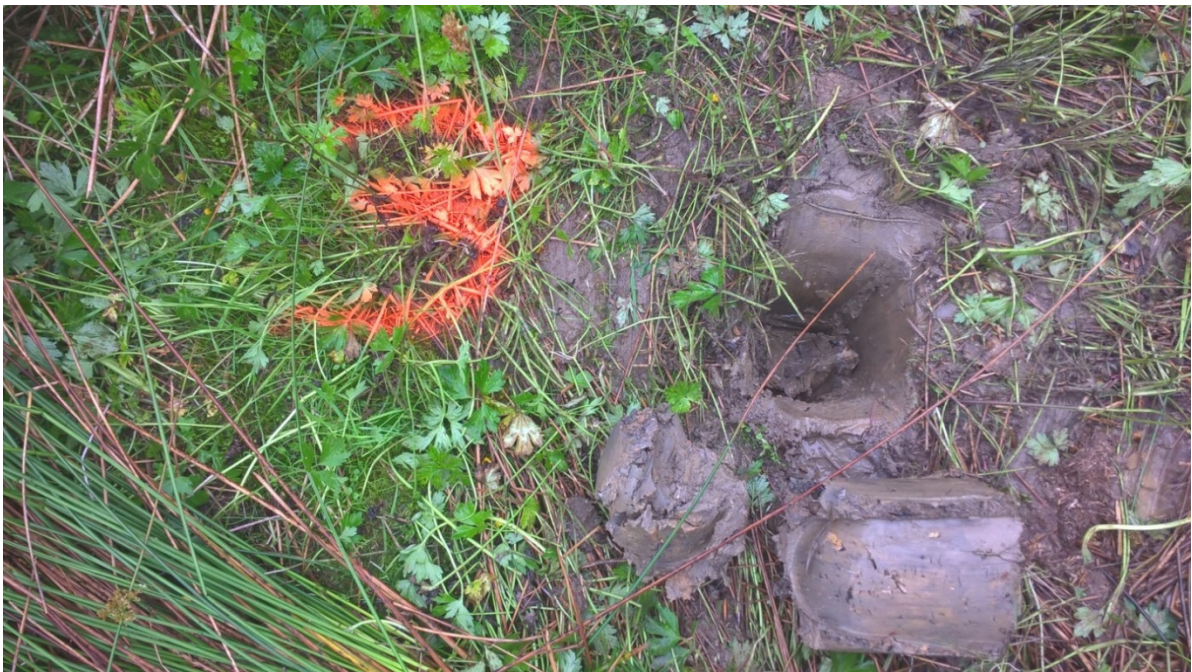
Dense vegetation with rushes and other weed species. Clearly identifiable boundary was visible between treated and untreated parts of the area. There was evidence of organic matter at 30 cm depth.

Plate 6: Area 3, showing dense vegetation and some indication of organic matter at 30 cm depth.

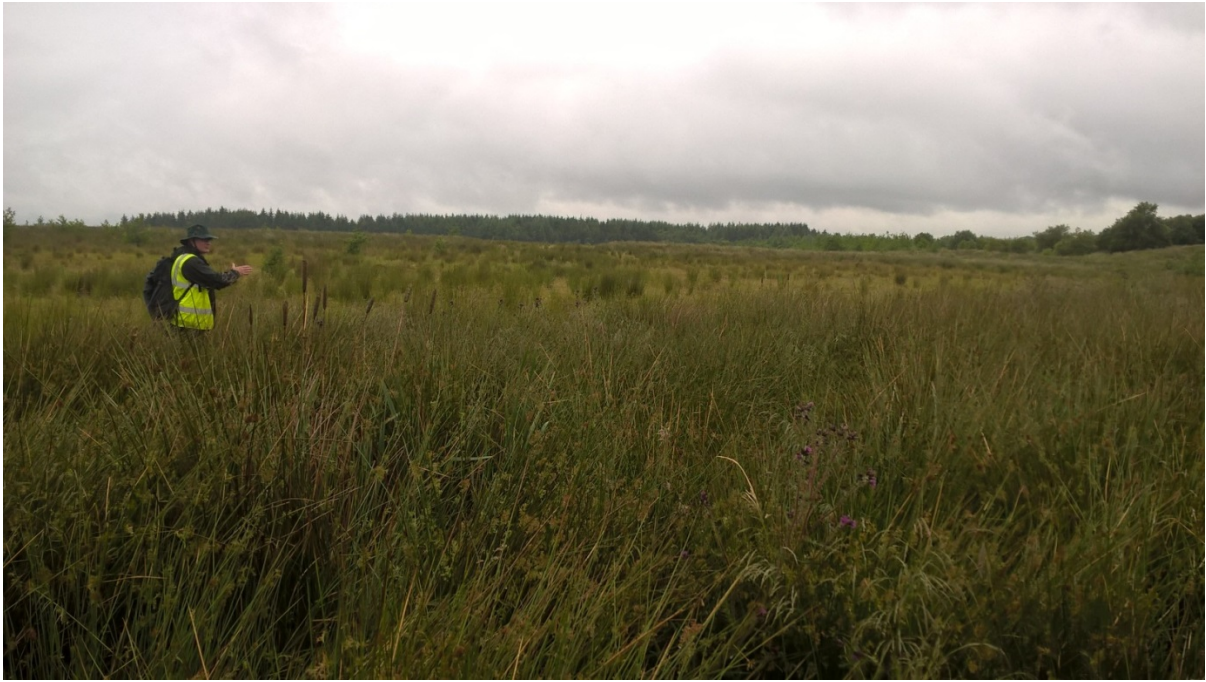
Plate 7: Area 3, looking from the treated part of the area across to untreated (or less treated) land.

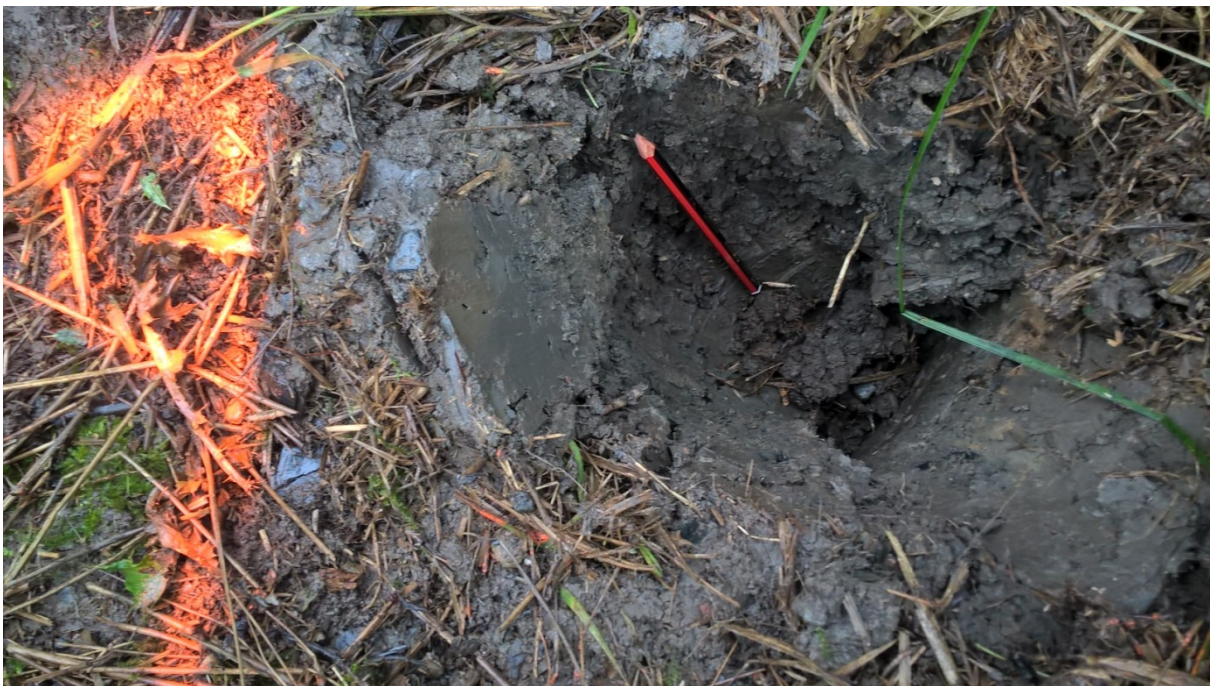
Heavy cover of weedy vegetation was obvious across much of the area, with a clear boundary between treated and untreated parts of the area.

Plate 8: Area 4, showing dense weed cover within a clear boundary and signs of organic matter in profile.

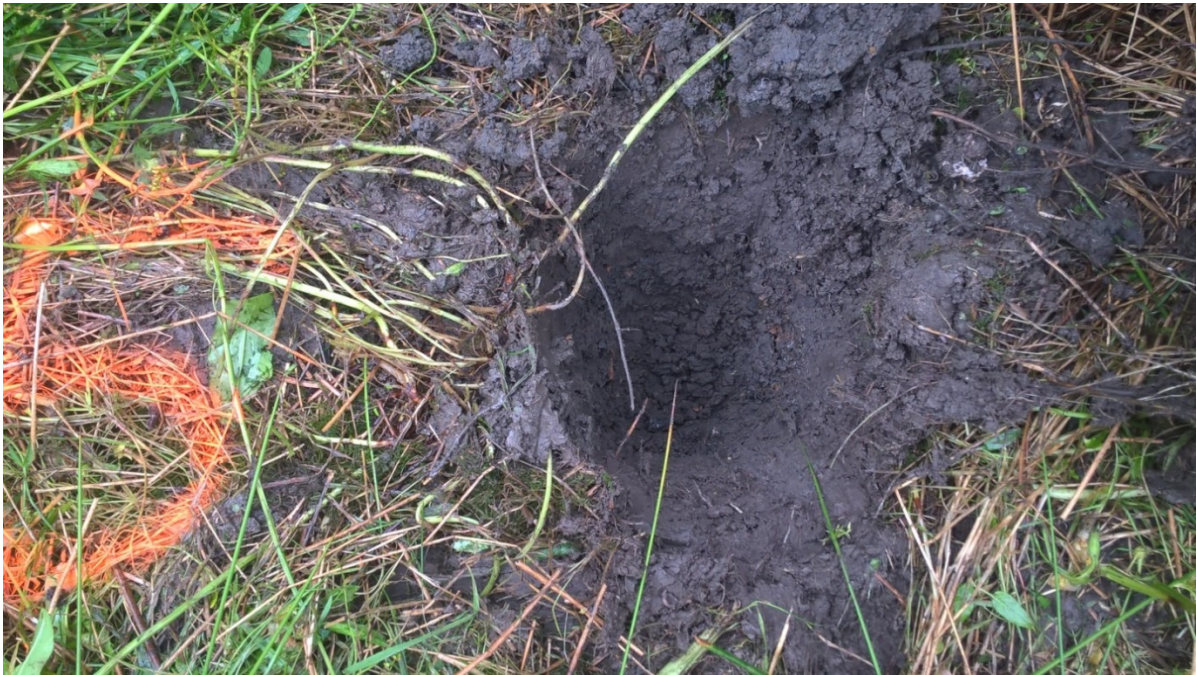
Of all the areas examined, this is the one with the least certainty as to treatment type, based on vegetation growth. It has clearly been treated but it was not possible to identify a clear treatment boundary.

Plate 9: Area 5, showing clear evidence of treatment but plant density was less than other points.

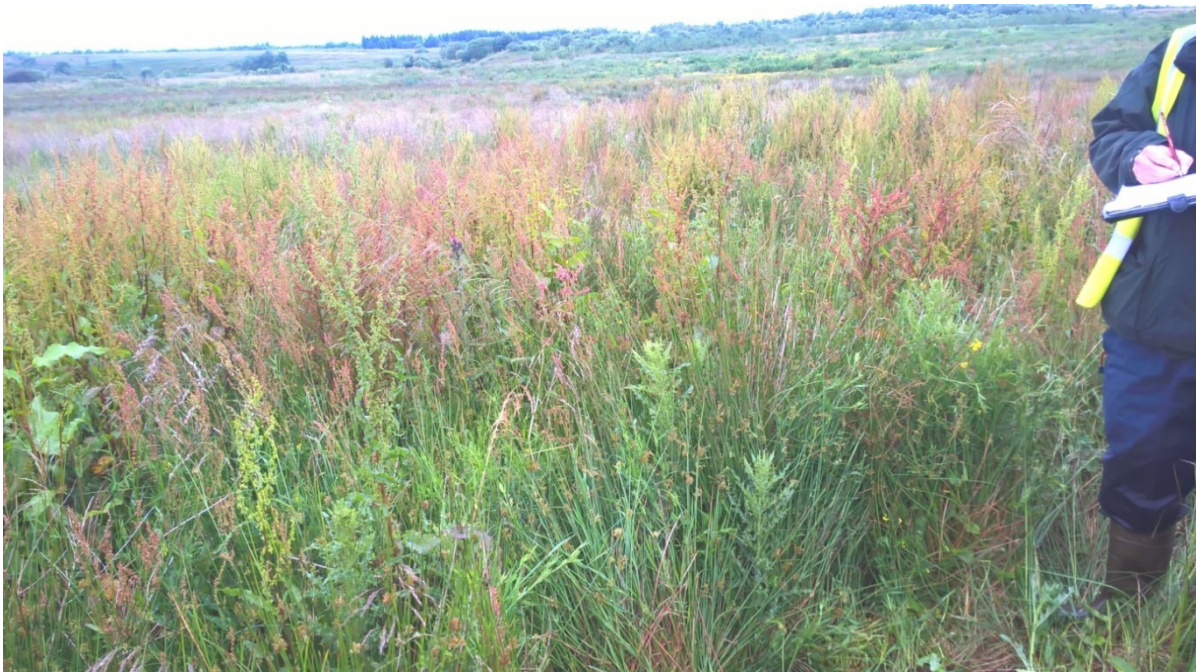
Plate 10: Area 5, showing strong growth of weed species but plant density is less than other locations.

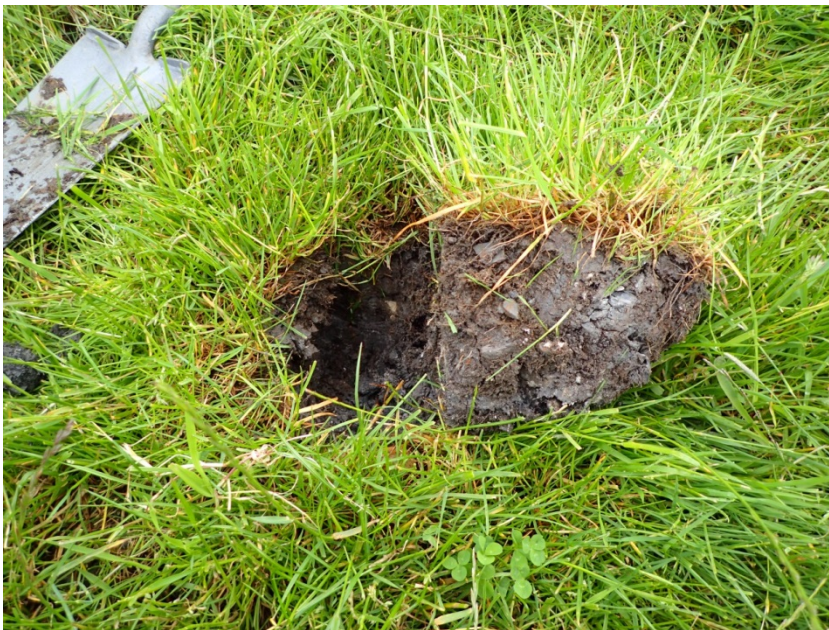
Both areas (Areas 1 and 2) were uniform in terms of drainage (which was good), vegetation type and percentage vegetation cover. The two locations were chosen to represent different parts of the site.

Plate 114: Example of topsoil and vegetation in an area restored using a disking method (Areas 1 and 2).

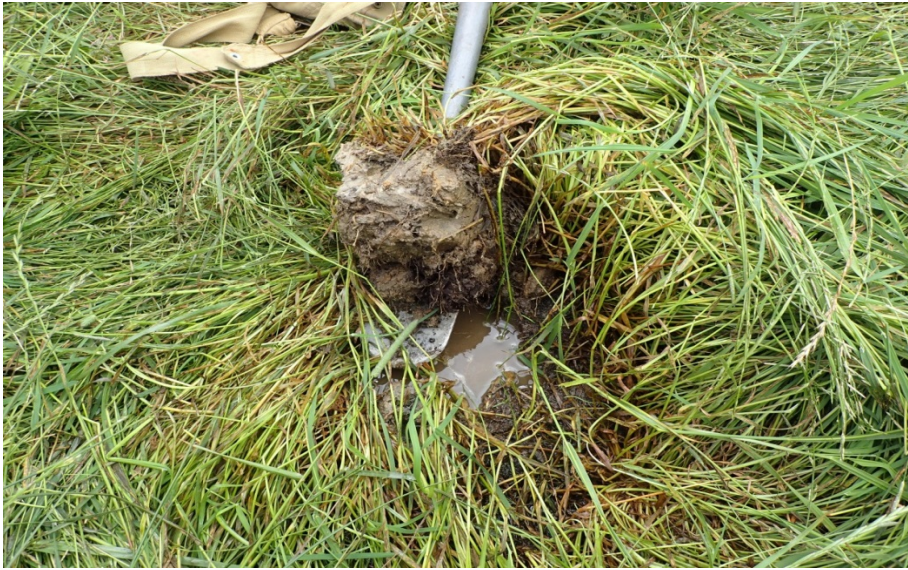
Areas 3, 4 and 5 represented typical restoration outcomes for the site (based on quick vegetation assessments and quick spade digs in the topsoil). The first, which was poorly drained, was covered in a mixture of rushes, pasture grasses and weed grasses. Poor drainage is common in this geographical area, and the presence of poor drainage is not a judgment on the success of the restoration. Overall this represented approximately a third of the area restored using sludge with a double digging methodology.

Plate 122: Areas restored with double and digging, poor drainage (Areas 3, 4 and 5).

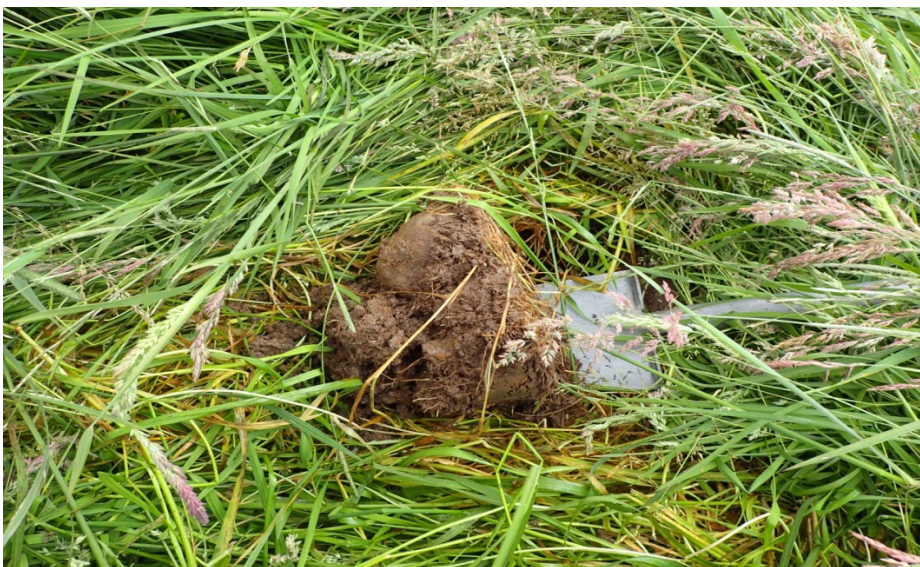
The other two areas each represented approximately one third of the total area restored using the double digging methodology. Both were slightly better drained than Area 3 and were covered with a reasonable to good percentage cover of target vegetation (i.e. sown pasture grasses).

Plate 133: Area restored with double digging soil is well-drained , good cover of desirable, sown plant species.

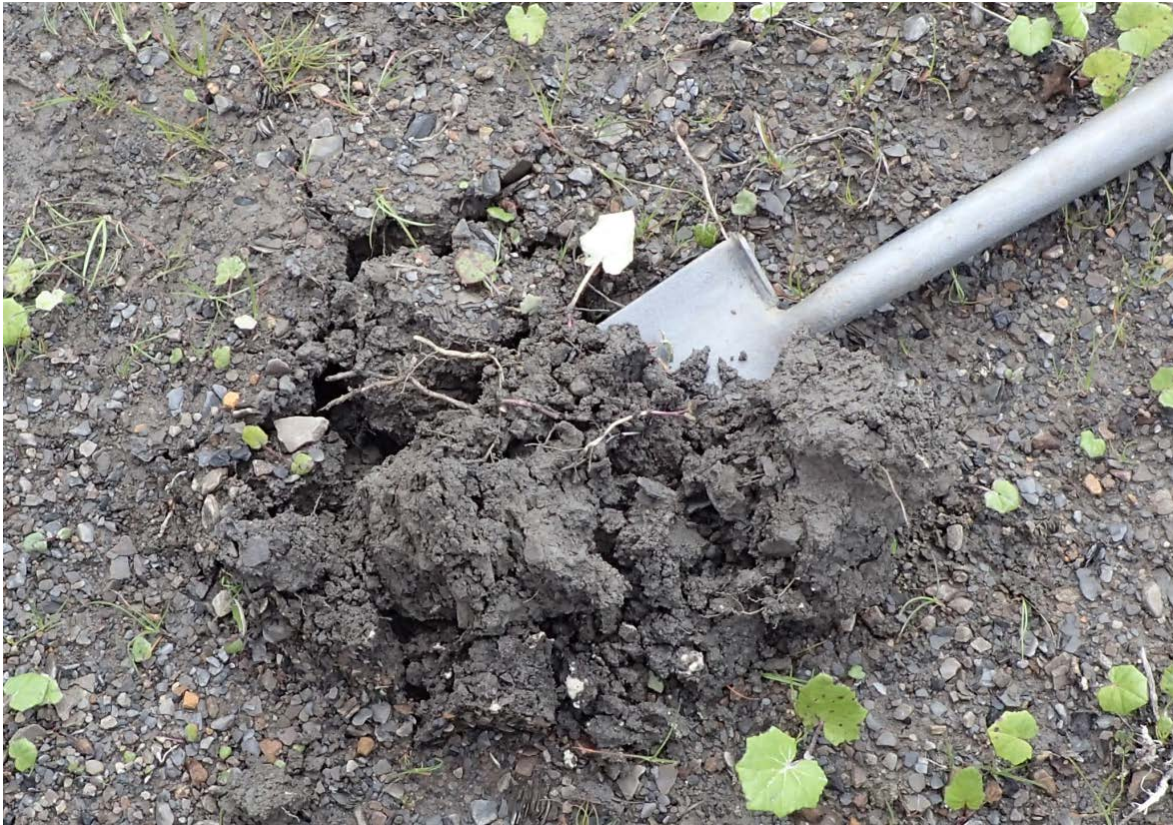
This was a relatively small, low lying area with reasonable drainage that was not included in the original remediation program. The ground surface was very compact and there was little or no vegetation present on it at the time of the initial site visit.

Plate 114: Un-amended soil in Area 6.

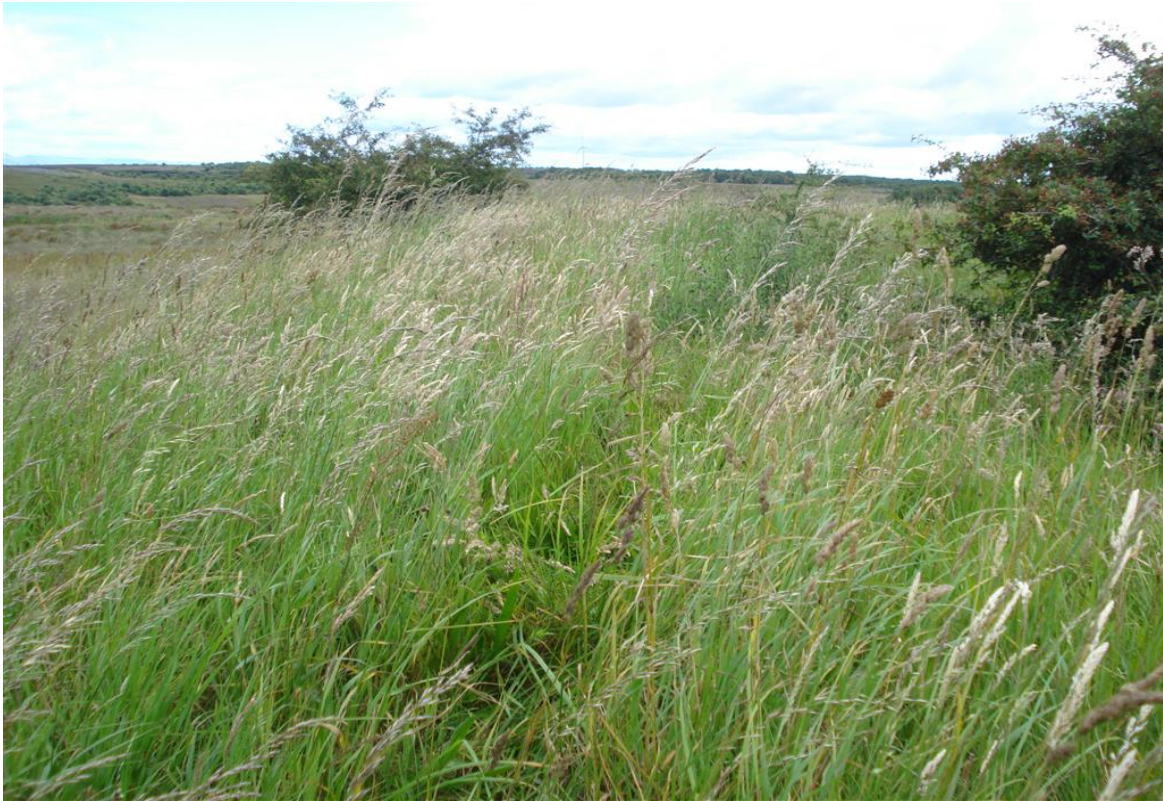
**Area 1** - Vegetation cover was almost complete and generally very dense (Appendix 6a, Plate 1). There were 39 species present in the area and creeping soft grass and soft rush were abundant. Although the authors have heard unofficially (by "word of mouth") that the area was sown, no written records exist of the species used, the rate at which the seed mixture was applied or the application method. It is unlikely that any of the species most commonly found in this area were sown, with the most frequent species being creeping soft grass, marsh thistle, soft rush, tufted hair grass, yorkshire fog and common sorrel. Although some of the species present had value for wildlife such as insects, spiders and the larger organisms which depend on them, the most abundant species were aggressive and of relatively low ecological value.

There were almost no bare patches of soil, with vegetation cover being almost complete other than on a very few small (a few square centimetres here and there) heavily compacted patches. Most plants, including the desirable grass species were of good health and had a size and colour consistent with their textbook descriptions. There was no evidence of nutrient deficiencies in the vegetation.

Plate 1. Site 1, Area 1, showing one of the better parts of the area, with a few hawthorn trees and grasses of low forage value (mainly Yorkshire fog and tufted hair grass).

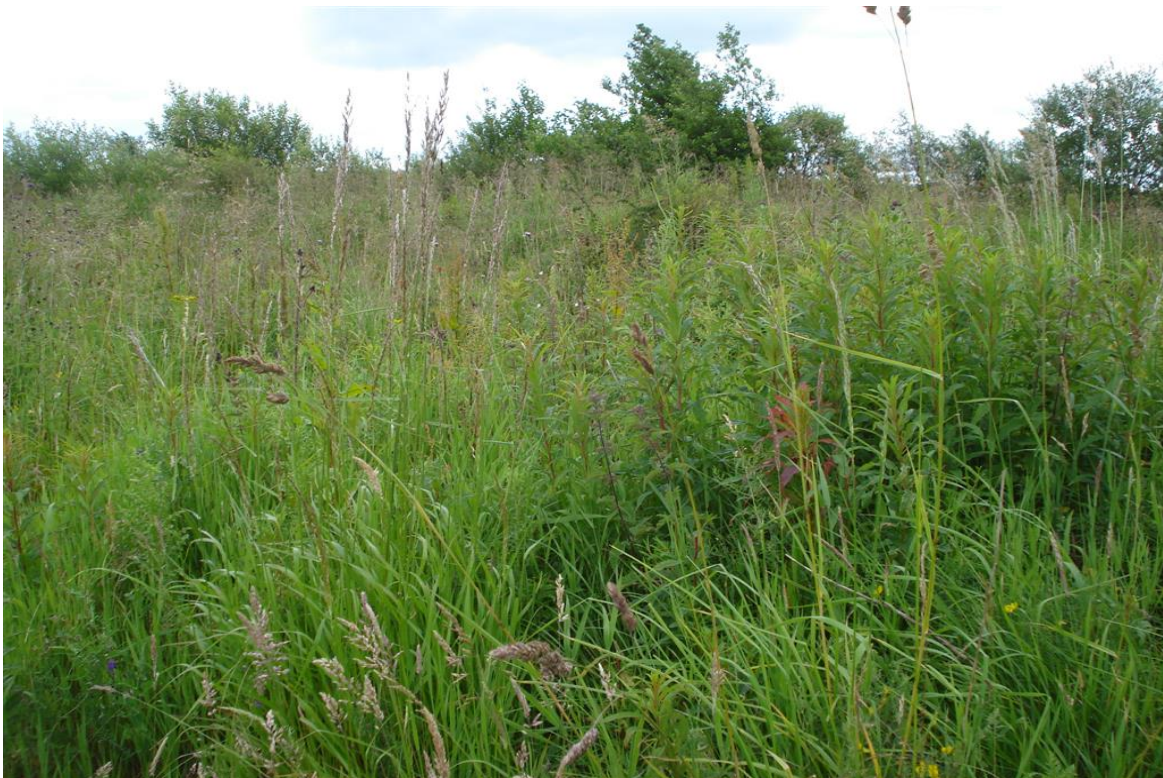
Plate 2. Site 1, Area 2, showing dense growth of willowherbs and weed grasses such as Yorkshire fog, creeping soft grass and tufted hair grass).

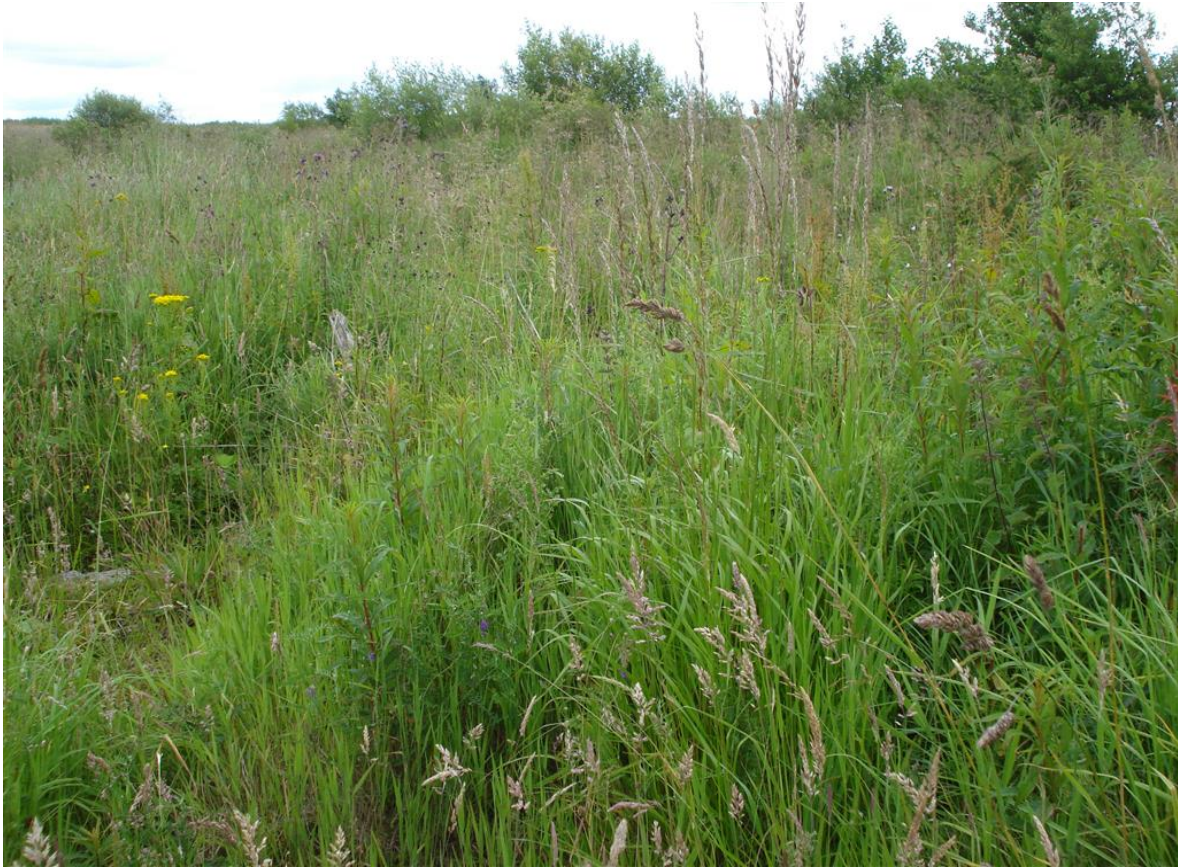
Area 3 - Vegetation cover was variable and often very tall and dense (Appendix 6a, Plate 3). There were relatively few (27) species present and soft rush was abundant. There were almost no bare patches and those which were present were only a few square cm in size. Again, although the authors have heard unofficially (by “word of mouth”) that the area was sown, no written records exist of the species used, the rate at which the seed mixture was applied or the application method. It is unlikely that any of the species most commonly found in this area were sown, with the most frequent species being creeping thistle, tufted hair grass, creeping soft grass, soft rush and creeping buttercup. Although some of the species present had value for wildlife such as insects, spiders and the larger organisms which depend on them, the most abundant species were aggressive and of relatively low ecological value.

Most plants were of good health and had a size and colour consistent with their textbook descriptions, although some appeared very dark green, as though they were growing in a soil which contained high concentrations of N. There was no evidence of nutrient deficiency. The nature and suitability of vegetation present is summarised in this and other areas at Site 1 in Table 6.5.1.

Plate 3. Site 1, Area 3, showing evidence of bare patches, along with dense growth of weedy species of low forage value such as yorkshire fog, creeping soft grass and tufted hair grass.

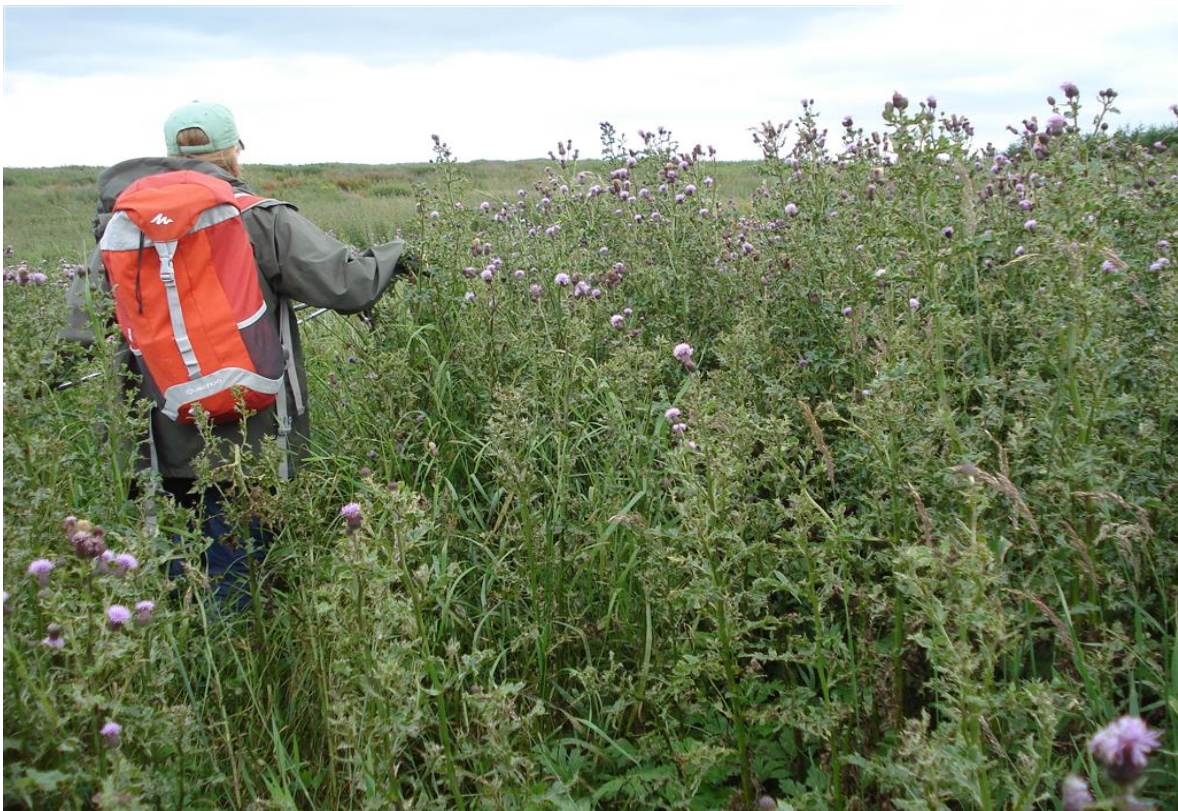
It is not known whether either parts of Area 4 were sown: no written records exist of the species used, the rate at which the seed mixture was applied or the application method. It is unlikely that any of the species most commonly found in this area were sown, with the most frequent species generally being classed as weed species with no agricultural value.

Most plants in the densely vegetated, species-poor Area 4a were of good health and had a size and colour consistent with their textbook descriptions, although some appeared very dark green, as though they were growing in a soil which contained high concentrations of N and P. There was no evidence of nutrient deficiency. In contrast, plants in the sparsely vegetated species-rich Area 4b were much smaller, with many appearing slightly stunted and pale.

Plate 4. Site 1, Area 4b, showing tall, dense growth of creeping thistle and couch grass.

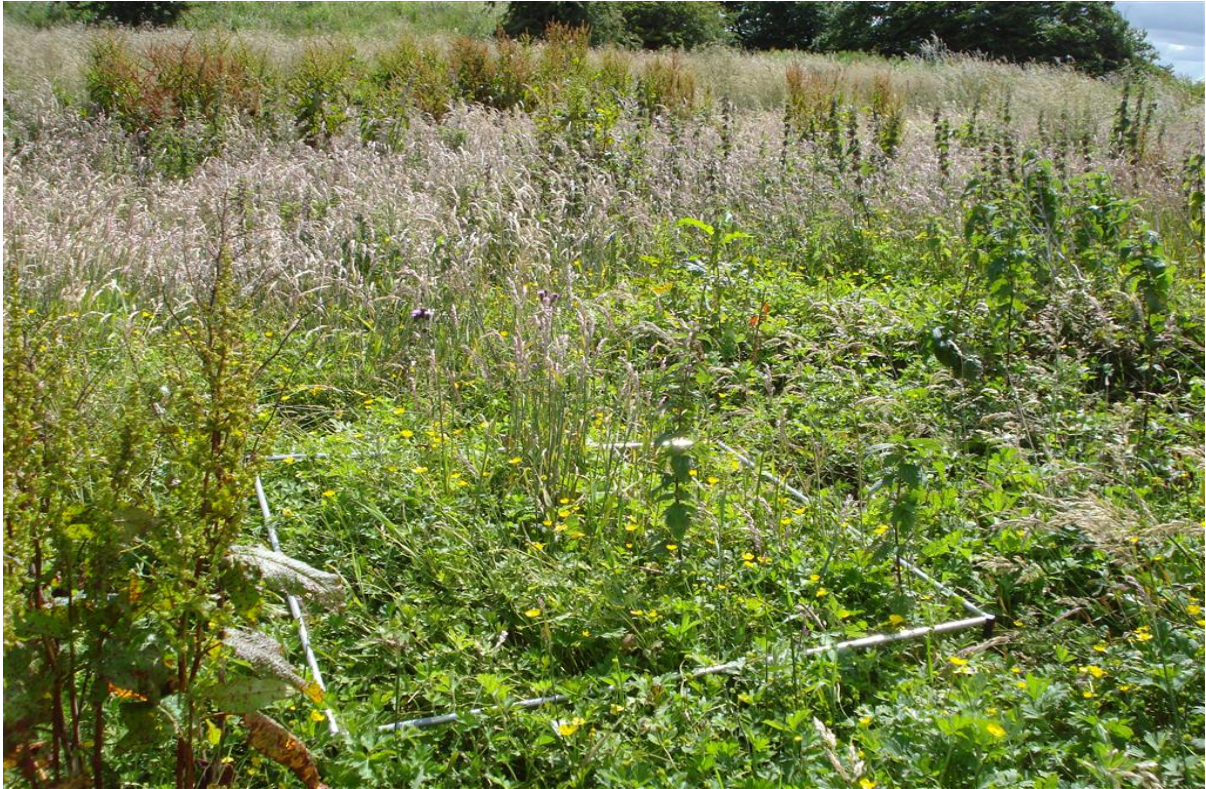
Area 5 - There were almost no bare patches of soil, in this area, with vegetation cover being almost complete other than on a very few small (a few square centimetres here and there) heavily compacted patches (Appendix 6a, Plate 5). The dense growth was often difficult to walk through. 51 species were present in this area and tufted hair grass, yorkshire fog, creeping soft grass and soft rush were abundant. The number of plants of the other species was low. Again, although the authors have heard unofficially (by “word of mouth”) that the area was sown, no written records have been found of the species used, the rate at which the seed mixture was applied or the application method. It is unlikely that any of the species most commonly found in this area were sown, with the most frequent species generally being classed as weed species with no agricultural value. Although some of the species present had value for wildlife such as insects, spiders and the larger organisms which depend on them, the most abundant species were aggressive and of relatively low ecological value.

Plate 5. Site 1, Area 5, showing the growth of creeping buttercup, Yorkshire fog, dock and other weed species of low forage value on heavily compacted, wet ground.

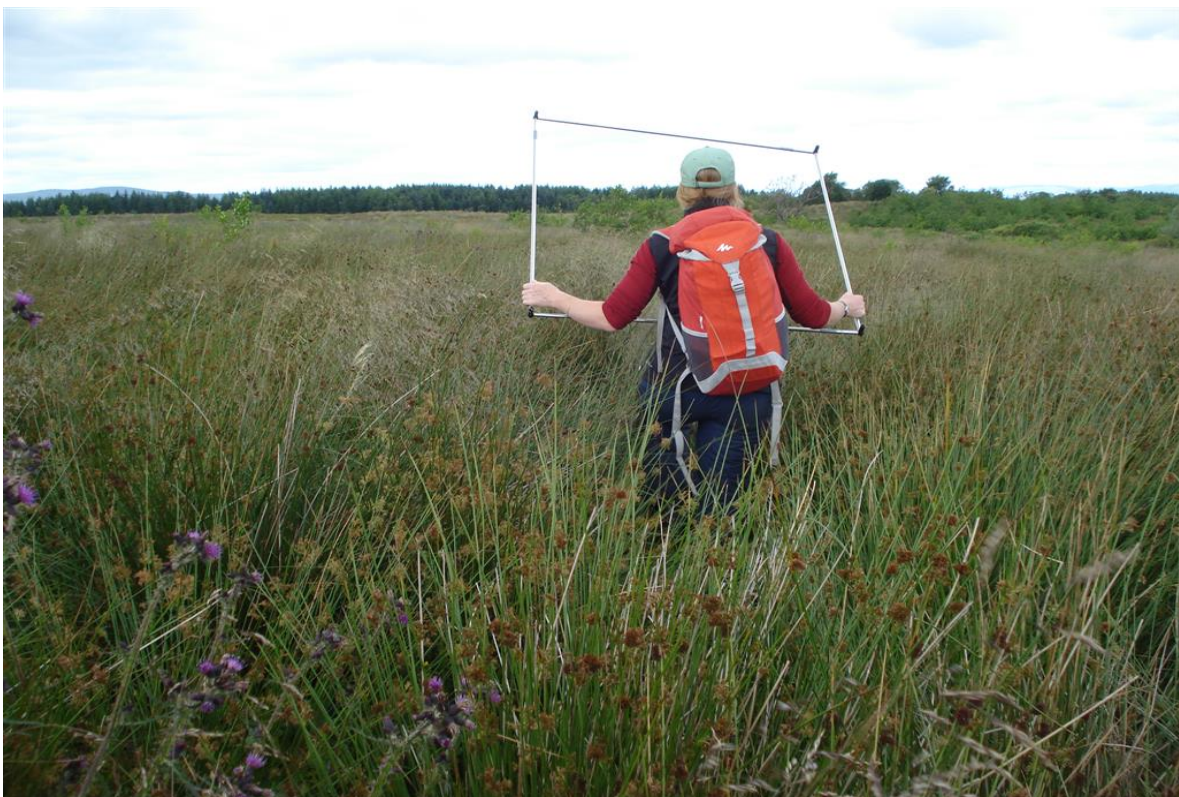
Plate 6. Site 1, Area 6, showing dense growth of soft rush on damp, heavily compacted ground.

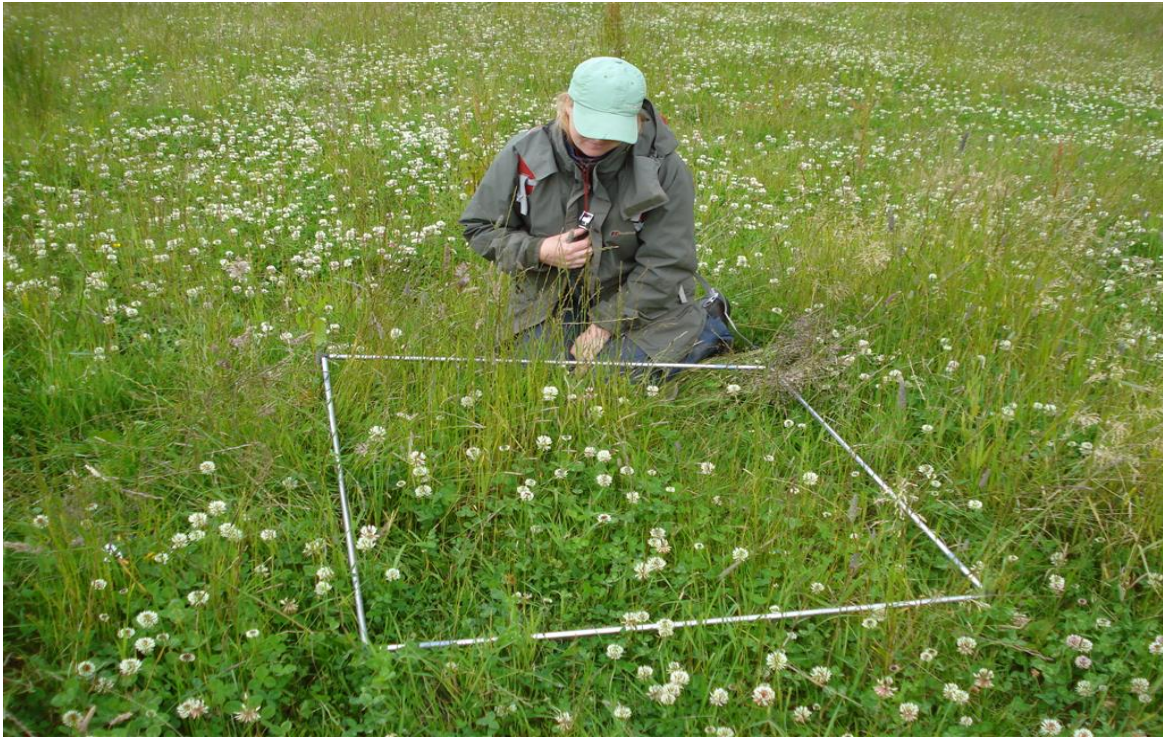
Plate 1. Site 2, Area 1, showing excellent cover of sown grass and clover species.

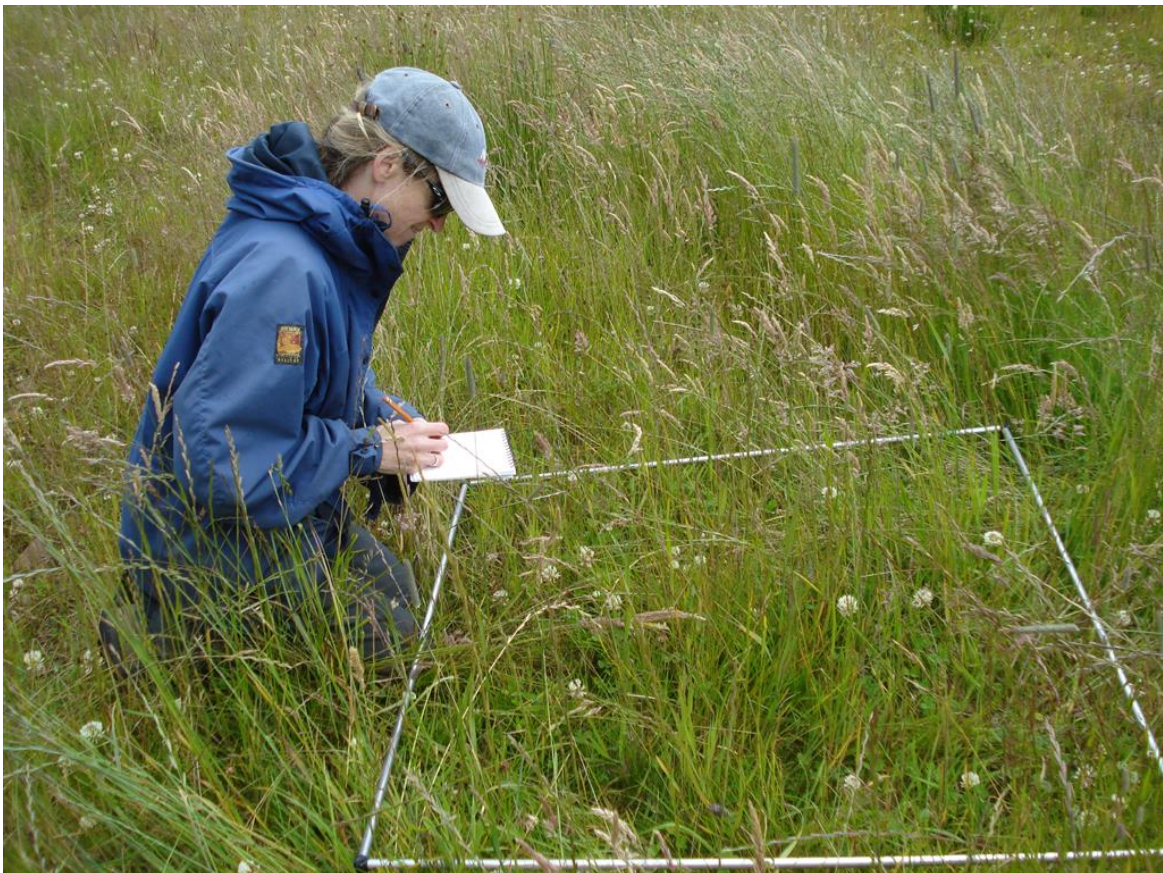
Plate 2. Site 2, Area 2, showing good growth of sown grass species with some white clover.

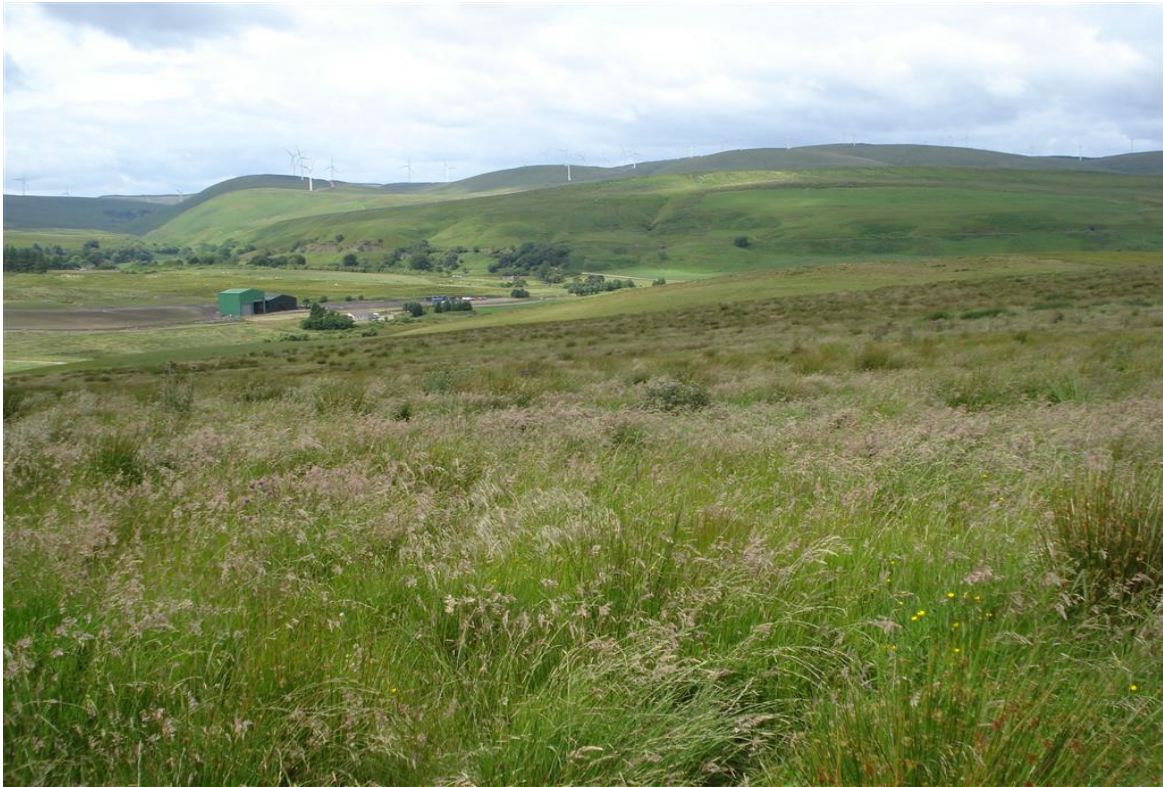
Plate 3. Site 2, Area 3, showing the predominance of sown pasture grasses in a sward which contains some aggressive weeds and is in need of further management to improve sward quality.

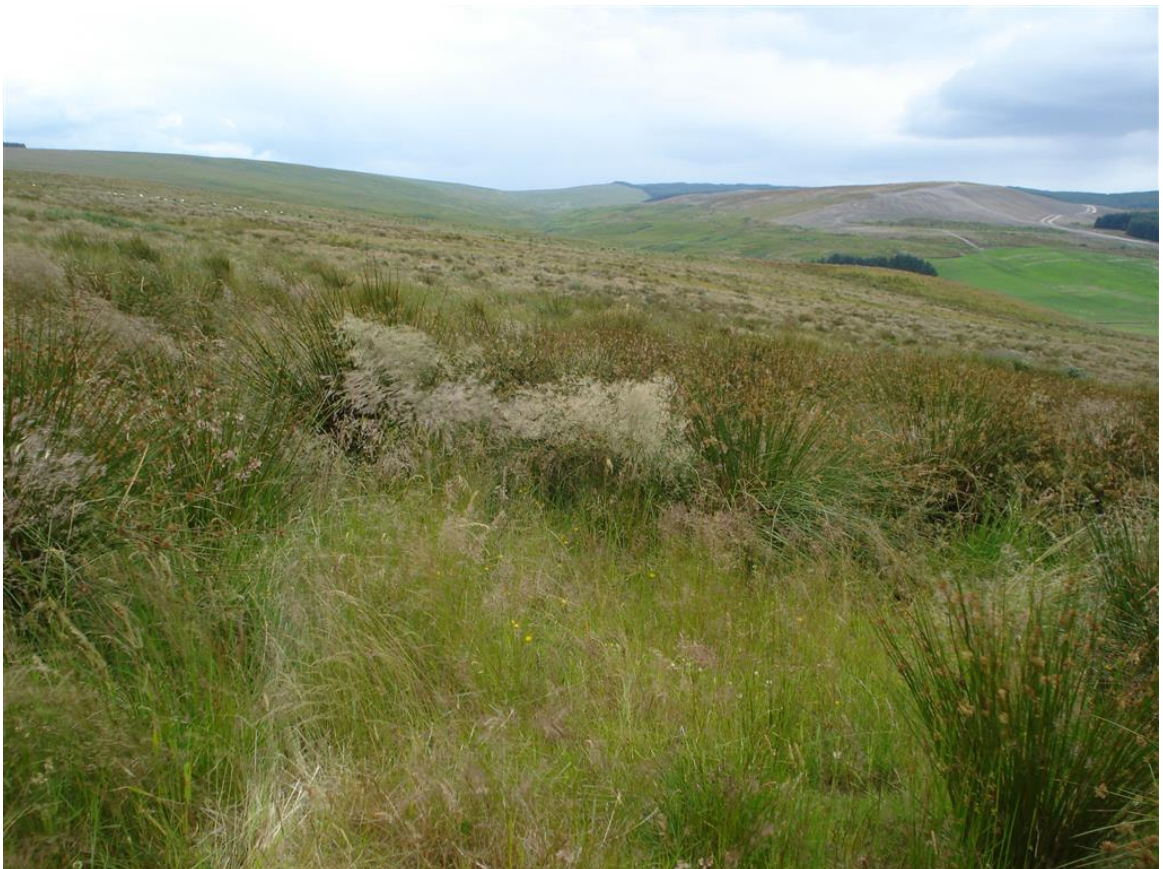
Plate 4. Site 2, Area 4, showing the predominance of soft rush in some parts, where they are beginning to outcompete the sown grasses.
