## Review of Restoration Achievements at two Scottish Opencast Mines

Prepared for: **SEPA**

Prepared by: **Bill Crooks &  
Audrey Litterick**

Date: July 2018

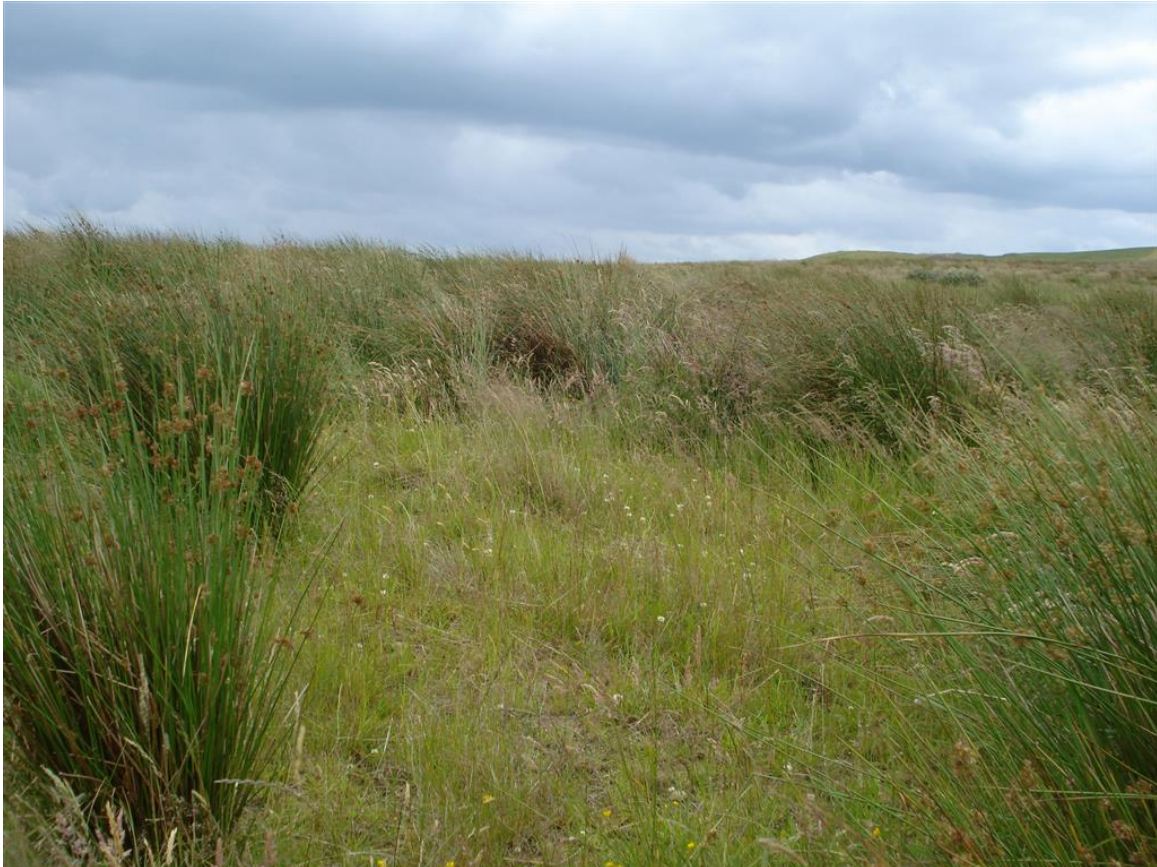
Plate 5. Site 2, Area 5, showing small patches of bare, compacted ground, a few creeping buttercups and some soft rush in amongst the sown pasture grasses.

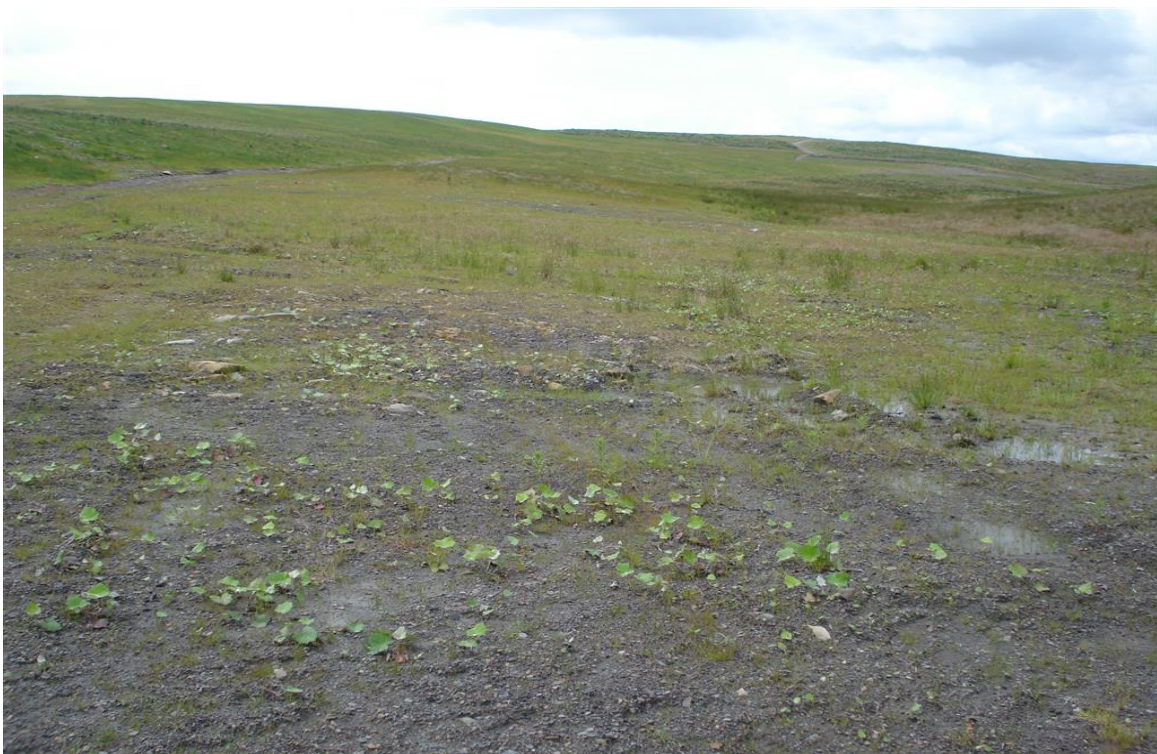
Plate 6. Site 2, Area 6, showing limited growth of pale stunted weed species (predominantly coltsfoot in this picture) on damp, heavily compacted ground.
