Radium Contamination at Dalgety Bay, Fife

Probabilistic and Hazard Assessment: A Screening Assessment

Scottish Environment Protection Agency

May 2006

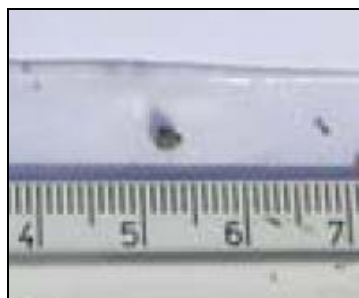
It had been assumed that all of the contaminated items were large and physically robust, however, the 2006 survey showed this assumption to be invalid. The following photographs are taken from the 2006 survey.

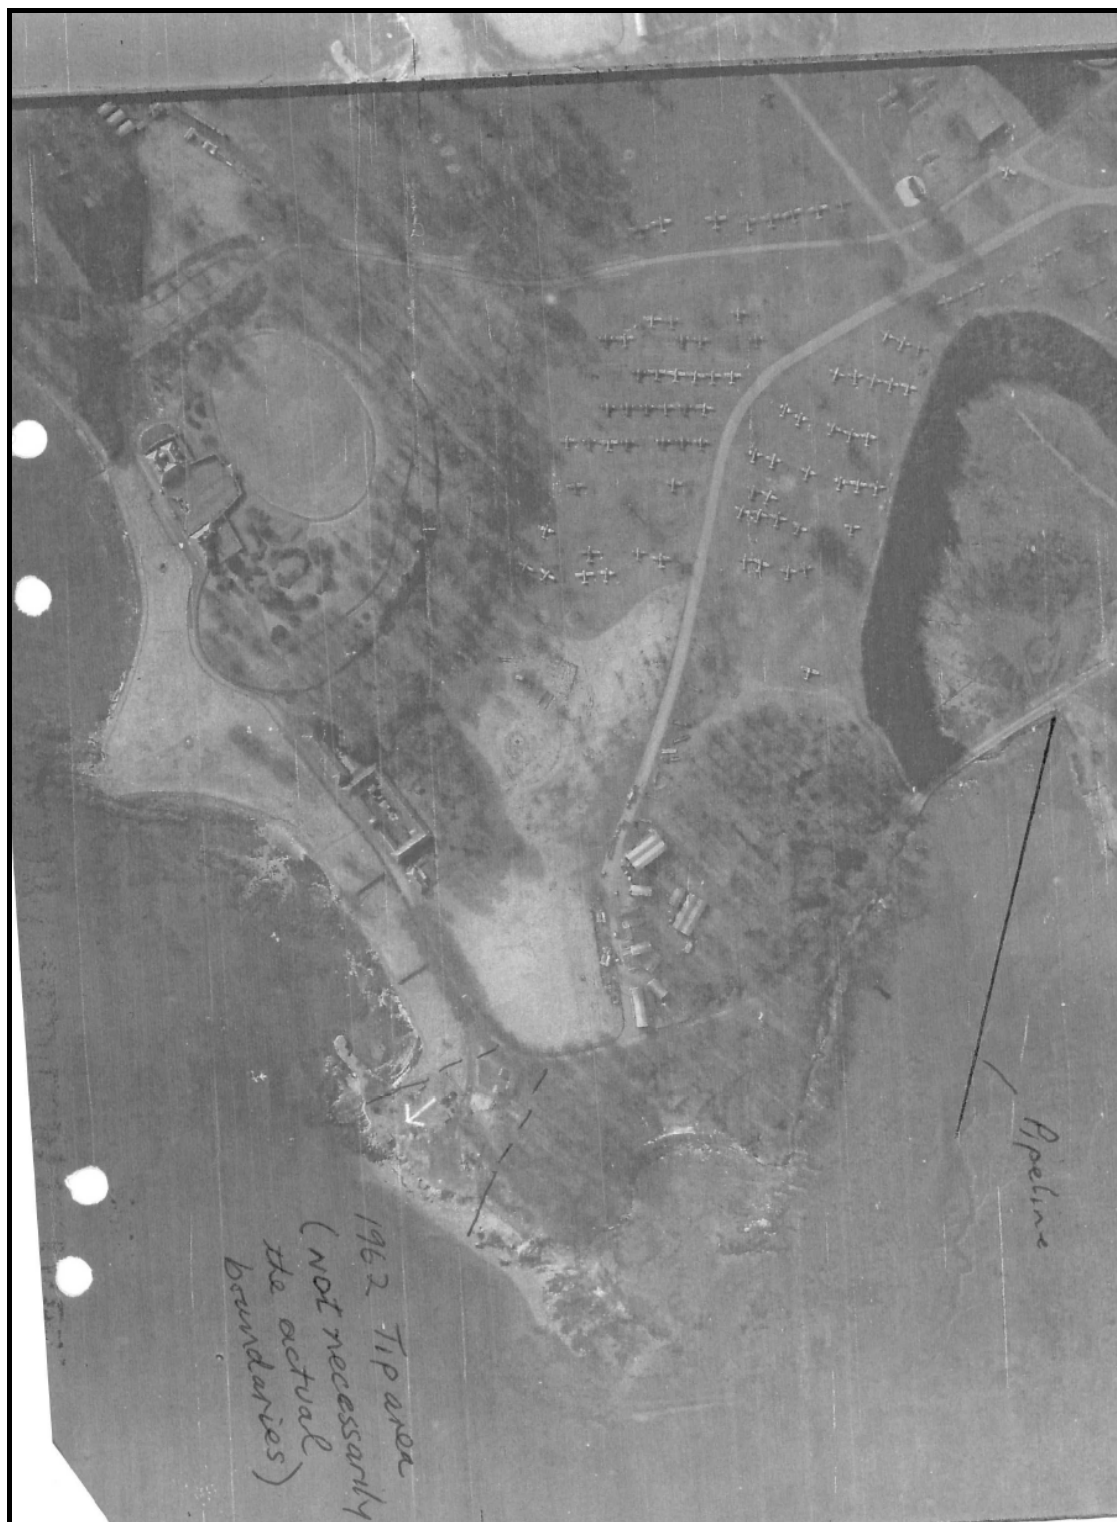
Figure 3: Aerial Photograph of Dalgety Bay (during MoD occupation).

(The origin of the annotation is unknown)

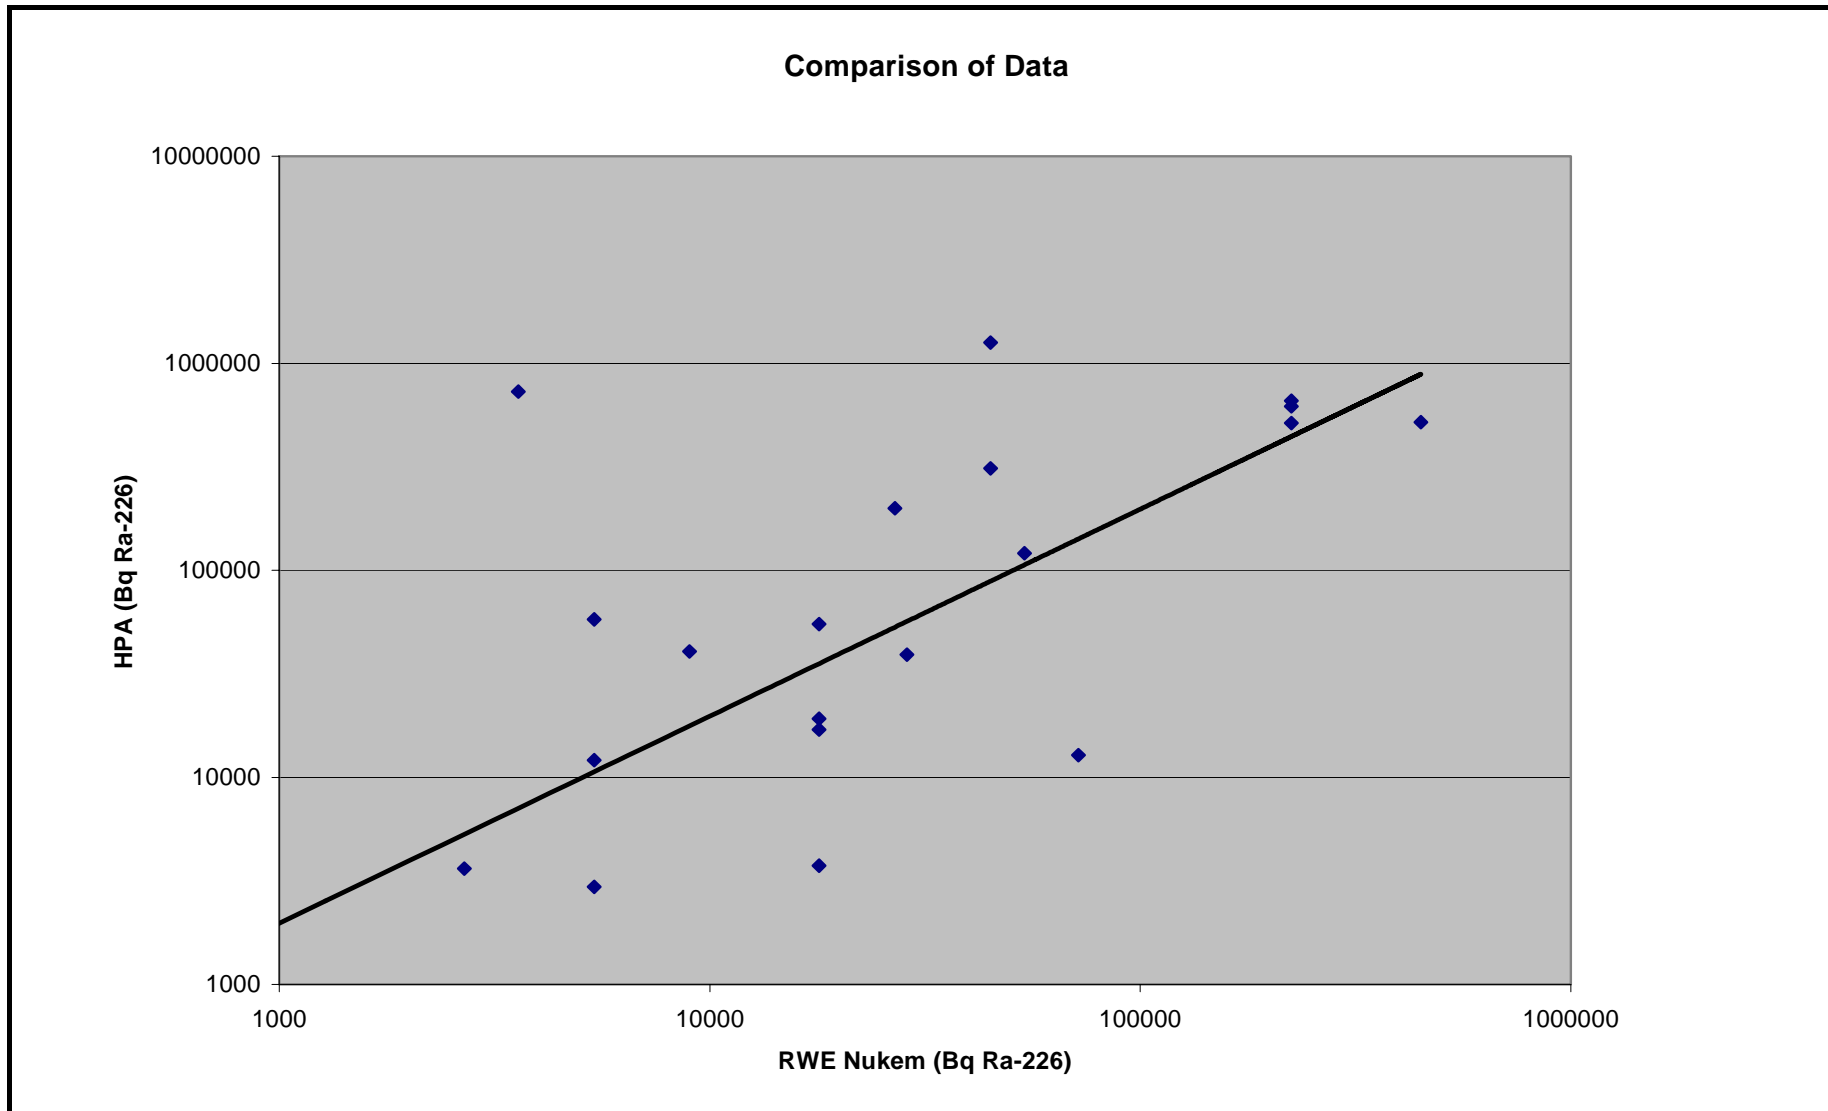
Figure 7: Comparison of HPA Analysis Data and RWE Nukem Data

The results of the laboratory analysis are shown in Tables 4.1 and 4.2. This showed discrepancies between the RWE Nukem data and HPA data (Figure 7).

The assessment of hazard has been based on activity data provided by the Health Protection Agency – Radiological Protection Division (HPA-RPD). It is noteworthy that large discrepancies exist between the data provided by HPA-RPD and that from RWE Nukem which undertook the monitoring (Figure 7). Given the absence of any relationship between the two data sets and that not all of the recovered and monitored by RWE Nukem were analysed by HPA-RPD, it is possible that items recovered by RWE Nukem could have had greater or less activity than the range reported by HPA-RPD.
