# groundcheck

**Location:** Dalgety Bay, Dunfermline

**Ref:** P3191-11-R1-A

## SUMMARY REPORT

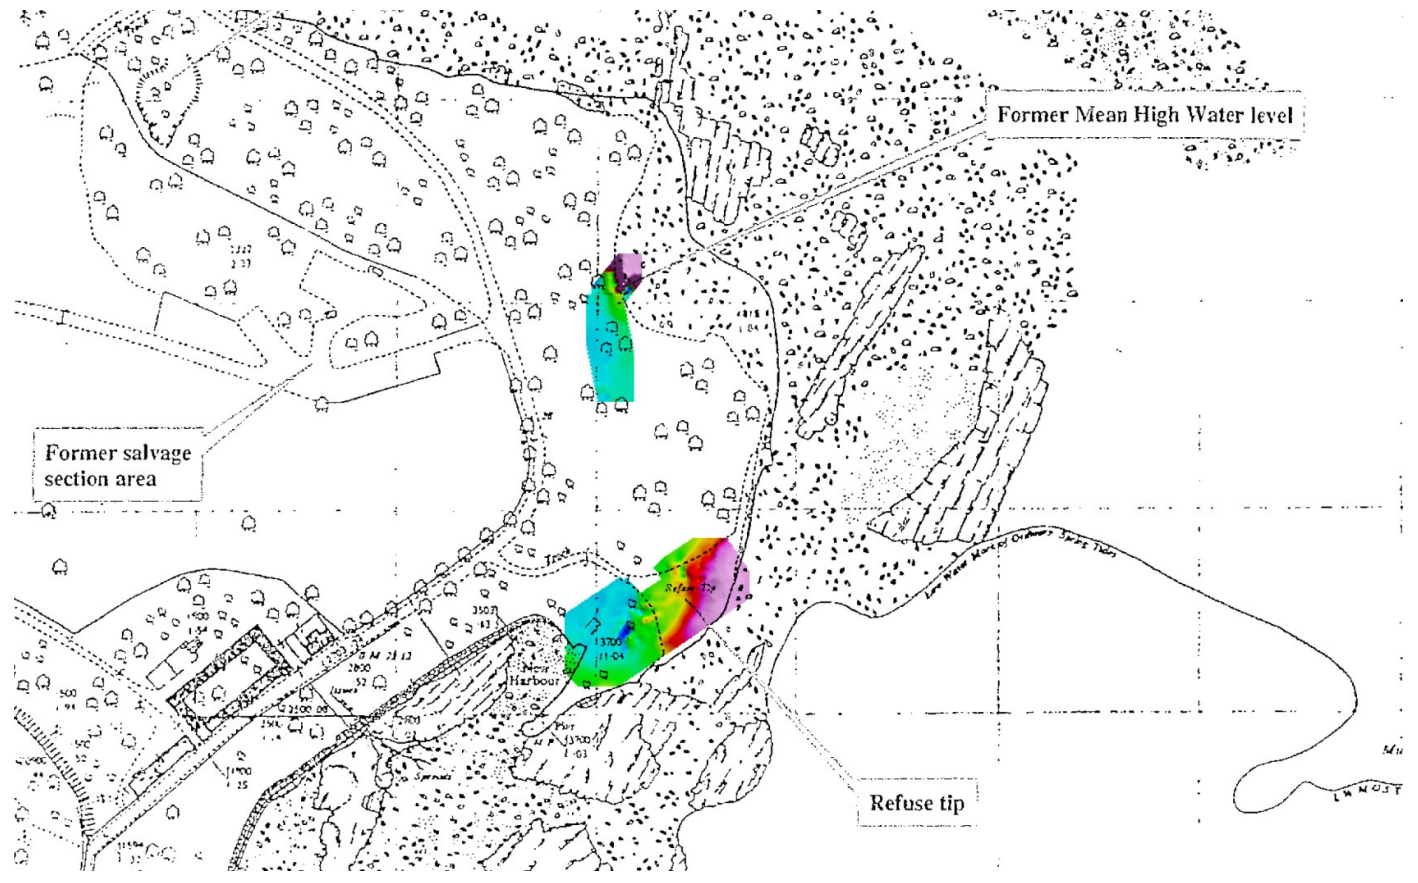
Figure 5: FEM data overlaid on historical mapping

FEM data (as shown in Zetica drawing P3191-11-DWG01-A) overlaid on the Client-supplied c. 1958 Ordnance Survey map.

The FEM data (see Zetica drawing P3191-11-DWG01-A) in this area shows a high conductivity anomaly ('warm' colours) to the south-east. This anomaly coincides closely with the location of a refuse tip shown in the historical mapping (see Figure 5). Borehole logs in this area show layers of ash and clinker within the Made Ground. It is therefore considered likely that this anomaly corresponds to an increased concentration of the incinerator waste suspected to have been deposited in this area. This area corresponds to 'Made Ground - Zone 1' in DWG03.

In the northern area, the FEM data again shows a high conductivity anomaly which closely coincides with a feature in the historical mapping (see Figure 5). In this case the edge of the anomaly coincides with the former coastline indicated on Ordnance Survey map. The FEM data in this area were significantly affected by the presence of boats and other metal objects on the surface so this feature must be interpreted with caution. However, the shape and character of the anomaly is difficult to explain based on the surface metal alone. Furthermore, the edge of the anomaly coincides closely with a change in stratigraphy observed in the GPR data. Finally, the boreholes within this anomaly are the only ones in this vicinity of the survey area which contain ashy Made Ground. This anomaly has therefore been interpreted as 'Made Ground - Zone 1'.
