Bathing Water Profile for Thurso Bay (Central)

Thurso, Scotland

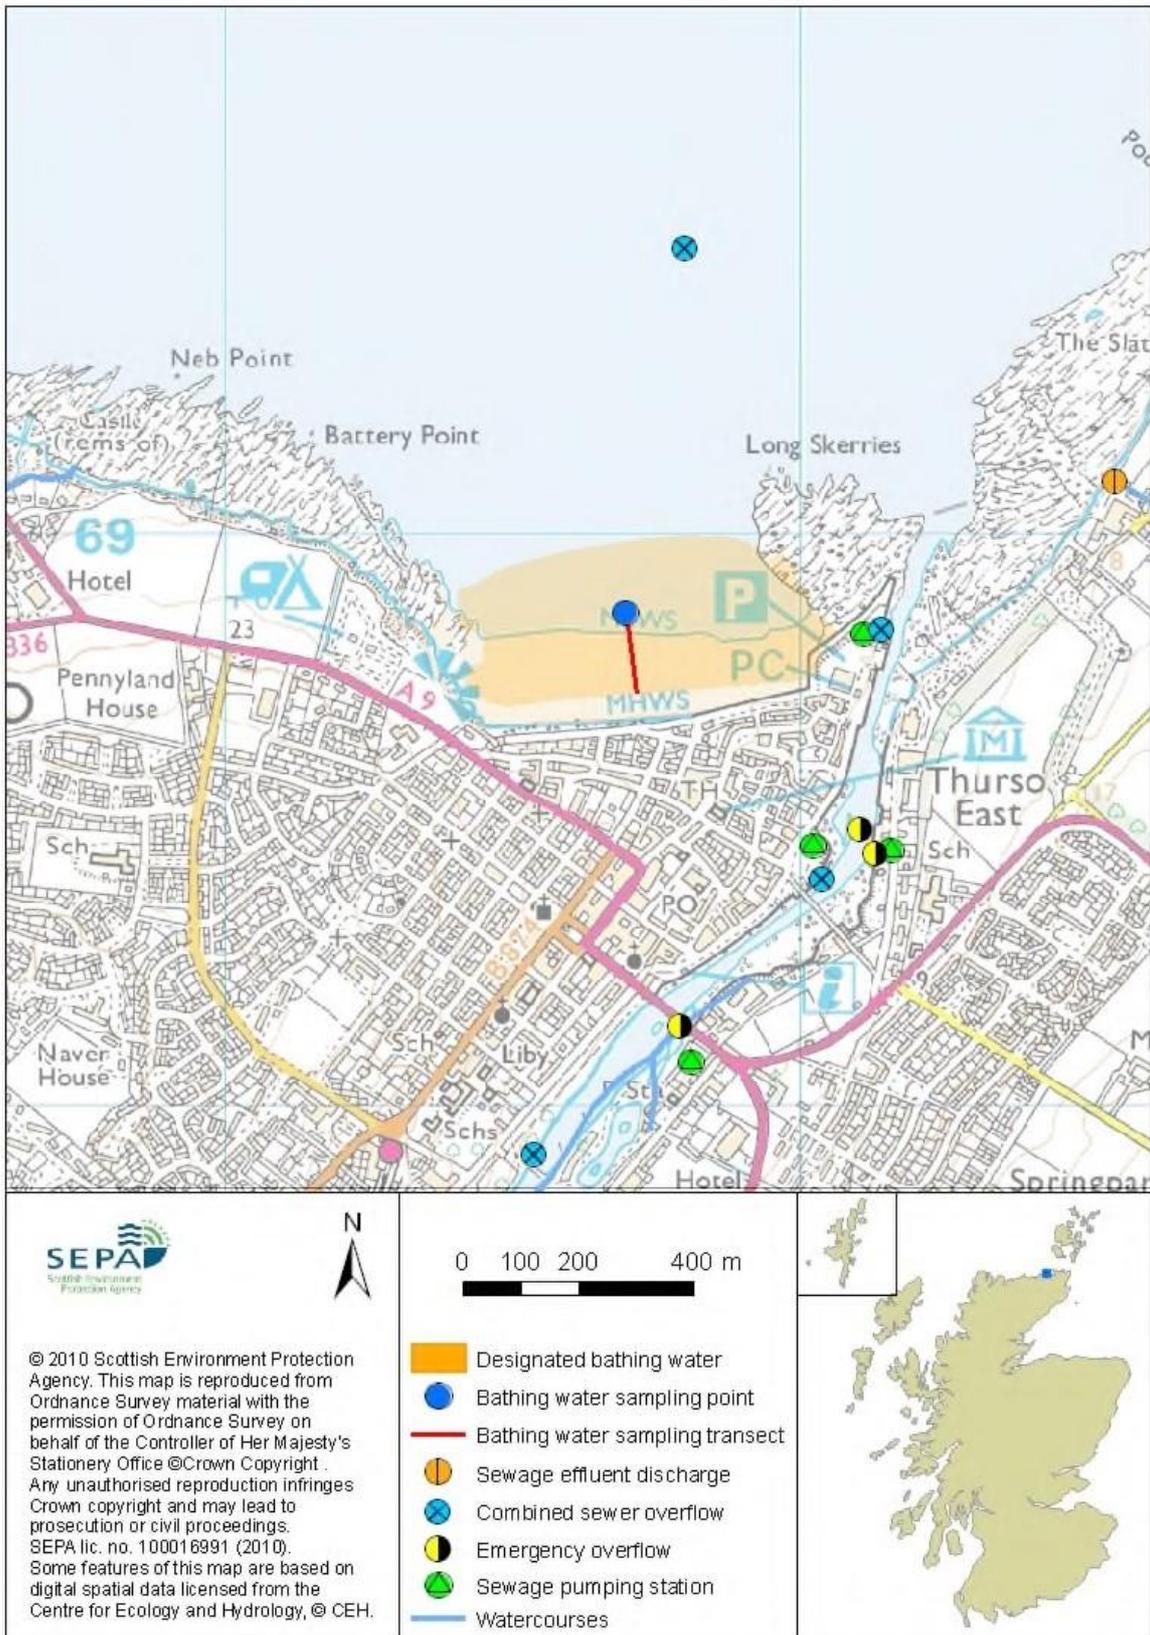
Map 1: Thurso Bay (Central) bathing water

Thurso Bay (Central) bathing water is situated on the north coast of Scotland adjacent to the town of Thurso. The designated bay is less than 1 km long and extends from Rockwell Point in the west to Little Ebb in the east. The beach is popular with bathers and water sport enthusiasts.

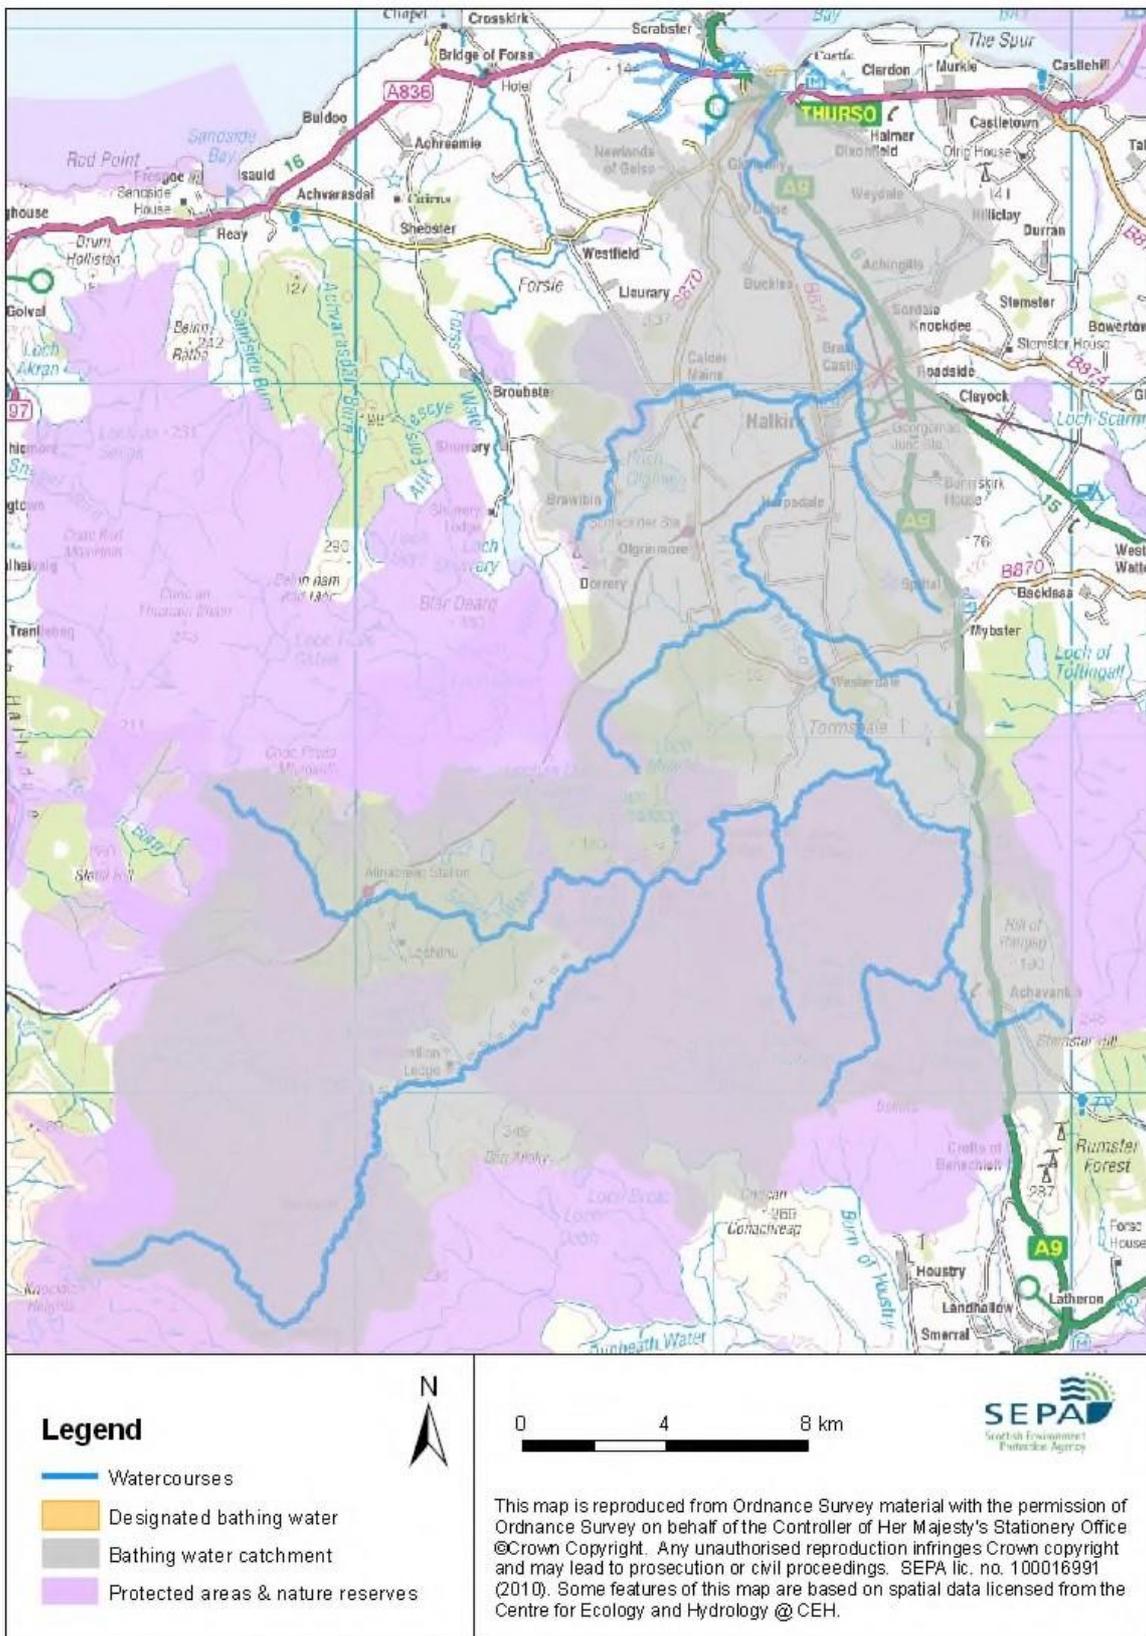
Map 2: Catchment draining into Thurso Bay (Central) bathing water

The catchment draining into the Thurso bathing water extends to 487 km². The catchment varies in topography from hills (maximum elevation 440 metres) in the south to the low-lying land (average elevation 5 metres) along the coast. The main river within the bathing water catchment is the River Thurso which discharges to the east of the designated bathing water.

Land use in the catchment is mainly split between rural land and bog. The principal rural land uses in the area are improved grassland (14%), shrub (12%) and coniferous woodland (10%). The upper catchment around Halkirk is mainly sheep farming with beef farming around Thurso. Less than one percent of the bathing water catchment is urban. The main population centre is the town of Thurso situated adjacent to the bathing water. Population density outside of Thurso is generally low (Map 2).

There are several protected areas either fully or partially within the bathing water catchment including two Special Areas of Conservation, two Special Protection Areas, 17 Sites of Special Scientific Interest, two Ramsar sites and two bird reserves (Map 2).
