Dalgety Bay Land Quality Assessment

Final Factual Investigation Report
DIO Project No. 13032

15 April 2013

Prepared by AMEC Environment & Infrastructure UK Limited for the Ministry of
Defence, under commission DE4/4513

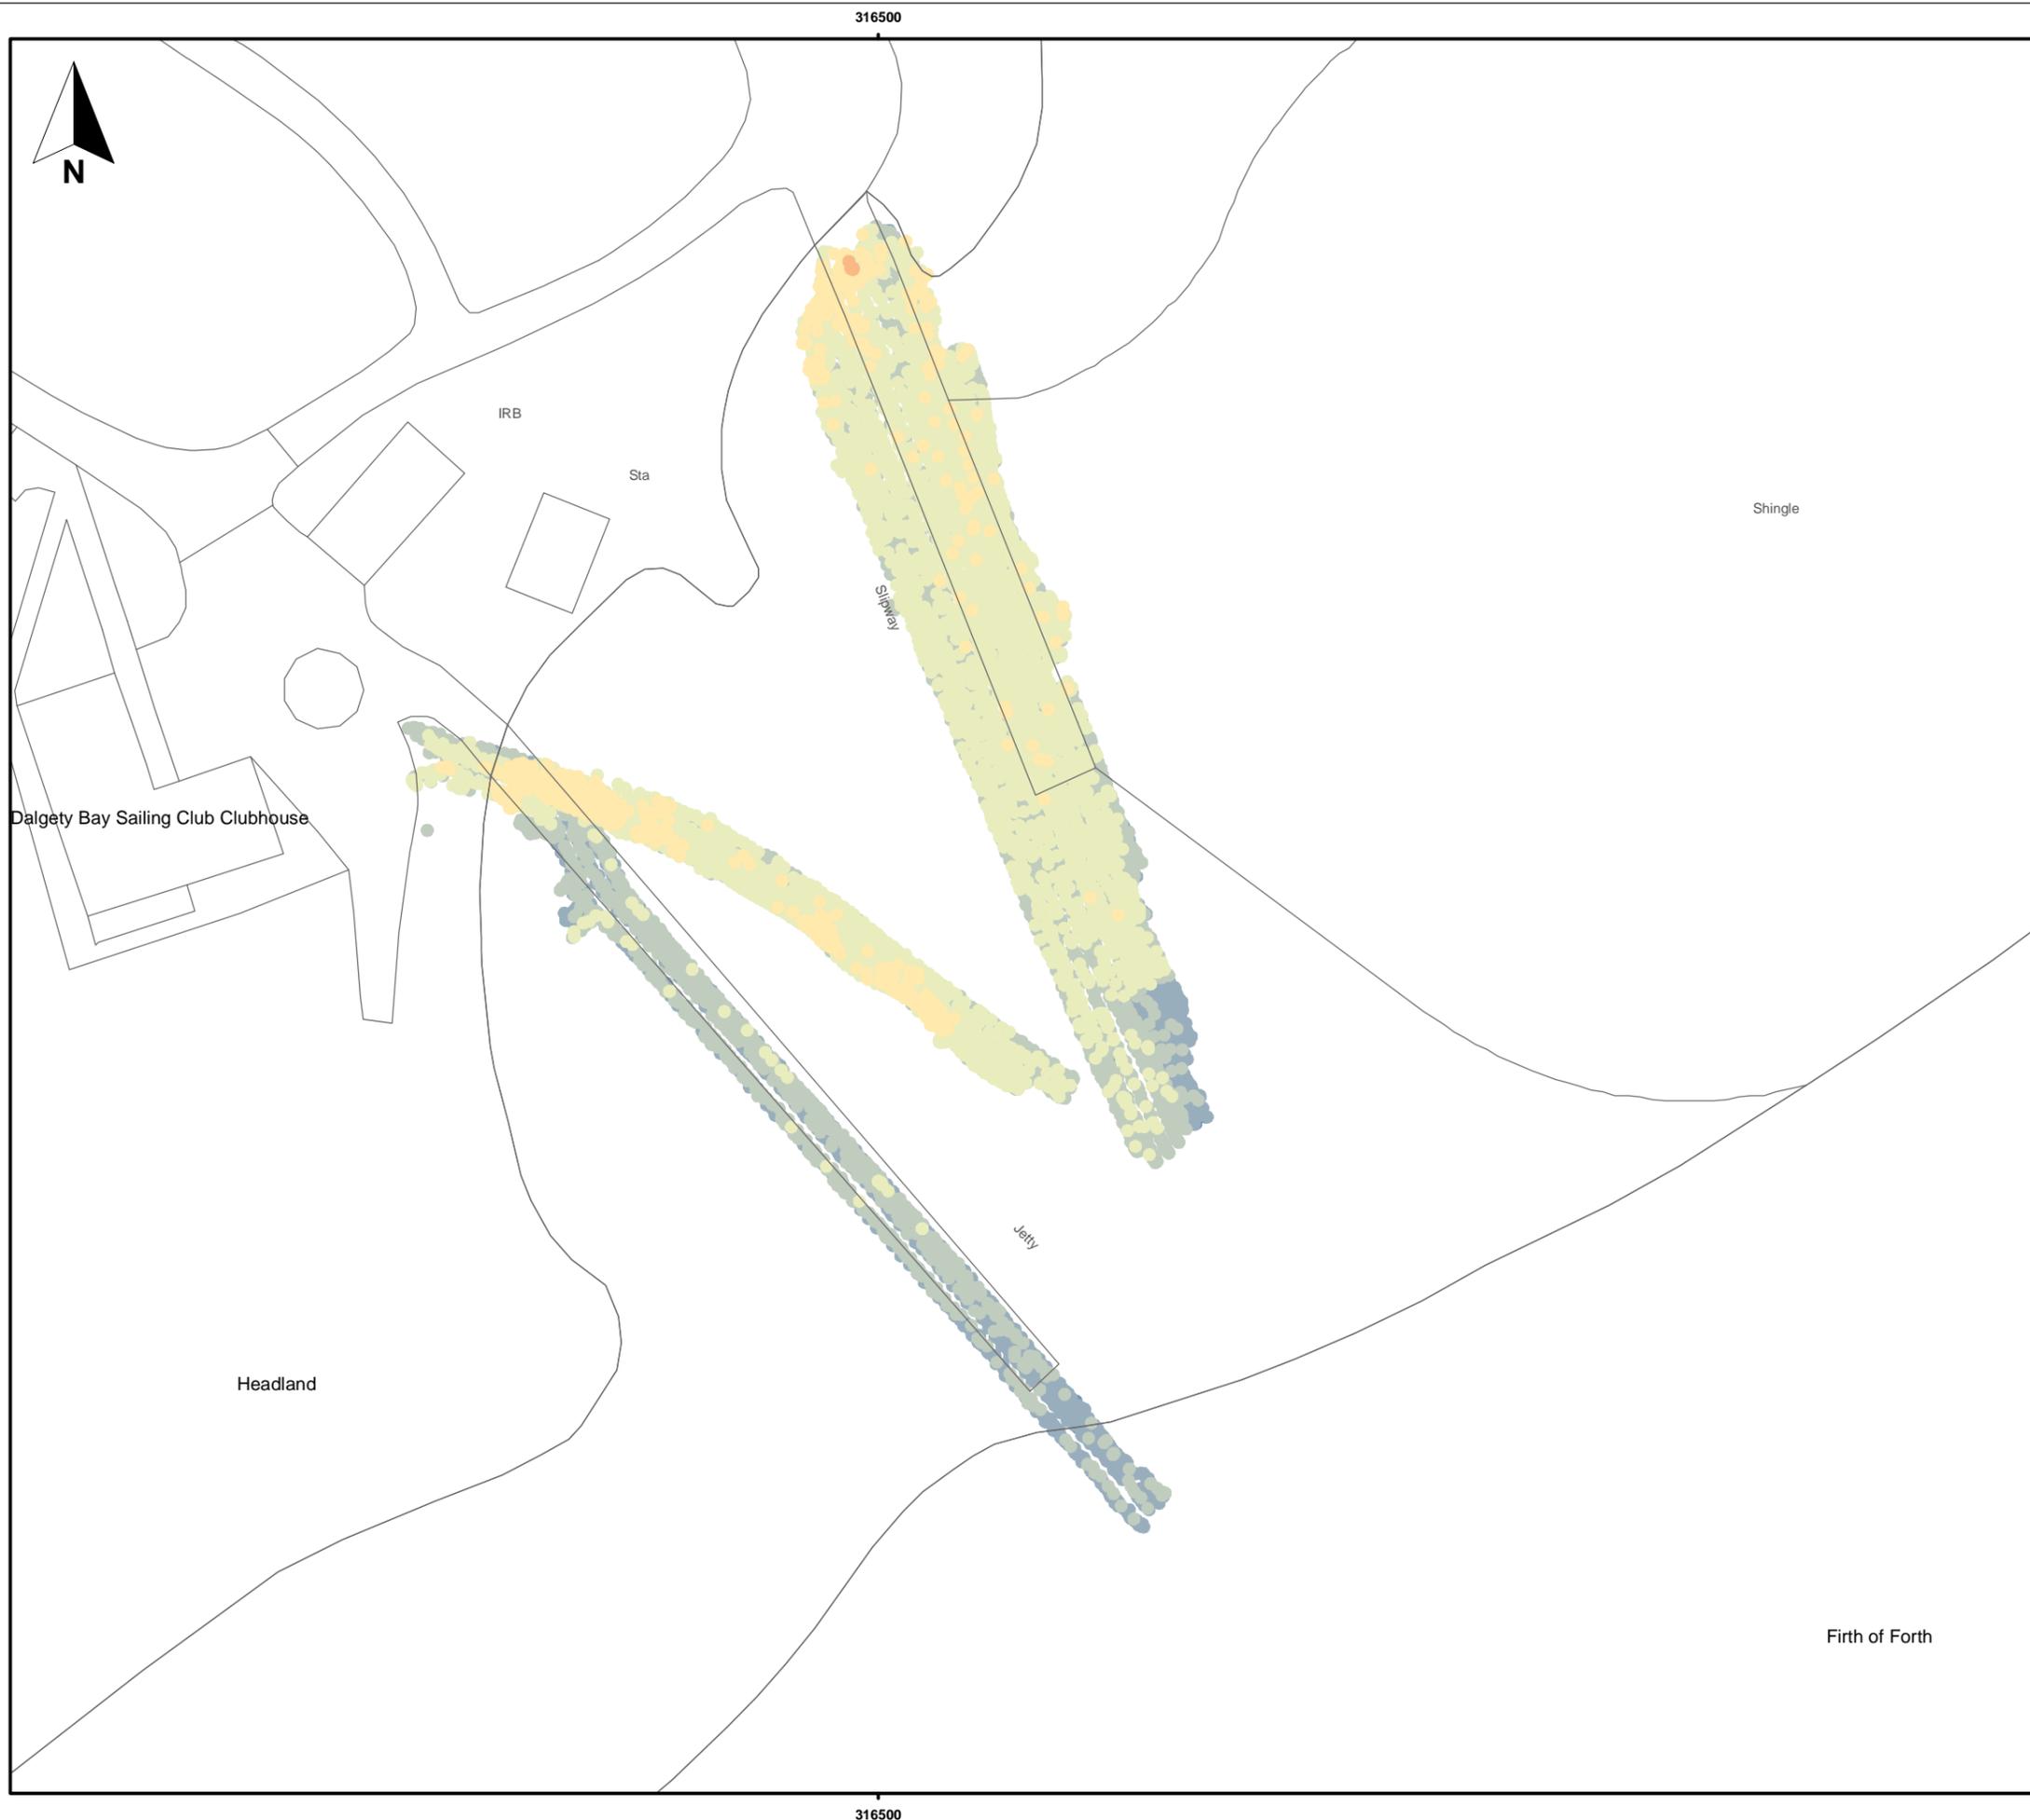
A radiological walkover survey was undertaken of the hard standing areas comprising the three slipways south east of the Dalgety Bay Sailing Club. The results are presented on Figure 6.

Whilst areas of elevated count rates were detected, no point sources were encountered which were recoverable from the surface of the hardstanding.
