# Defence Infrastructure Organisation

## Dalgety Bay

Coastal Processes Review

March 2013

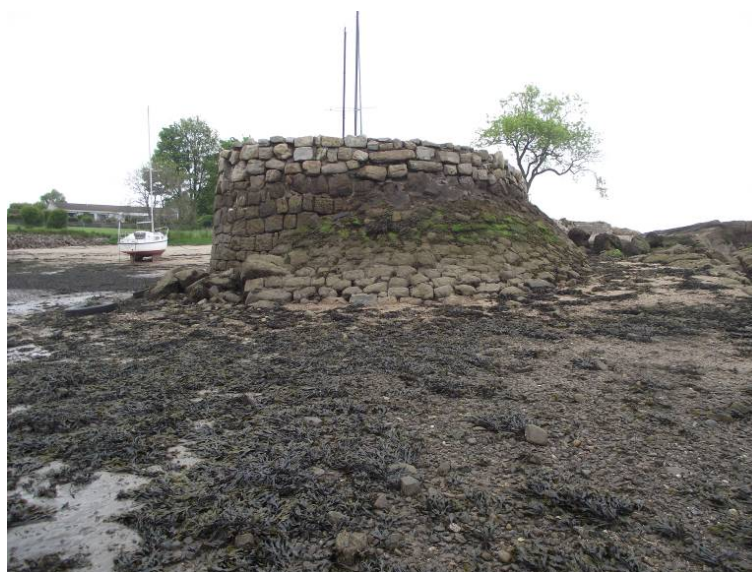
**Figure 1** New Harbour Quay (Chainage 0m)

The study area commences at the extremity of the SW facing stone quay or breakwater that protects a small sandy bay with well graded shell particles giving a white appearance to the beach, visible to the north/ left in Fig.1. The quay is approximately 30m long and up to 5m tall, built using roughly dressed boulders typically of 0.5m diameter. There is little evidence of mortar between boulders, with gaps typically 0.5m deep suggesting the quay could be vulnerable to further storm damage.

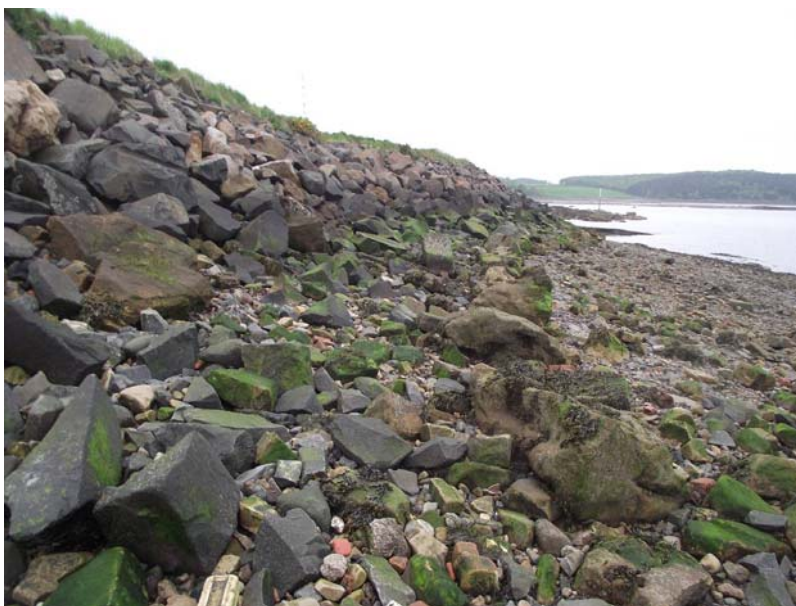
**Figure 3** Armour stone to Promontory 1 (Chainage 70-140m)

This area of open grassland, which is termed the ‘Headland’ in accompanying AMEC reports, is significantly higher than the surrounding coastline and extends further onto the intertidal foreshore. The reclaimed nature of this land is confirmed by the Fife SMP (ref.1) detailed maps, showing the seaward corner furthest from the previous coast forming Promontory 1 at Chainage 140m. The two faces of this promontory are protected with armour stone of various sizes and gradings, forming slopes varying from 1:1 to 1:2. Along the SE facing edge (Chainage 70 to 140 m), an armour stone revetment of up to 5m high has been formed with up to 1m boulders at MHWS level, reducing to smaller boulders near the crest and at the foot of the structure. There is no apparent geotextile nor toe detail and minimal evidence of a separate filter stone layer. Localised erosion is visible near the crest, notably at Chainage 140m (visible in Fig.5), but the stone generally appears to be tipped randomly rather than placed, with a significant variation in stone sizing.

The foreshore seaward of the armour stone comprises a steep (approximately 1 in 10) beach full of debris which appears to have been partially eroded from the armour stone; the evidence for which consists typically of 50-200mm size bricks/cobbles down to the mudflats just visible at MLWS, as shown on Fig.3. Such erosion could be linked to localised slumping of the armour stone, that would explain the variations in armour stone gradient observed.

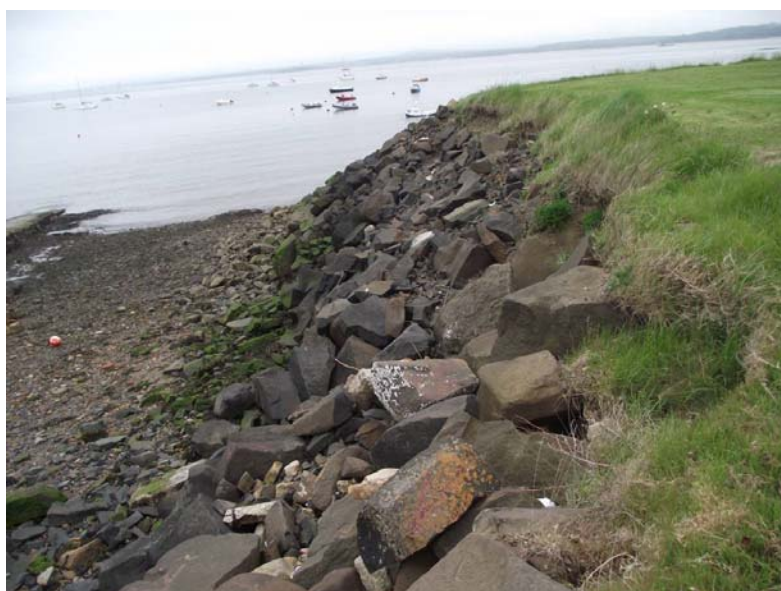
**Figure 4** NE Face of Promontory 1 (Chainage 60-80m)

The return face of Promontory 1 (Chainage 140 to 200m) is of similar armour stone construction, but facing ENE approximately parallel with the DBSC jetty, as shown in Fig.4. It is consequently comparatively sheltered and shows a more uniform 1:1.6 gradient, and less crest erosion, but still plenty of typically 50-200mm size bricks/cobbles on the beach along the toe, suggesting reduced wave erosion is also occurring here.

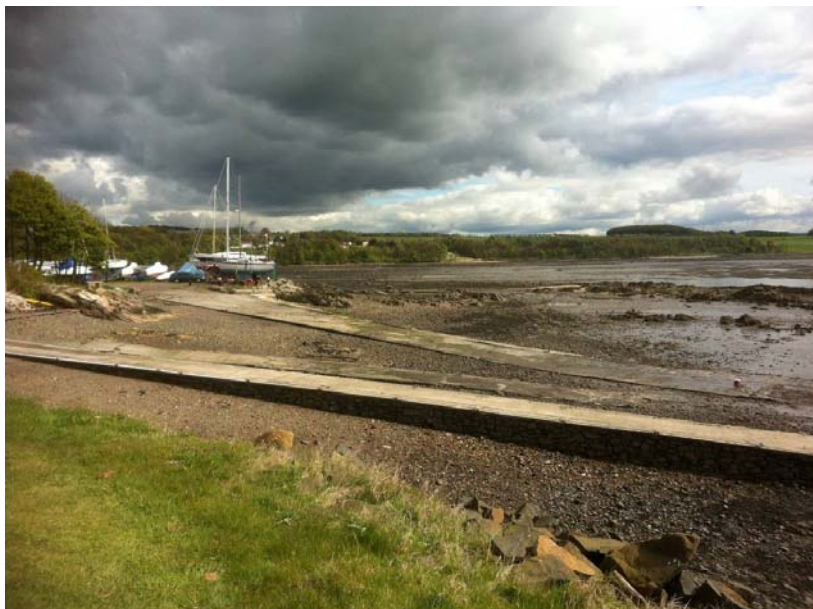
**Figure 7** Showing Slipways and Promontory 2 (Chainage 300m) from Promontory 1 (Chainage 170m)

This promontory is built on a substantial bedrock outcrop that extends up to 50 m out into the bay, exhibiting N-S strata, and causing a local raising of beach levels. The boat storage area is protected by armour stone, placed variably on damaged filter cloth/no filter stone, topped up with ad-hoc precast blocks/smaller stone.

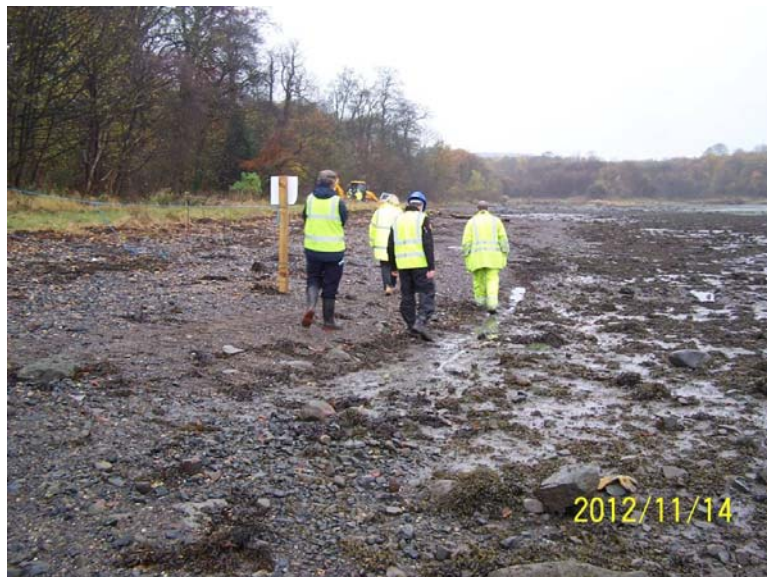
**Figure 10** Ross Plantation (Chainage 520m) – showing mature trees/ raised beach

This length of beach appears the most stable, comprising an approximately 5m wide shingle strip along the strand lines merging into the mud flats, with minimal evidence of erosion where the head of the shingle beach turns to grassland, footpath and the mature Ross Plantation. Ross Plantation features tall deciduous trees. The trees reach heights exceeding 10m within short distances of the beach, suggesting permeable soil allowing root development to significant depths.

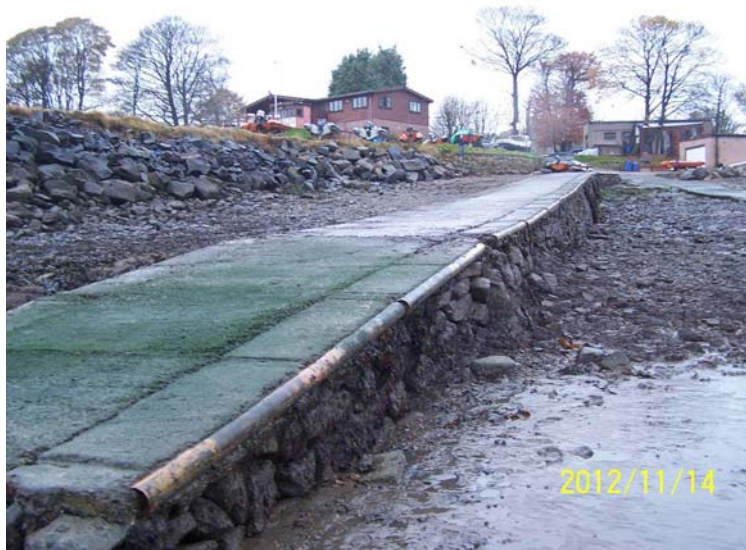
**Figure 13** Groyne Effect of Jetty on beach levels

This foreshore area has no rock outcrops, so the beach has formed a classic concave profile from the low sandstone “cliff”, slowly flattening to seawards as it merges into the mud flats at MLWS. This is evident from Section 5 (Drg.No. 23218-rr415-04) drawn along the east slipway that was built with in-situ concrete slabs presumed to be laid flush with this pre-existing beach profile.

The beach comprises gravel/shingle, cobbles and a few boulders but no sand, merging into mudflats at the foot of the slipways as seen in Figs 6 & 7. The comparative lack of boulders compared with the beach SW of the slipway further points to this groyne effect, suggesting the jetty forms a terminal barrier to larger sediment movement as well as throttling the finer material.

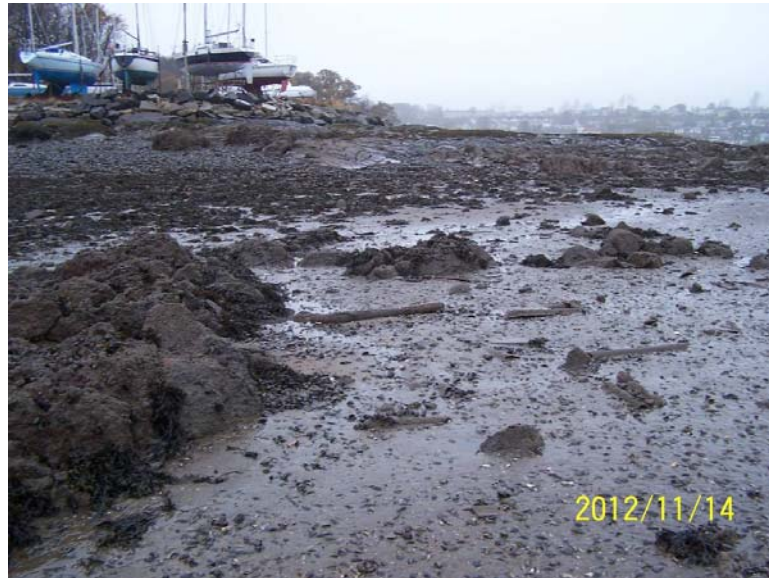
**Figure 14 Roofing Debris**

- Roofing Debris – this silty beach area just west of the east slipway (as shown in Fig.14) was strewn with corrugated roofing panel debris, typically 100 to 800mm long and of a type that is often found to contain asbestos. The unusual concentration of this material here suggests a batch of this material being eroded or tipped and being sorted into groups of broadly similar aspect ratios that react similarly to storm wave movement at high tide.

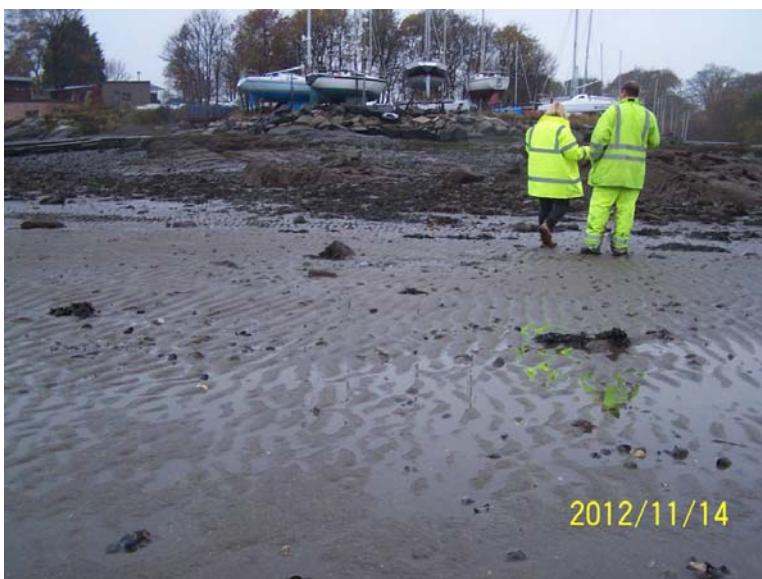
**Figure 15 Silt Ripples between Rock Outcrops**

- Beach Ripples – the surface of the silty channel between rock outcrops was marked by ripples typically 25mm high by 200mm long, aligned across the channel in a ENE/WSW direction, suggesting predominant wave action from the SSE direction immediately preceding the site visit. These ripples only form as the tide ebbs away, and the rock outcrops dominate wave directions more than at high tide, but it still gives an indication of prevailing wave activity, which aligns with the high tide wave crests shown on Fig.15.

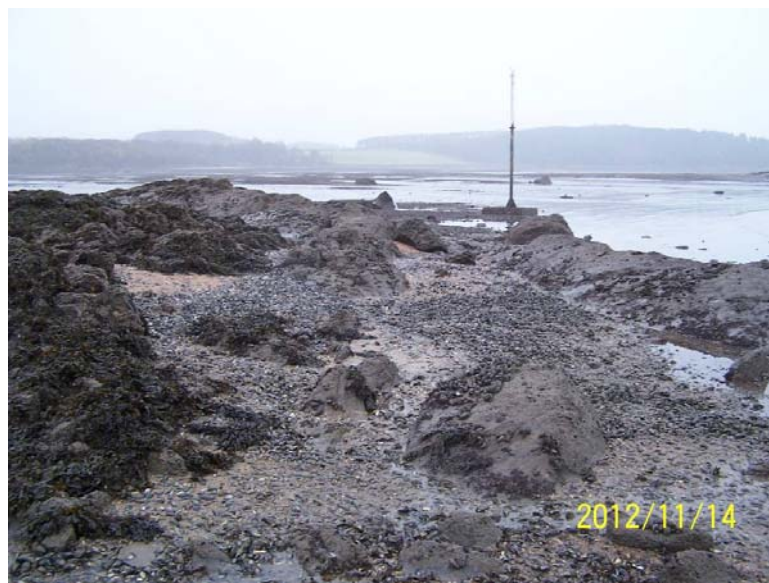
**Figure 16 Mussel Beach & Marker Post**

- Coarse sandbank / mussels – various discrete locations around the main rock outcrop were noted to attract deposits of coarse (0.5-2mm) pink coloured sand/shell fragments, together with banks of mussels. These are indicative of more sheltered areas where the comparative lack of wave action allows residual tidal currents to deposit sediment and provide a suitable environment for the mussels to feed. This coarse sand is shown in Fig. 16 and is the same sand accreting at the SW foot of the jetty (Fig 6).

- Of particular littoral significance however is the curving sandbank approximately 20 long and approximately 0.5m tall that extends from the northern end of the rock outcrop in an arc curving inland to the NE before fading into the silt, as shown on Fig 17. This suggests either prevailing SSE waves refracting clockwise into Dalgety Bay, or ESE waves becoming more dominant at the north end of the outcrop as SSE/S waves break and lose energy on the rock as the tides ebb. Even if both are true, the evidence clearly points to sediment movement around Promontory 2 from the south and into Dalgety Bay.

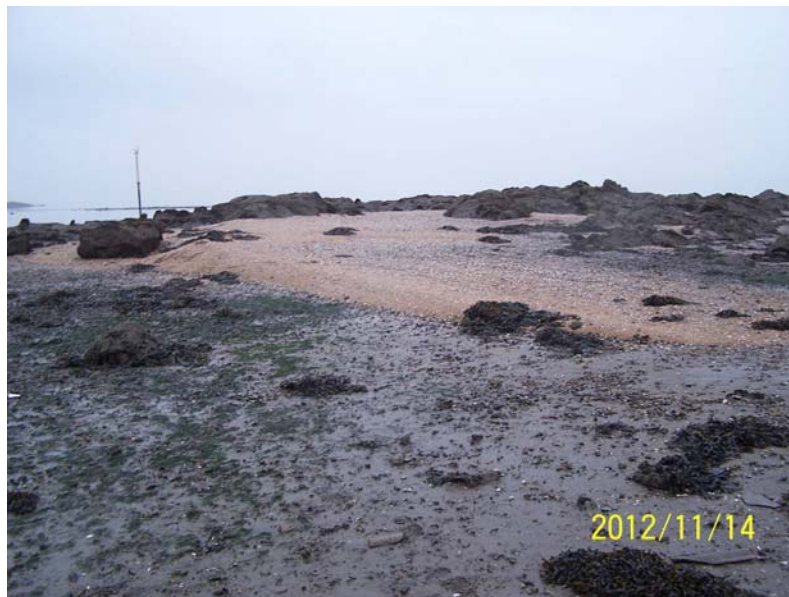
**Figure 17 Coarse Sandbank & Leaning Marker Post**

- Leaning navigation marker post – there is a tubular steel marker post bolted to an insitu concrete base slab to mark the end of the surface water outfall just off the main rock outcrop, as shown on Drg. No. 23218-rr415 – 01. Normally this would have no significance, but it is clear from comparing Figs 16 & 17 that the post has a pronounced lean of 2-3° in a NE direction. The age of this post is unknown, but this lean is very likely to be the result of fatigue loading caused by years of prevailing wave loadings that will obviously be greatest during high tides. The direction of this lean is therefore a stronger pointer to large wave /deep water conditions than the sandbanks and silt ripples, that are generally formed at lower ebbing tide levels.
