**APPENDIX H**

Catchment photographs relating to NFM assessment

**River Nith restoration, cbec UK Ltd, October 2013**

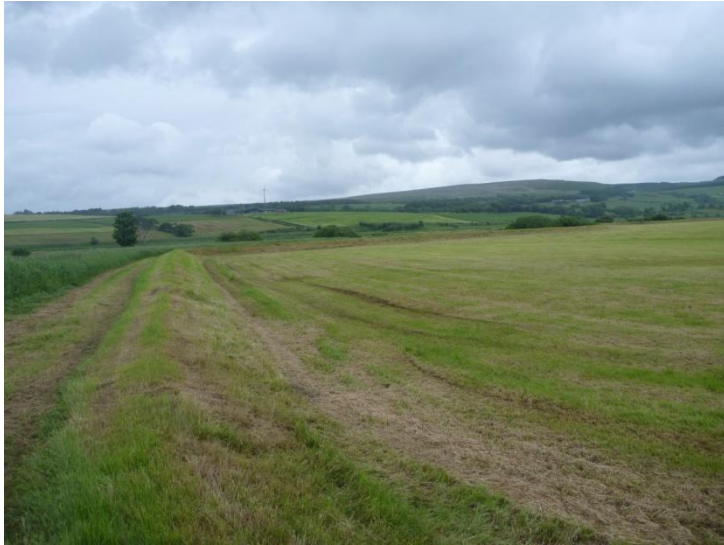
Figure H.1: Section of embankment located along the edge of an arable field. Located on the right bank of the River Nith, within the centre of the New Cumnock model domain.

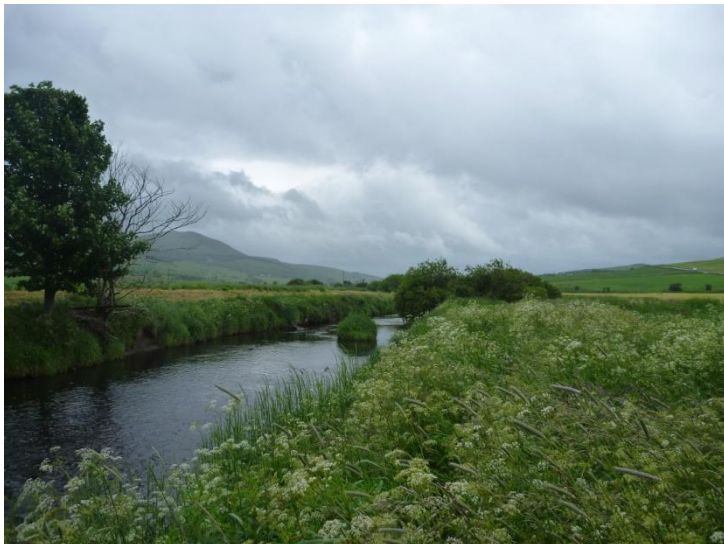
Figure H.2: River Nith within the New Cumnock model domain. Embankment on the right bank of the River Nith. Floodplain on both sides of the Nith.

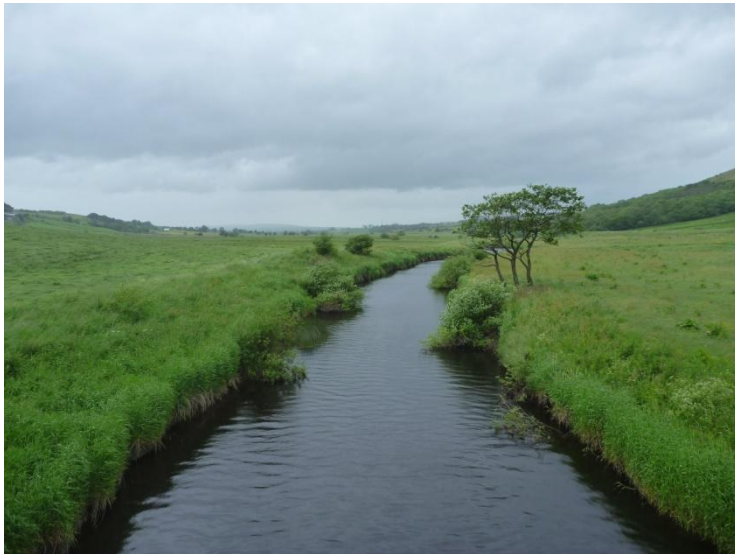
Figure H.3: River Nith in the lower section of the New Cumnock model domain. No significant embankments within this section.

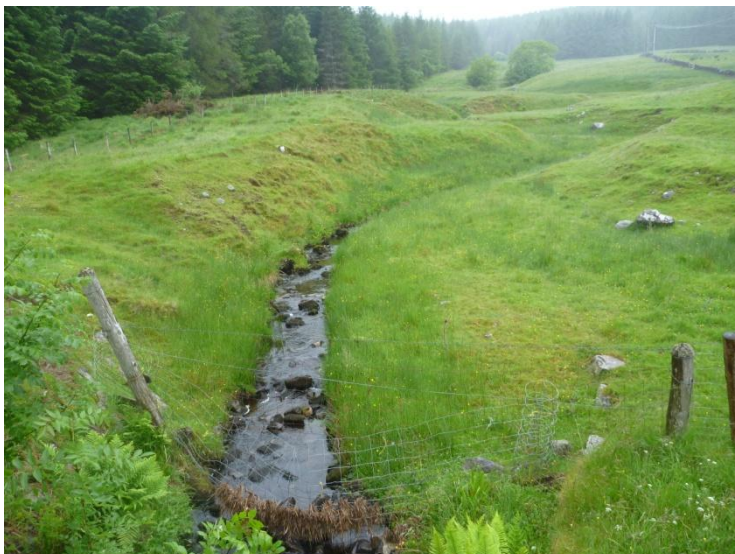
Figure H.4: Example of a small tributary located in the upper catchment of the Nith (Tributary of the Afton Water). Steep relief, with land cover predominately of grazing land and coniferous forestry.

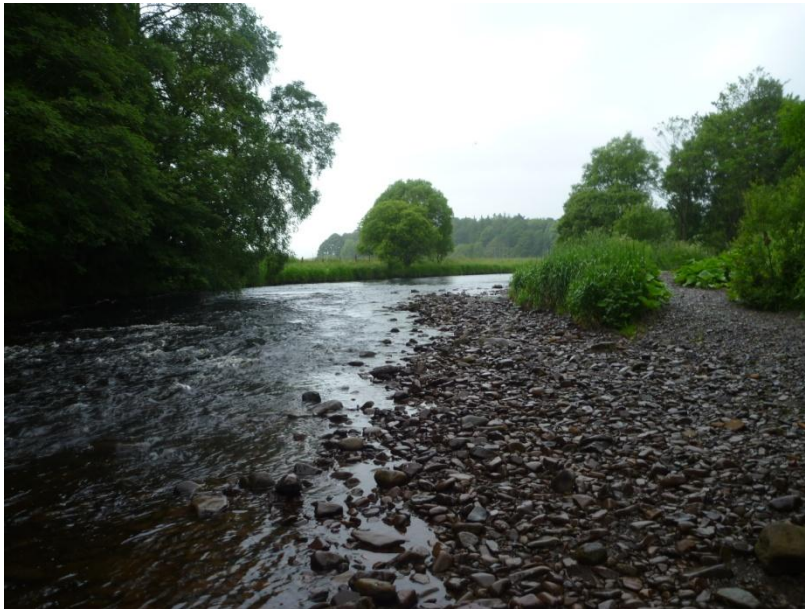
Figure H.5: River Nith 1km south of the Sanquhar modelling section. Bed material consists of flat angular pebbles.

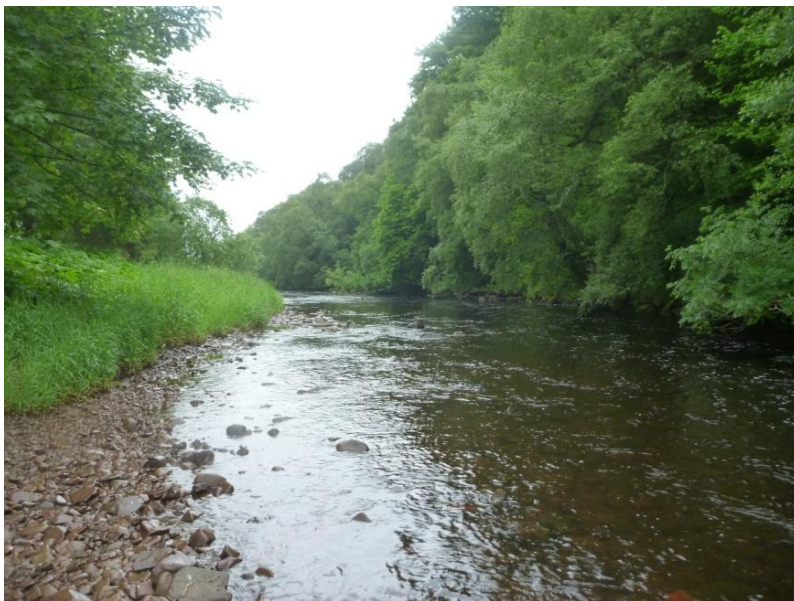
Figure H.6: Main channel between the Sanquhar and Thornhill model sections. Steep right bank and densely vegetated right and left banks.

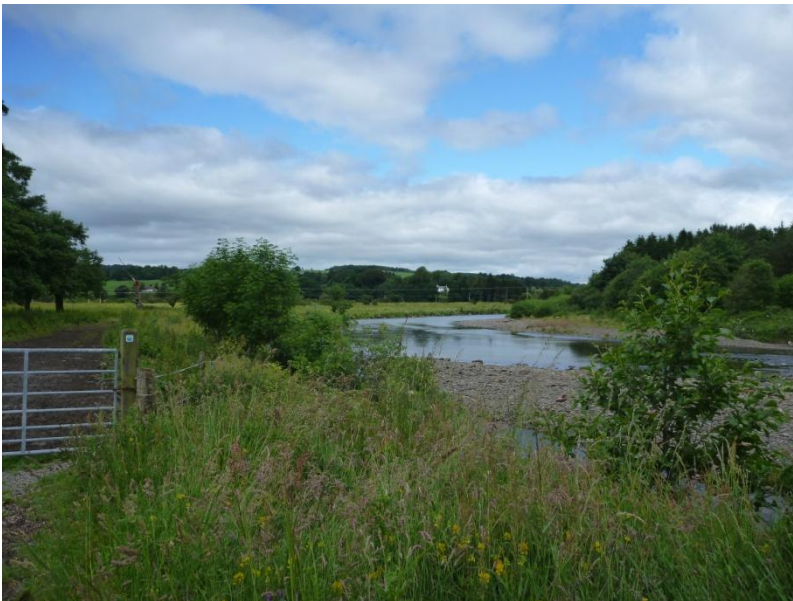
Figure H.8: Nith near Thornhill, Example of meandering section, floodplain, embankment and channel bar

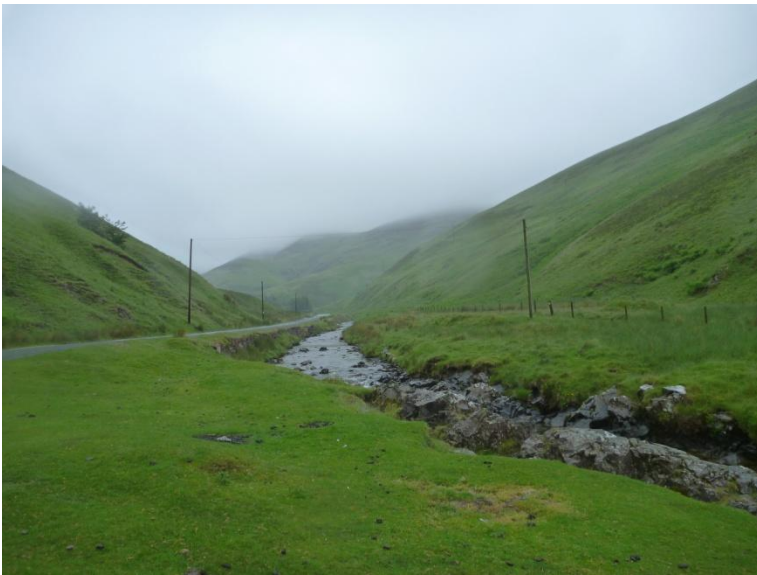
Figure H.10: Example of an upland tributary of the Nith; Mennock Water which originates near Wanlockhead, steep relief with land cover predominately of grazing land.

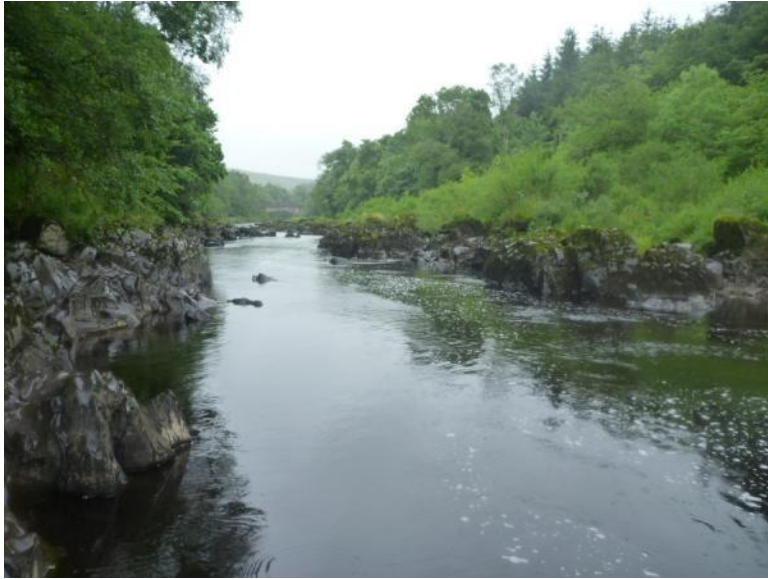
Figure H.11: Main stem of Nith, located north of Drumlanrig, just north of the Thornhill model domain. It is a steep gorge reach of the Nith, with significant amounts of visible bedrock.
