APPENDIX M

Reach summary sheets

Information for reach summary sheets

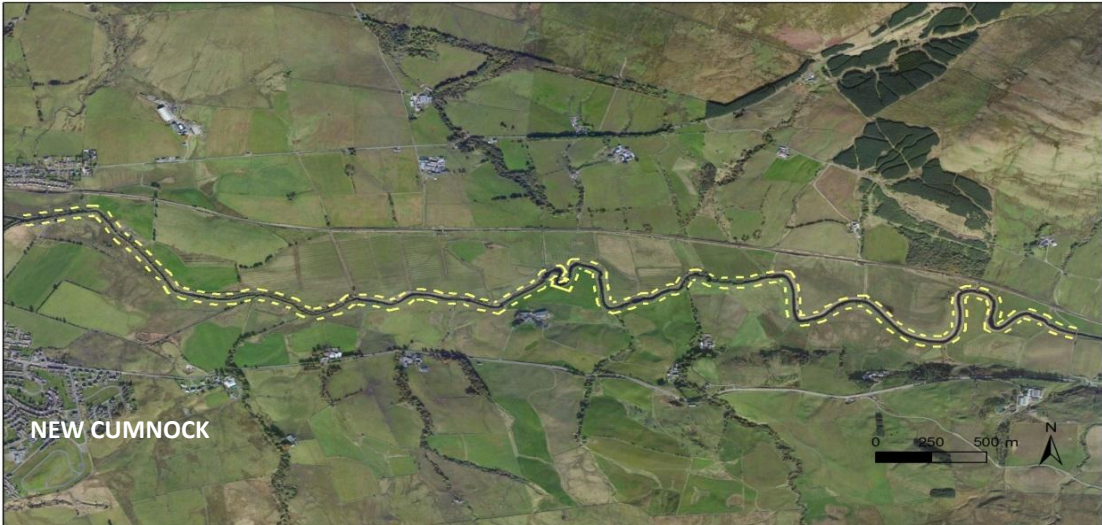
Water body ID	10611	Water body name	Nith - Sanquhar to New Cumnock	MCA rank	1	MCA score	76
Reach no.	1	Reach location	Upstream Duncansburn Bridge	Cost band	4		
Context 6.5km length of channel flowing through low quality pasture. Connection with both floodplains is limited by embankments.

Restoration opportunity <ul style="list-style-type: none"> Remove embankments to allow reconnection with floodplain Enhance vegetation structure and complexity throughout reach 41% MImAS capacity released, improves status to good. Only 26% MImAS capacity required to achieve good status for morphology – therefore only a proportion of embankments need to be removed to achieve this Detailed assessment should be carried out to determine the locations where embankment removal would be most feasible. 							
Degree of potential NFM benefit <ul style="list-style-type: none"> Potential for embankment removal to contribute to reduced flood risk at Kirkconnel PVA

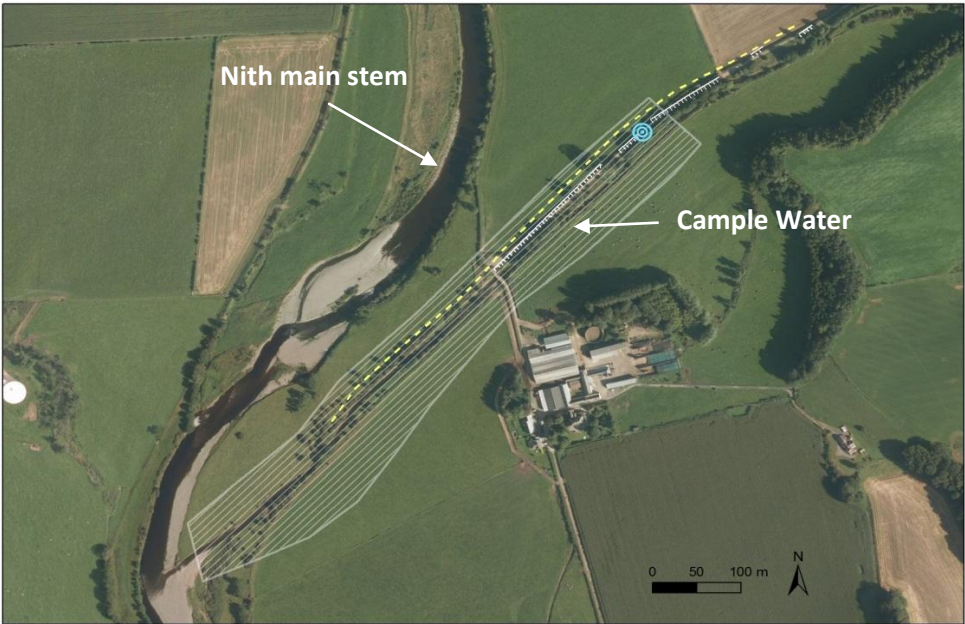
Water body ID	10629	Water body name	Cample Water	MCA rank	2	MCA score	51
Reach no.	1	Reach location	Downstream Kirkbog Bank	Cost band	2		
Context A kilometre-length reach flowing across the Nith floodplain and joining the Nith at its downstream extent. Channel has been straightened and is constrained by embankments and a weir

Restoration opportunity <ul style="list-style-type: none"> • Re-meandering, removal of embankment, bank protection and weir to allow reconnection with floodplain and increase morphological diversity. • 44% MImAS capacity released, improves status from bad to moderate. 							
Degree of potential NFM benefit <ul style="list-style-type: none"> • No significant benefit likely 							
Other benefits <ul style="list-style-type: none"> • Potential for local awareness raising • Potential to address other pressures on the channel 							
Land use/ownership <ul style="list-style-type: none"> • Improved pasture land use • Highest land capability value in reach is 3.2. • Dairy farm which was previously organic.

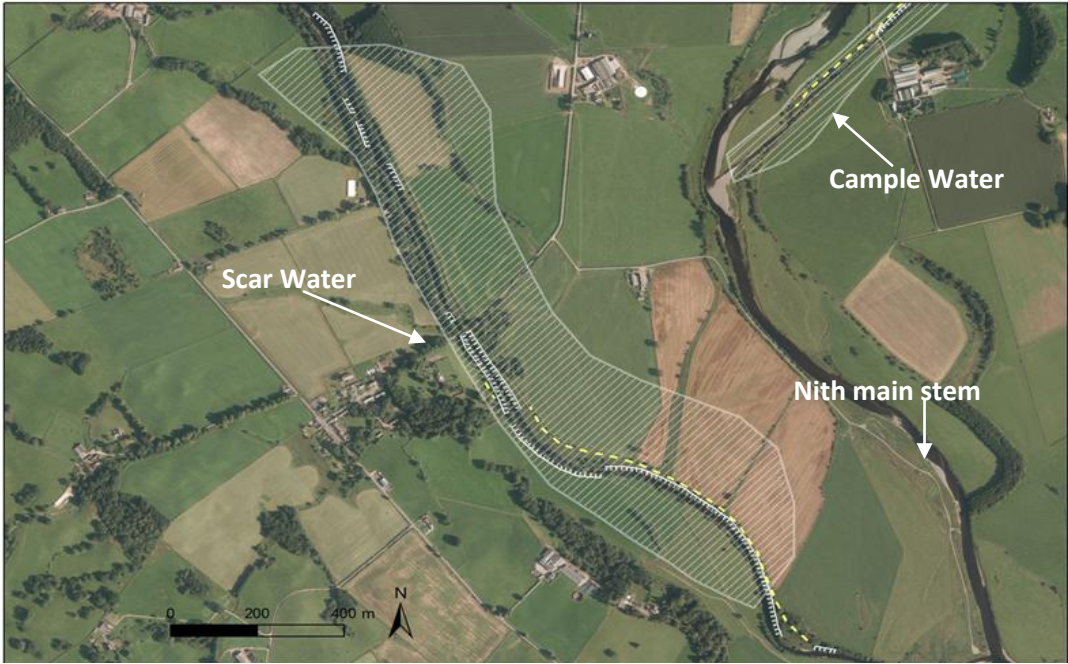
Water body ID	10624	Water body name	Scar Water	MCA rank	3	MCA score	46
Reach no.	1	Reach location	Downstream half	Cost band	4		
Context 2.2 km reach. Moderately large gravel-bed channel just upstream of its confluence with the Nith, which has been straightened and is constrained by embankments and bank protection.

Restoration opportunity <ul style="list-style-type: none"> • Re-meandering, removal of embankments and bank protection to allow reconnection with floodplain and operation of natural physical process. • 86% MImAS capacity released, improves status from bad to moderate. 							
Degree of potential NFM benefit <ul style="list-style-type: none"> • No significant benefit likely 							
Other benefits <ul style="list-style-type: none"> • Potential for local awareness raising within local community 							
Land use/ownership <ul style="list-style-type: none"> • Highest land capability value in reach, 3.2. • Mostly dairy pasture land use

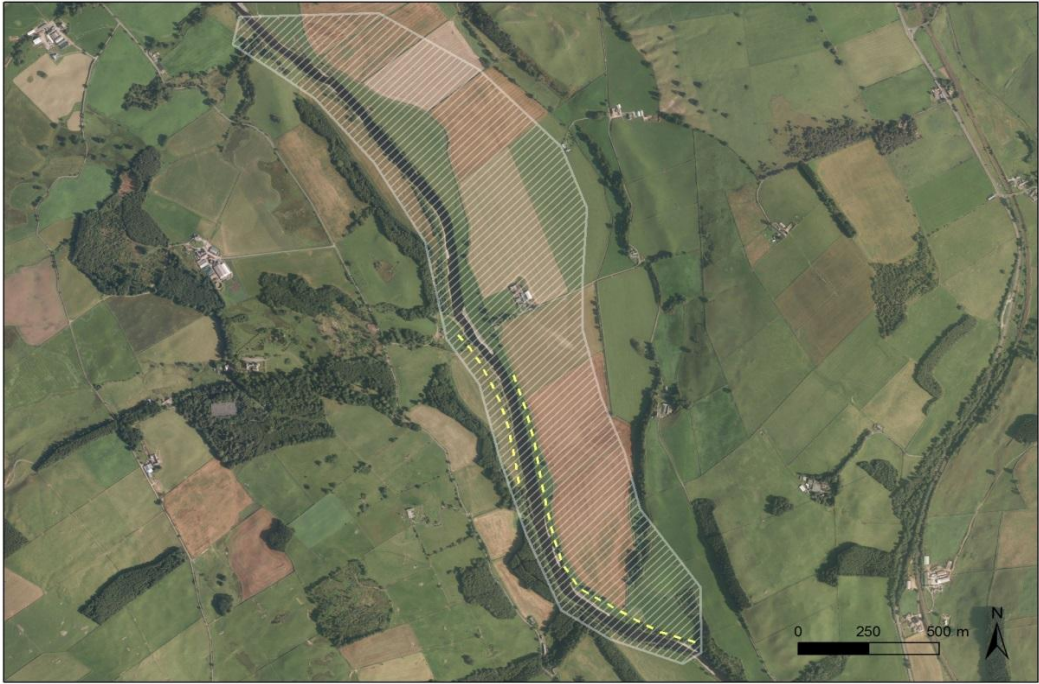
Water body ID	10610	Water body name	Nith: Dumfries to Sanquhar	MCA rank	7	MCA score	39
Reach no.	5	Reach location	Upstream Auldgirth	Cost band	5		
Context Approximately 3km reach on the main stem Nith, which has been straightened to the right hand side of its floodplain and constrained by embankments in its lower section.

Restoration opportunity <ul style="list-style-type: none"> • Re-meandering, removal of embankments and bank protection to allow reconnection with floodplain and operation of natural physical process. • 10.5% MImAS capacity released, no improvement to status. 							
Degree of potential NFM benefit <ul style="list-style-type: none"> • No significant benefit likely 							
Other benefits <ul style="list-style-type: none"> • Significant potential to increase connectivity with surrounding habitats • Potential for local awareness raising • Potential to address other pressures on channel

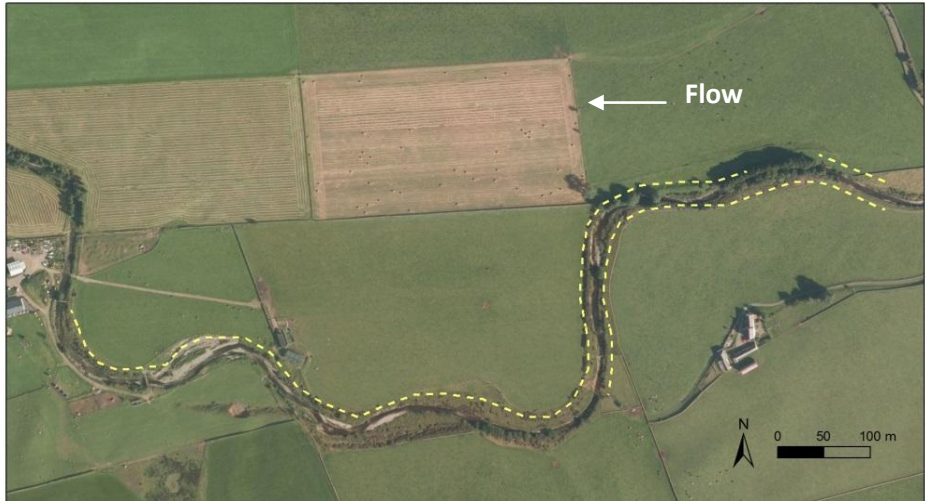
Water body ID	10629	Water body name	Cample Water	MCA rank	10	MCA score	37
Reach no.	3	Reach location	Cample to New Cample	Cost band	1		
Context 1.1km reach, active meandering channel with significant gravel transport that has been constrained by embankments and bank protection

Restoration opportunity <ul style="list-style-type: none"> • Removal of embankments would allow reconnection with floodplain • 24.8% MImAS capacity released; improves status from bad to poor. • Removal of bank protection would allow for greater operation of natural physical process, but would release very little capacity in terms of MImAS (and increase the cost of the option). 							
Degree of potential NFM benefit <ul style="list-style-type: none"> • No significant benefit 							
Other benefits <ul style="list-style-type: none"> • Potential for local awareness raising • Potential to address other pressures on channel

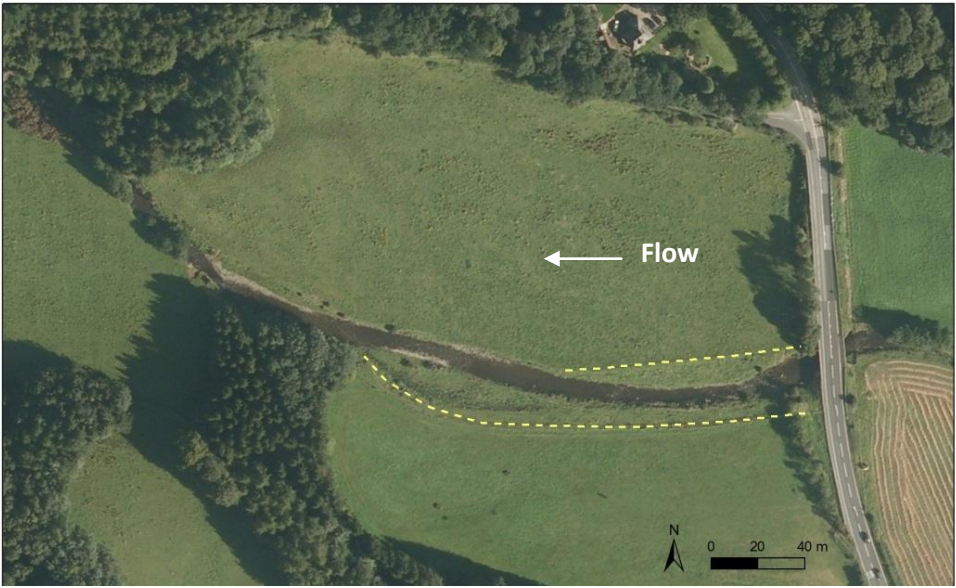
Water body ID	10629	Water body name	Cample Water	MCA rank	14	MCA score	32
Reach no.	2	Reach location	Gallows Knowe	Cost band	1		
Context Short reach downstream of road bridge where minor embankments reduce connectivity with floodplain.

Restoration opportunity							
<ul style="list-style-type: none"> • Remove embankment • 4.7% MImAS capacity released, no improvement to status. 							
Degree of potential NFM benefit							
<ul style="list-style-type: none"> • No significant benefit 							
Other benefits							
<ul style="list-style-type: none"> • Potential for local awareness raising • Potential to increase connectivity with surrounding habitats • Potential to address other pressures on the channel 							
Land use/ownership

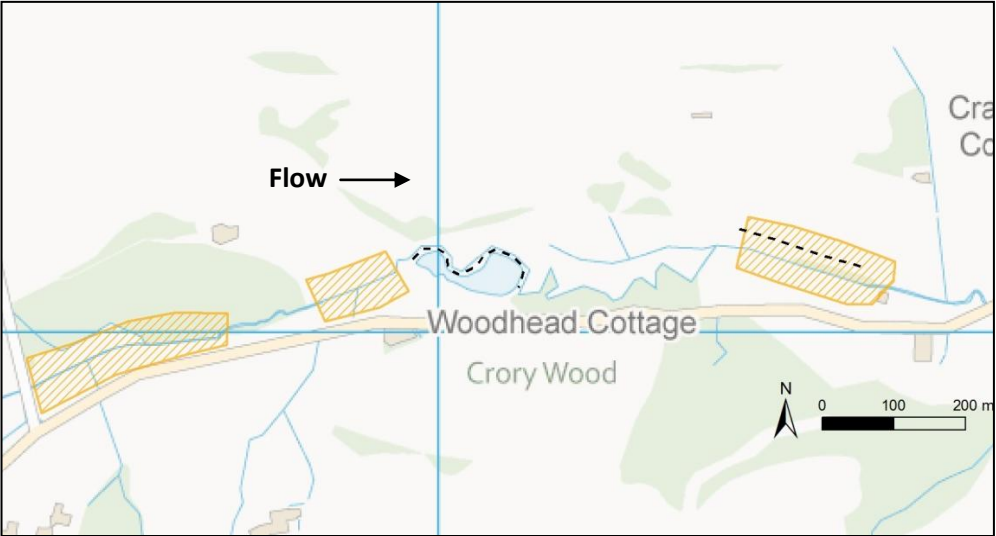
Water body ID	10633	Water body name	Laggan Burn	MCA rank	9	MCA score	37
Reach no.	2	Reach location	Woodhead	Cost band	2		
Context

1.9km reach through woodland and improved pasture. Parts of the reach have been subject to realignment. There are two sections of embankments, one of which is associated with an artificial off-line pond adjacent to the right bank.							
Restoration opportunity							
<ul style="list-style-type: none"> • Re-meander in realigned sections; remove weir and culverts to increase morphological diversity • Remove embankments to increase connectivity with floodplain. • 11.1% MImAS capacity released, improves status from poor to moderate. 							
Degree of potential NFM benefit							
<ul style="list-style-type: none"> • Overall NFM benefit score is zero 							
Other benefits							
<ul style="list-style-type: none"> • Significant potential to increase connectivity with surrounding habitat • Potential to address other pressures on the channel

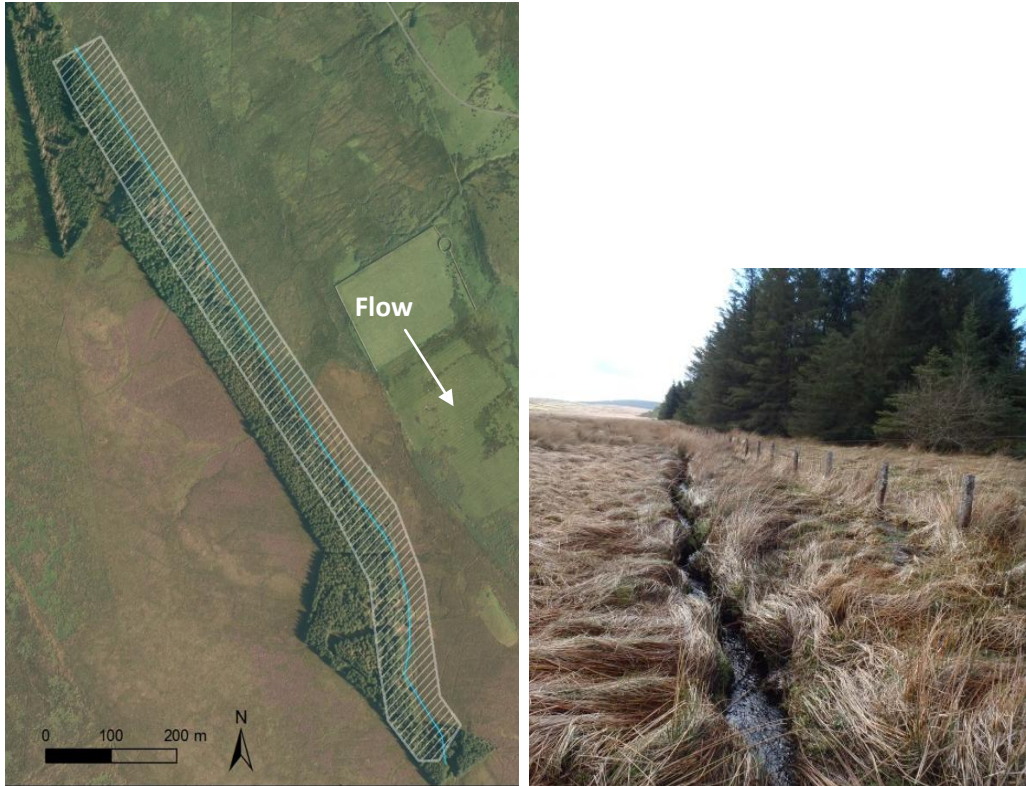
Water body ID	10631	Water body name	Crichope Linn	MCA rank	8	MCA score	38
Reach no.	1	Reach location	Adjacent to forestry	Cost band	3		
Context 1.2km reach. Minor headwater channel flowing through upland moorland, which has been realigned/straightened adjacent to forestry, resulting in a ditch-like channel form.

Restoration opportunity							
<ul style="list-style-type: none"> Mitigate high impact realignment. Further assessment would be needed to determine an appropriate approach, but may involve measures that encourage the channel to revert back to its natural form (likely to be a wetland). Enhance vegetation structure and complexity throughout reach 20.7% MImAS capacity released, improves status from moderate to good 							
Degree of potential NFM benefit							
<ul style="list-style-type: none"> No significant benefit 							
Other benefits							
<ul style="list-style-type: none"> n/a
