# **CONCEPTUAL DESIGN GUIDELINES**

## Application of Engineered Logjams

Scottish Environmental Protection Agency

June 2006

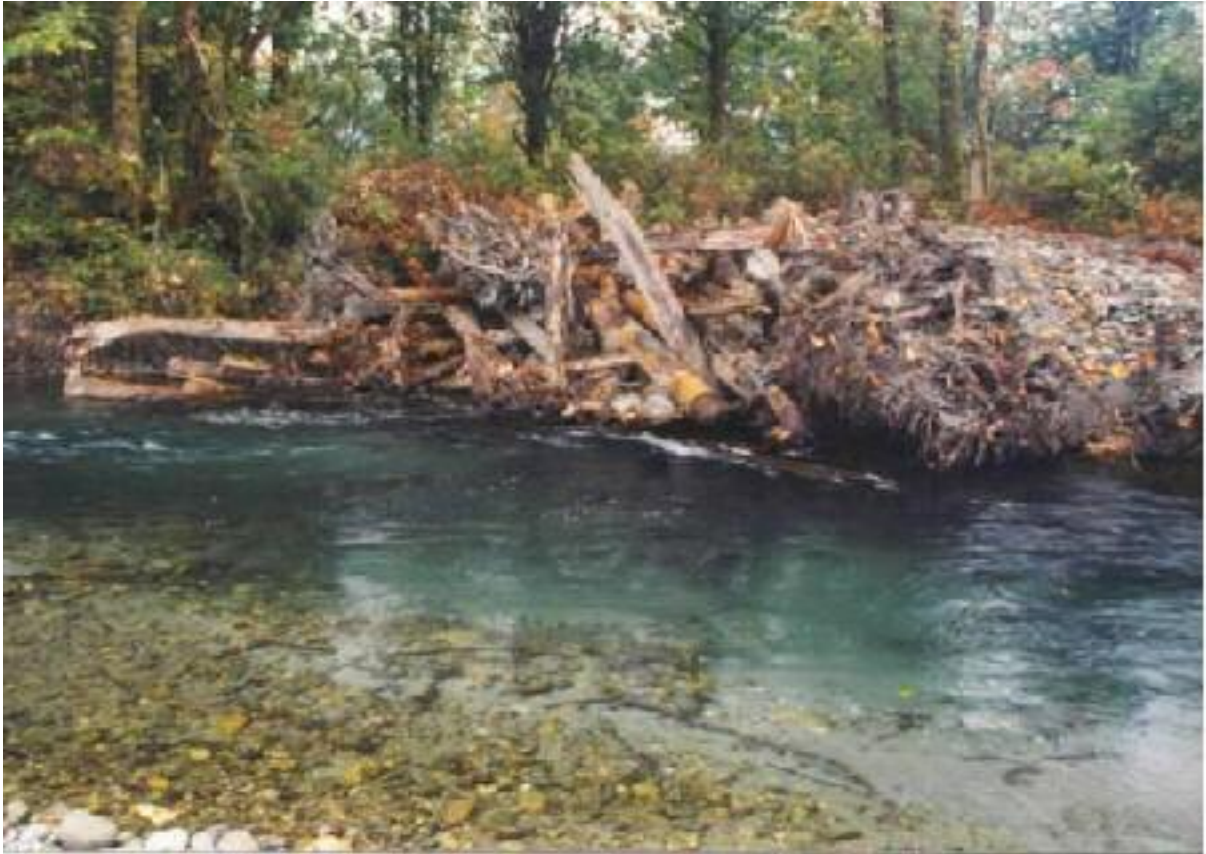
**Figure 2. Typical design of flow deflection ELJ and example of as-built structure protecting the left bank (facing downstream) and creating pool, riffle, and complex cover for fish in the North Fork Stillaguamish River, Snohomish County, Washington (flow is left to right). Racked logs are visible but core of ELJ is buried.**

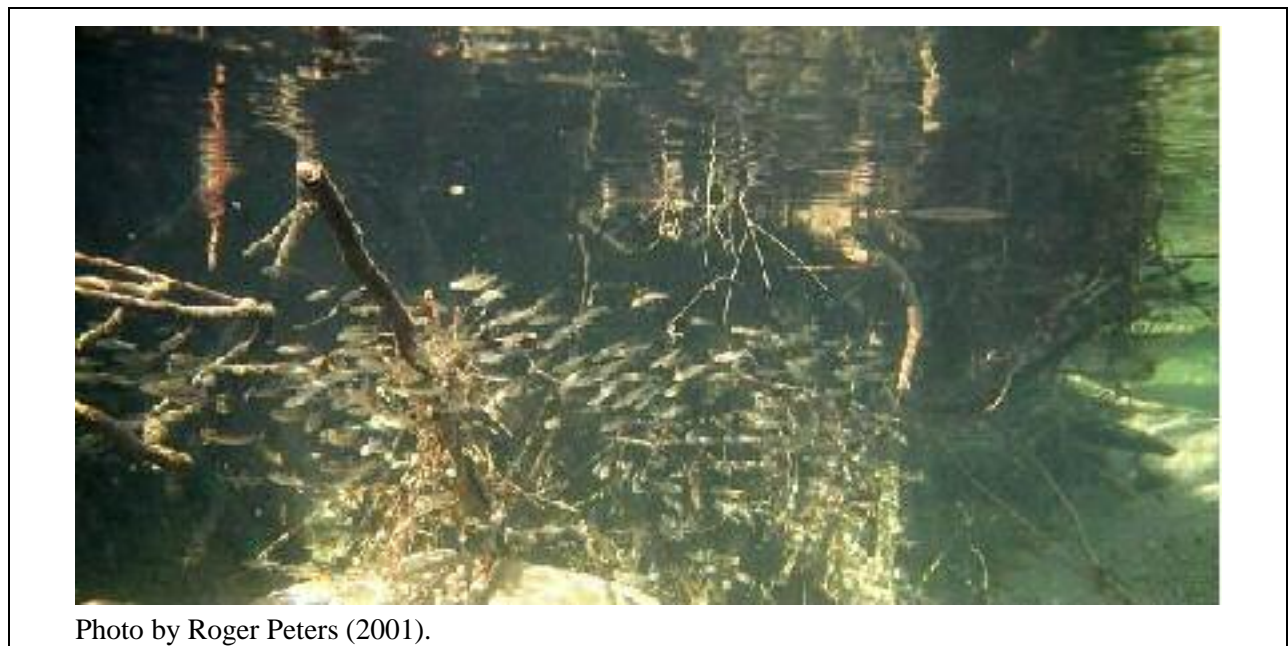
**Figure 3. Chum salmon redds adjacent to ELJ in the Big Quilcene River, Jefferson County, Washington.**

A small ELJ constructed in the lower Big Quilcene River in western Washington is an example of an ELJ solution that resulted in immediate benefits to salmon populations in a river that had undergone significant historical change. The local head differentials introduced by the constructed ELJ enhance downwelling and upwelling into the substrate and connectivity with hyporheic flow. Upwelling areas improve the survival of eggs and emergent fry by modulating the egg incubation environment and increasing the water exchange around the egg pocket, thereby replenishing oxygen and removing metabolites (Bjornn and Reiser 1991; Freeze and Cherry 1979). Hyporheic flow helps to modulate the temperature inside redds (spawning nests) by providing an input of water that is warmer than the river, thereby protecting the eggs during periods of extreme low temperature and ensuring emergence at optimal times (Berman and Quinn 1991). Several weeks after the ELJ was constructed in the lower Big Quilcene River, there were seven redds within 10 meters of the structure and none 10 to 50 meters farther upstream or downstream (Figure 3). Currently, the ELJ promote localized variations in bed topography, substrate material, and hyporheic flow, which in turn influence where salmon spawn in this river reach. Increased use of ELJs by fish for cover, food, or hydraulic conditions has been observed at almost every ELJ project.

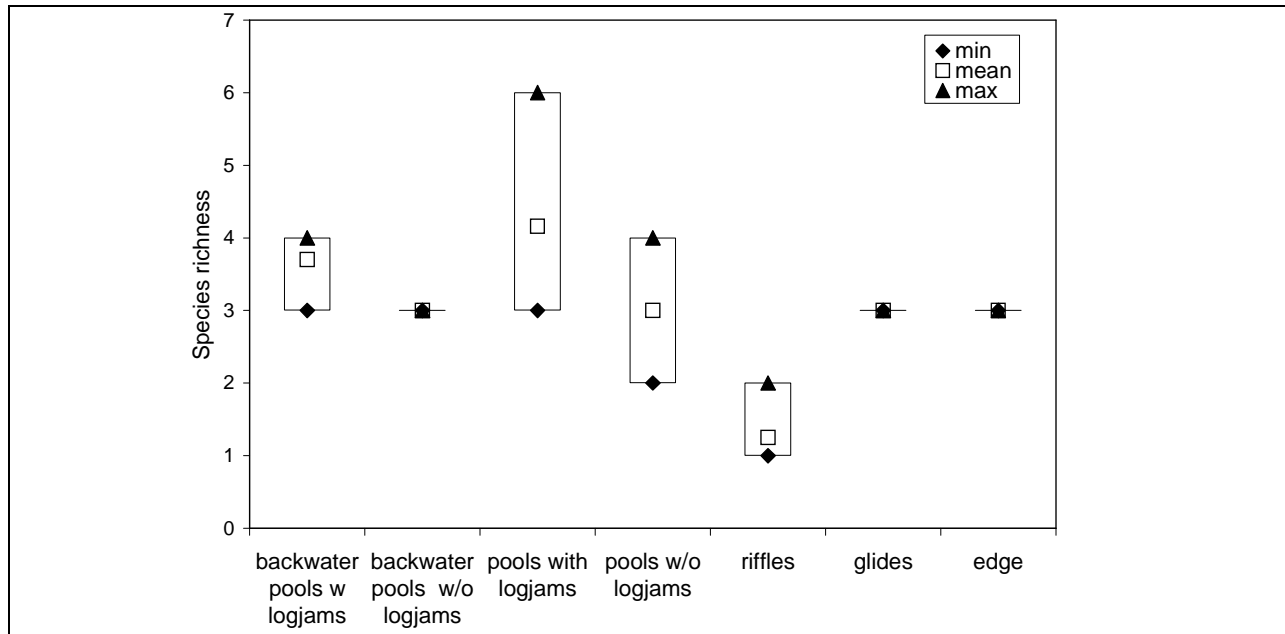
**Figure 8. Fish species richness in the lower Elwha River in habitat units with and without logjams.**

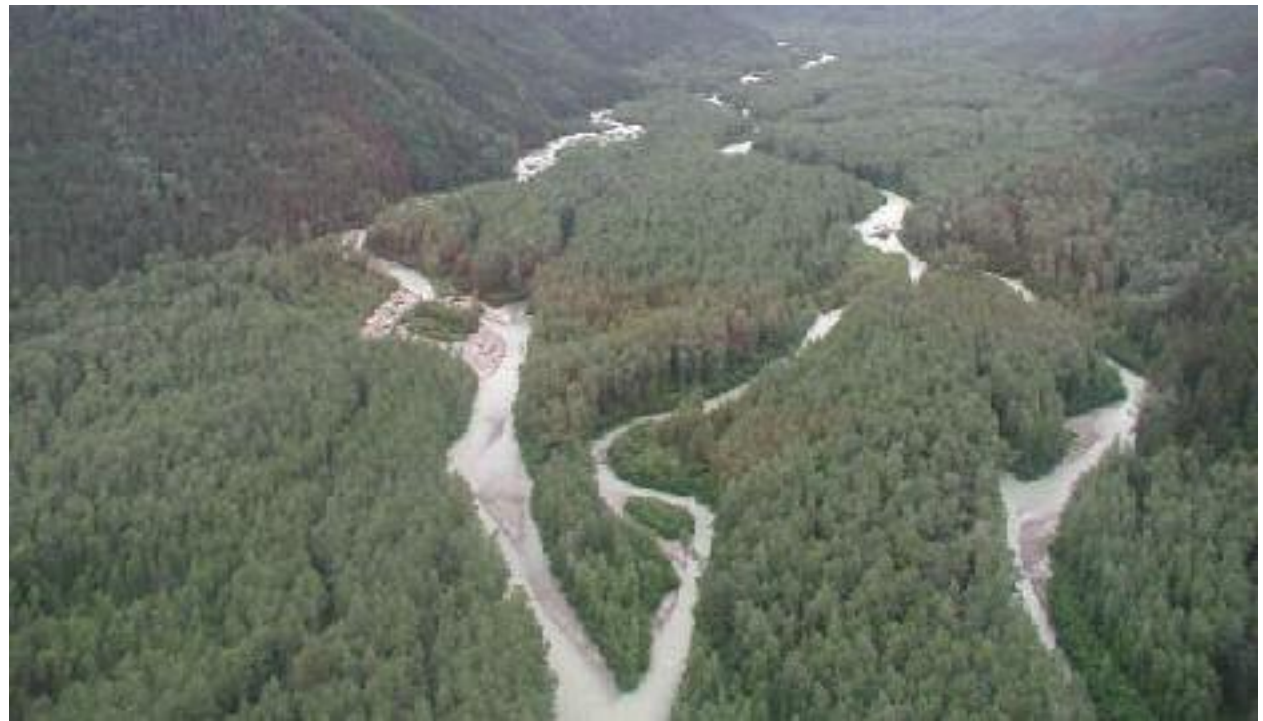
**Figure 13. Example of the branching Taiya River in southeastern Alaska, where natural logjams and riparian forests sustain the channel morphology. These systems are extremely productive with respect to the availability of diverse habitat used by salmonids.**

integral to the creation and sustainment of anabranching channel systems such as that illustrated in Figure 13.

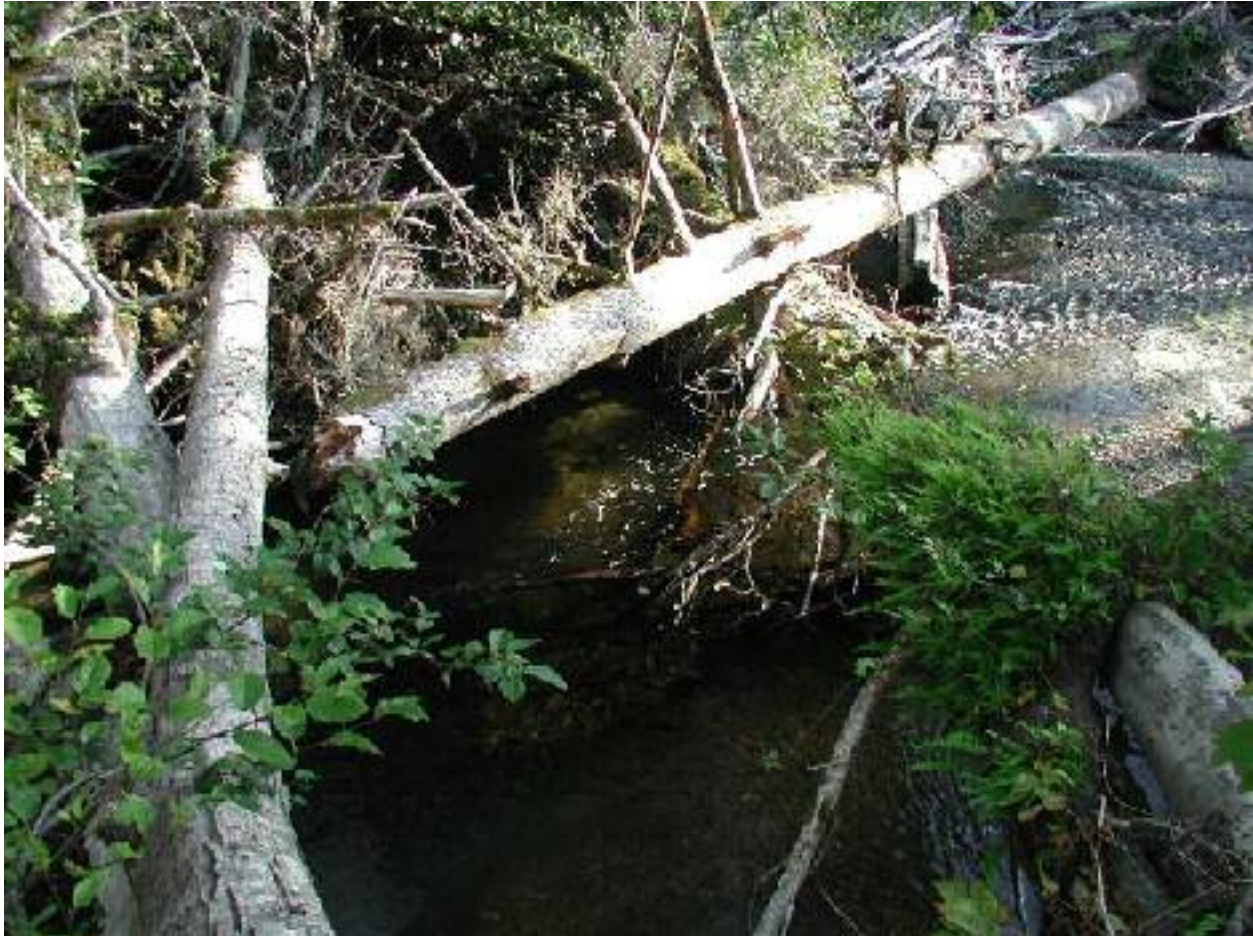
**Figure 14. Example of complex cover and diverse hydraulic and substrate conditions created by natural wood debris accumulation in the South Fork Hoh River, Jefferson County, Washington (flow is from right to left).**

ELJs can be constructed specifically to enhance habitat and increase the hydraulic diversity of river and creek systems. As discussed above, increasing the wood in a river system provides additional cover and high-quality habitat for fish (Figure 14). Habitat enhancement ELJs can be designed with varying levels of complexity and can function over a wide range of flow conditions. Simple structures can be created by adding one or several pieces of wood to a system, with the expectation that the structure may be deformed during high flows and, therefore, may not be permanent. More complex and stable habitat enhancement ELJs can be designed to the desired level of stability, to withstand for example the 50-, 100-, or 200-year flood (or higher), with a proportionate increase in costs. ELJs can be used to provide local habitat with minor effects on the channel, or they can be used to significantly alter the river channel. For example, habitat enhancement ELJs can transform relatively simple homogenous channels into one or more channels with a greater density and diversity of habitat units (Figures 15 and 16).

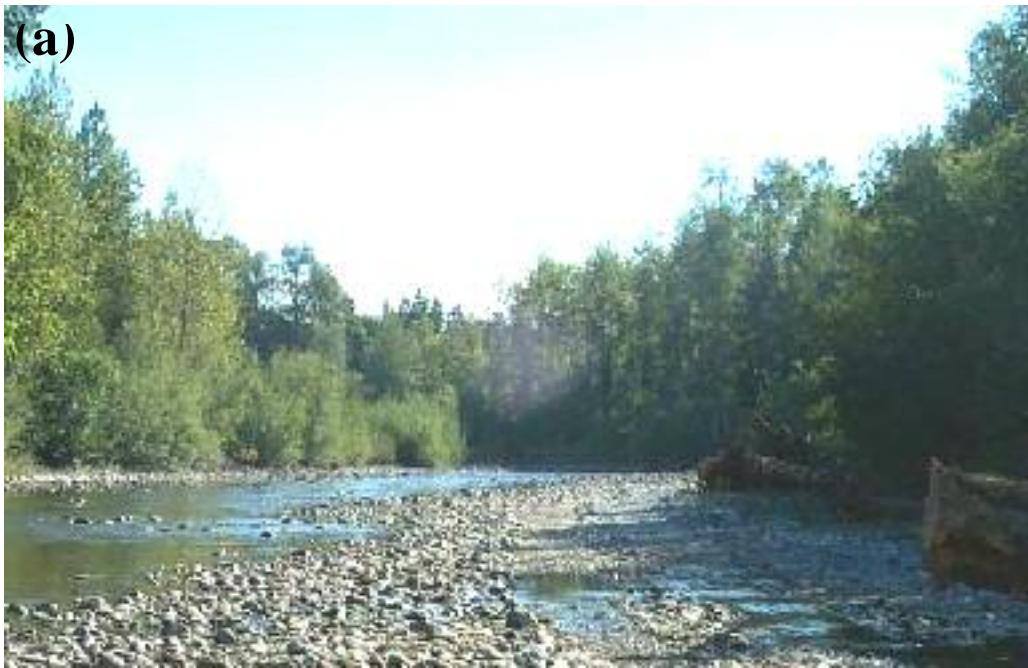
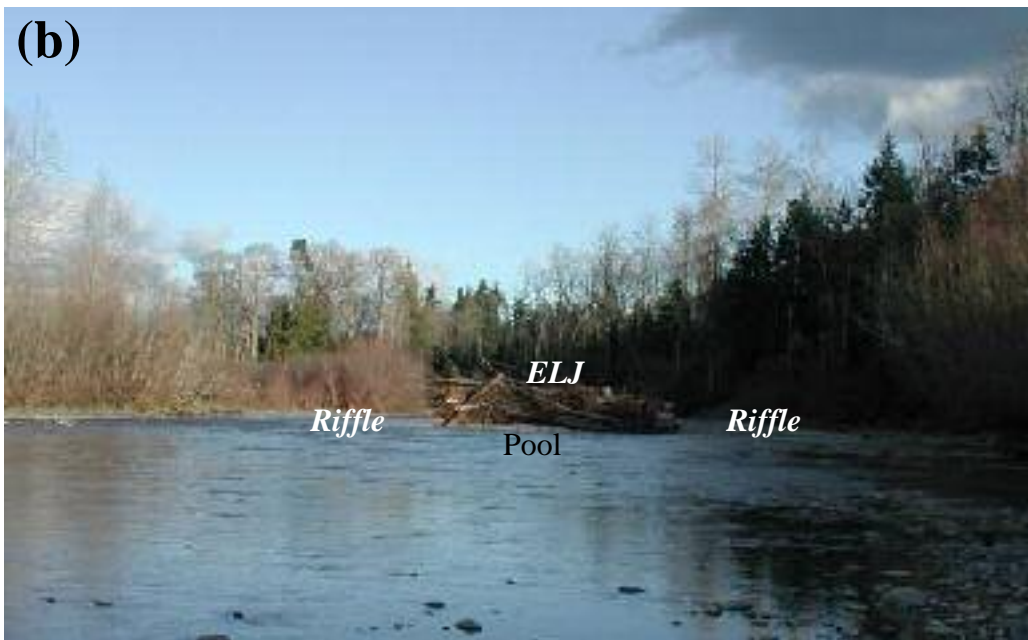
**Figure 15. Bar apex ELJ in the east reach of the lower Elwha River, Clallam County, Washington, looking downstream: (a) preexisting conditions before construction in 2002 and (b) 1 year after construction in 2003, showing change in channel segment from a simple plane-bed to pool-riffle morphology and increase in number of habitat units from one to five.**

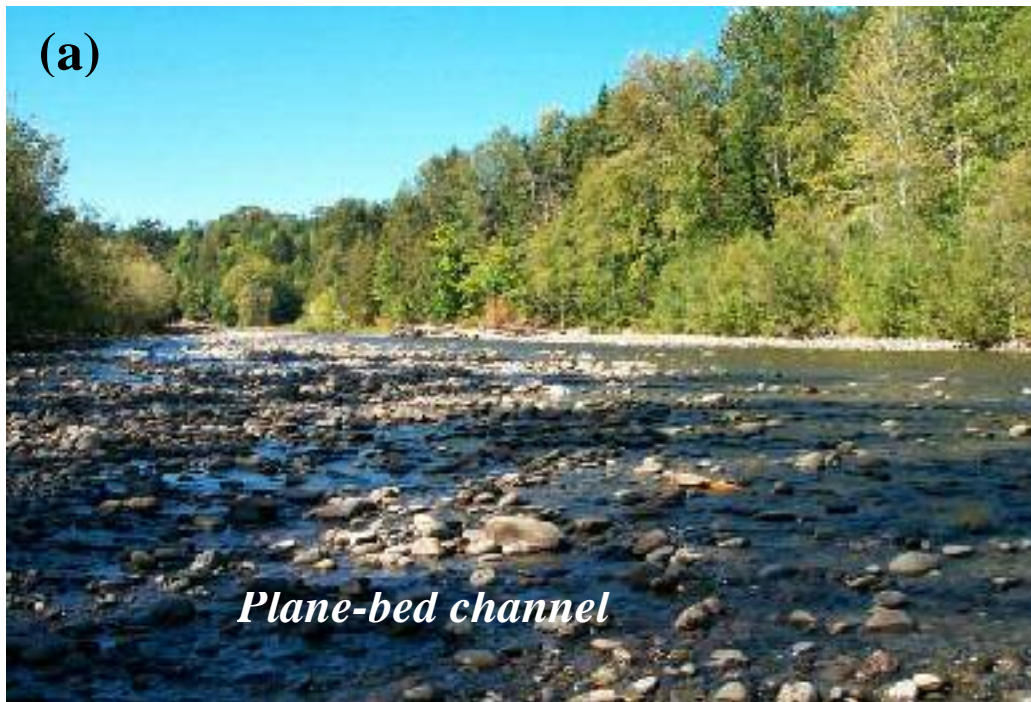
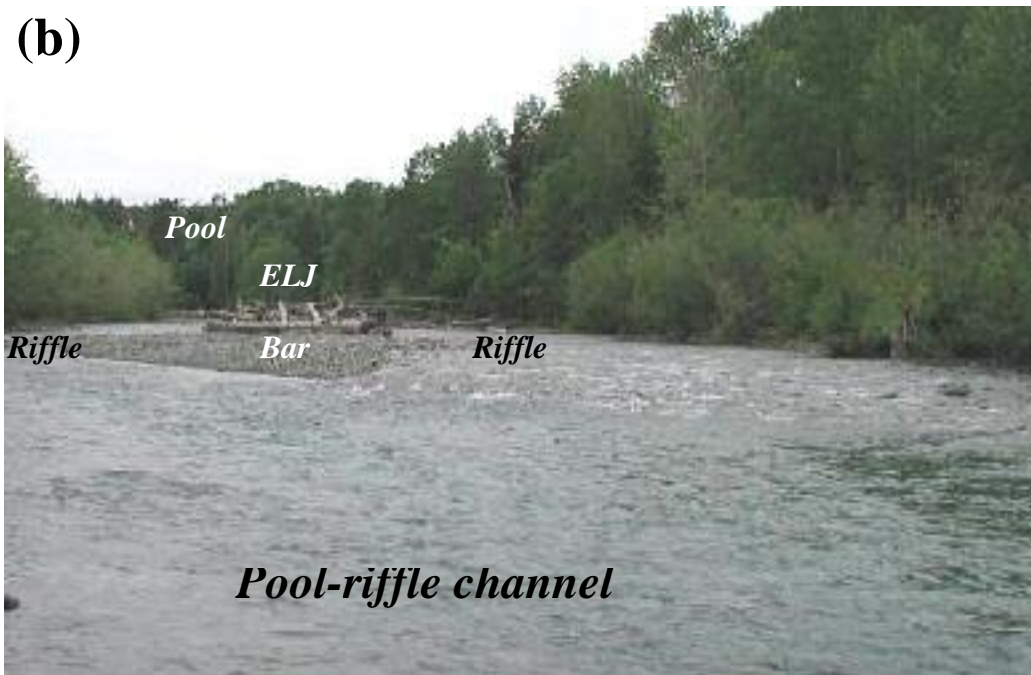
**Figure 16. Same channel segment of lower Elwha River looking upstream: (a) before construction of bar apex logjam in 2002 and (b) 2 years later in 2004, showing increased channel complexity and diversified habitat within the reach after ELJ construction.**

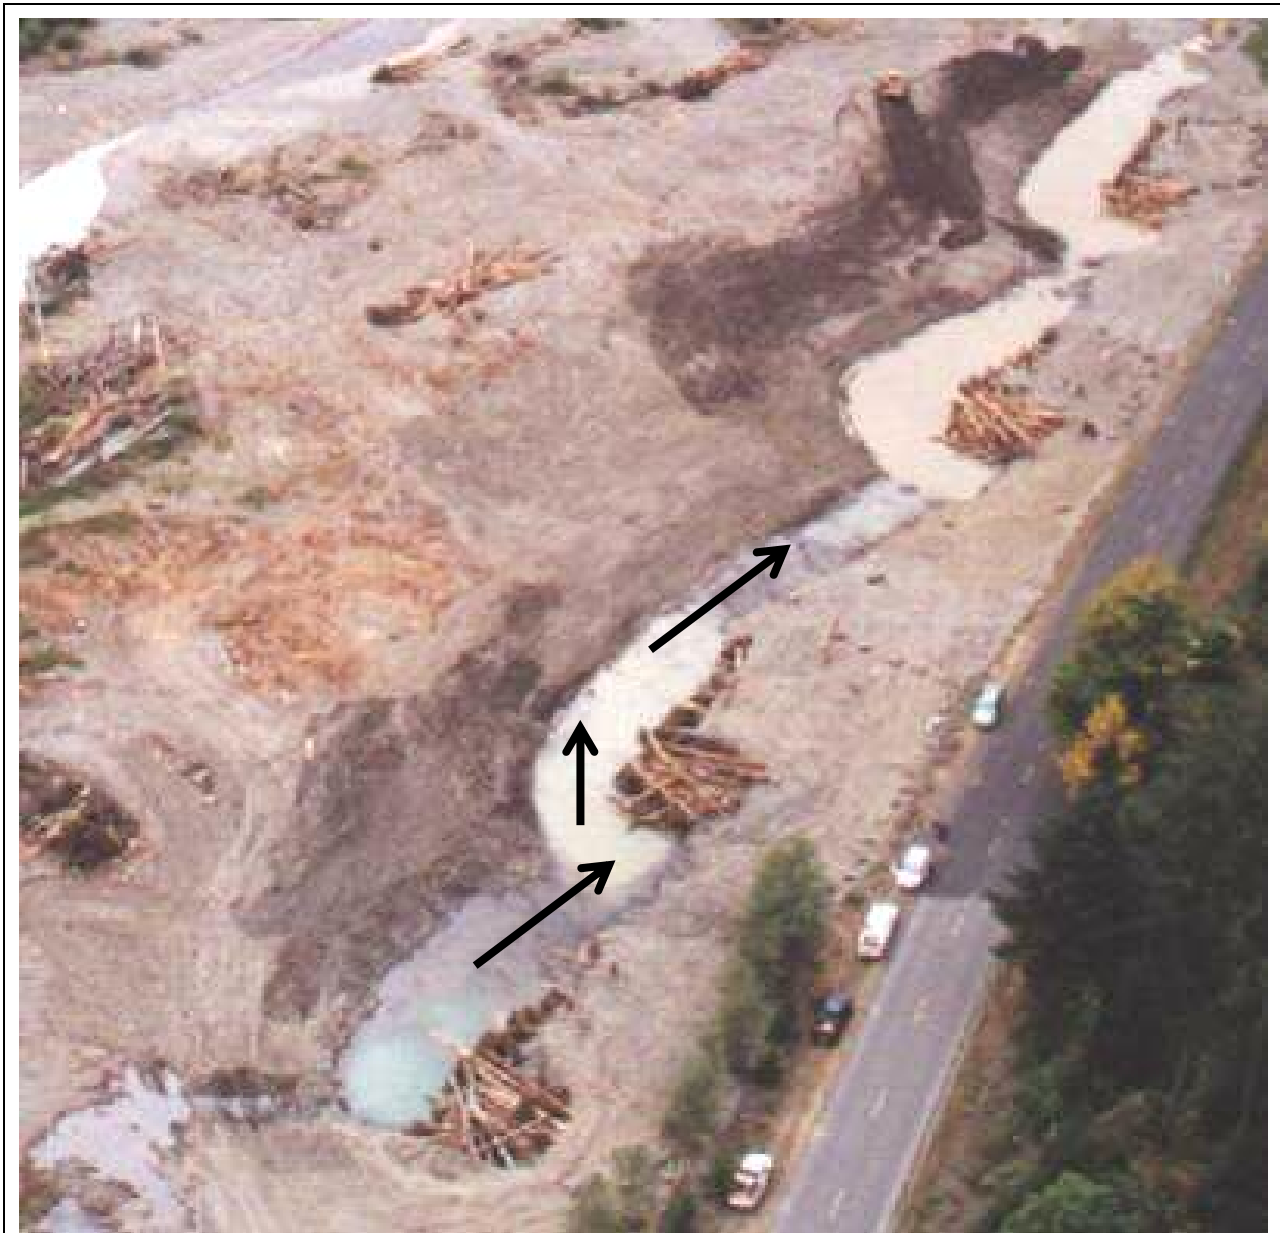
**Figure 17. Example of bank protection ELJs along the Cispus River, Lewis County, Washington, showing as-built construction along Forest Road 23 in Gifford Pinchot National Forest, September 1999 (flow is from lower left to upper right).**

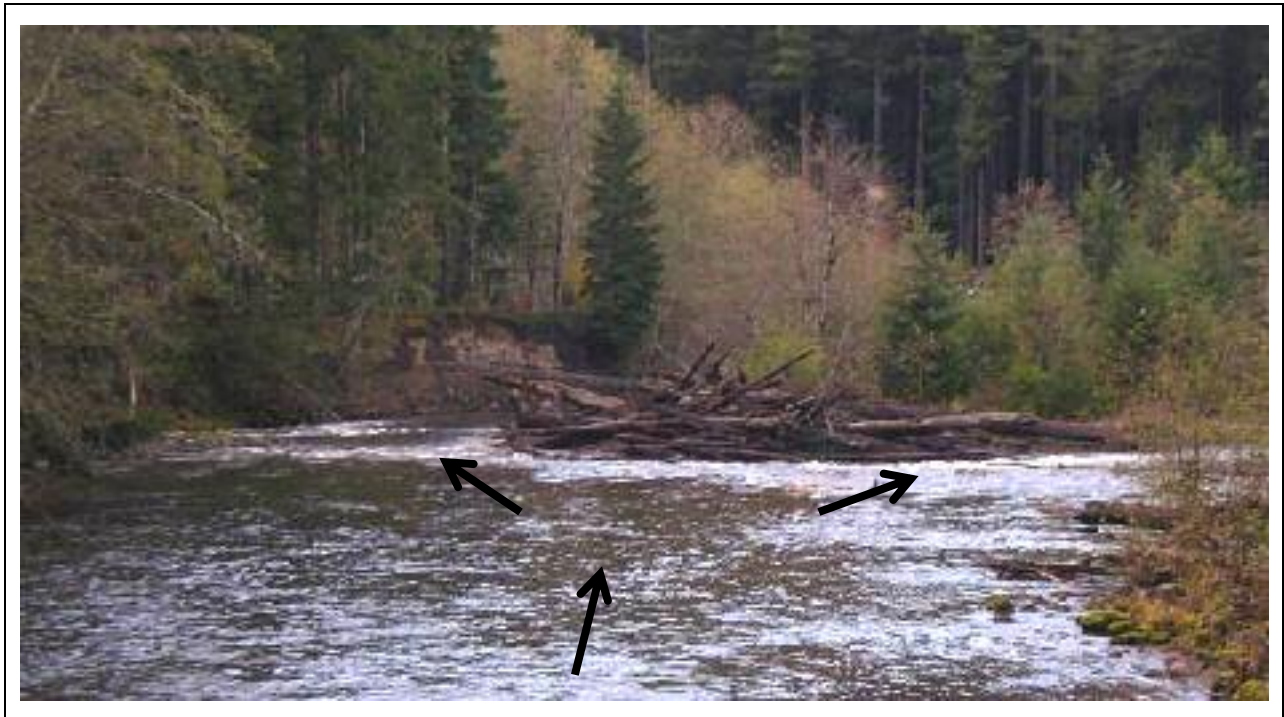
**Figure 18a.** Example of natural bar apex ELJ bifurcating flow in the Cispus River, Lewis County, Washington, November 2004.

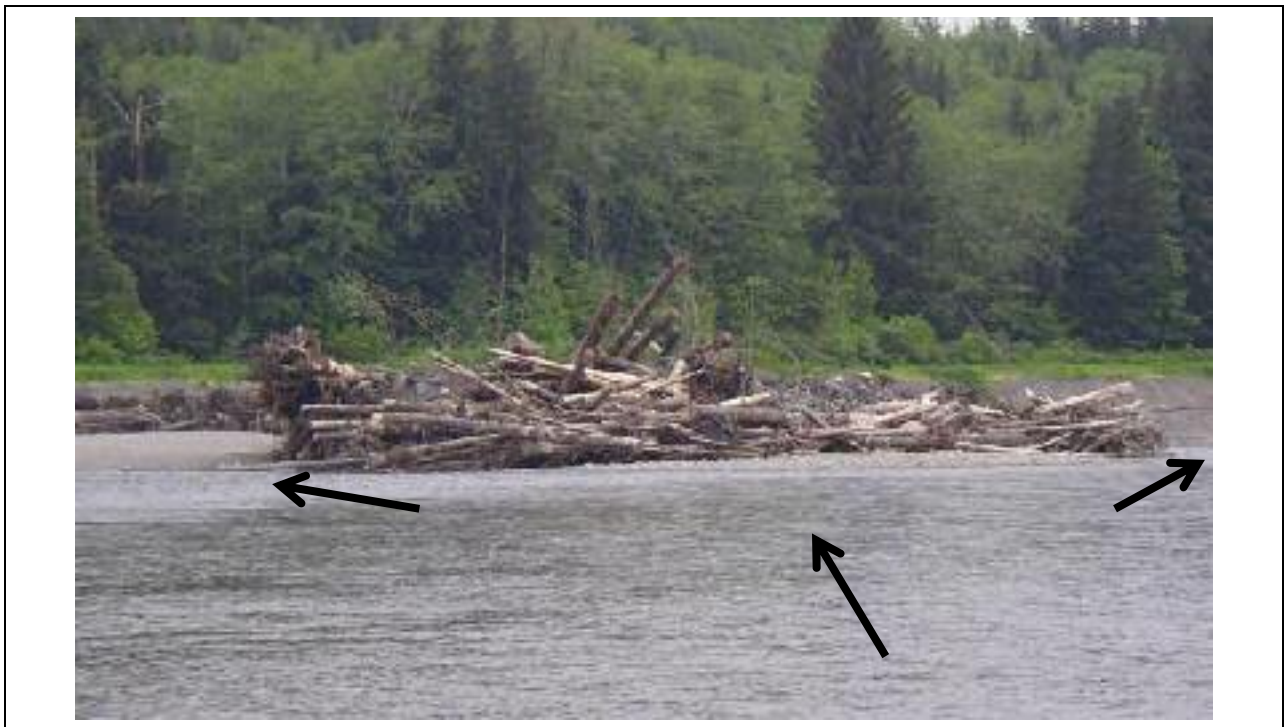
**Figure 18b.** Example of bar apex ELJ constructed in September 2004 in the Hoh River, Jefferson County, Washington, showing conditions in March 2005 after two peak flows of approximately 850 centimeters.

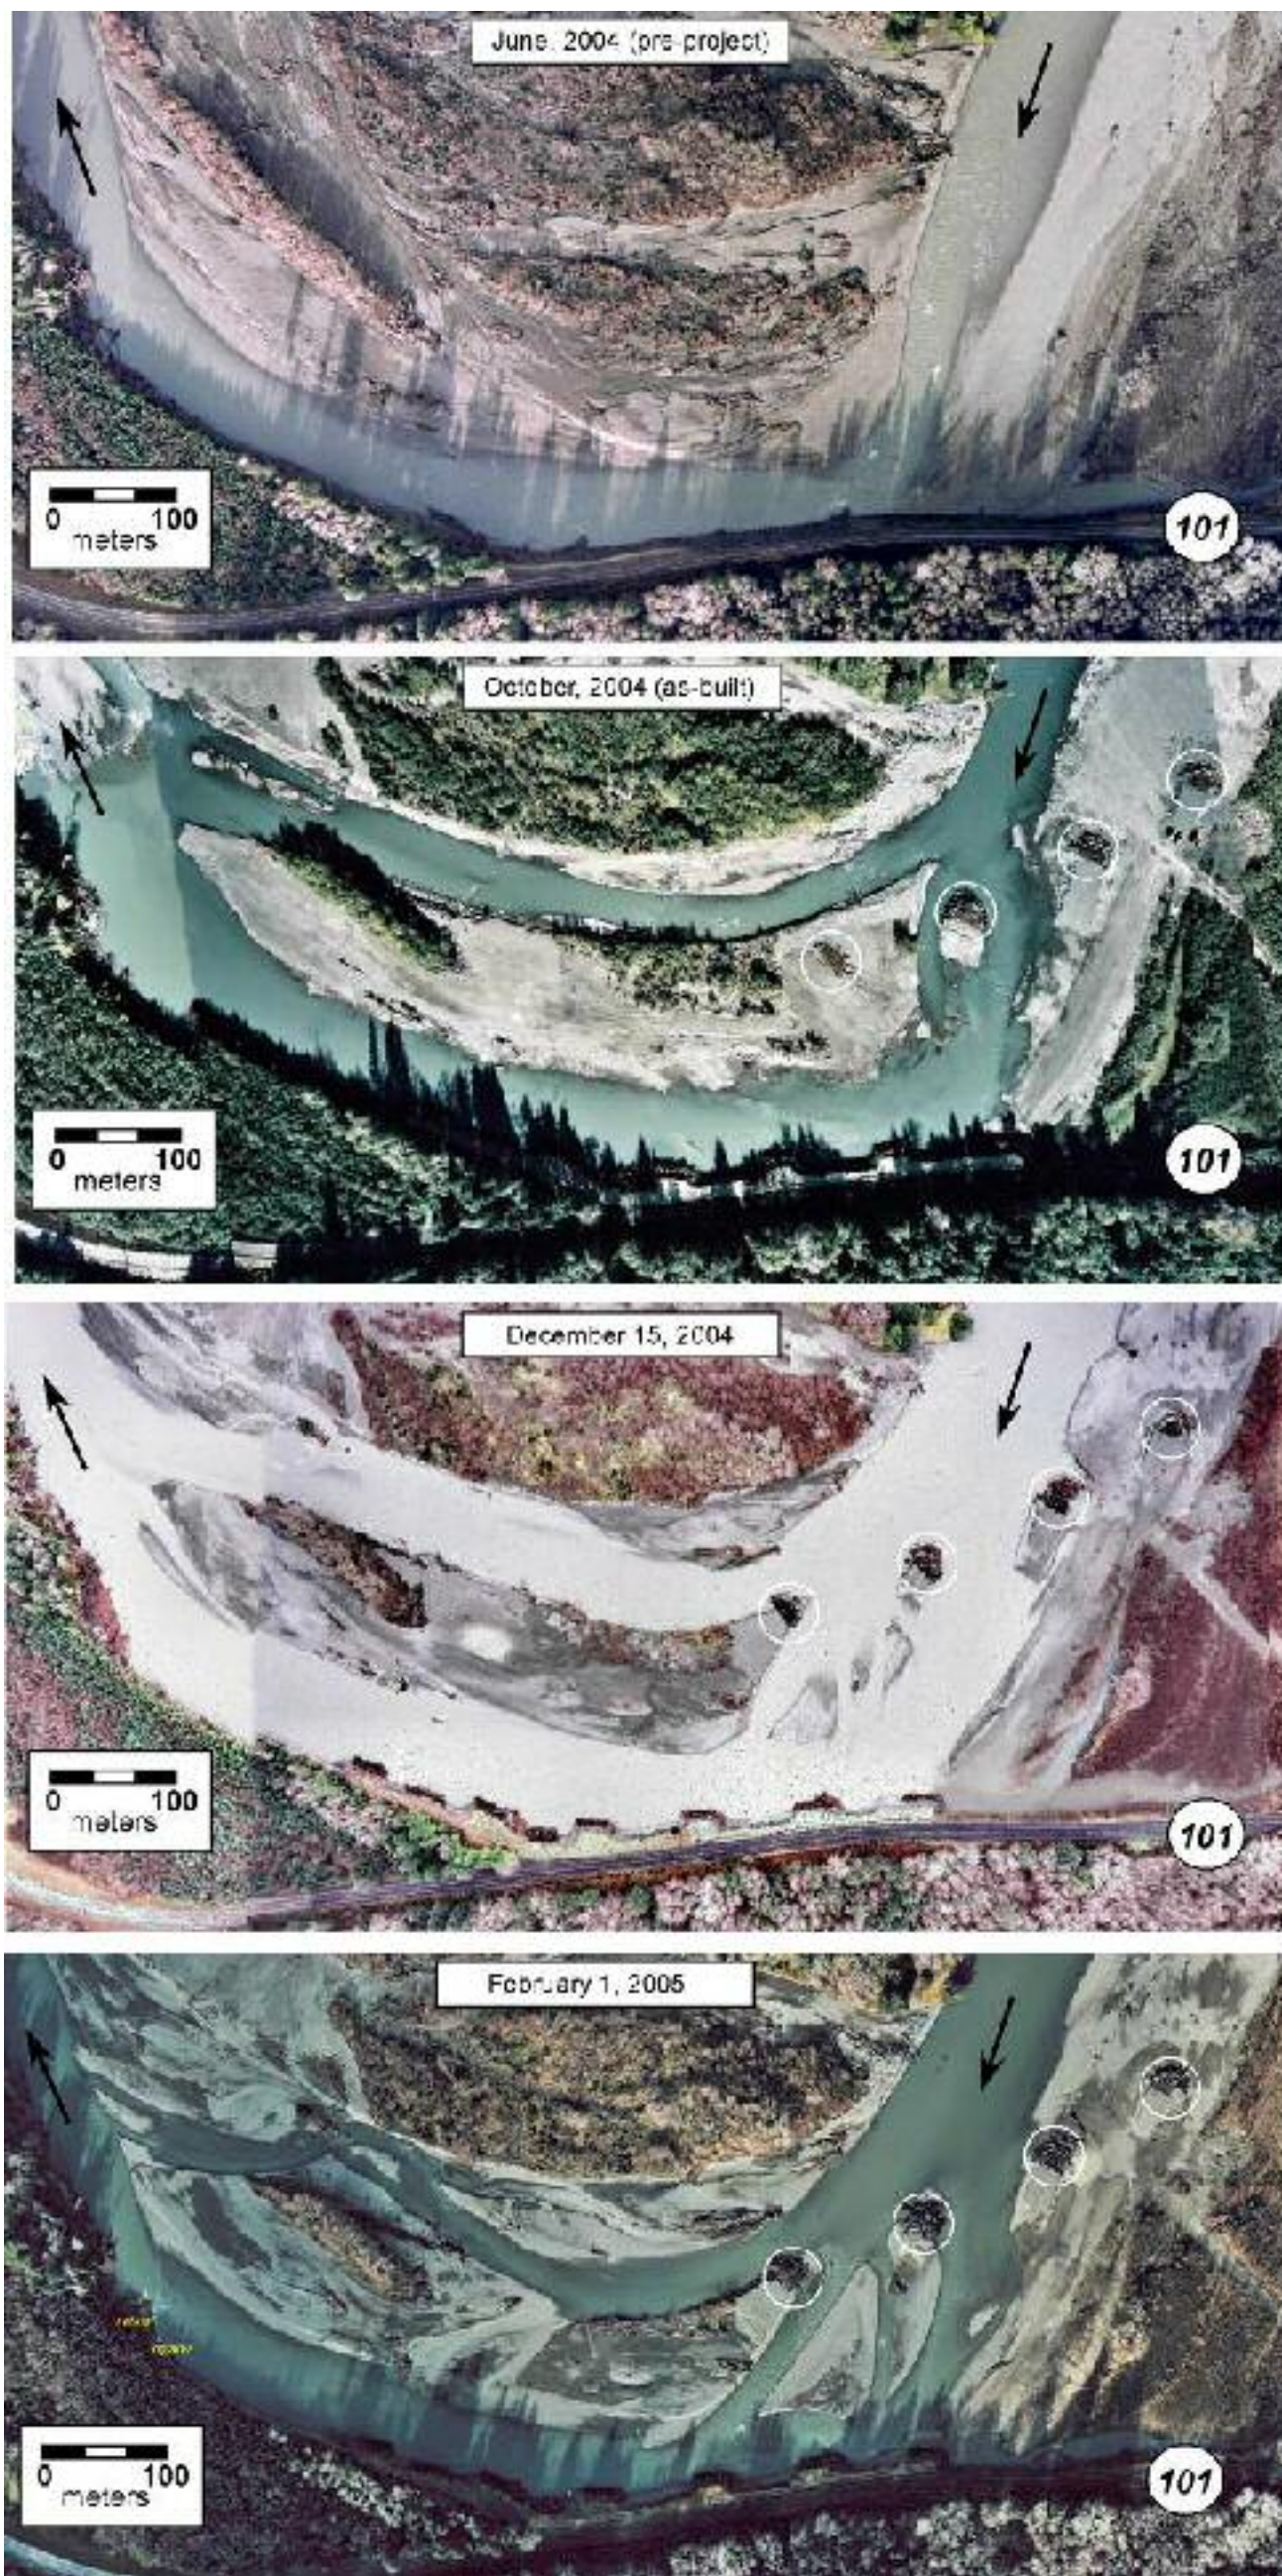
**Figure 19. Channel changes in response to construction of six bank and four bar apex ELJs (circled) in the Hoh River in 2004. Bar apex ELJs (circled) were constructed upstream of threatened highway to deflect flow through chute cutoff channel and diffuse flow in main channel. Bank ELJs were constructed to create “hardened” riparian buffer along highway.**

Over the last decade, bar apex ELJs have been successfully constructed in several rivers in Washington and Oregon. The habitat benefits of bar apex ELJs are enormous since the river interacts on all sides of the structure, typically resulting in the development of a crescent-shaped scour pool on the sides and upstream and the formation of a bar upstream and downstream of the ELJ. Sample engineering drawings of bar apex ELJs are provided in Appendix A (South Fork Nooksack River and White River projects). The effectiveness of bar apex ELJs at redirecting river flows can be seen in the aerial photos of the Hoh River project where the structures were intended to deflect river flow away from the highway, diffuse the river’s energy, and increase the amount and quality of aquatic and riparian habitat. The four ELJs in the Hoh River have successfully reduced the risk to U.S. Highway 101 by deflecting flow into a chute cutoff channel and diffusing the river’s energy before it reaches the highway while also increasing the number of pools and cover for fish (Figure 19).

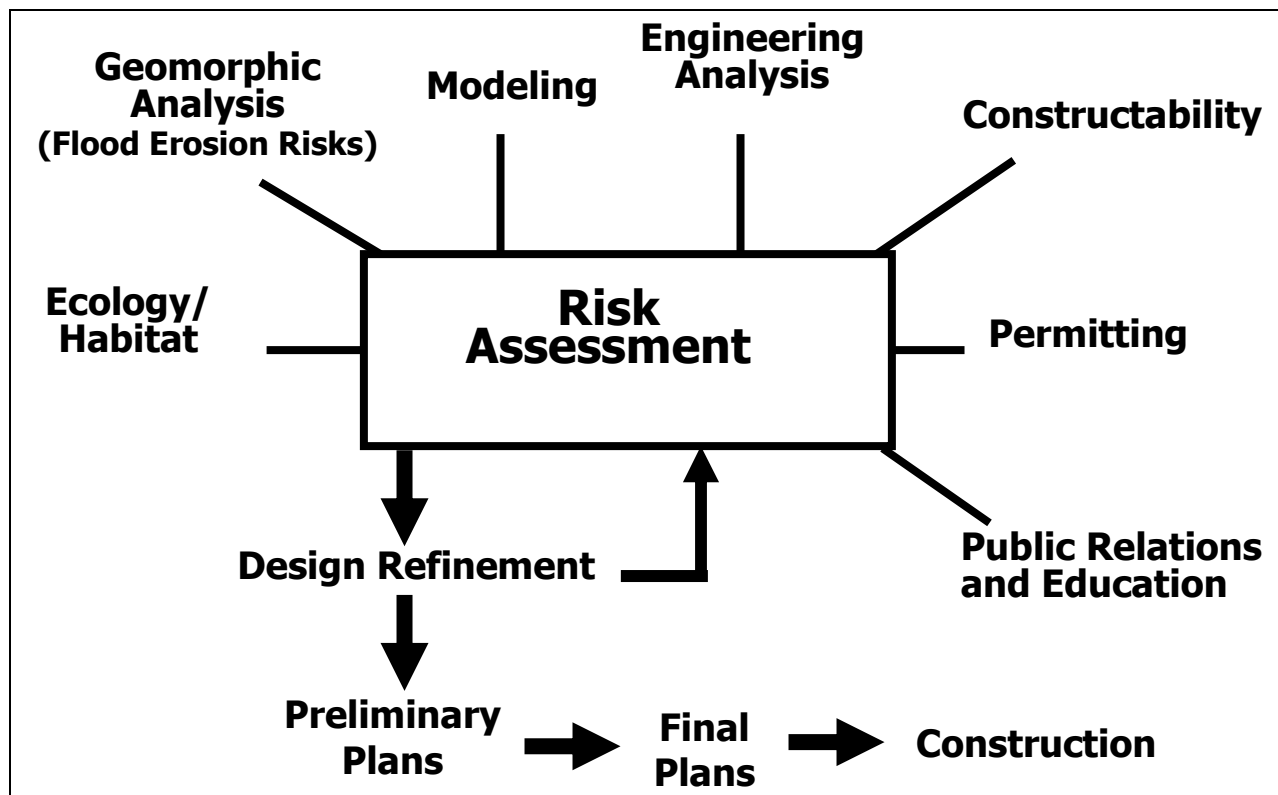
Figure 24. Iterative ELJ design process.

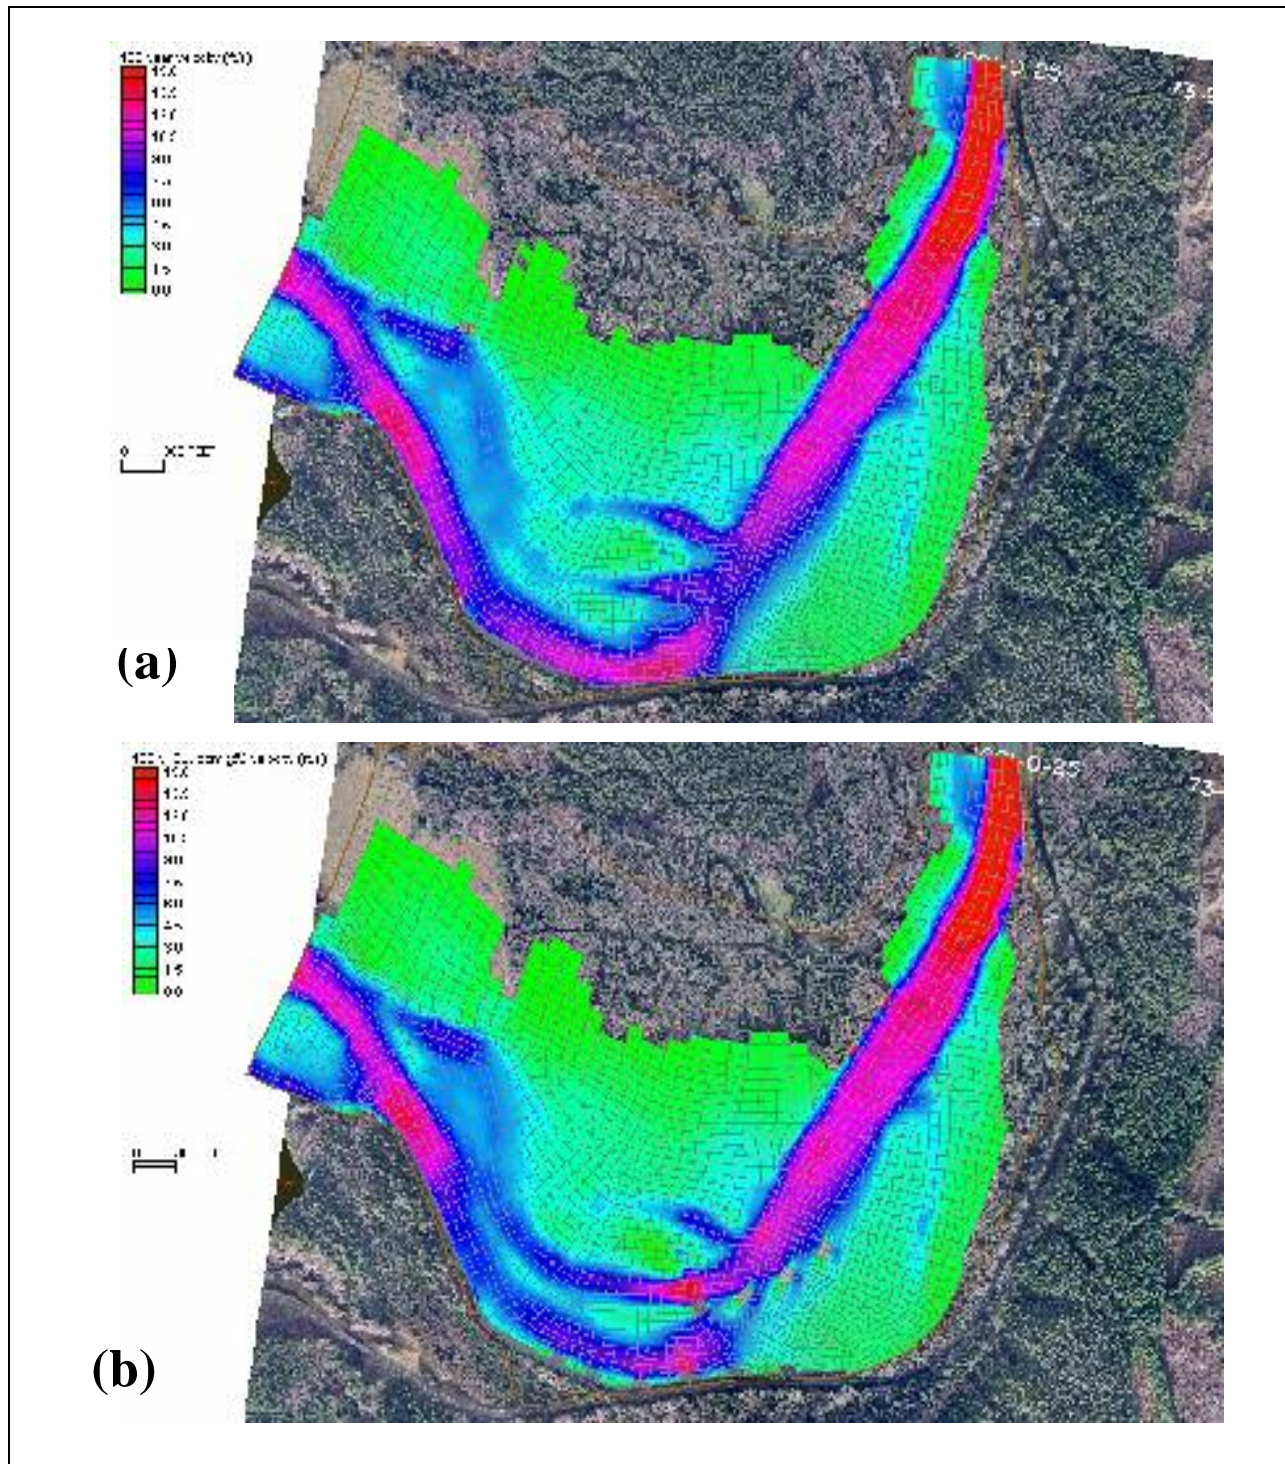
**Figure 25. Example output of two-dimensional hydrodynamic modeling (FESWM 2D) performed for Hoh River ELJ project: (a) existing conditions before construction and (b) predicted changes after ELJ construction, showing lower velocities along road and increased complexity of river channel.**

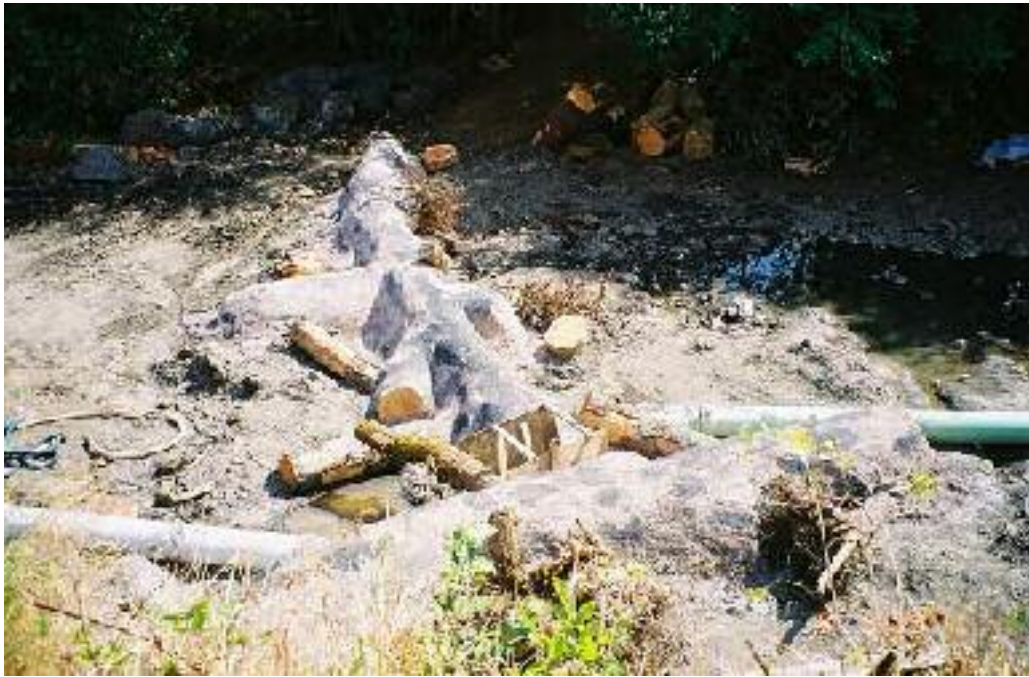
**Figure 29. Example of concrete cast-in-place log weir for treatment of an urban incised creek channel in Rickreall Creek, Lane County, Oregon.**

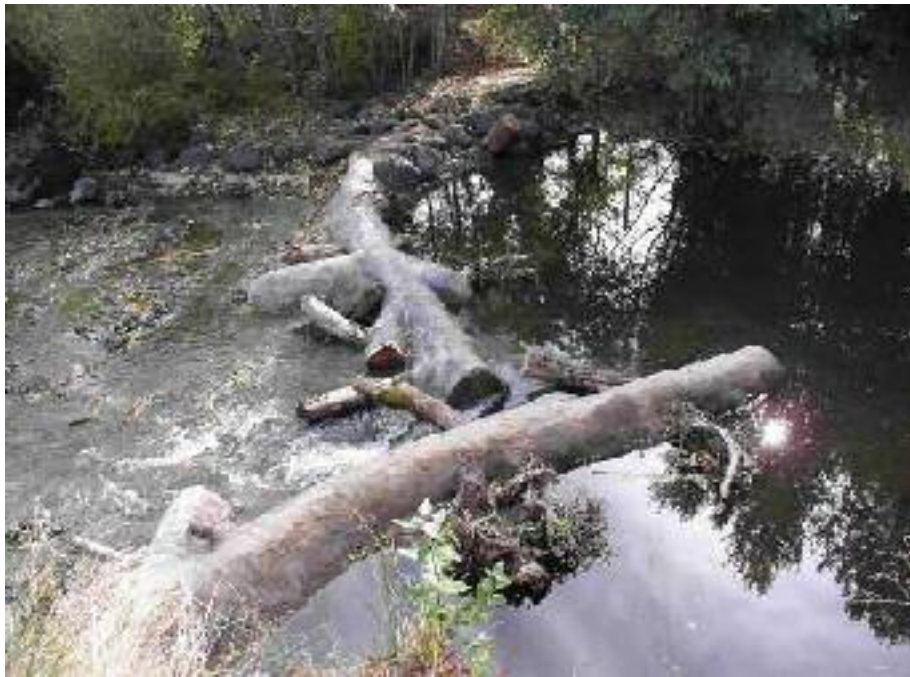
**Figure 30. Same site on Rickreall Creek after flow was reintroduced to creek.**

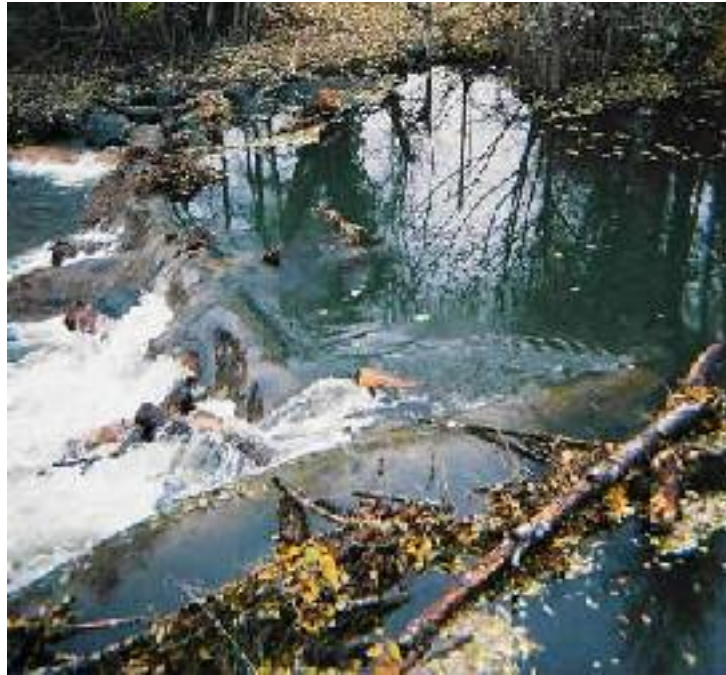
**Figure 31. Same site on Rickreall Creek after flow was reintroduced to creek in winter 2004.**

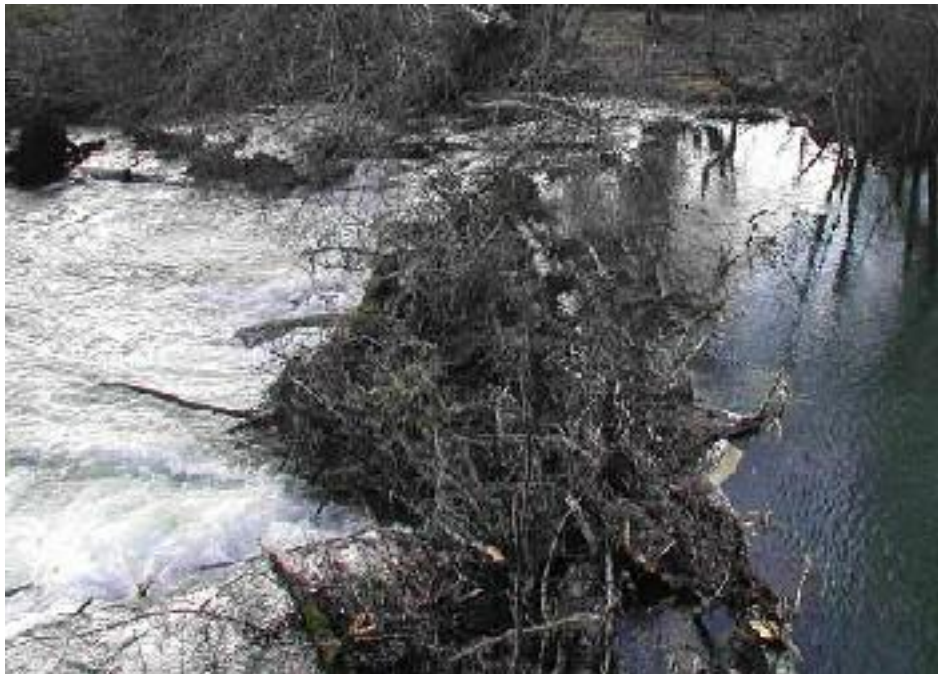
**Figure 32. Same site on Rickreall Creek during moderate flow in winter 2004, showing accumulation of flotsam on the structure and the natural appearance of a complex logjam.**
