# **CONCEPTUAL DESIGN GUIDELINES**

## Application of Engineered Logjams

Scottish Environmental Protection Agency

June 2006

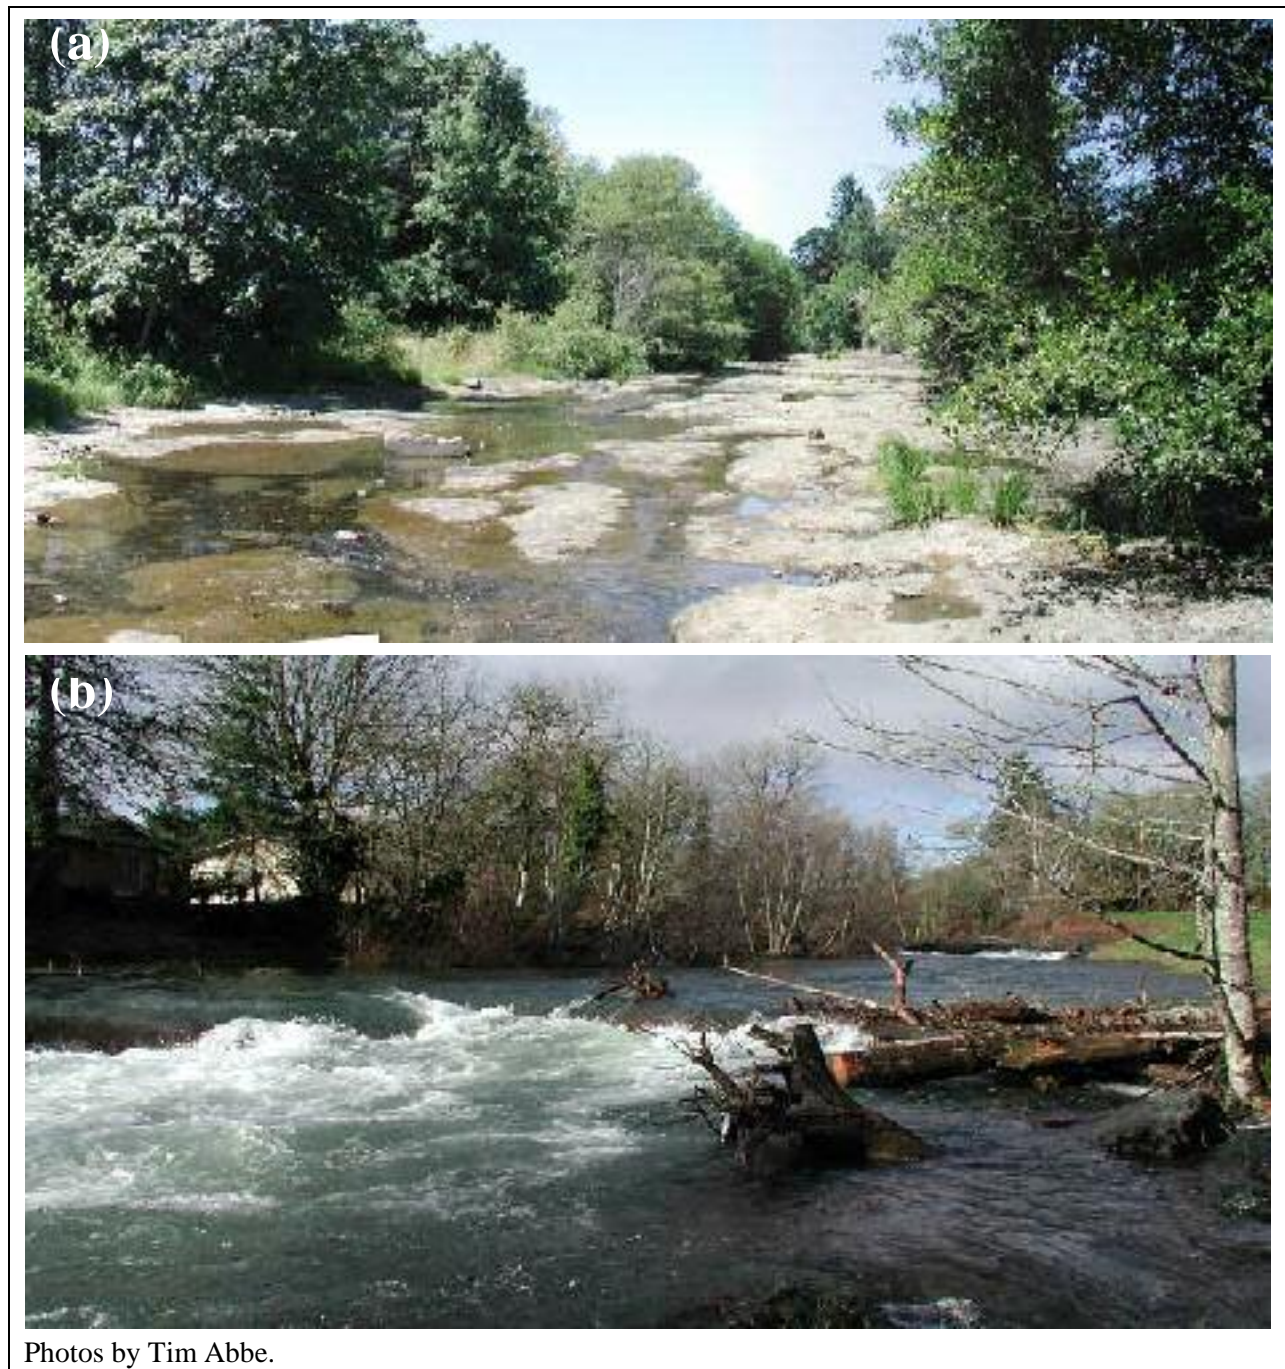
**Figure 33. Conversion of incised bedrock channel to step-pool and pool-riffle channel using ELJ grade control structures in Rickreall Creek, Dallas, Oregon: (a) conditions during summer low flow in 2002, before project construction and (b) conditions during winter peak flow in 2004, after project construction (flow is from upper right to lower left).**

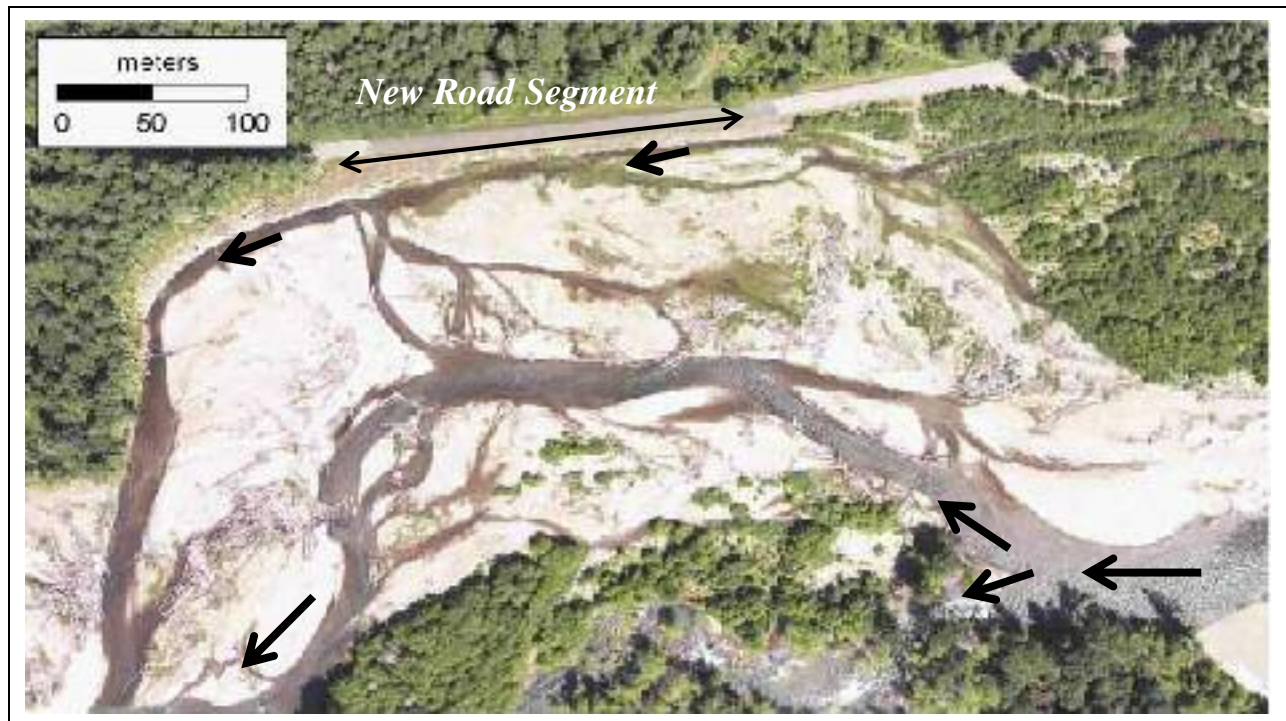
Figure 34. Site B on Cispus River in 1999 before ELJ construction where 150-meter road segment was washed out in 1996.

Two sets of ELJ structures were constructed along the Cispus River in 1999. Four ELJs were constructed directly adjacent to Forest Road 23 at RM 20 (Site B) (Figure 34 and 35), and another set of three ELJs was constructed upstream at RM 21 (Site C).

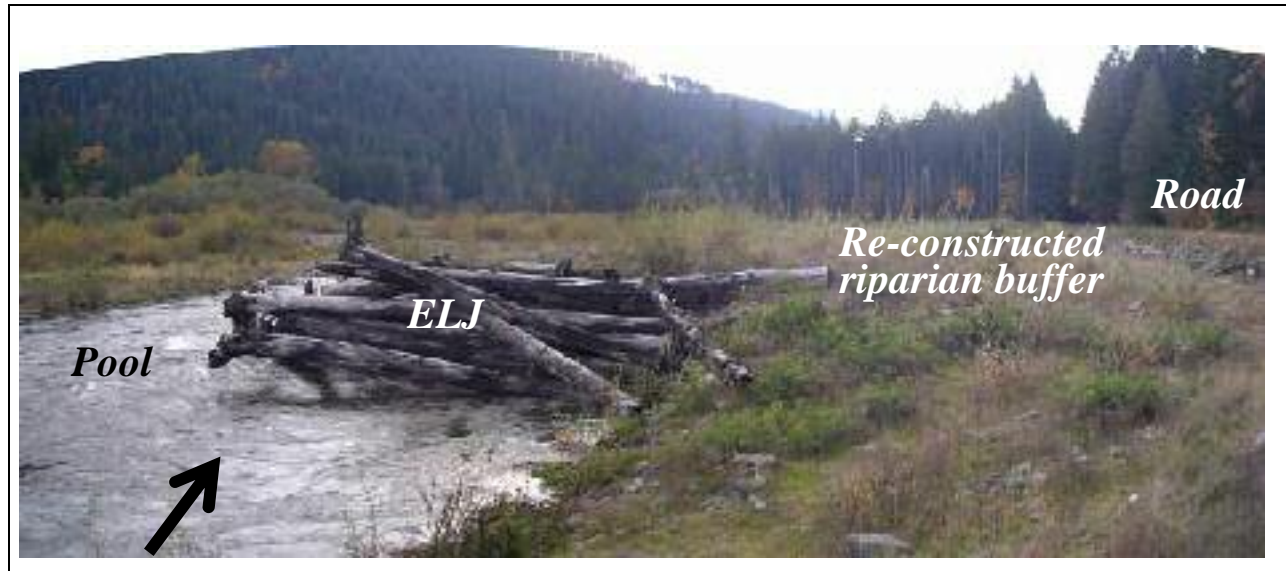
**Figure 36. One of four flow deflection ELJs in Cispus River constructed to increase pool frequency and cover, improve riparian conditions, and protect the road, 5 years after construction (November 2004).**

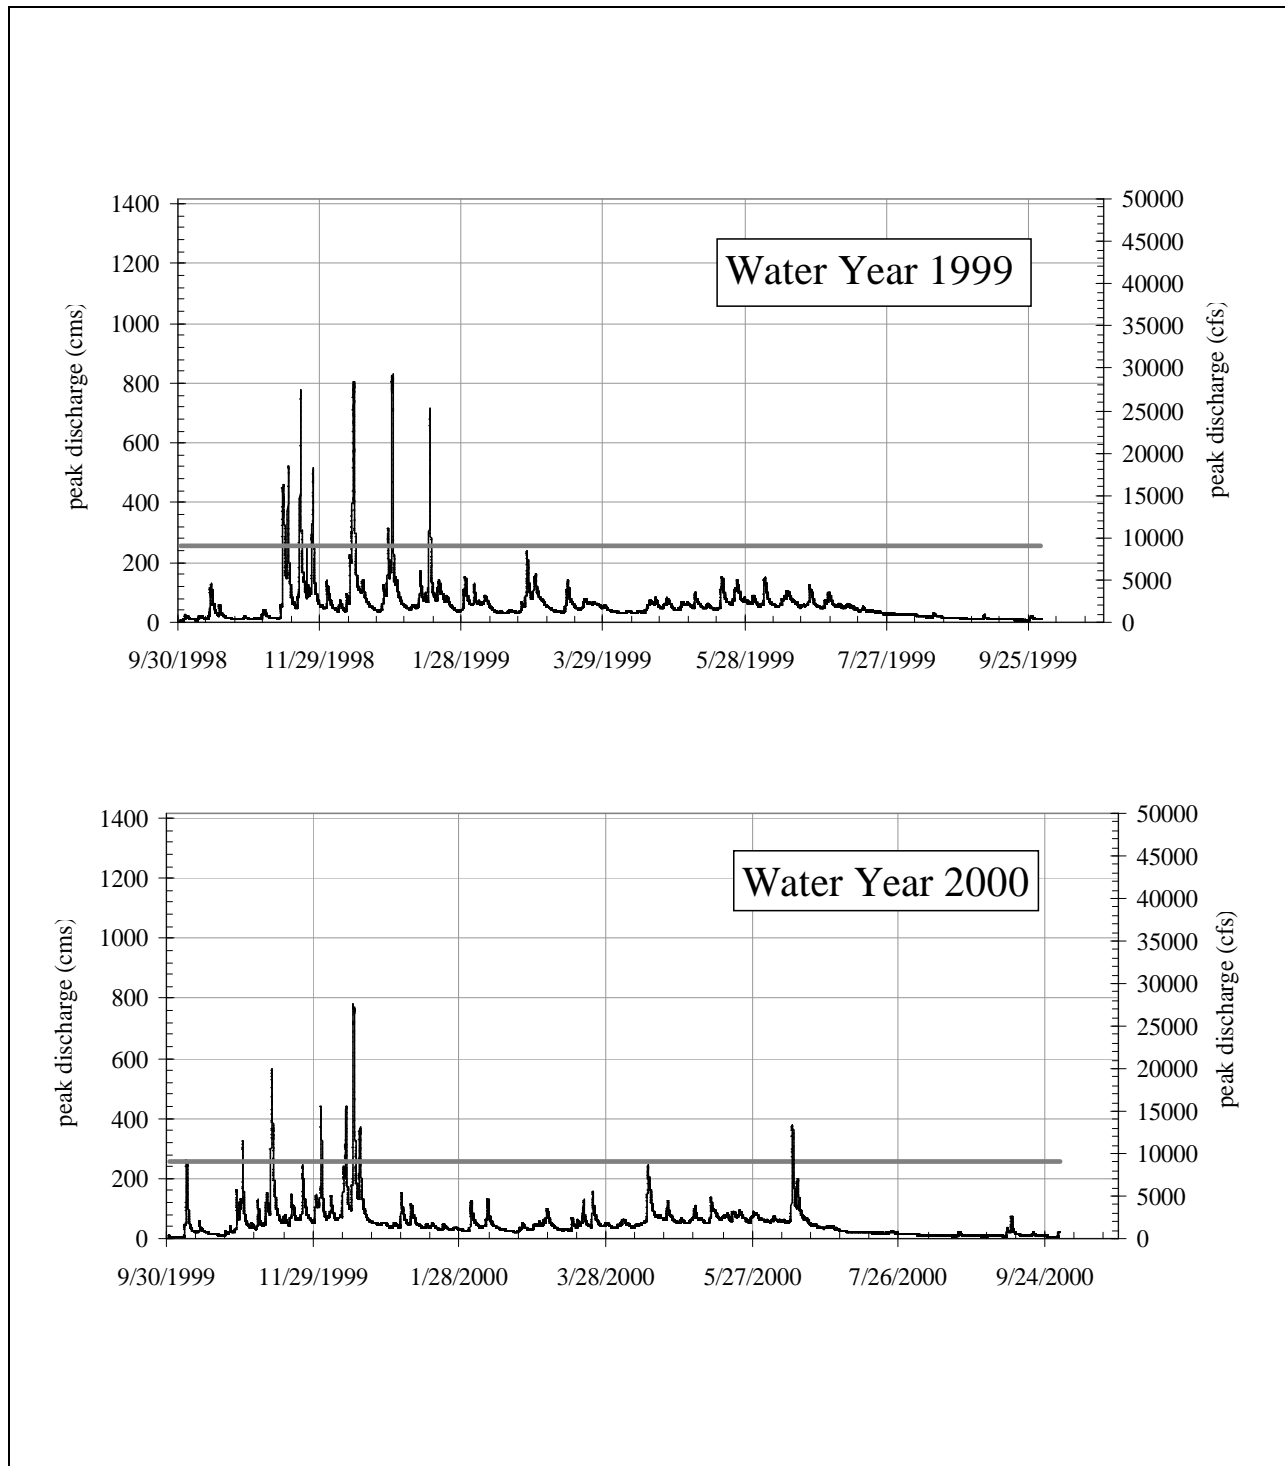
**Figure 38. Hydrographs of peak flows in North Fork Stillaguamish in water year (October 1 to September 30) 1999 and water year 2001. There were eight peak flow events equal to or exceeding bankfull stage at the North Fork Stillaguamish ELJ project site in 1999 and seven in 2000. The ELJ structures are immersed at bankfull flows.**

Between September 1999 and February 2000, at least 15 flows equaling or exceeding bankfull stage occurred (Figures 38, 39, 40, and 41). In 2005, all five ELJs remained in place. During the first high flows in November and December of 1998, ELJ 1 was damaged when one of the structure's seven key members was lost. Significant scour occurred beneath the outer upstream corner of the ELJ and undercut the member that was lost. With nothing to support the saturated log from below, it sank, broke in half, and was carried 10.5 kilometers downstream, where it was found in the summer of 1999. The loss of the outer key member of ELJ 1 was confirmed only when the structure was inspected from below, since there was almost no change in the appearance of the structure from above (Figure 42). Even with the loss of a key member, ELJ 1 remained in place and continued to perform as predicted. Each of the five ELJs has formed and maintained scour pools ranging from 2 to 4 meters in depth. Sand deposition has occurred

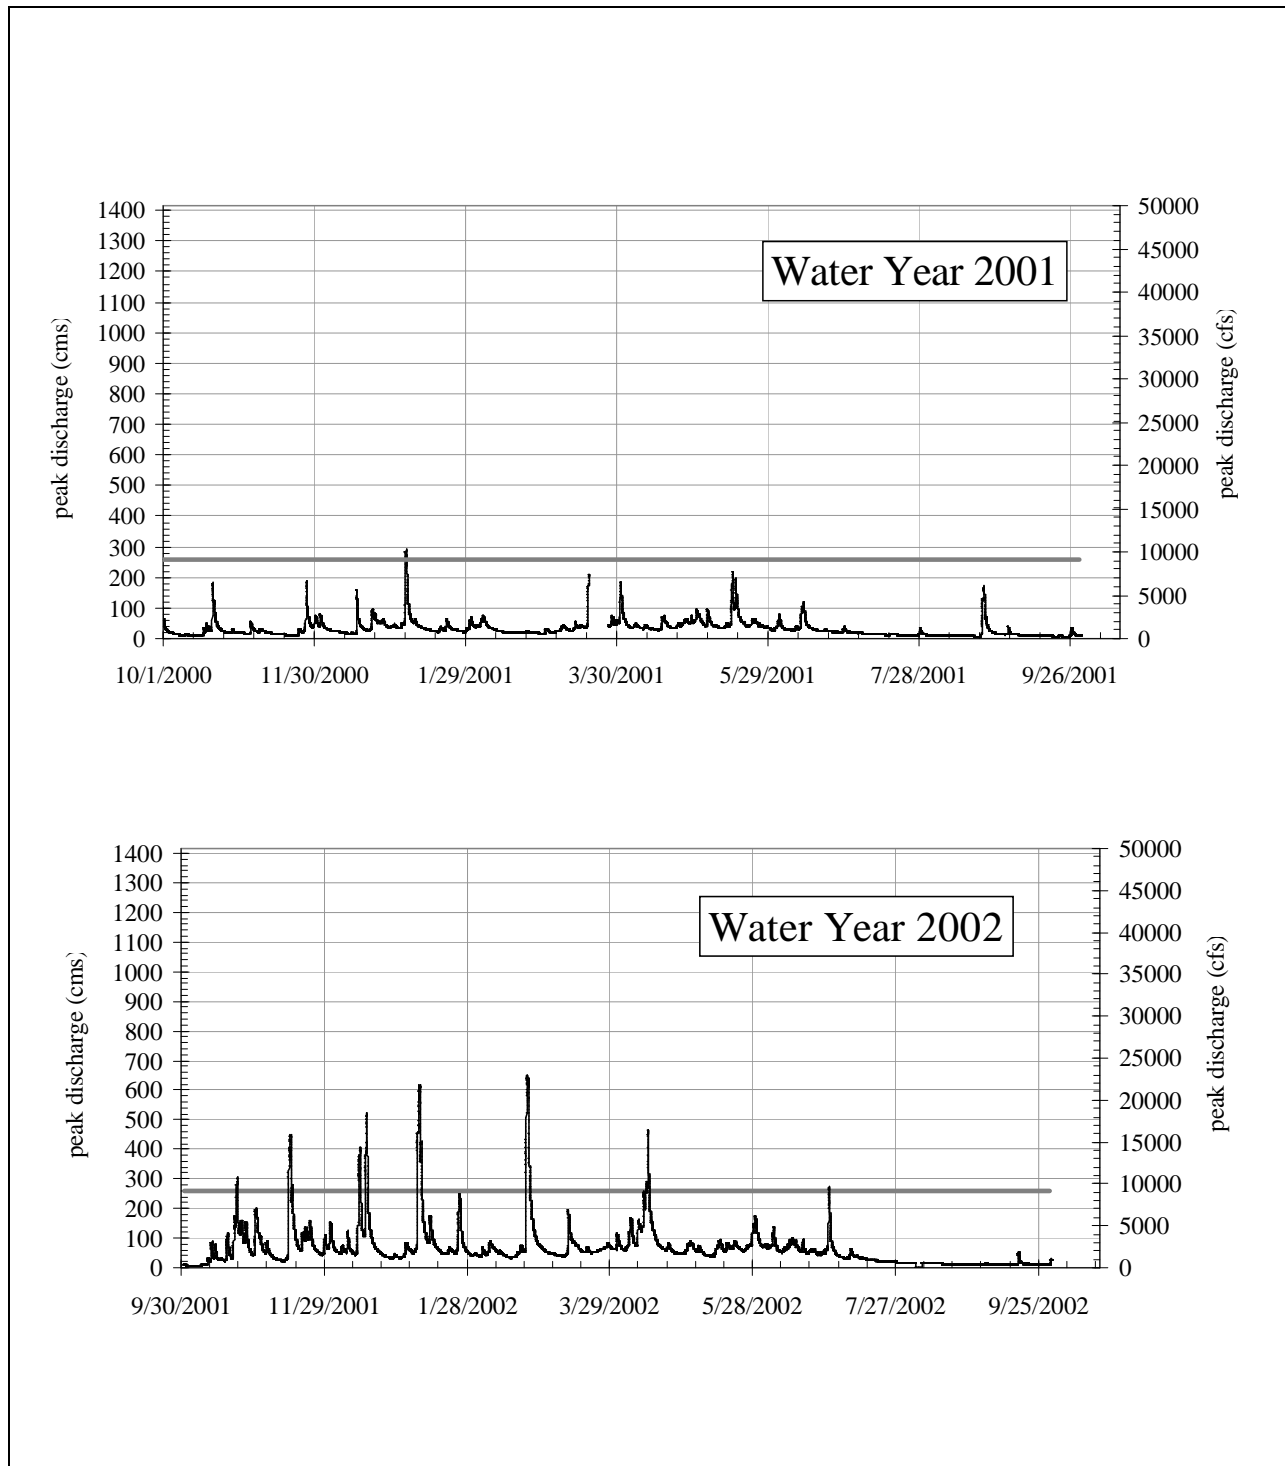
**Figure 39. Hydrographs of peak flows in North Fork Stillaguamish in water year (October 1 to September 30) 2001 and water year 2002. There was one peak flow event equal to or exceeding bankfull stage at the North Fork Stillaguamish ELJ project site in 2001 and eight in 2002. The ELJ structures are immersed at bankfull flows.**

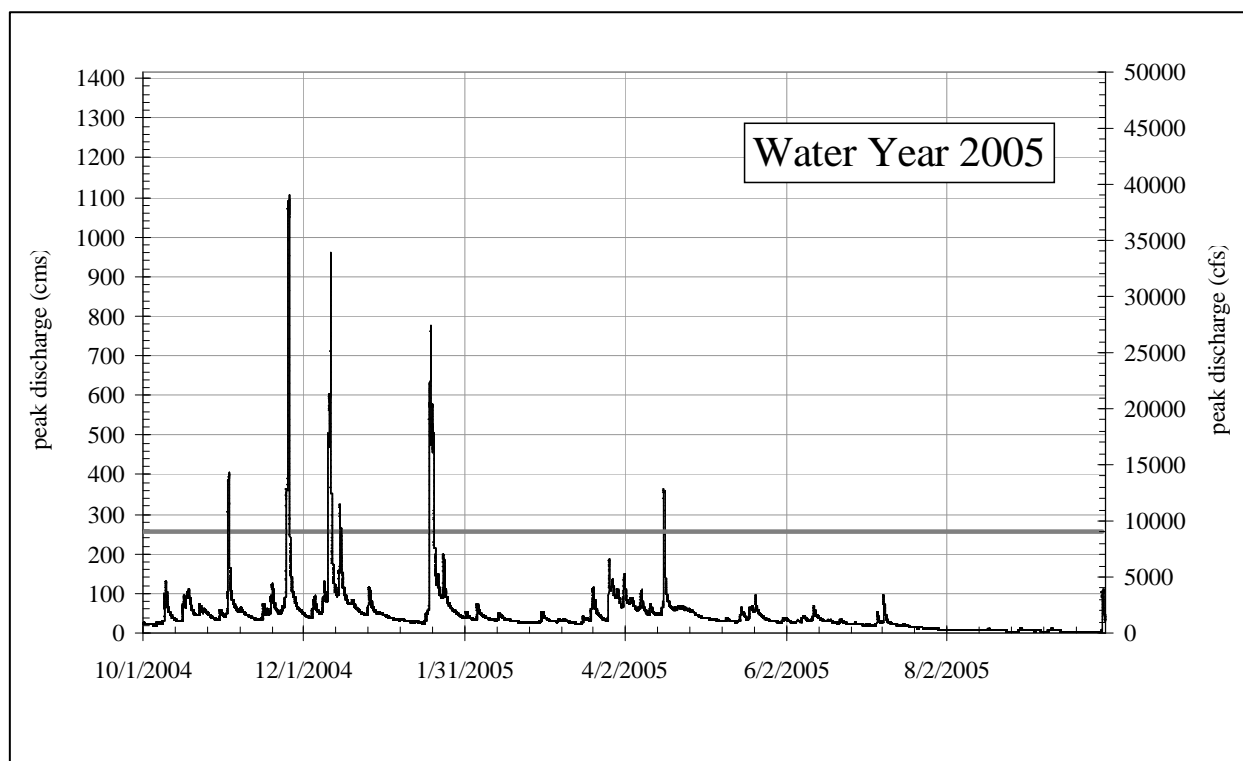
**Figure 41. Hydrographs of peak flows in North Fork Stillaguamish in water year (October 1 to September 30) 2005. From 1999 through 2005, there were 43 peak flow events equal to or exceeding bankfull stage at the North Fork Stillaguamish ELJ project site. The ELJ structures are immersed at bankfull flows.**
