Bathing water profile:

Luss

<p>Bathing water: Luss</p>

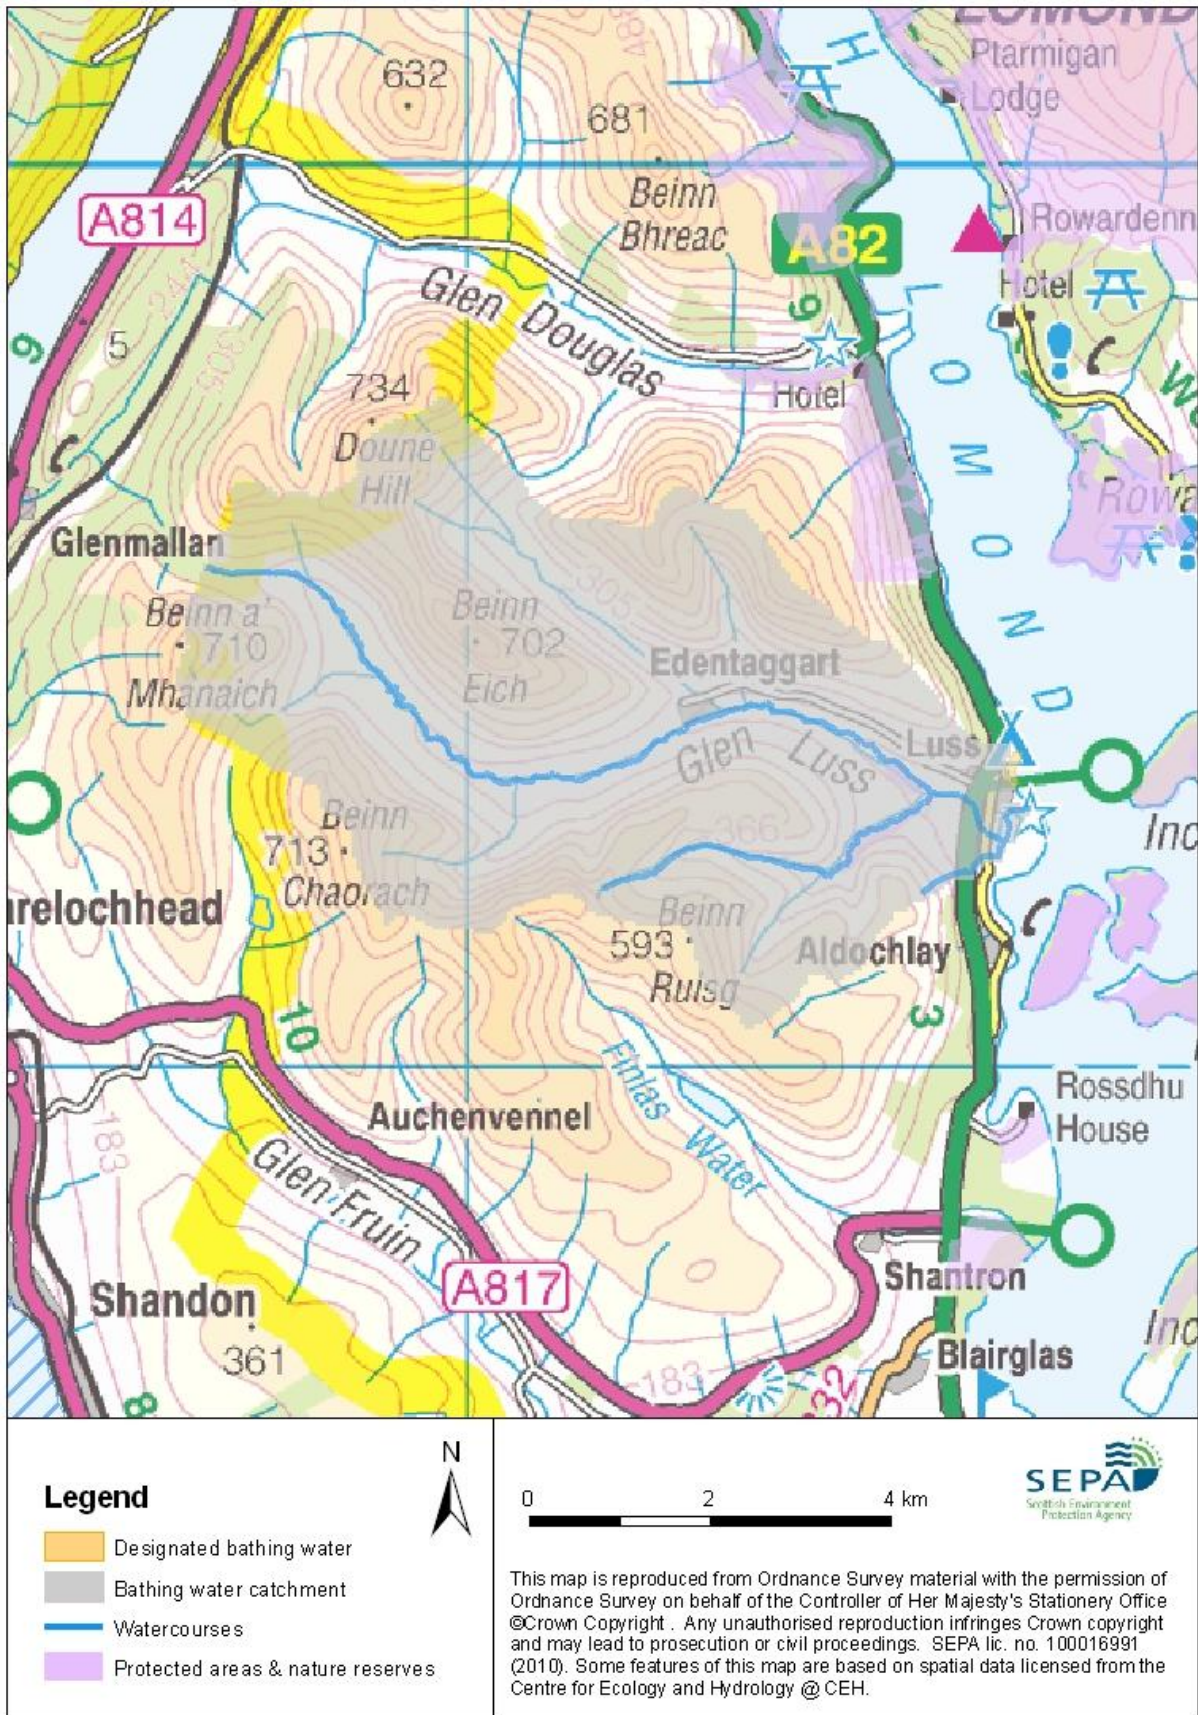
Map 2: Catchment draining into Luss bathing water

The catchment draining into the bathing water extends to 37 km². The area is mountainous with the highest peaks in the catchment being Beinn Eich at 703 metres in the north-west and Deinn Chaorach at 713 metres to the west of the bay. These two peaks form the steep valley along which Luss Water flows towards the bathing water.

The main rivers within the bathing water catchment are the Luss Water, Auchengavin Burn, Sron an Laoigh Burn and Molloch Burn.

There are several protected areas near the bathing water catchment, the closest being the Special Areas of Conservation at Loch Lomond woods which support otter populations. Inchlonaig island is a Site of Special Scientific Interest due to the number of fallow deer and common scoter which frequent the site (Map 2). See Scottish Natural Heritage's [information service website](#)⁴ for more information.
