Bathing water profile:

Machrihanish

<p>EC bathing water ID number: UKS7616034</p>	
<p>Location of bathing water: UK/Scotland/Argyll and Bute (Map1)</p>	
<p>Year of designation: 1999</p>	
<p>© Copyright Leslie Barrie and licensed for reuse under this Creative Commons Licence.</p>	
<p>Bathing water description</p> <p>Machrihanish Bay is a 5 km long quiet rural sandy beach located on the Mull of Kintyre Peninsula in Argyll and Bute. It is close to the small village of Machrihanish and adjoins the Machrihanish golf course via an established sand dune system. There is a car park at either end of the bay (Map 1) and access to the beach is via a gate at Machrihanish. It was designated as a bathing water in 1999.</p> <p>During high and low tides the approximate distance to the water's edge can vary from approximately 30–100 metres. The beach slopes gently towards the water. There are powerful rip currents and submerged rocks on part of the beach. For local tide information please see: http://easytide.ukho.gov.uk/EasyTide/</p> <p>The beach is prized for its unspoilt golden sands and is popular with locals, as well as surfers and other watersports enthusiasts.</p> <p>Our monitoring point f

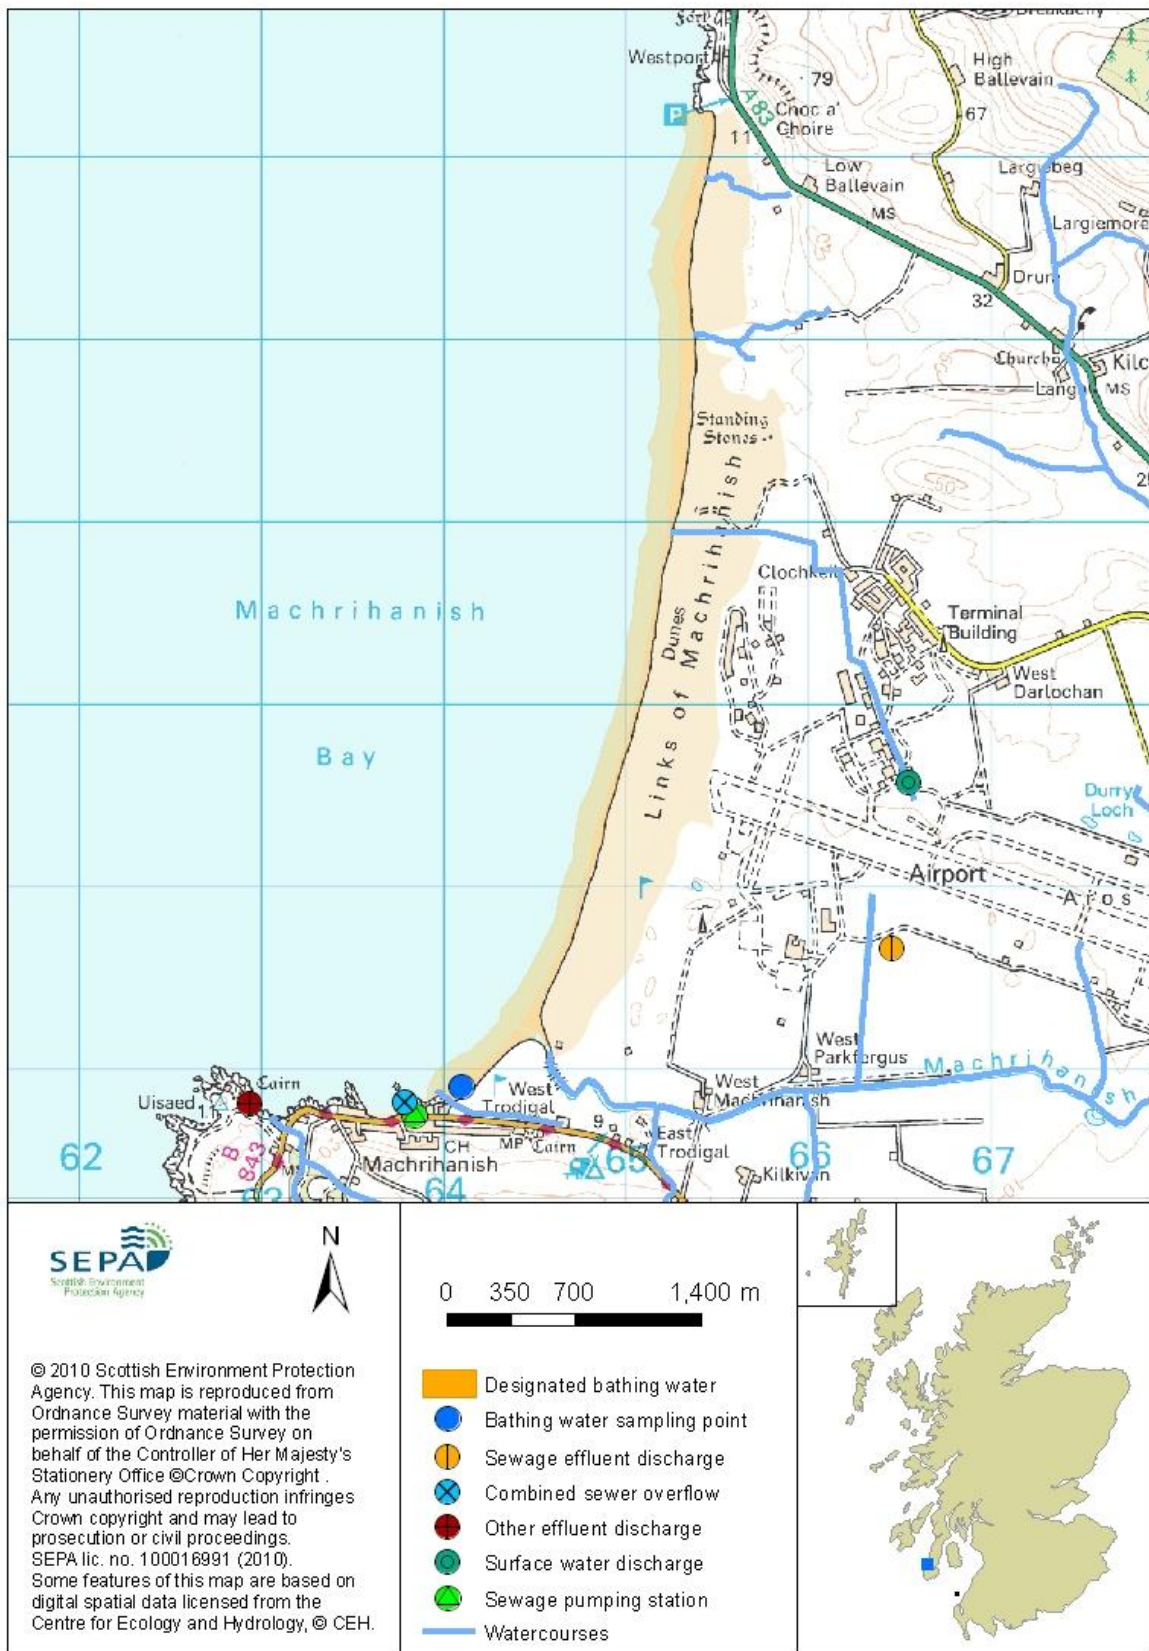
Map 1: Machrihanish bathing water

The potential relevant pollution sources at, or near, this bathing water are highlighted on Map 1. There are no direct discharges to the bathing water.

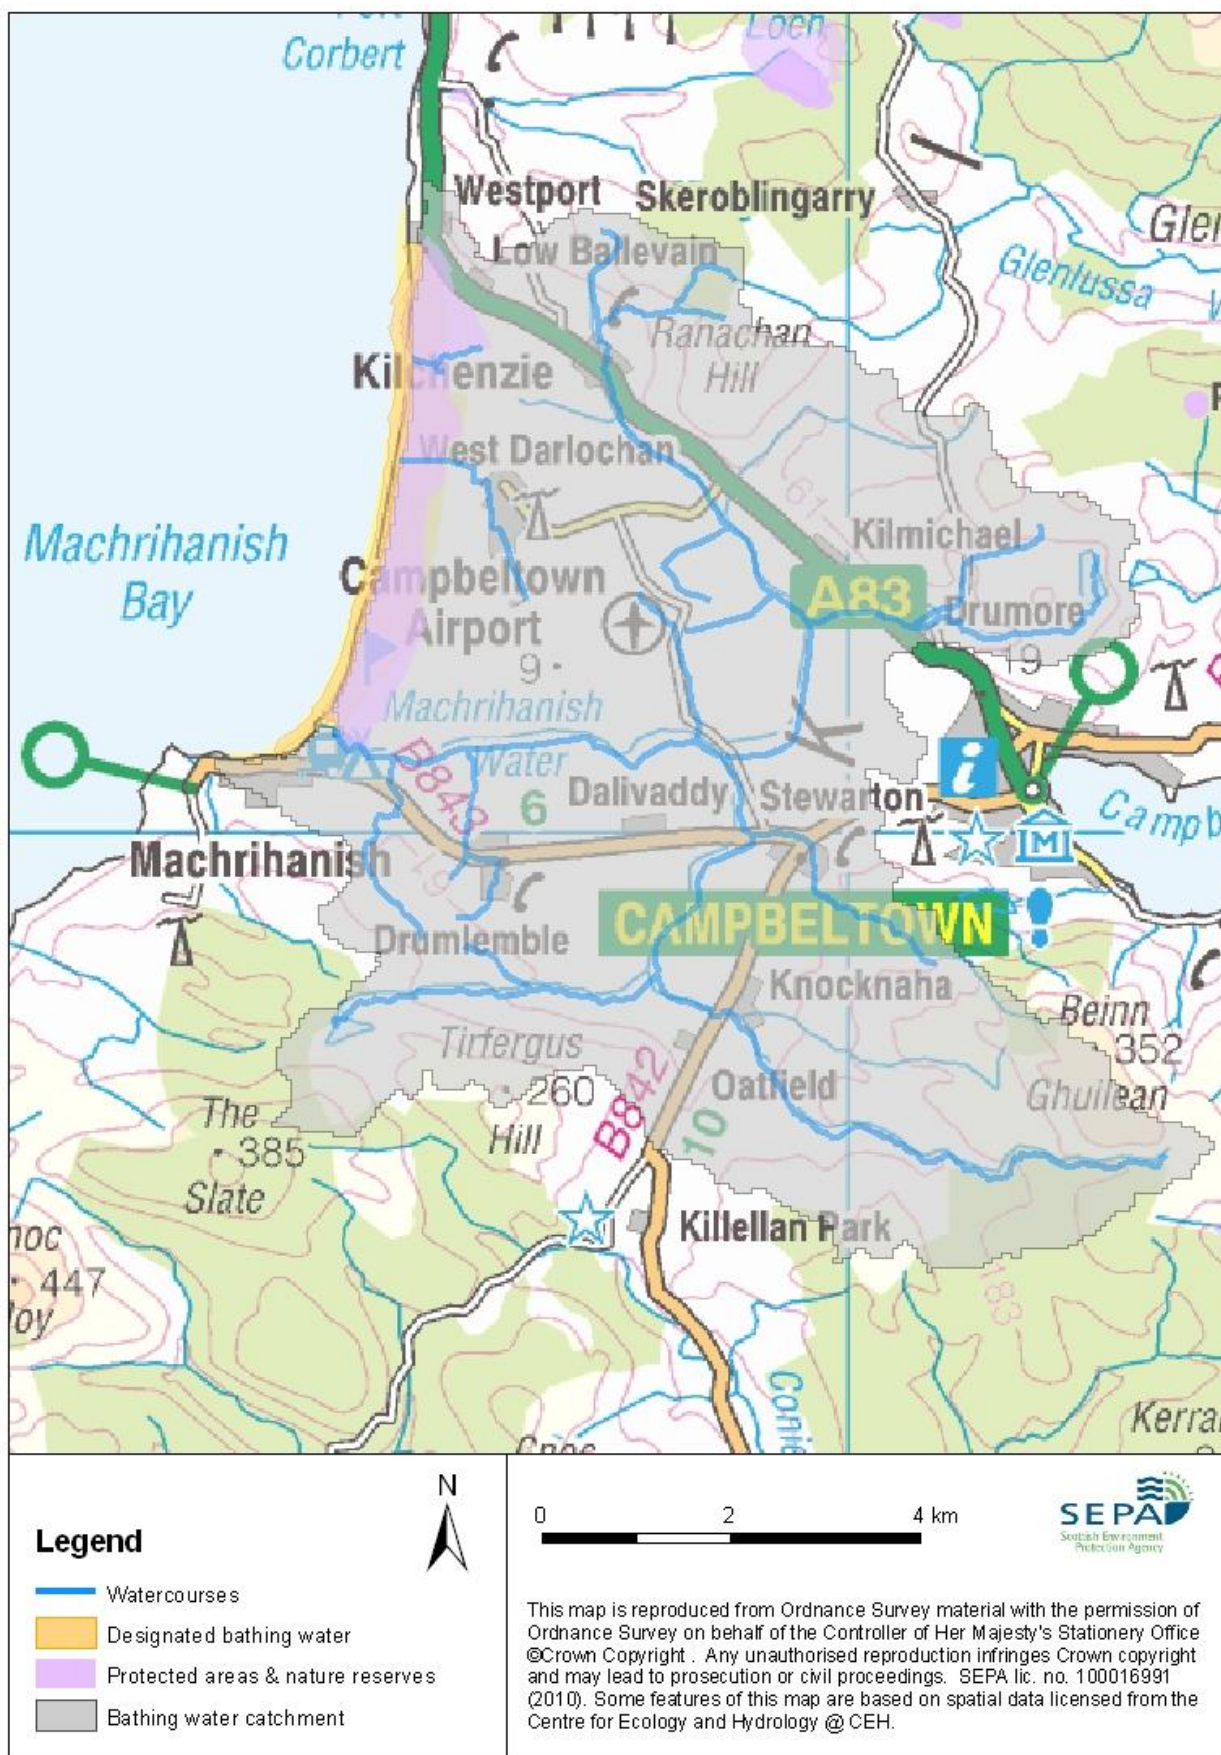
Map 2: Catchment draining into Machrihanish bathing water

The catchment draining into the designated bathing water extends to approx 66 km². The land area adjacent to the bathing water is flat and low-lying and has been subjected to extensive drainage works over the years. Beyond this low-lying area the land rises to approx 200 metres. Average summer rainfall for the region is 350 mm compared to 331 mm across Scotland as a whole.

The catchment is predominantly rural (98%) with grassland (74%) the major land use. The upland areas support mixed sheep and beef farming whilst the lowlands are used for intensive dairy farming, particularly the plains and northern part of the catchment. Most farms grow a small acreage of barley for feed and straw. Approximately 2% of the bathing water catchment comprises of bog, standing water and inland rock. Population density within the catchment is generally low. The village of Machrihanish is at the southern end of the bathing water. The area also includes Campbeltown airport and both Machrihanish and Machrihanish Dunes golf clubs (Map 2).

The bathing water includes the Machrihanish Dunes Site of Special Scientific Interest (SSSI) (Map 2). This SSSI is the largest sand dune complex in mainland Argyll and is notified for its important coastal habitat and associated flora. For more information see Scottish Natural Heritage's [information service website](#)³.
