Gravel Deposits and Flood Risk to Agricultural Land

Using three different sites across Scotland, SEPA has investigated the link between sediment deposits in the river channels and flood risk to adjacent agricultural land. The three sites were located on the River Feshie at the confluence with the River Spey, the River Tay near Ballinluig and the River Dee at Ballater.

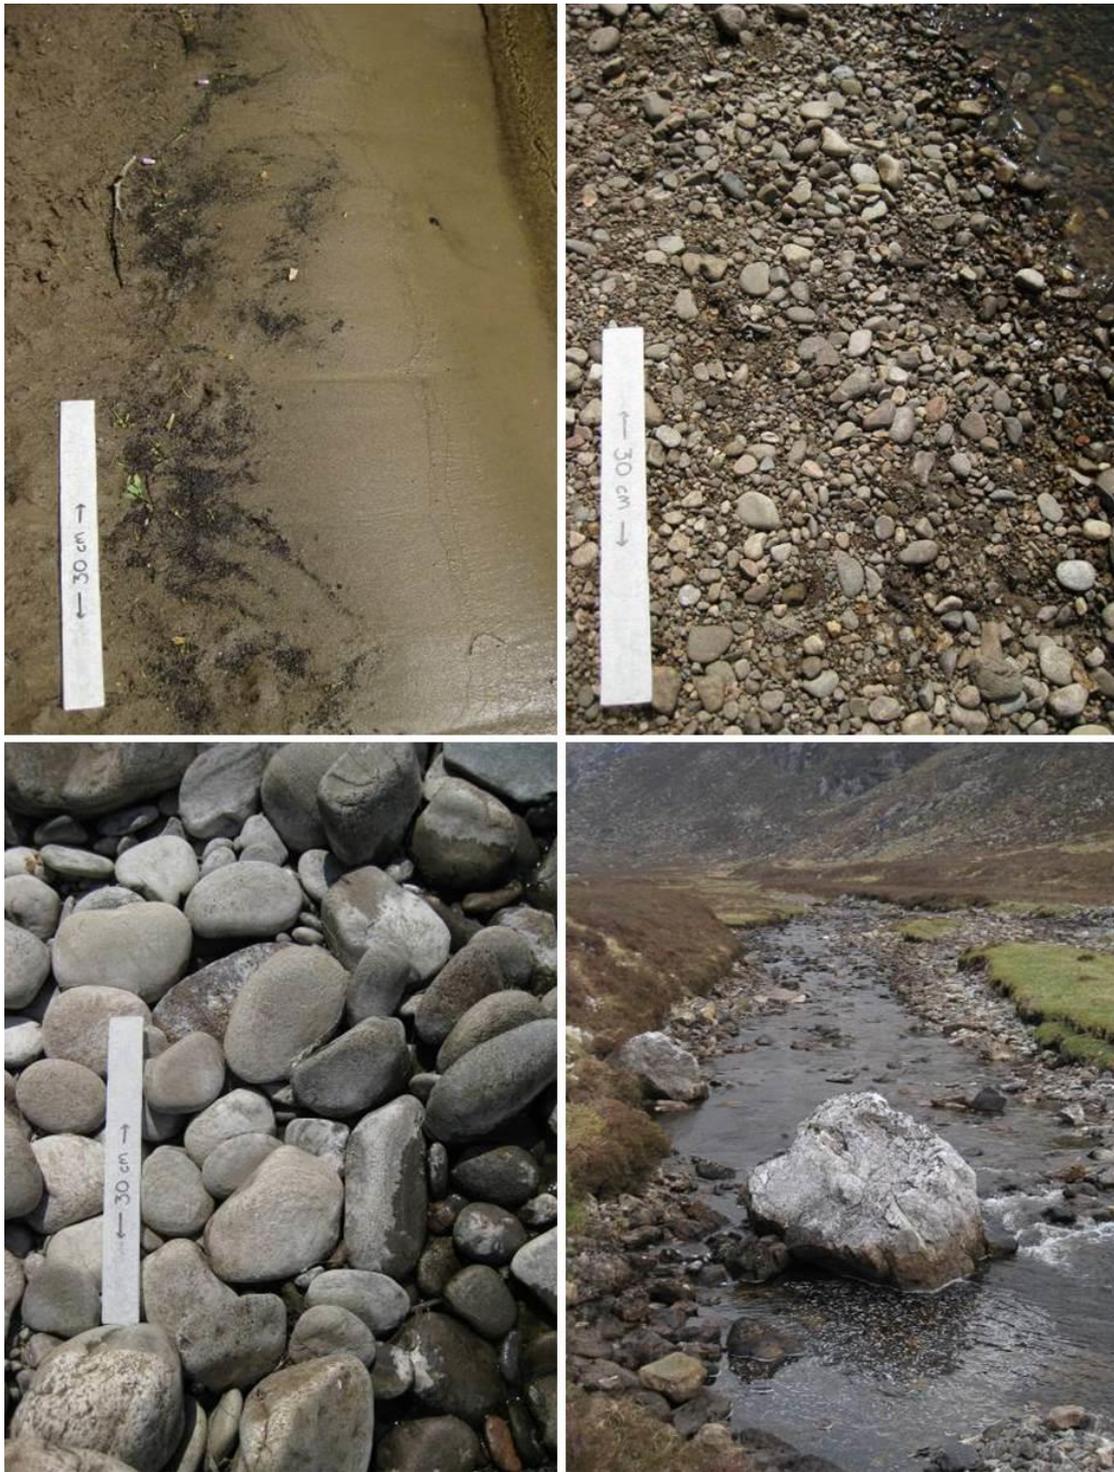
Figure 1: Examples of river sediment. Top left is clay, silt and sand. Top right is sand and gravel. Bottom left is gravel and cobble. Bottom right is cobble and boulder (including that really big boulder mid picture!).

In this report sediment is defined as any non-organic natural material moved by a river. Images of river sediment are shown in Figure 1 which includes:

- clay, silt and sand (particles less than 2mm in diameter);
- gravel (particles 2mm to 64mm in diameter i.e. up to tennis ball size);
- cobbles (particles 64mm to 256mm in diameter i.e. up to football size);
- boulders (particles larger than 256mm in diameter).

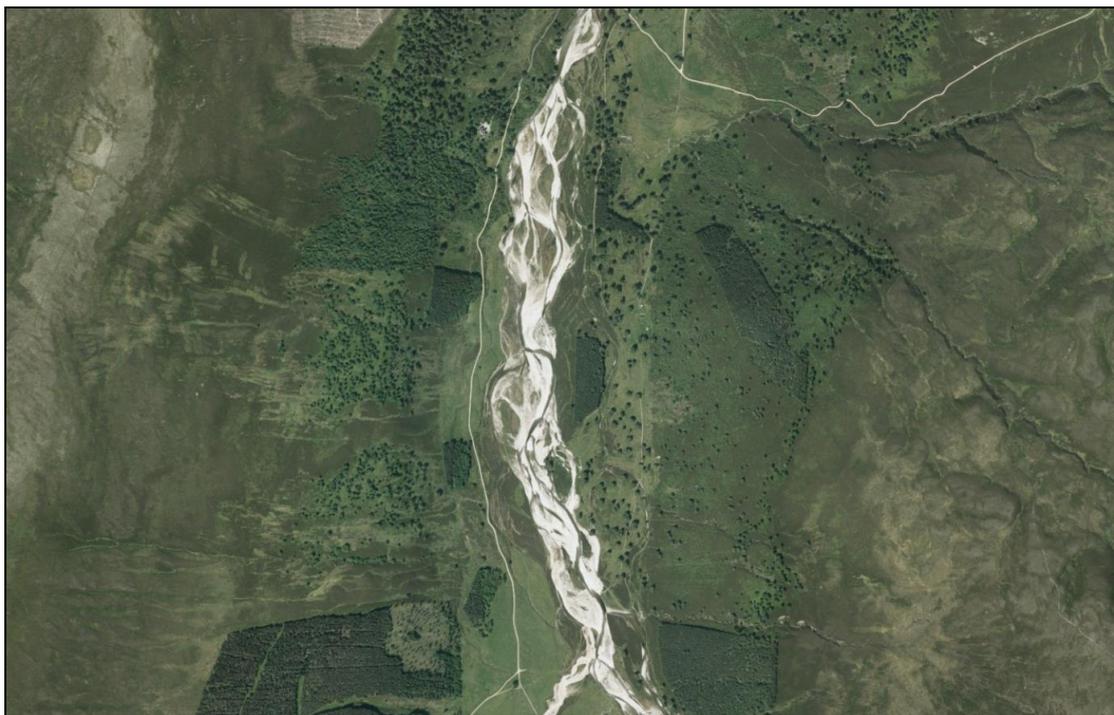
Figure 6: Aerial image of a typical braided and wandering section of the River Feshie near Glenfeshie Lodge. Note the multiple channels and large areas of exposed sediment in the channel which show that frequent erosion, transport and deposition occurs. The active channel is up to 200m wide in places.

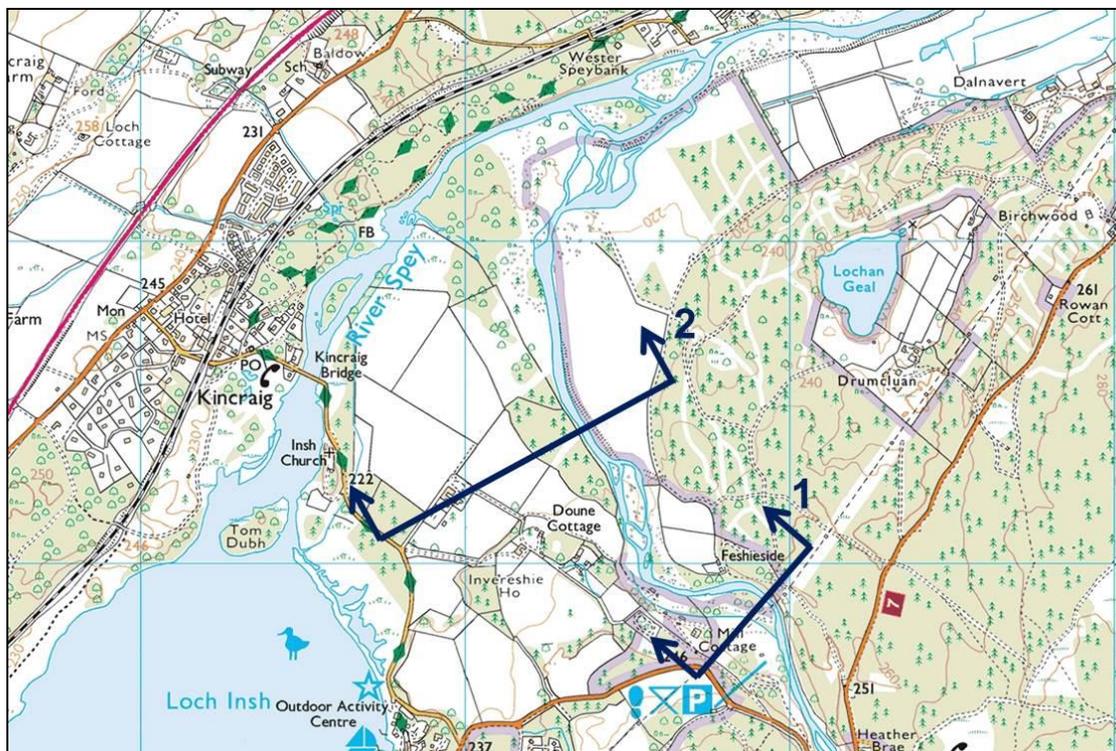
Figure 15: Plan of reach showing location of cross-sections.

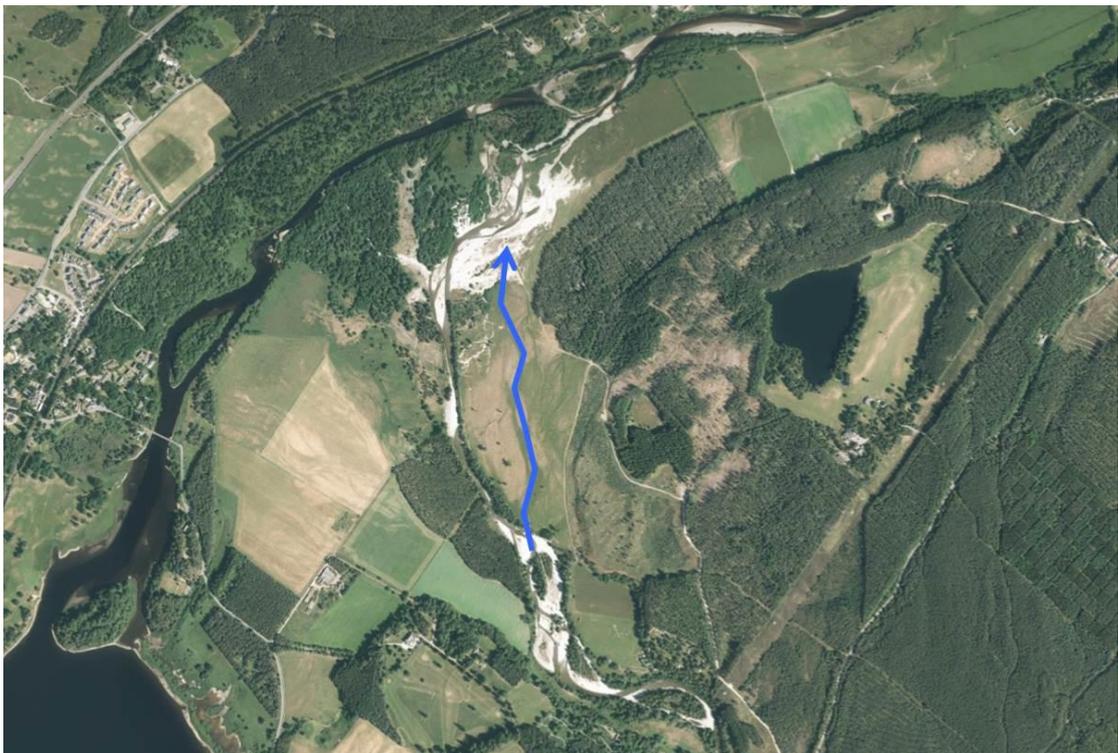
Figure 21: Aerial image of reach overlaid with option to realign channel to a lower part of the alluvial fan utilizing an old channel. © Getmapping

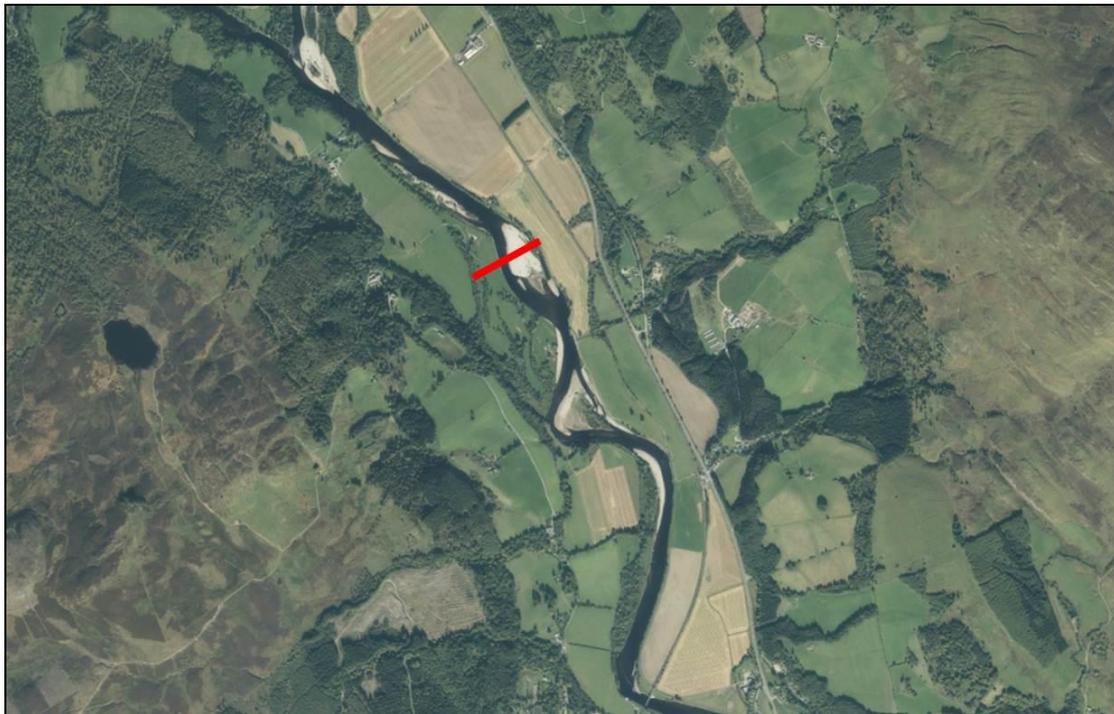
Figure 36: Aerial image of reach showing location of one of the cross-sections where comparison of 2011 and 2015 surveys was undertaken. © Getmapping

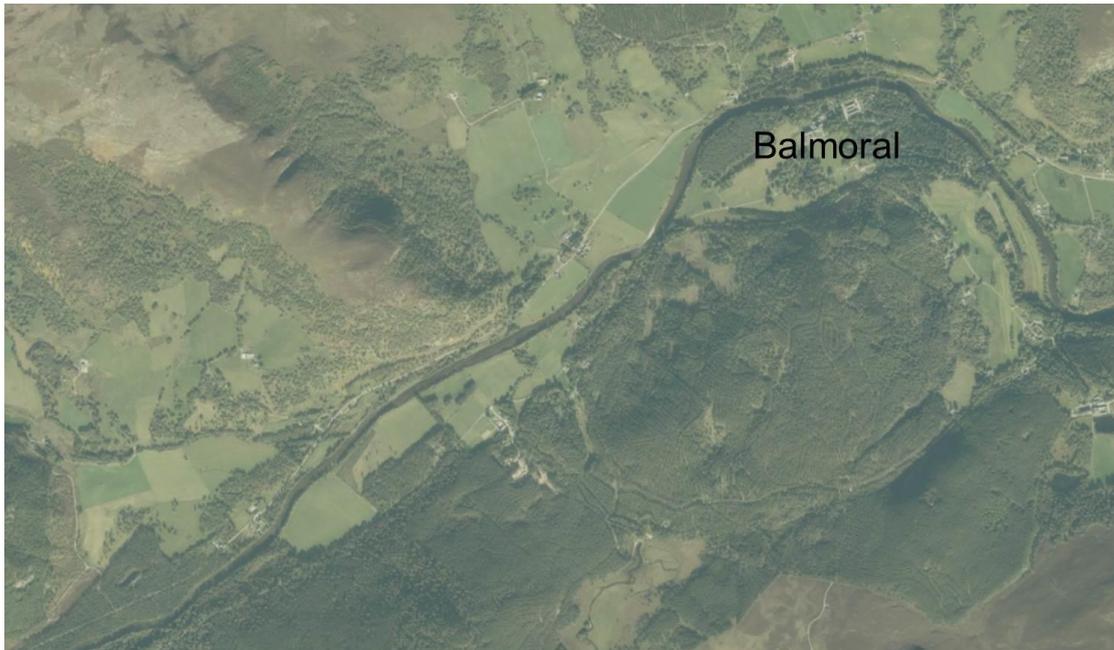
Figure 45: Recent aerial image of a typical section of the River Dee between Invercauld Bridge and Ballater showing reduction in sediment deposits.

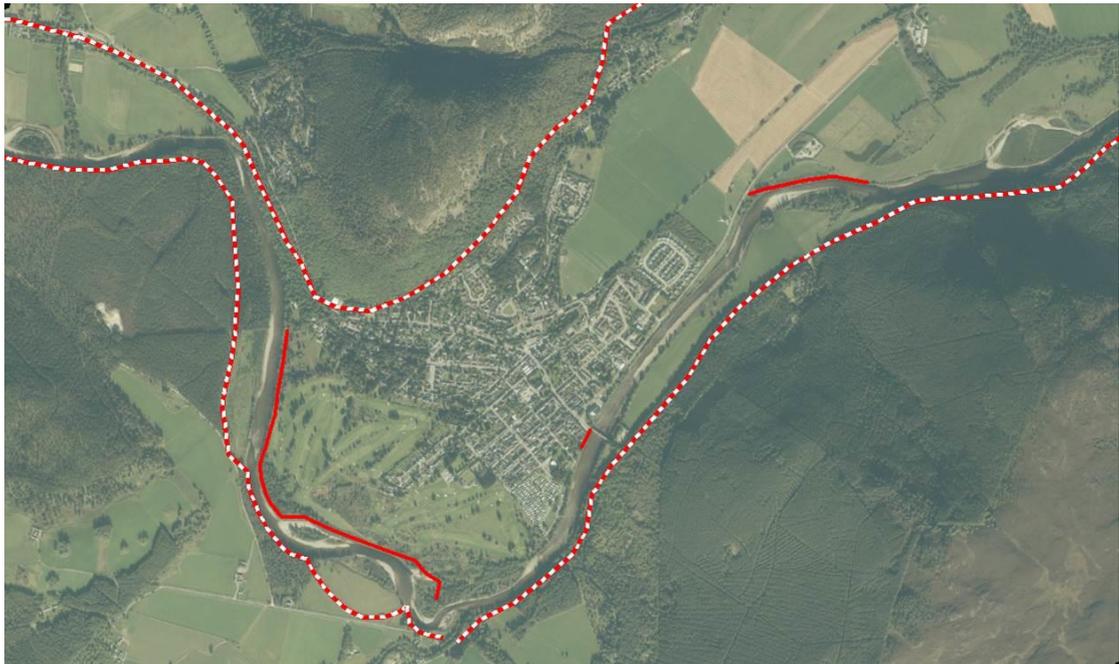
Figure 49: Recent aerial image of Ballater area. Red and white dashed lines indicate edges of River Dee valley. Solid red lines indicate extent of embankments. © Getmapping

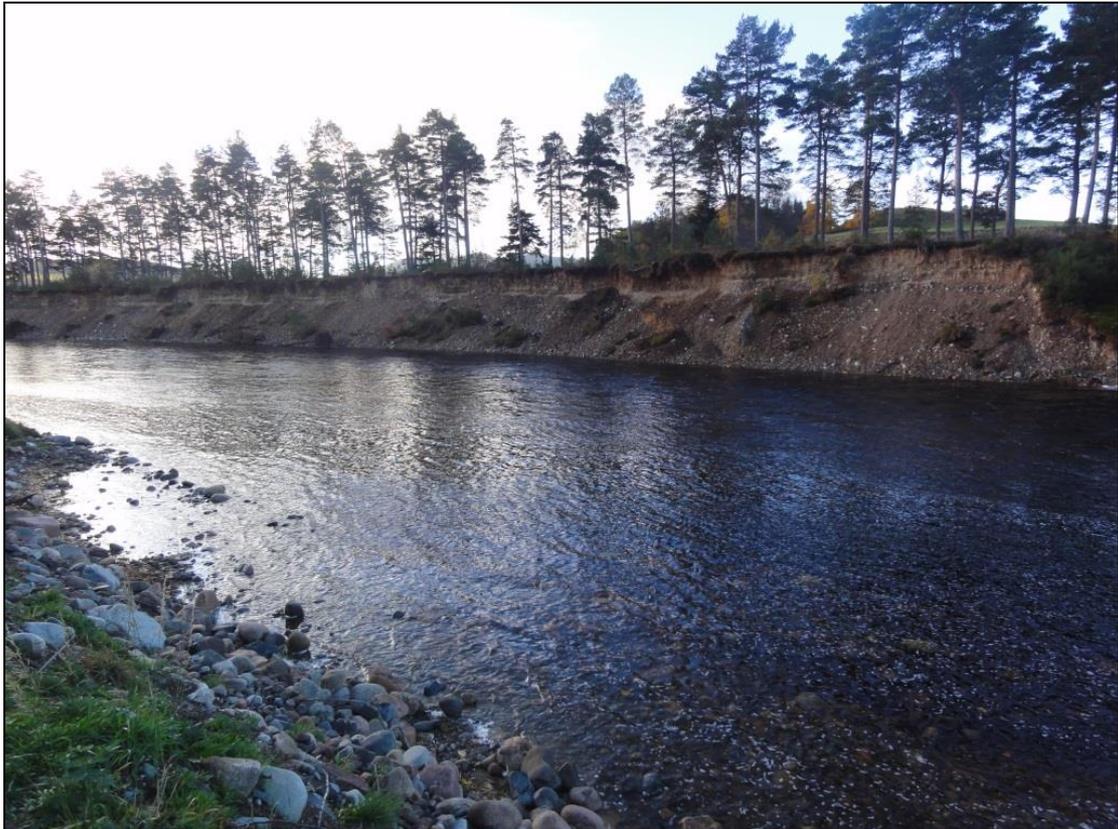
Figure 52: Severe erosion on the outside bend of the River Dee at Ballater immediately downstream from constriction caused by the embankment.

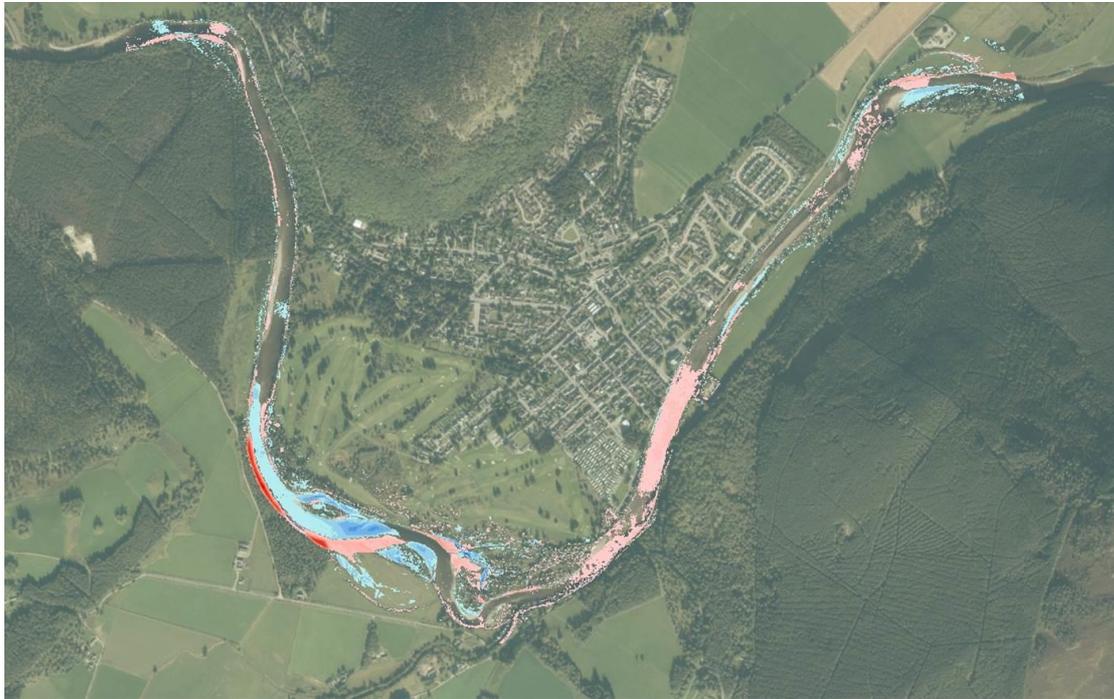
Figure 53: Aerial image of 5km reach at Ballater overlaid with comparison of LiDAR between 2011 and 2016. Red areas show erosion (land lower in 2016 than 2011) and blue areas show deposition (land higher in 2016 than in 2011). Light colours indicate small changes and dark colours indicate large changes.

We first compared the surveys over a 5km length of channel around Ballater (Figure 53). We found that there had been roughly 100,000 Tonnes of erosion and 55,000 Tonnes of deposition between 2011 and 2016. This means that there was net

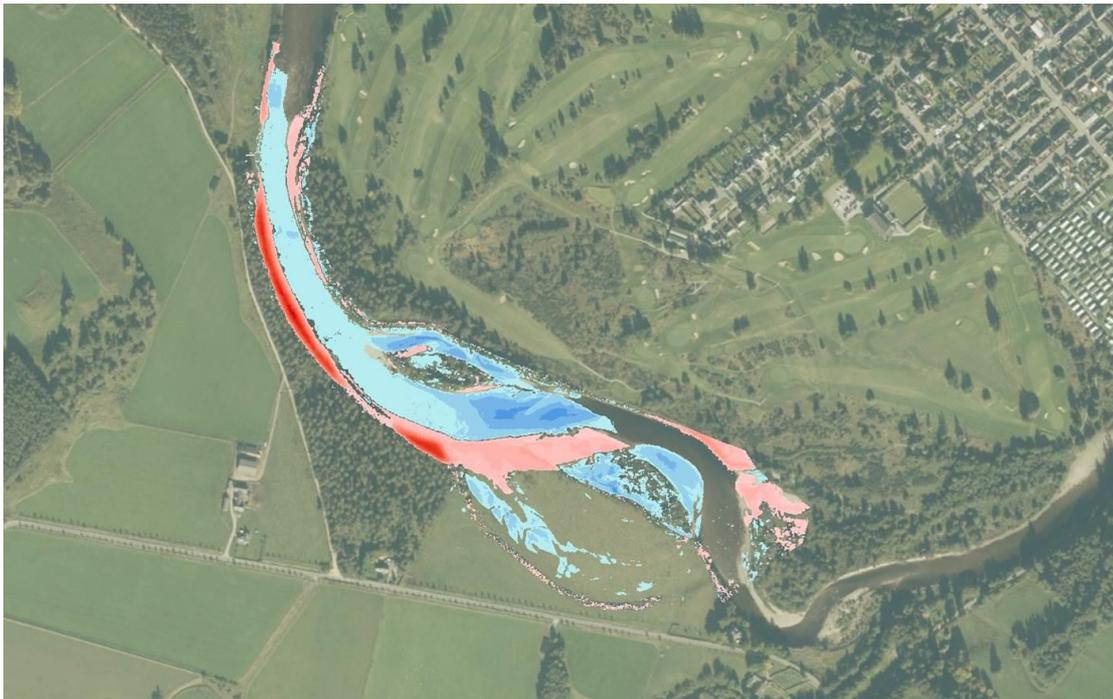
Figure 54: Aerial image of the “Red Brae” area overlaid with comparison of LiDAR between 2011 and 2016. Colours as per Figure 53. © Getmapping

We found that in this area there was net overall erosion of about 18,000Tonnes (allowing for water level difference). This is equivalent to about 4 Olympic sized swimming pools worth of sediment. It is interesting that despite the appearance of significant areas of “new” sediment following the floods in Dec 2015 in particular (e.g. **Figure 55**), there has in fact been net erosion. In other words, the large flood events have re-distributed sediment in the channel but overall the channel is now slightly bigger.

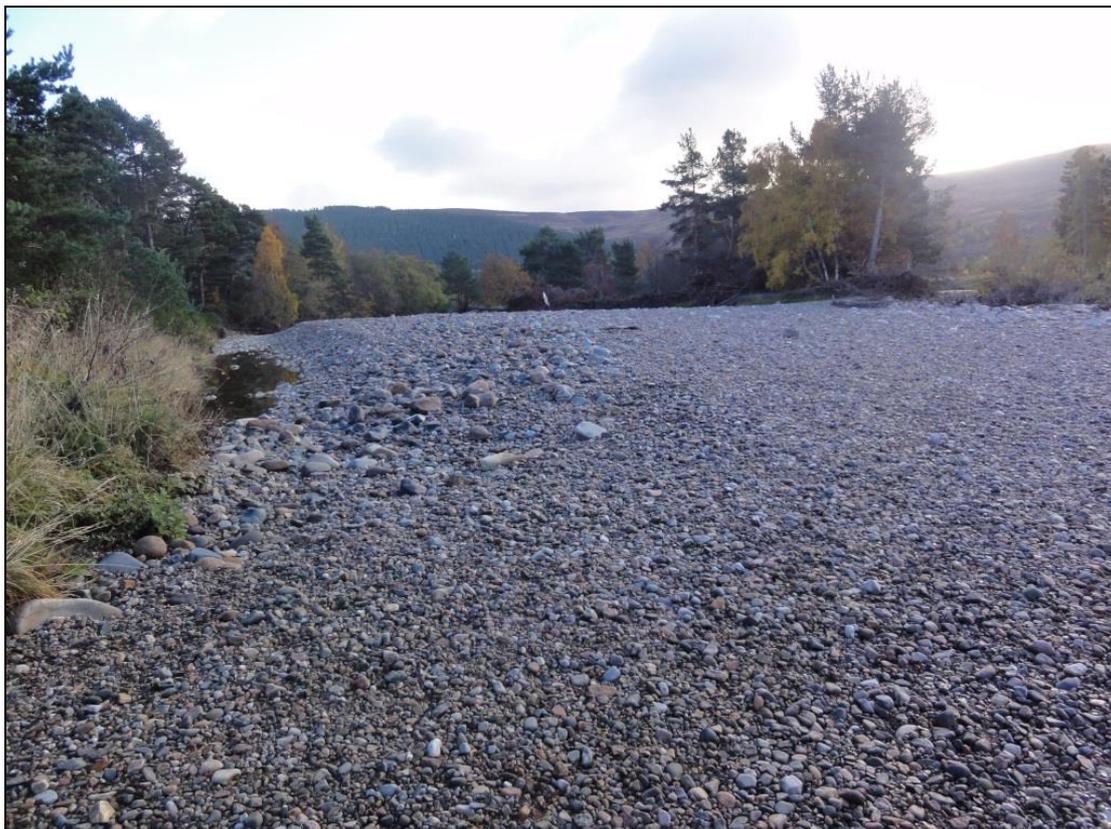
Figure 55: Significant area of recently deposited sediment in the side channel opposite the Red Brae. Sediment had been removed from this side channel in 1994 following concerns about flooding and erosion of the Red Brae opposite.

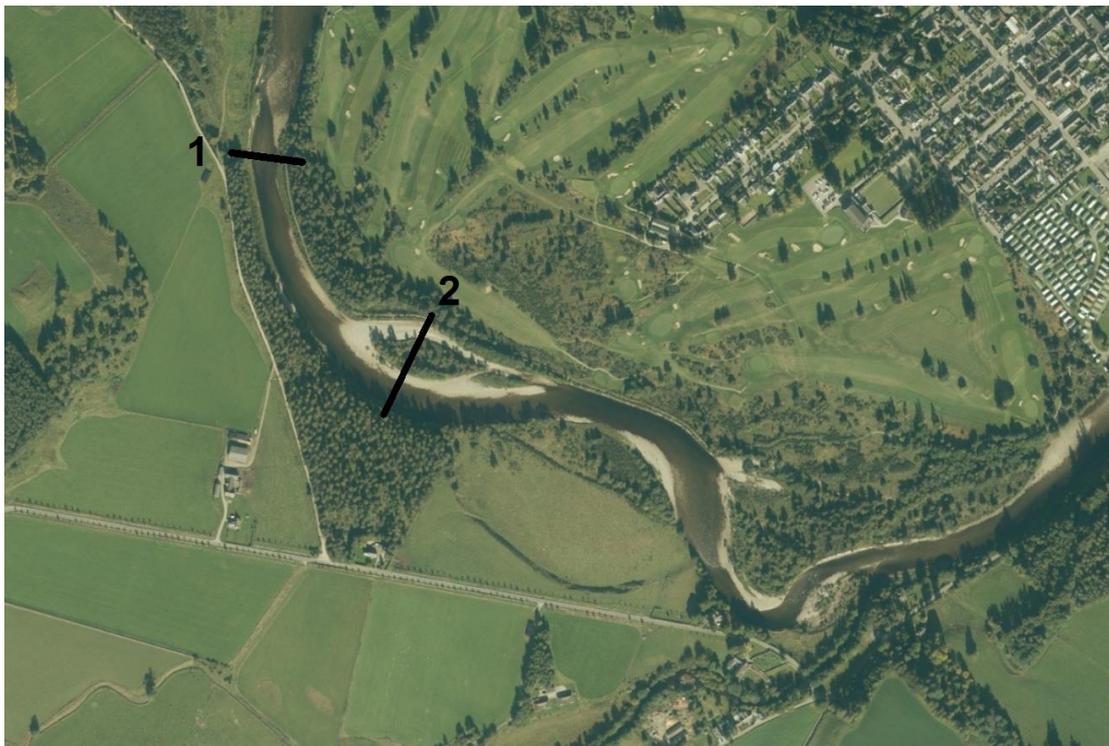
Figure 56: Aerial image of Red Brae area showing location of cross-sections.
