Bathing water profile:

Arbroath (West Links)

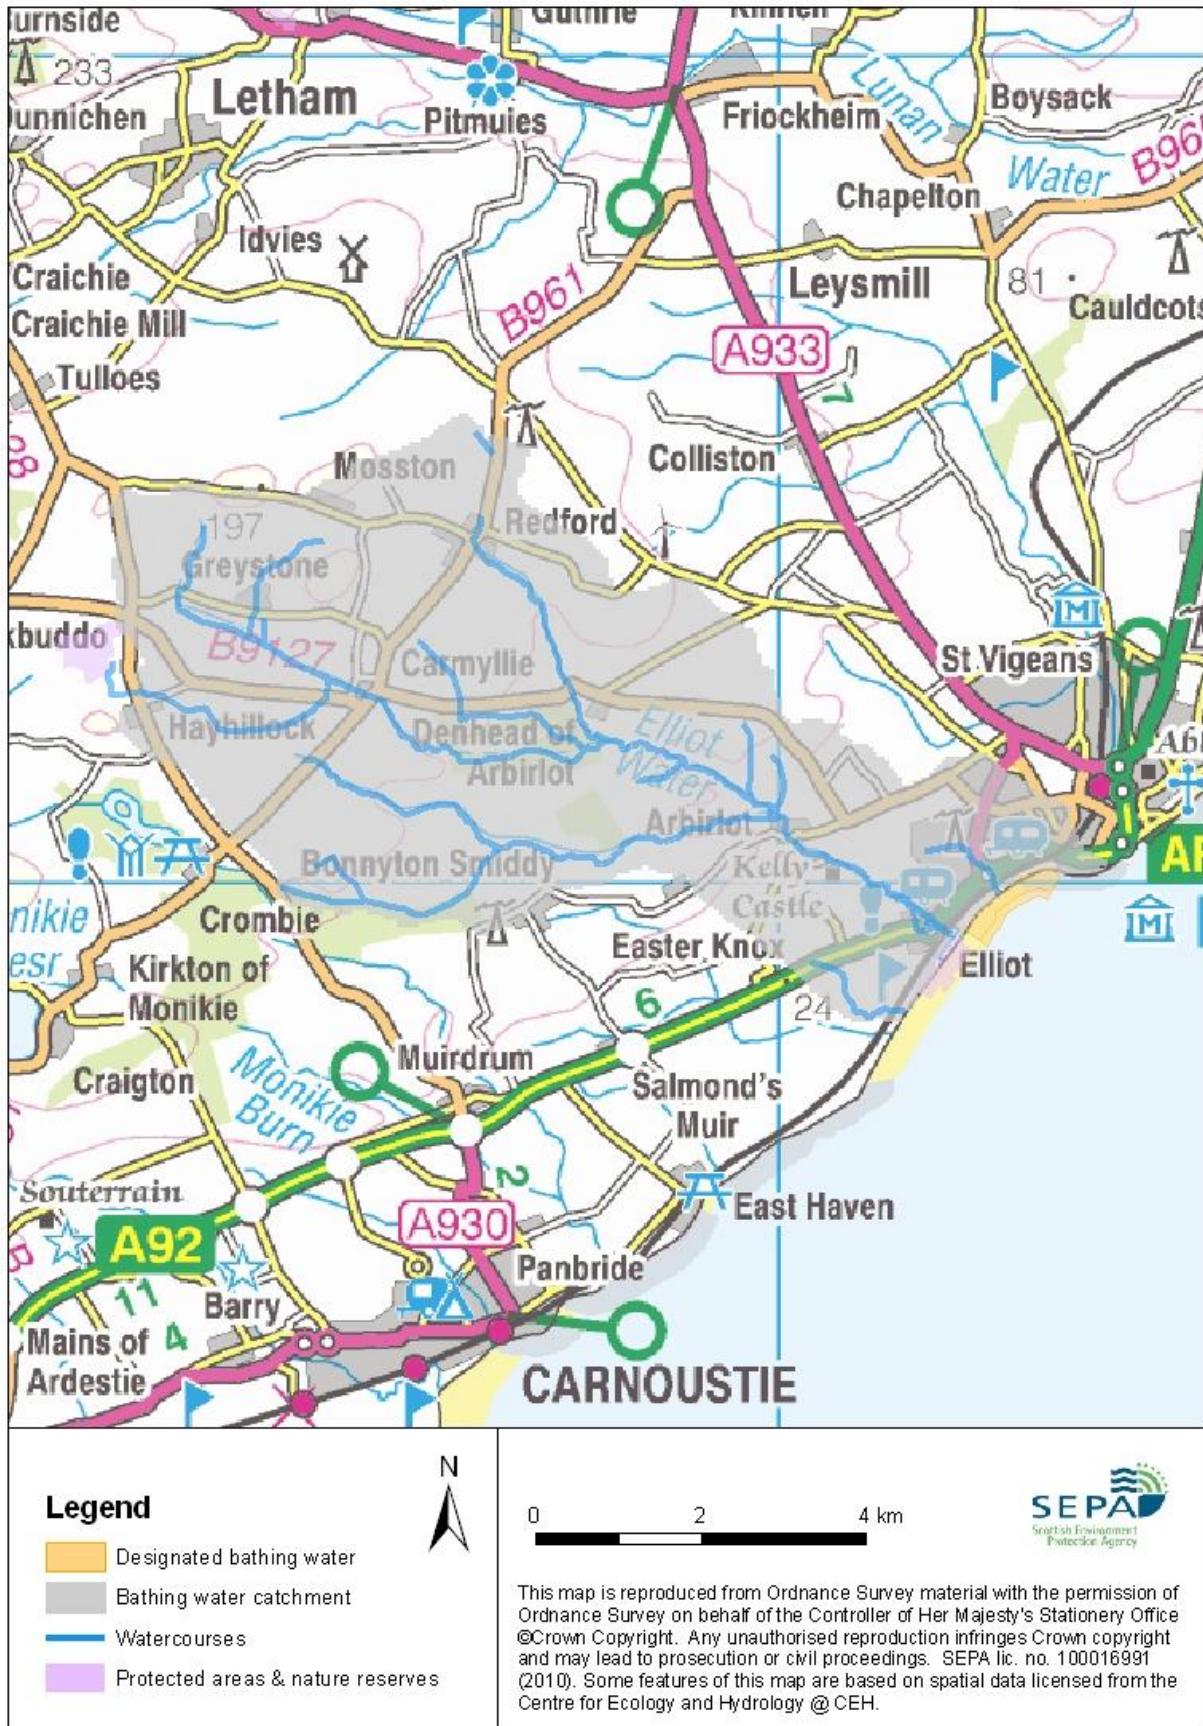
Map 2: Catchment draining into Arbroath (West Links) bathing water

The catchment draining into the Arbroath (West Links) bathing water extends to 44 km². It varies in topography from low-lying areas (average elevation 5 metres) along the coast to low hills (max elevation 190 metres) in the west.

The catchment is predominantly rural (96%) with arable agriculture (including a small amount of soft fruit production) the major land use. There is also some beef and sheep farming in the area. Approximately 4% of the bathing water catchment is urban; the main urban area being the south-western part of the town of Arbroath. There are also a number of other small towns within the catchment.

The main rivers within the bathing water catchment are the Elliot Water and its tributaries (Rottenraw Burn and Black Burn), the Geordies Burn and the Brothock Water.
