Bathing Water Profile for Carrick

Kirkcudbright, Scotland

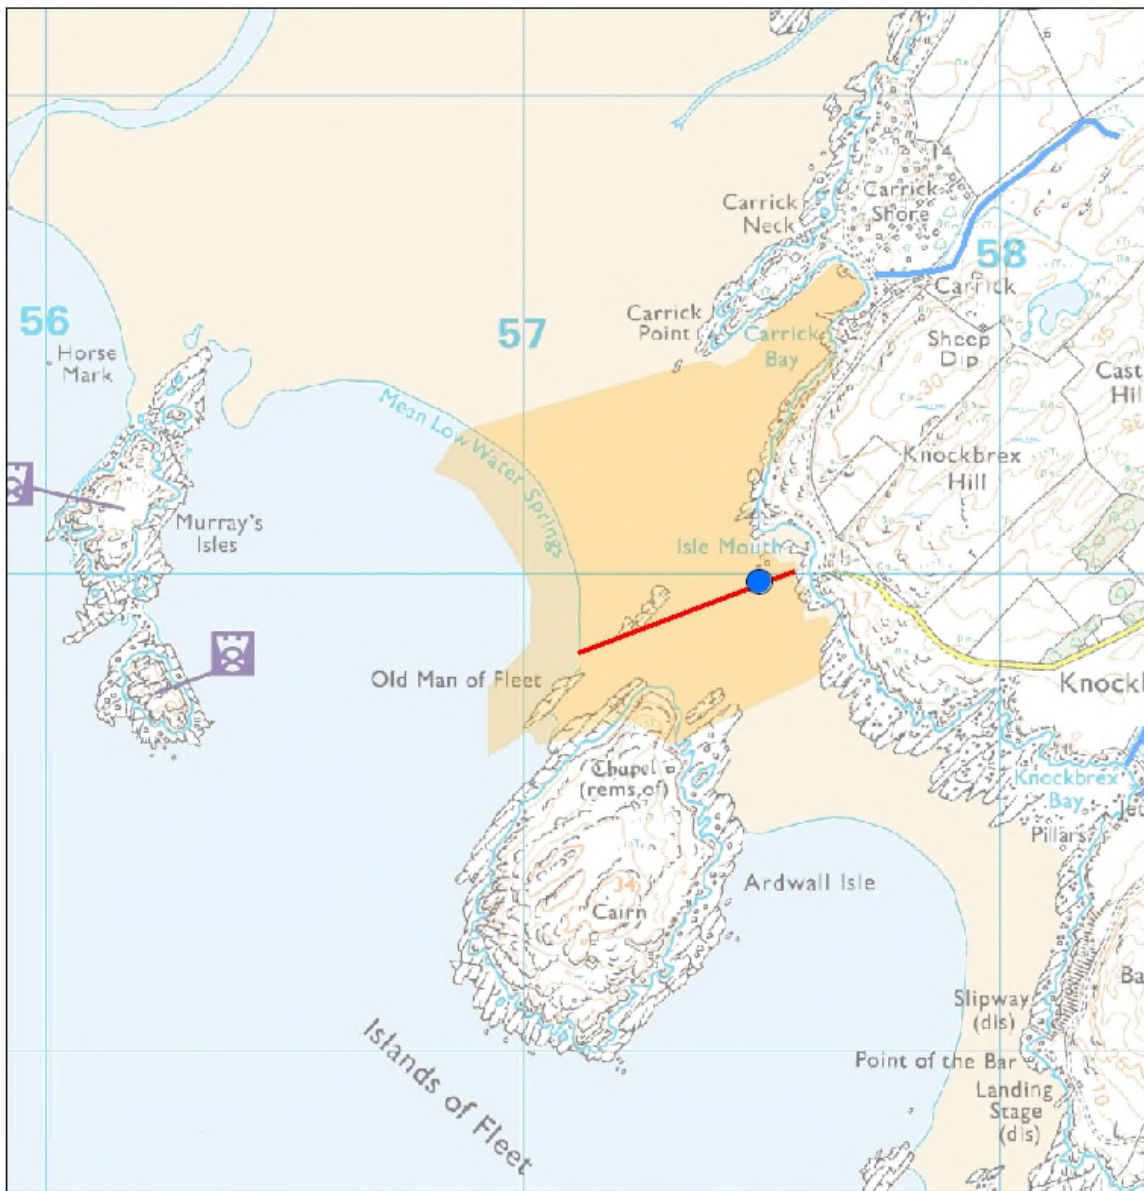
Map 1: Carrick bathing water

0 125 250 500 m

- Designated bathing water
- Bathing water sampling point
- Bathing water sampling transect
- Watercourses

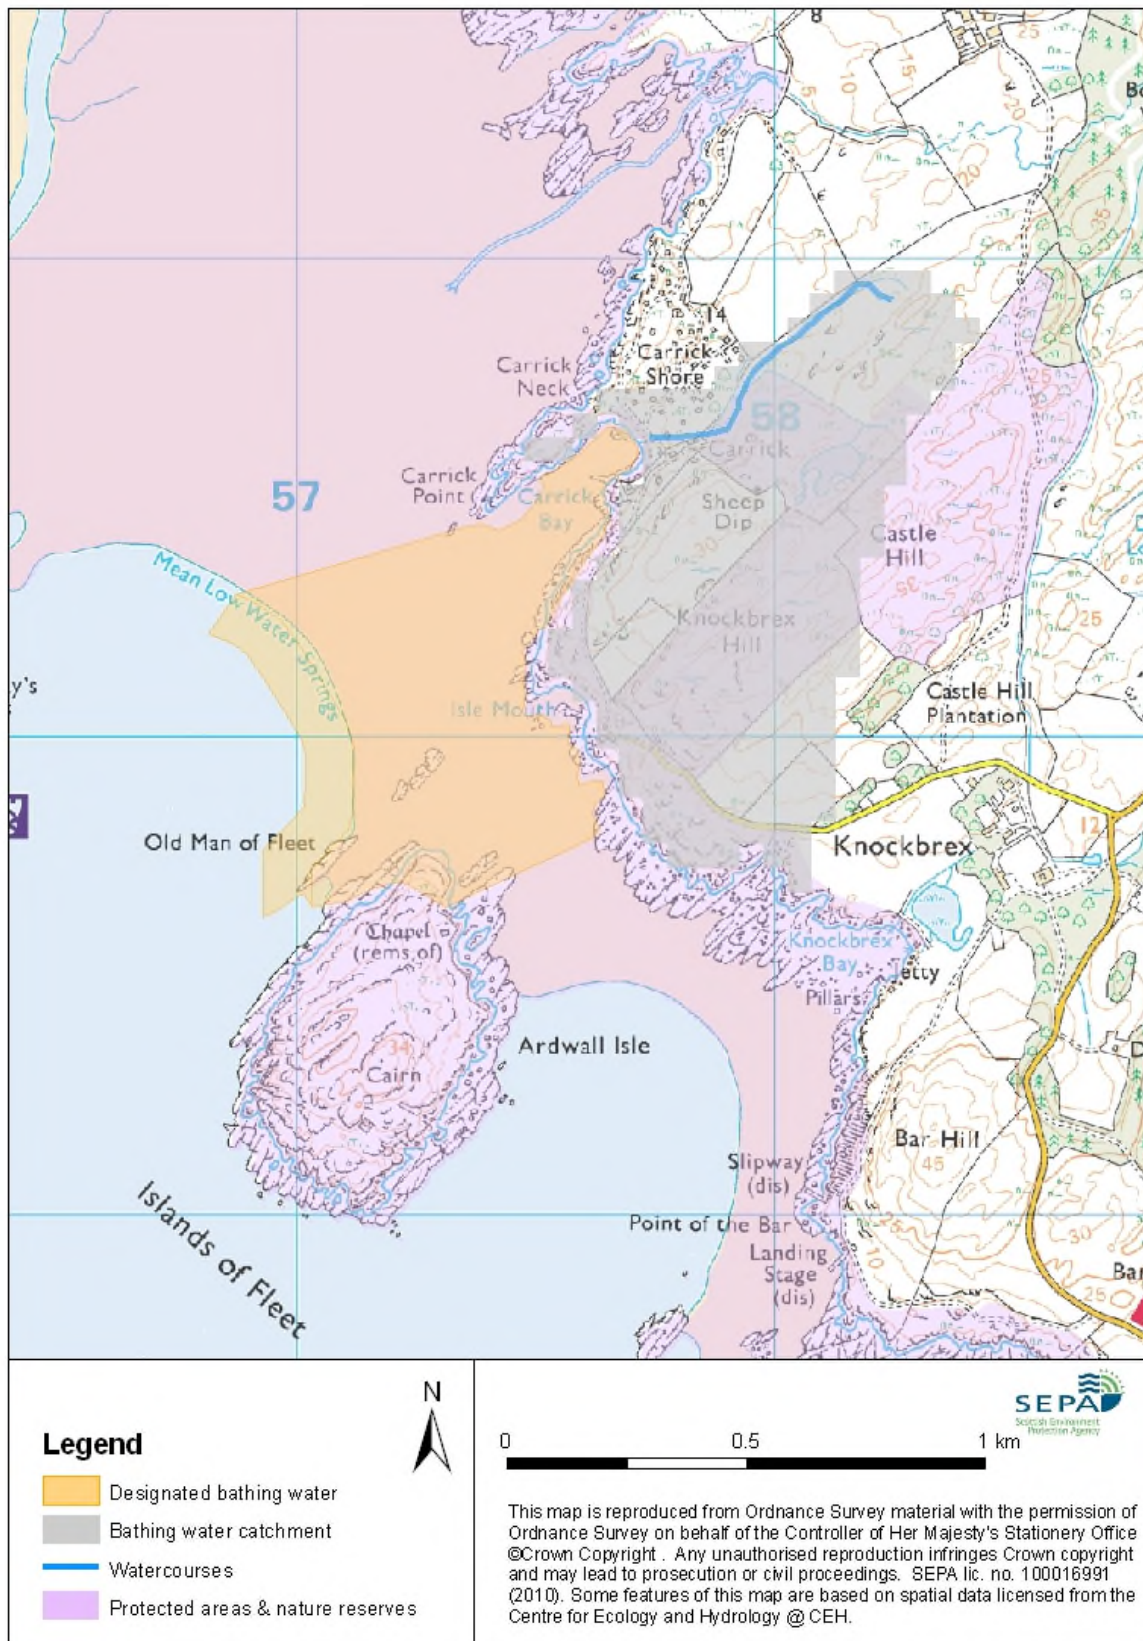
Map 2: Catchment draining into Carrick bathing water

The immediate catchment draining into the Carrick bathing water extends to only 600 m². The maximum elevation within the catchment is 35 metres at Castle Hill, which lies to the east of the bathing water.

There is only one small unnamed tributary within the bathing water catchment. This enters the bathing water at Carrick Bay.
