# Bathing Water Profile for Crail (Roome Bay)

Crail, Scotland

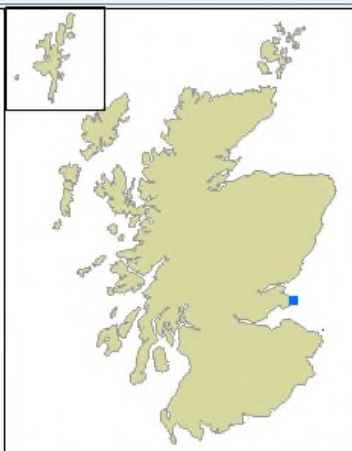
Map 2: Catchment draining into Crail (Roome Bay) bathing water

The catchment draining into the Crail (Roome Bay) bathing water extends to 5 km<sup>2</sup>. The area is predominantly rural (93%) with arable agriculture the major land use. The main population centre in the catchment is the town of Crail. Population density outside of the towns is generally low

The main water course within the bathing water catchment is the Crail Burn, also known as Den Burn. It flows into the bathing water at the western end of the bathing beach.
