Bathing water profile:

Fraserburgh (Tigerhill)

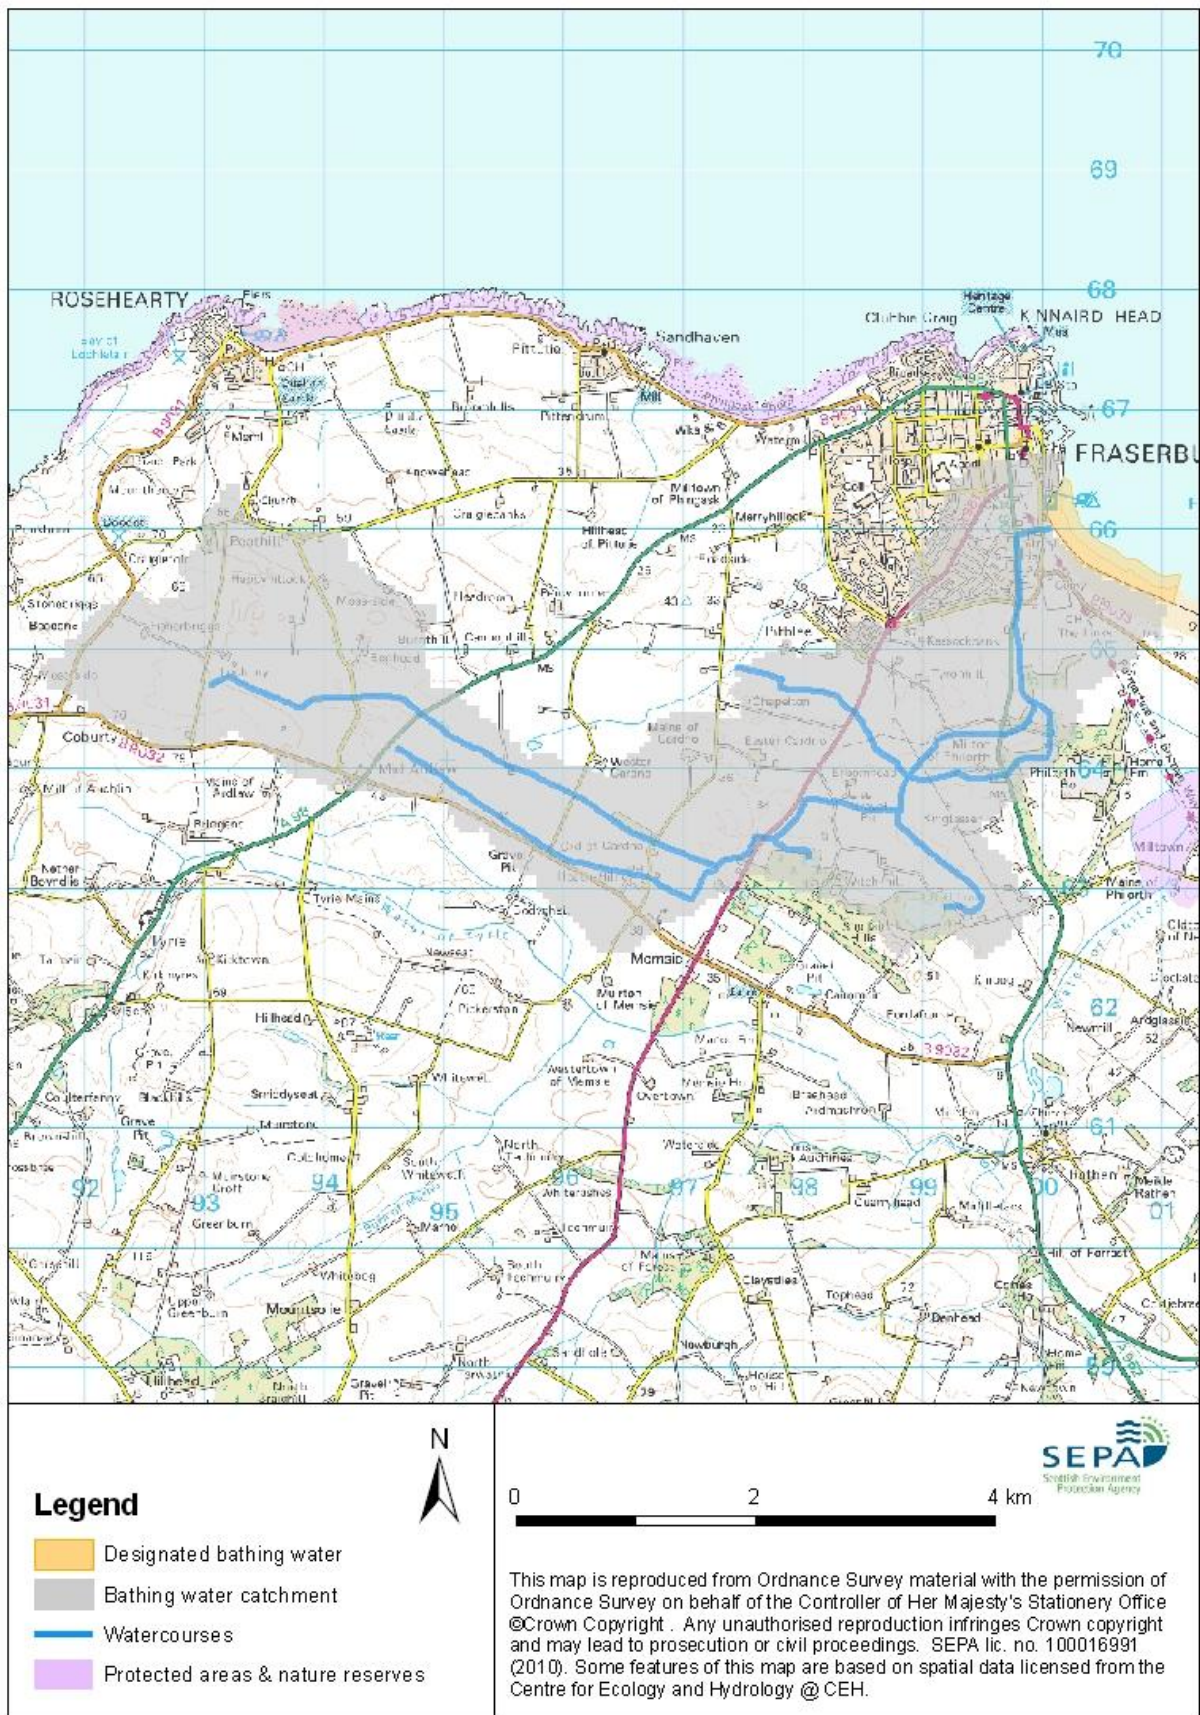
Map 2: Catchment draining into Fraserburgh (Tigerhill) bathing water

The catchment draining into the Fraserburgh (Tigerhill) bathing water extends to 16 km². The catchment varies in topography from gentle hills (max elevation 75 metres) in the west to the low-lying plains (average elevation 5 metres) along the coast. Average summer rainfall for the region is 267 mm compared to 331 mm across Scotland as a whole.

The main river within the bathing water catchment is the Kessock Burn which flows into the sea at the western end of the bay.

The catchment is predominantly rural (93%) with agriculture the major land use. The agricultural land is split between arable farming (60%) and grassland (26%). The area supports mixed farming. Approximately 6% of the bathing water catchment is urban. The main population centre is the town of Fraserburgh situated about 1km to the west of the bathing water. Population density outside of the town is generally low and is centred within a number of small villages (Map 2).
