Bathing Water Profile for Ganavan Bay

Ganavan, Scotland

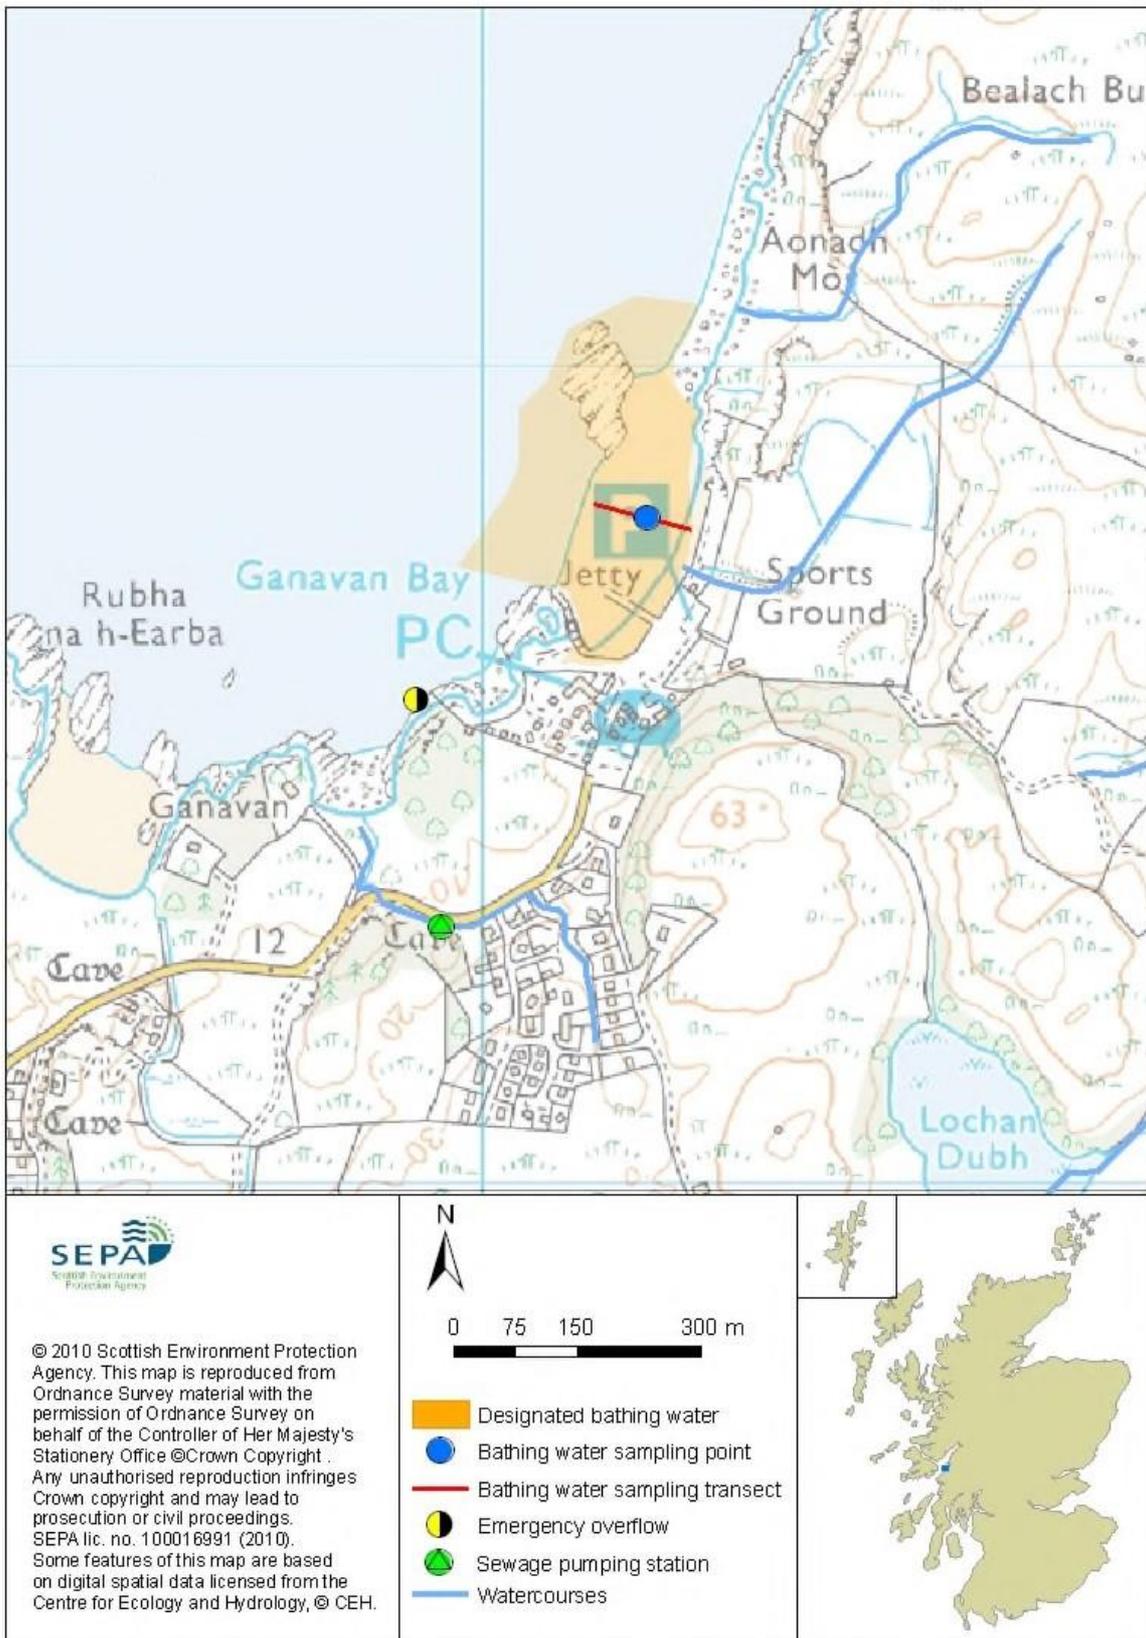
Map 1: Ganavan Bay bathing water

- Designated bathing water
- Bathing water sampling point
- Bathing water sampling transect
- Emergency overflow
- Sewage pumping station
- Watercourses

The principal risks and source of wet weather driven short term pollution at this bathing water arise from combined sewer overflows.

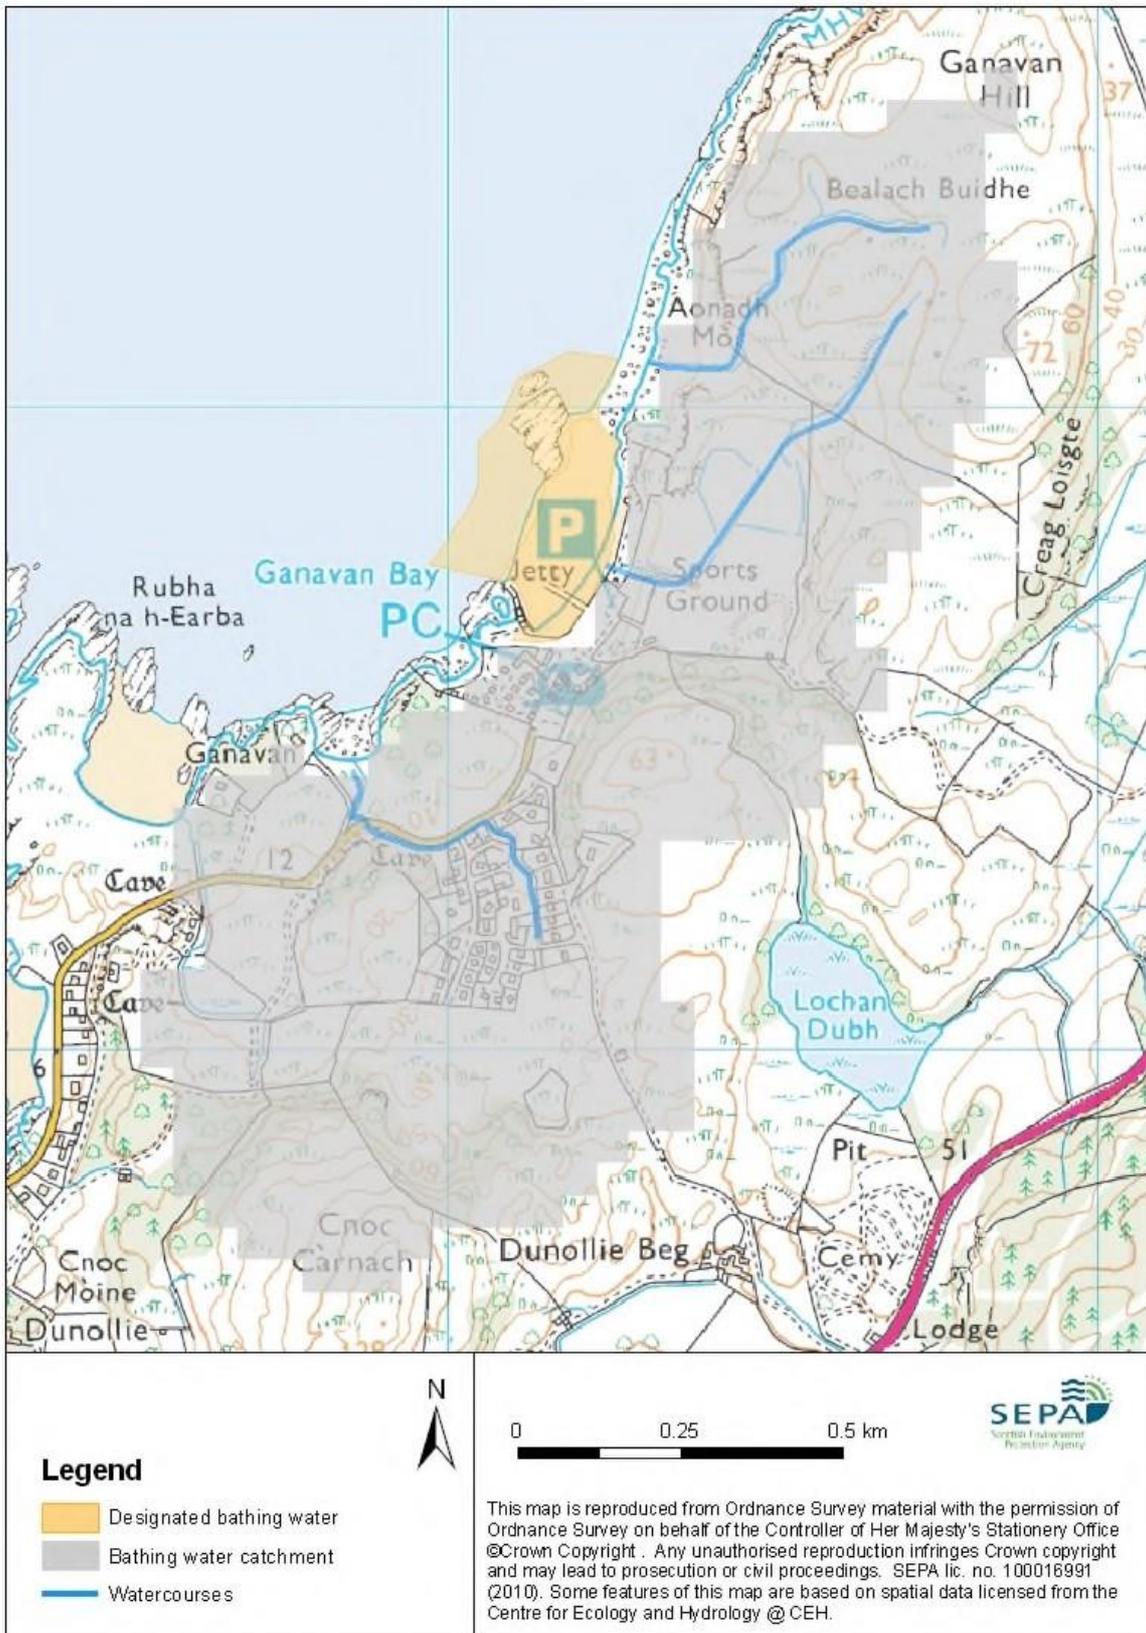
Map 2: Catchment draining into Ganavan Bay bathing water

The catchment draining into the Ganavan Bay bathing water extends to just over 1 km². It is a fairly low-lying catchment comprising of small hills. Cnoc Carnach, in the south of the catchment, is the highest point at approximately 130 metres. There are no major rivers within the bathing water catchment. However there are small streams discharging to the sea at the northern end and midpoint of the bathing water.

The area is predominantly rural (97%) with grassland the major land use. The upland areas support some sheep farming. The remaining 3% of the area is made up of rock and sediment. Population density within the catchment is generally low. South of the bathing water is an area of private housing. Oban town lies to the south of Ganavan Bay.
