# Bathing water profile:

## Lunderston Bay

<p><b>Bathing water:</b> Lunderston Bay</p>

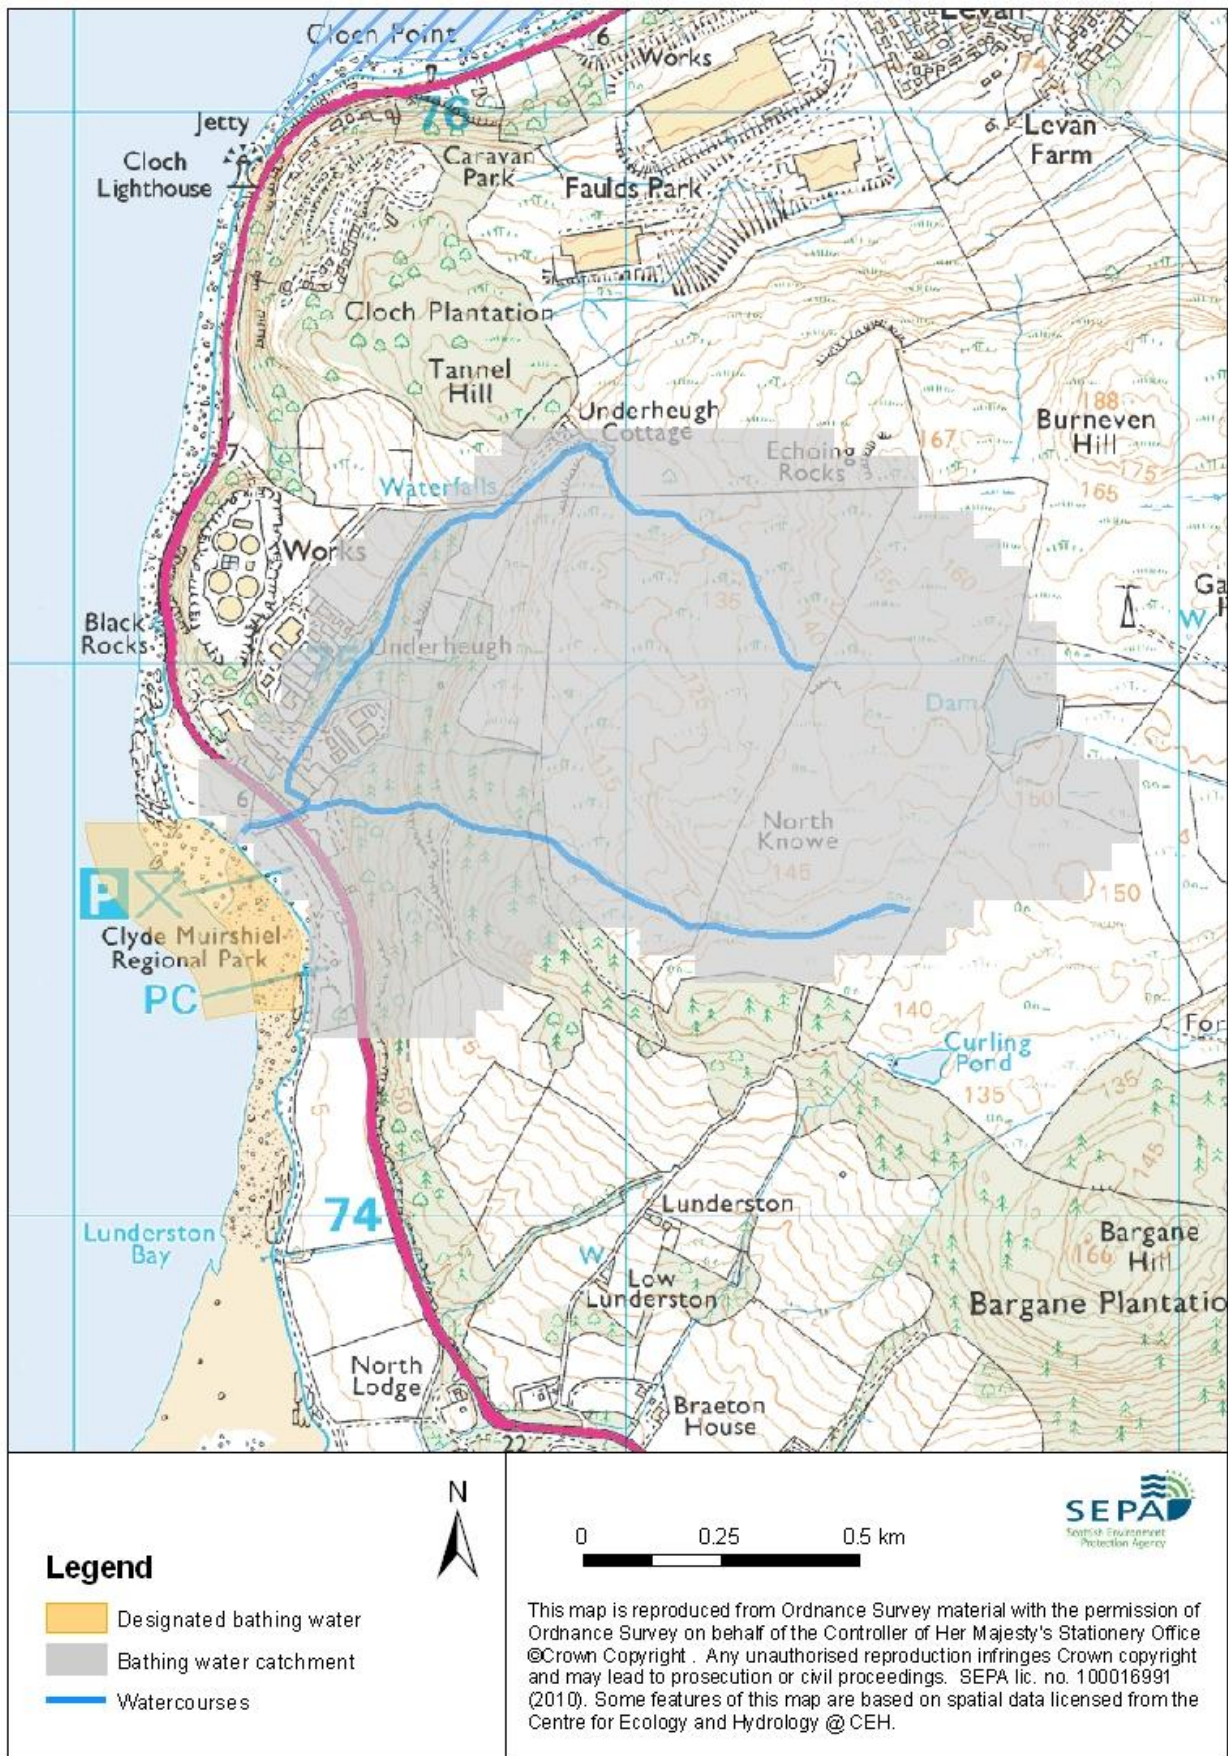
Map 2: Catchment draining into Lunderston Bay bathing water

The catchment draining into the Lunderston Bay bathing water extends to 1.3 km<sup>2</sup>. The area is fairly hilly and gently slopes towards the bathing water. Elevation ranges from 150 metres in the east to 5 metres along the coast.

The area is predominantly rural (98%) with grassland (38%), woodland (32%) and shrub heath (27%) being the major land uses. The upland areas support mixed sheep and beef farming whilst the lowlands are mainly used for recreation. Approximately 2% of the bathing water catchment is urban. Population density within the catchment is generally low (Map 2).
