Dalgety Bay Headland Investigation

Environmental Radioactivity Laboratory
School of Biological and Environmental Sciences
University of Stirling

Title: **Dalgety Bay Headland Investigation**

ERL No.: P083 0311

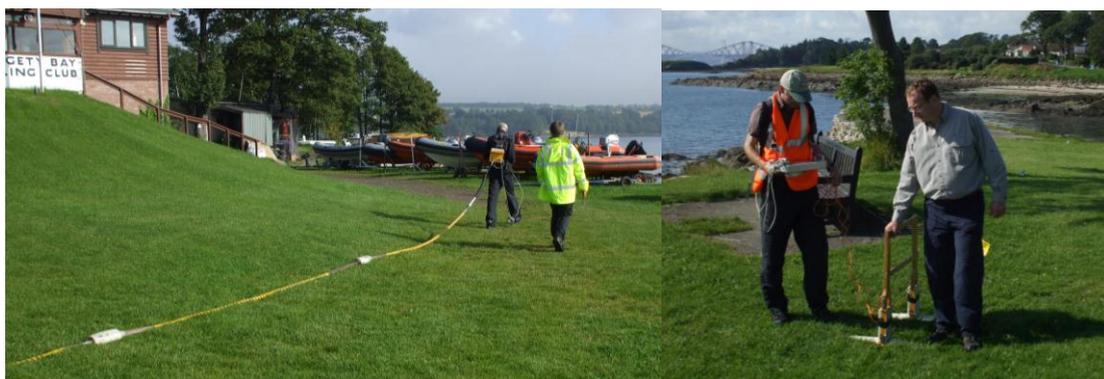
Figure 2. Deployment of GPR: 50MHz (image left) and 200 MHz (image right)

A Mala Geoscience GPR system was deployed. This system comprises a tablet-type computer viewer (XV11), connected to a backpack control unit (CU11), via parallel-port printer cable. All antennae used connect to the CU via fibre optic ports. Four antennae were deployed: unshielded 50MHz rough terrain, 100MHz and 200MHz unshielded, and 500MHz shielded. The thin (2-3m) nature of unconsolidated material on bedrock precluded use of the 50MHz unit, as it did not achieve successful penetration. Thus the majority of transects (9 lines) were shot using 100 and 200 MHz antennae. Figure 2 illustrates the deployment of the instrumentation. Appendix A provides some background information to GPR survey work.

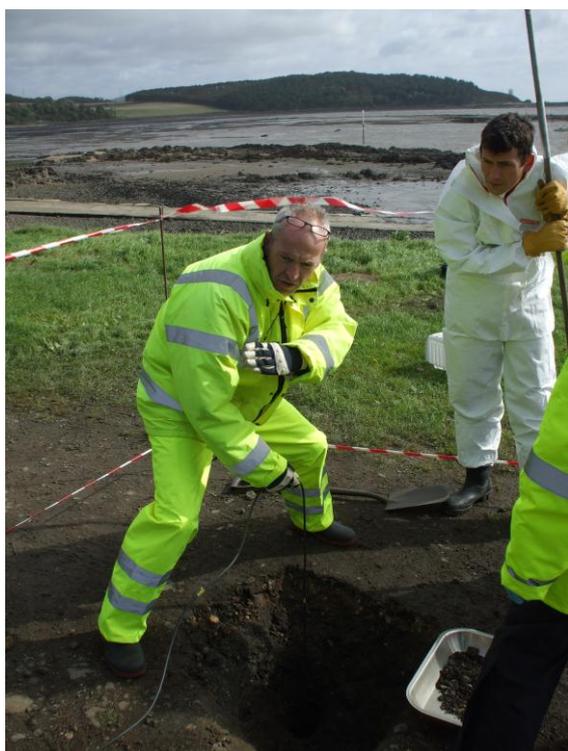
Figure 3. Magnetometer deployment

Prior to the commencement of any excavation or coring work, the site and coring location was surveyed with a 48mm diameter magnetometer, which was also deployed down a auger hole with a nominal 60 mm diameter. The magnetometer was deployed by an RPS Explosives Safety Engineer who surveyed the site for the presence of ferro-metallic objects. Once the engineer was satisfied that the site was clear of anomalies, the excavation of coring commenced. The engineer surveyed the excavation or auger holes every 30 cm or so, and the instrument was able to provide a 1m “look ahead” capability. The engineer also inspected the material being investigated for evidence of ferro-metallic material or objects. Anomalies were frequently encountered and progress on a number of sites was only achieved with the help of the engineer (Figure 3).

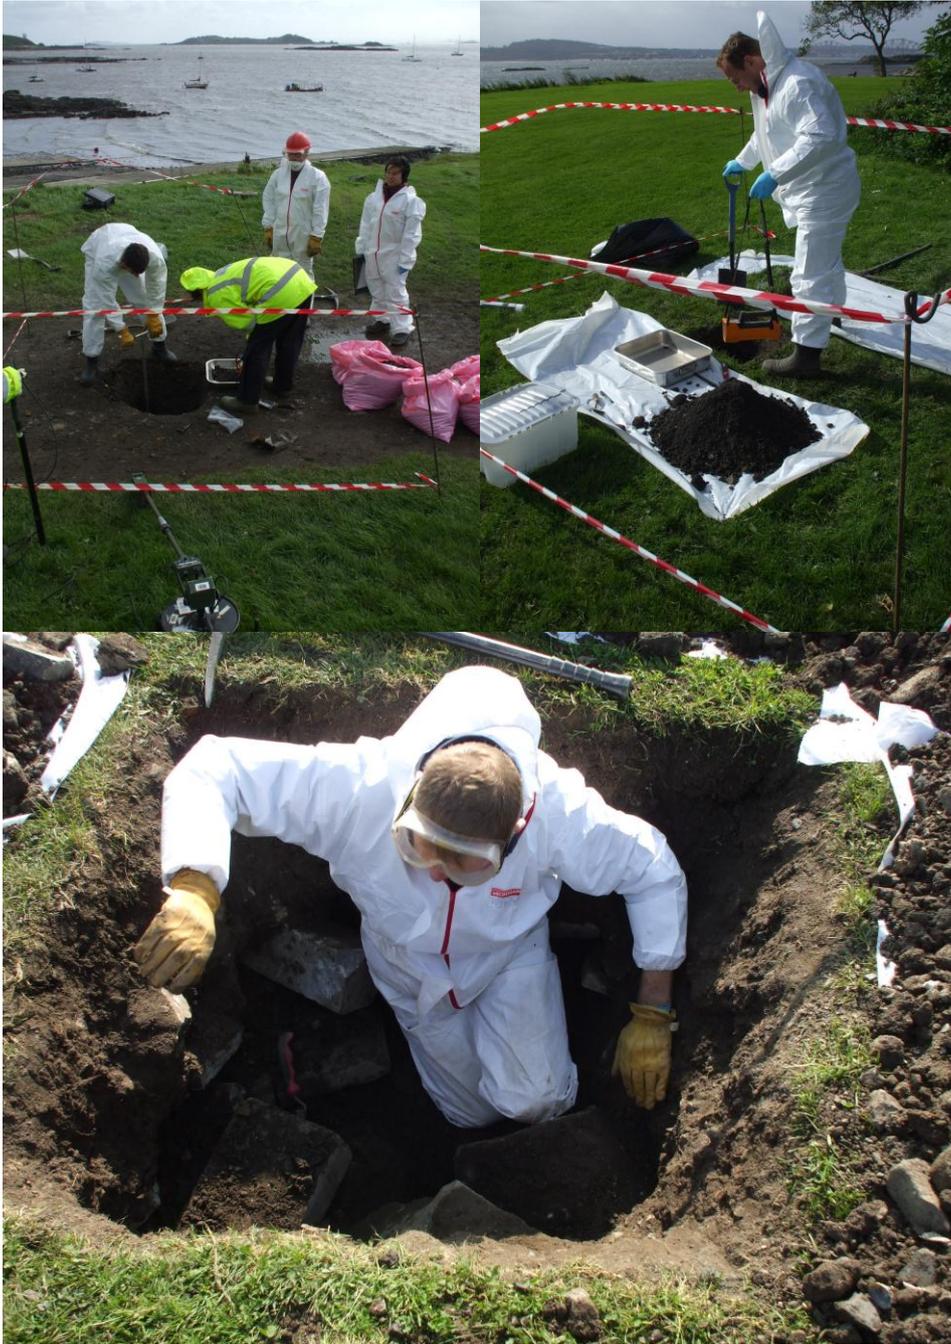
Figure 4. Site Excavation: Combined, digging and auguring (image top left); surface excavation (image top right); buried slabs of concrete (lower image).

To minimise site disturbance, the preferred method of excavation was by auguring holes of 70 mm diameter into the site. However, at about 150 mm into the soil cover, a number of locations have been armoured by clay/rock hard-core and or slabs of concrete (Figure 4). Where auguring was not possible, excavation was achieved by a combination of digging and use of pickaxes. All soil and waste from auguring and digging was monitored using the RT30 portable gamma detector, bagged or piled onto plastic sheets to protect the surface of the site (Figure 4). The excavated surface was also routinely monitored following every few centimeters of excavation to identify areas or points of contamination and establish whether the count rate was increasing with increasing penetration into the site.

Where surface radioactive contamination was detected, turf was lifted and checked for contamination. The excavation proceeded carefully until any contaminated particles or artefacts were removed (Figure 4).

Areas 11, 16 and 17, within the eastern corner of the made ground, were particularly difficult to excavate due to the presence of rock armour and broken concrete slabs (Figure 4). It was noted (and photographed) that there were substantial pore spaces

Site excavated by hand, towards the south eastern corner of the headland. Excavation was hindered by concrete slabs (Figure 4) at 80 cm. No significant ^{226}Ra contamination was detected, but an aircraft dial (no ^{226}Ra activity detected) was recovered from this site.

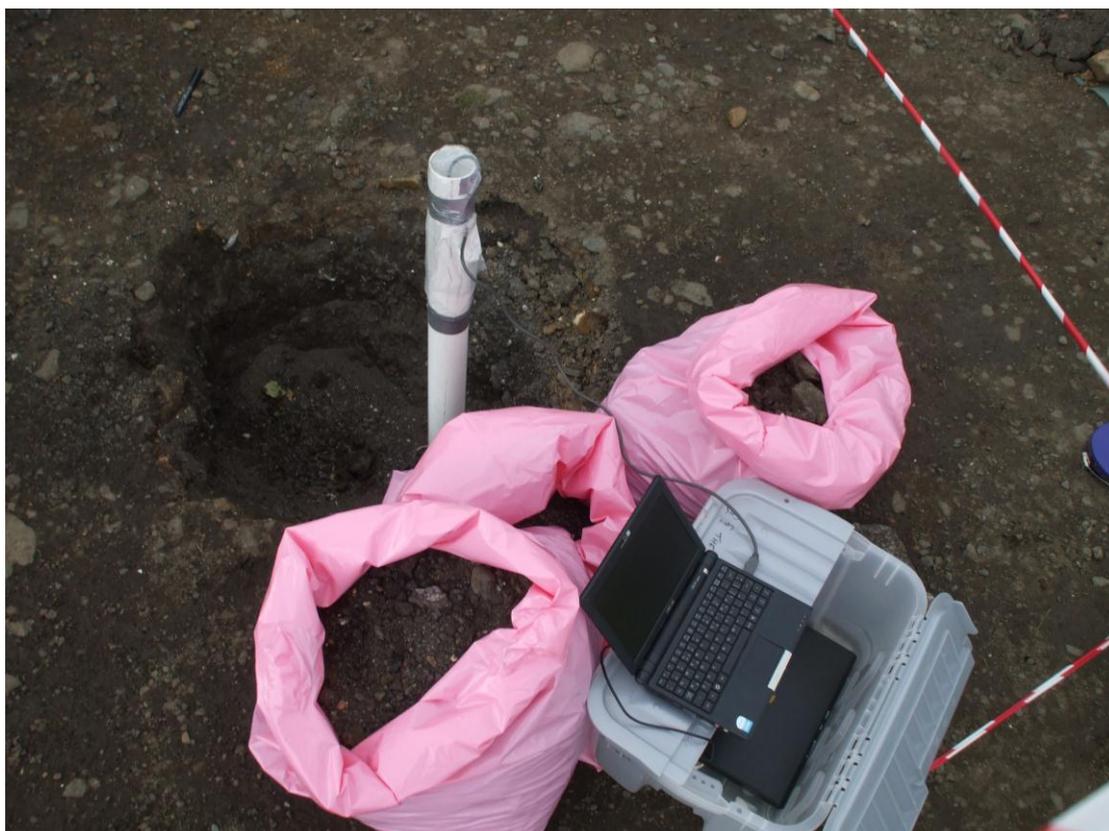
Figure 8. Deployment of the 50 mm x 50 mm NaI(Tl) detector at 1.5 m depth.

The NaI(Tl) detector was deployed to the required depth by pushing the detector into the augured hole (Figure 8). The detector was pushed in at intervals (100-200 mm) and spectra were acquired over a 600 s live time, or less when counting uncertainties of less than 5% were more quickly achieved.

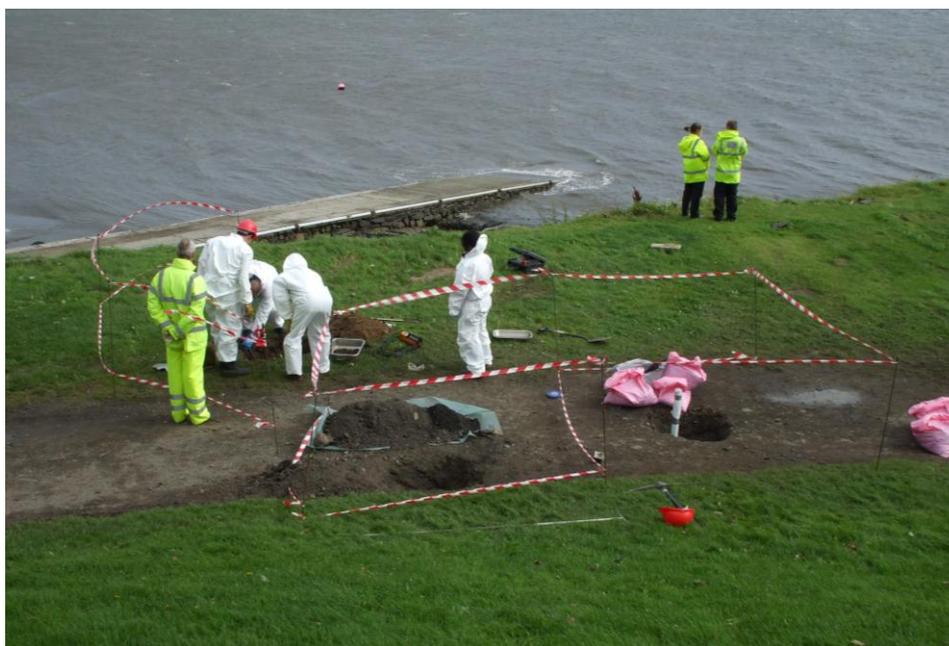
Figure C1. Showing the excavation at sites 5 to 7

RT 30 count rates from the surface ranged from 580 to 720 cps from 20-55 cm depth – indicating a relatively uniform distribution of elevated ^{226}Ra activity with depth. Results from 100-200 cm depth with the 50 mm x 50 mm NaI(Tl) detector provide some indication of a point source, commensurate with a particle of activity around 20 kBq at 120 cm. Overall activity levels within the contaminated layer ranged up to 150 Bq kg⁻¹ for ^{226}Ra , but may also be associated with particles of ^{226}Ra activity of a few kBqs.

RT 30 count rates at the surface ranged from 630 to 740 cps from 30-60 cm depth indicating a relatively uniform distribution of elevated ^{226}Ra activity at depth. From 60 cm downwards the results indicate the presence of two point sources, one at 100 cm and one at 140 cm depth. Again the activity is likely to be of the order of 20-30 kBq. Overall activity levels within the contaminated later ranged up to 200 Bq kg⁻¹ for ^{226}Ra .

Following excavation to about 50 cm, an augured hole was provided deeper penetration into the contaminated layer. Whilst there was no strong evidence for point sources at this site, ^{226}Ra activity concentrations measured up to 300 Bq kg⁻¹. However, this could also represent multiple small sources of a few kBqs.
