# Defence Infrastructure Organisation

## Dalgety Bay

Coastal Processes Review

March 2013

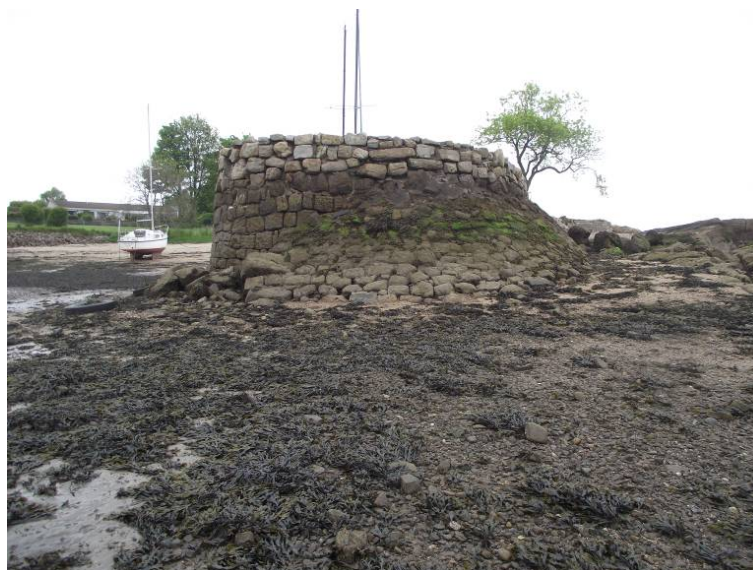
**Figure 1** New Harbour Quay (Chainage 0m)

The study area commences at the extremity of the SW facing stone quay or breakwater that protects a small sandy bay with well graded shell particles giving a white appearance to the beach, visible to the north/ left in Fig.1. The quay is approximately 30m long and up to 5m tall, built using roughly dressed boulders typically of 0.5m diameter. There is little evidence of mortar between boulders, with gaps typically 0.5m deep suggesting the quay could be vulnerable to further storm damage.

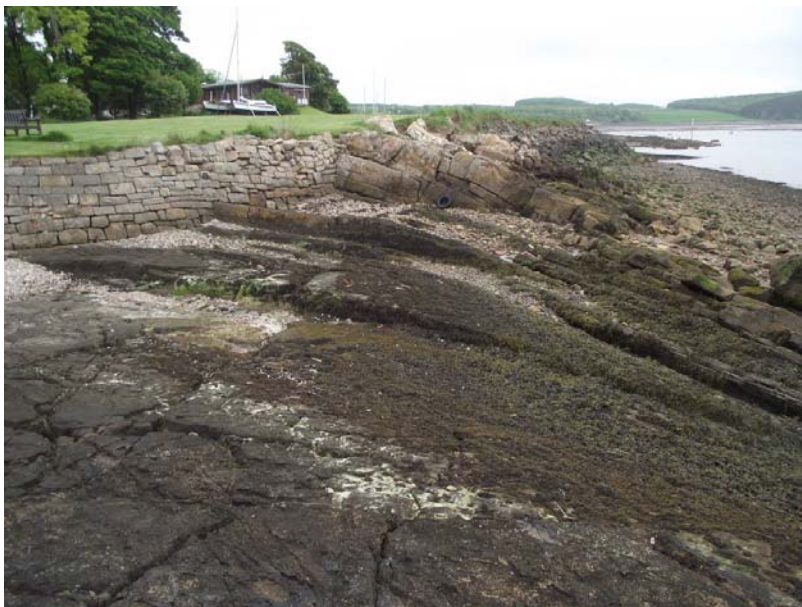
**Figure 2 Rock foreshore & Raised Beach (chainage 40 to 50m)**

The quay is founded on a large outcrop of bedrock folded into an anticline with a NE-SW axis, roughly parallel with the coast for Chainages 0-70m, visible to the right in Fig.1. This outcrop occupies the full foreshore down to MLWS mudflats for Chainages 0-50m, trapping a small raised beach against a modest block wall visible on Fig.2 at Chainage 60m before disappearing below the beach beyond Chainage 70m.

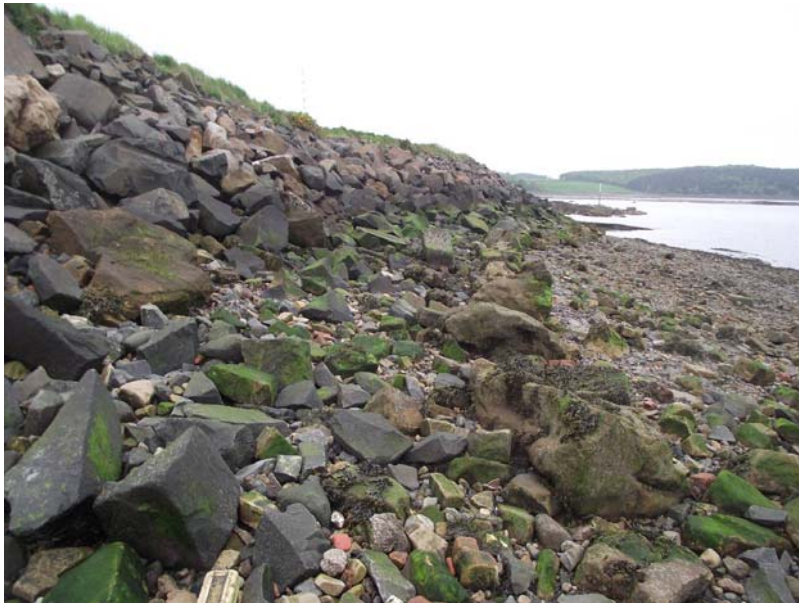
**Figure 3** Armour stone to Promontory 1 (Chainage 70-140m)

This area of open grassland, which is termed the ‘Headland’ in accompanying AMEC reports, is significantly higher than the surrounding coastline and extends further onto the intertidal foreshore. The reclaimed nature of this land is confirmed by the Fife SMP (ref.1) detailed maps, showing the seaward corner furthest from the previous coast forming Promontory 1 at Chainage 140m. The two faces of this promontory are protected with armour stone of various sizes and gradings, forming slopes varying from 1:1 to 1:2. Along the SE facing edge (Chainage 70 to 140 m), an armour stone revetment of up to 5m high has been formed with up to 1m boulders at MHWS level, reducing to smaller boulders near the crest and at the foot of the structure. There is no apparent geotextile nor toe detail and minimal evidence of a separate filter stone layer. Localised erosion is visible near the crest, notably at Chainage 140m (visible in Fig.5), but the stone generally appears to be tipped randomly rather than placed, with a significant variation in stone sizing.

The foreshore seaward of the armour stone comprises a steep (approximately 1 in 10) beach full of debris which appears to have been partially eroded from the armour stone; the evidence for which consists typically of 50-200mm size bricks/cobbles down to the mudflats just visible at MLWS, as shown on Fig.3. Such erosion could be linked to localised slumping of the armour stone, that would explain the variations in armour stone gradient observed.

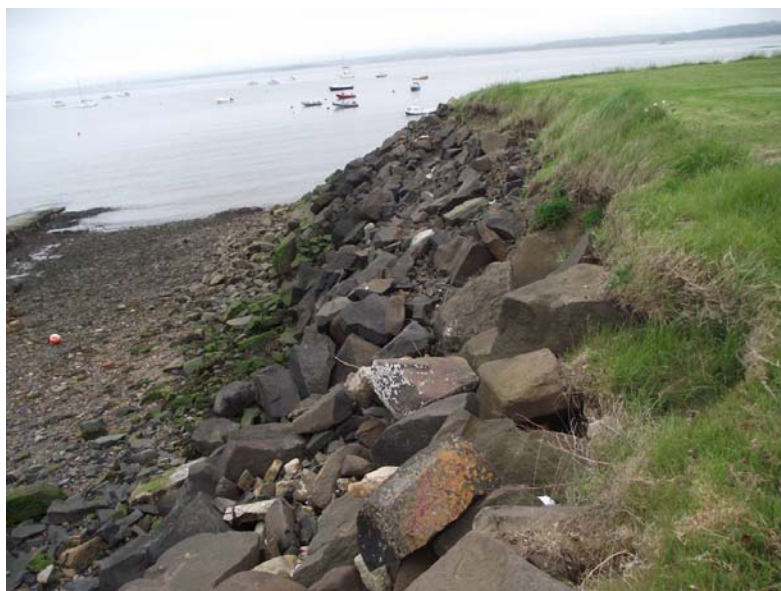
**Figure 4** NE Face of Promontory 1 (Chainage 60-80m)

The return face of Promontory 1 (Chainage 140 to 200m) is of similar armour stone construction, but facing ENE approximately parallel with the DBSC jetty, as shown in Fig.4. It is consequently comparatively sheltered and shows a more uniform 1:1.6 gradient, and less crest erosion, but still plenty of typically 50-200mm size bricks/cobbles on the beach along the toe, suggesting reduced wave erosion is also occurring here.

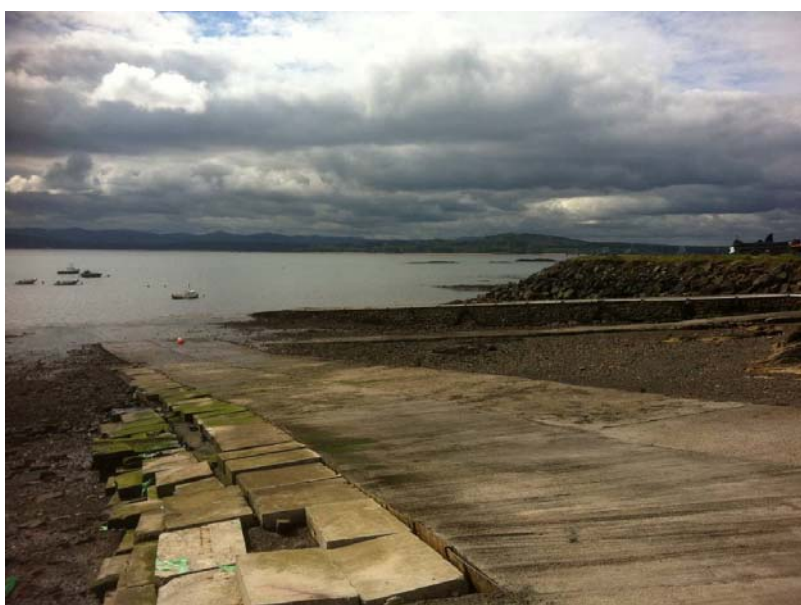
**Figure 6 East Slipway showing precast block protection to east face (Chainage 280m)**

- **East Slipway**– this is an approximately 10m wide 60m long slipway extending to MLWS, built with in-situ concrete slabs laid directly onto the beach with a central joint at beach level, although the eastern slabs appear to have been added later as a widening scheme. Although the slabs are at beach level to the west, the slab is protected along the east edge by more recently stacked precast blocks and posts, where the beach level is approached 1m below the slipway level. This again suggests the slipway acts as a groyne, trapping NE littoral drift along this coast. The different beach levels each side of the jetty are visible in Figs 6 & 7 and Drg. No. 23218-rr415 – 04. Records summarised in the AMEC Phase One Land Quality Assessment Conceptual Model Report indicate that the west half of this slipway is visible in the 1973 aerial photograph although the subsequent widening date is unclear.

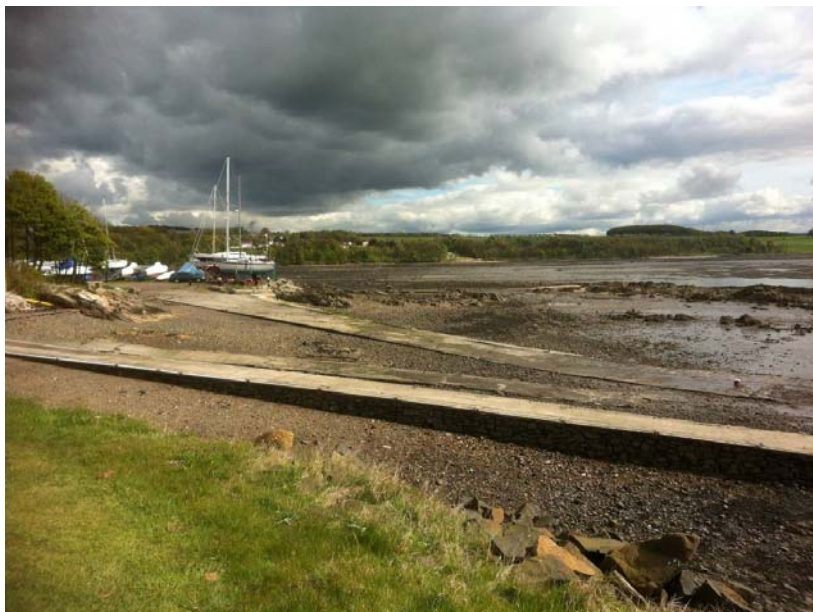
**Figure 7** Showing Slipways and Promontory 2 (Chainage 300m) from Promontory 1 (Chainage 170m)

This promontory is built on a substantial bedrock outcrop that extends up to 50 m out into the bay, exhibiting N-S strata, and causing a local raising of beach levels. The boat storage area is protected by armour stone, placed variably on damaged filter cloth/no filter stone, topped up with ad-hoc precast blocks/smaller stone.

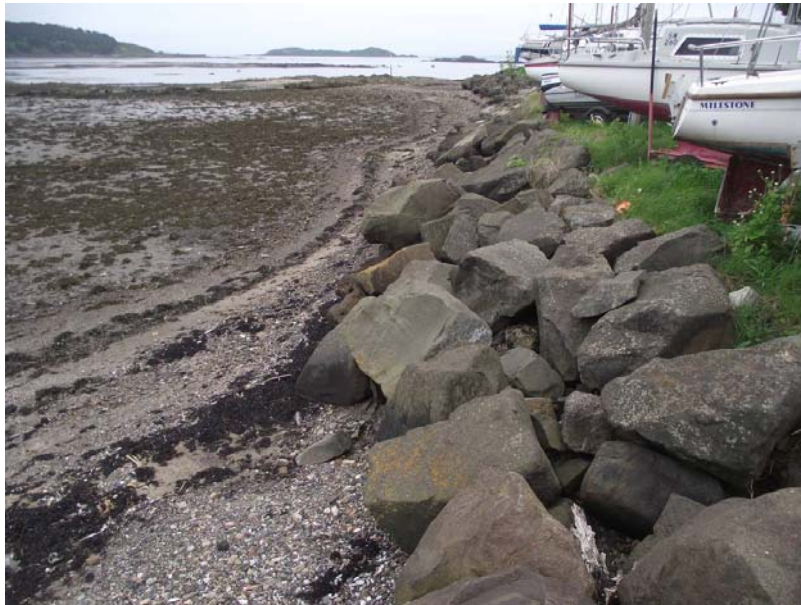
**Figure 8 Boatyard Bay South (Chainage 320-400m)**

This section of the boat storage area is slightly higher and more exposed than further north, comprising a double layer of approximately 1m rock armour boulders on damaged filter cloth with no evidence of filter stone, bedding or toe details. There is evidence of localised wave erosion behind some boulders and ad-hoc filling/repairs with smaller stone. The typical beach profile is shown in Section 9 on Drg.No. 23218-rr415 – 04. Records summarised in the AMEC Phase One Land Quality Assessment Conceptual Model Report indicate the armour stone construction along the coastline has been added as repeated, minor extensions from the 1970s to the present day.

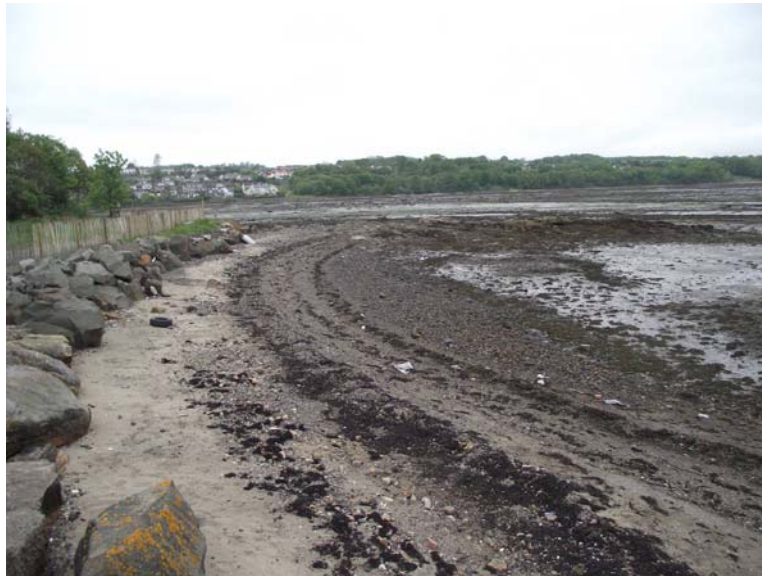
**Figure 9** Boatyard Bay North – showing strandlines and tide lag

This bay extends in a single 140m long curve from Promontory 2 to Promontory 3, backed by the DBSC boat storage area which is protected by continuous rock armour. However the north half is slightly lower lying (hence its inclusion in the SEPA flood maps (ref.2) ), requiring a single layer of approximately 1m rock armour boulder as a sea wall, but built on inadequate filter cloth, again with no apparent filter stone or toe detail. At Chainage 400m, there is a 100mm diameter flapped outfall pipe at the foot of armour that was not flowing on either visit, but is assumed to provide land drainage of some form from the low lying boat park behind. Again there is evidence of localised wave erosion behind some boulders and ad-hoc repairs using waste building materials.

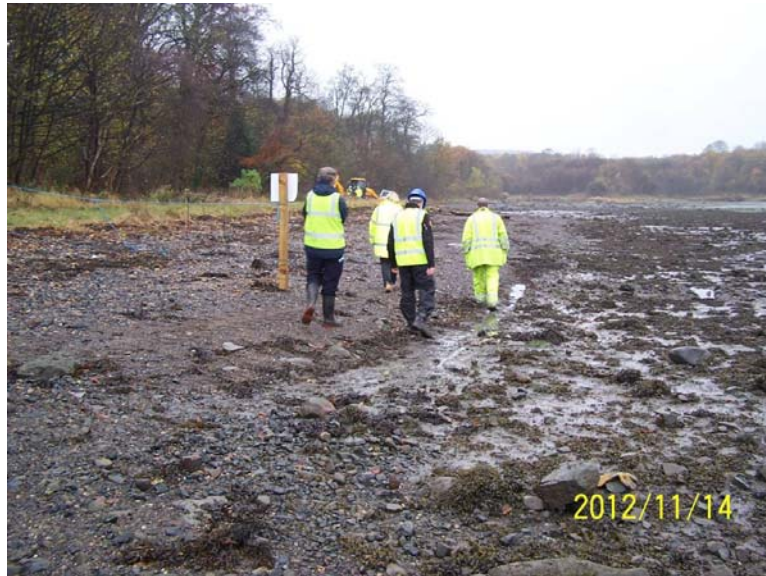
**Figure 10** Ross Plantation (Chainage 520m) – showing mature trees/ raised beach

This length of beach appears the most stable, comprising an approximately 5m wide shingle strip along the strand lines merging into the mud flats, with minimal evidence of erosion where the head of the shingle beach turns to grassland, footpath and the mature Ross Plantation. Ross Plantation features tall deciduous trees. The trees reach heights exceeding 10m within short distances of the beach, suggesting permeable soil allowing root development to significant depths.

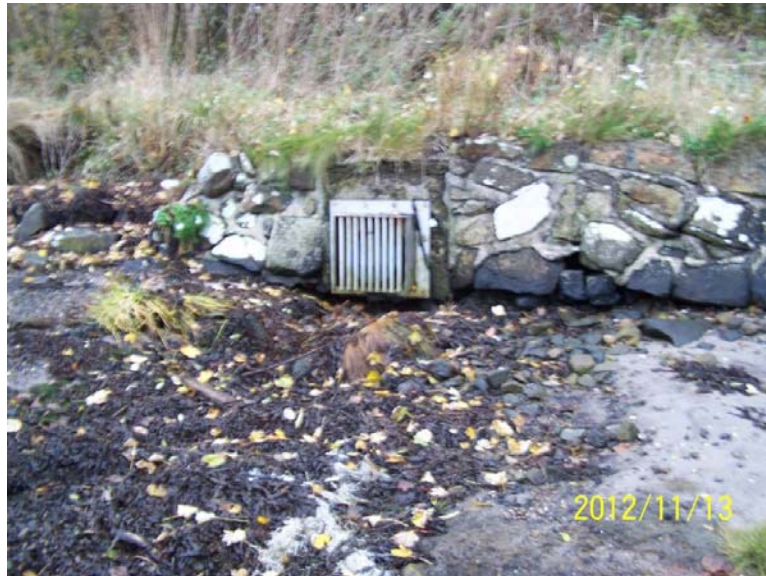
**Figure 11 Spinneys SPS Emergency Outfall (Chainage 740m) – showing scour under wall**

This section comprises an approximately 30 m long concrete/coarsely dressed boulder constructed sea wall up to 1.5m high in poor condition, with undermining near 250mm diameter flapped emergency overflow from Spinneys sewage pumping station (SPS) which is located approximately 30m inland. The wall has collapsed and shows localised wave erosion at two separate locations. These and the leaking flap valve are a possible source of erosion and leaching onto the foreshore of deposited Made Ground materials from landward area.

A buried outfall is indicated on the Admiralty Chart (and reproduced on Drg No. 23218-rr415 – 06) running from this wall to the navigation post shown on Fig.16, which marks the end of this and a longer outfall from the north coast of Dalgety Bay. No further utility searches have been made, but it is assumed both outfalls are storm outfalls from Scottish Water SPSs, that are normally required by SEPA to reach MLWS or beyond. The backfilled trench construction that would have been used for both outfall pipes is routed away from the rock outcrops, and through an obvious gap in the Promontory 3 outcrop for the Spinneys SPS storm outfall, as shown on Drg. No. 23218-rr415 – 01.

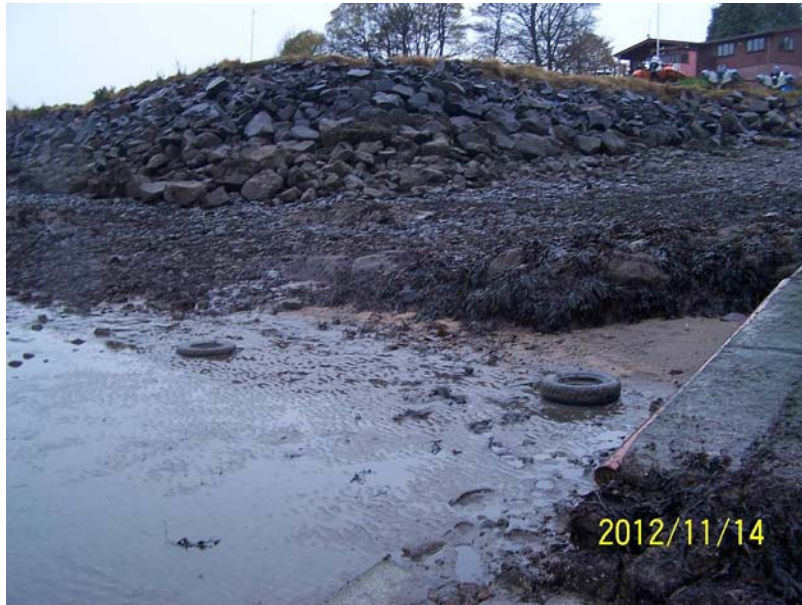
**Figure 12 Coarse Sand Beach formed updrift of Jetty off Promontory 1 (Chainage 170m)**

The only variation from this pattern is the c.10m long coarse sandy beach trapped between the jetty and bedrock outcrop just above the mudflats at MLWS, as shown on Fig.12.

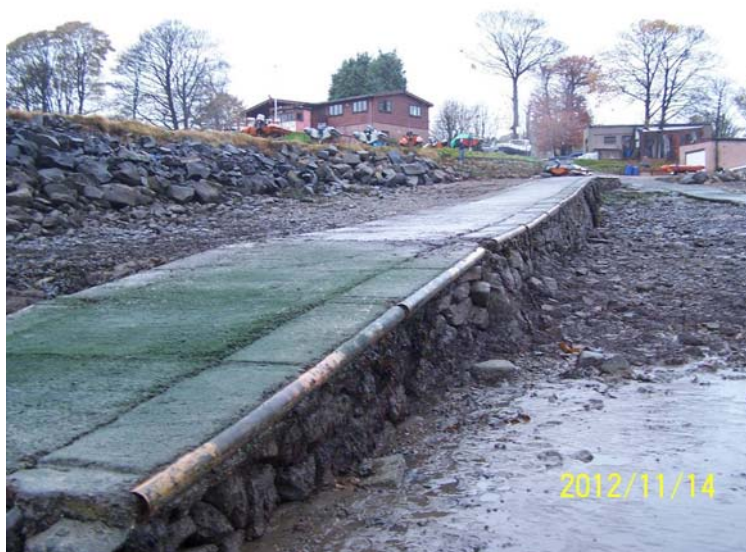
**Figure 13** Groyne Effect of Jetty on beach levels

The beach comprises gravel/shingle, cobbles and a few boulders but no sand, merging into mudflats at the foot of the slipways as seen in Figs 6 & 7. The comparative lack of boulders compared with the beach SW of the slipway further points to this groyne effect, suggesting the jetty forms a terminal barrier to larger sediment movement as well as throttling the finer material.

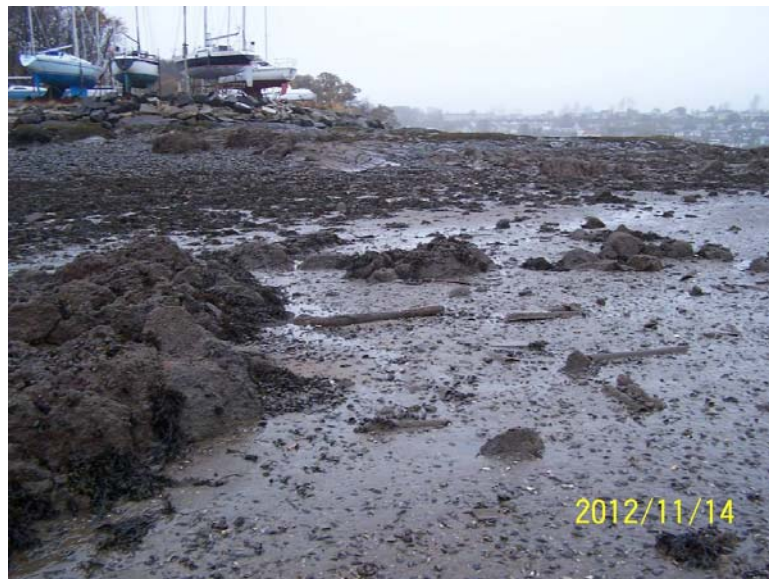
**Figure 14 Roofing Debris**

- Roofing Debris – this silty beach area just west of the east slipway (as shown in Fig.14) was strewn with corrugated roofing panel debris, typically 100 to 800mm long and of a type that is often found to contain asbestos. The unusual concentration of this material here suggests a batch of this material being eroded or tipped and being sorted into groups of broadly similar aspect ratios that react similarly to storm wave movement at high tide.

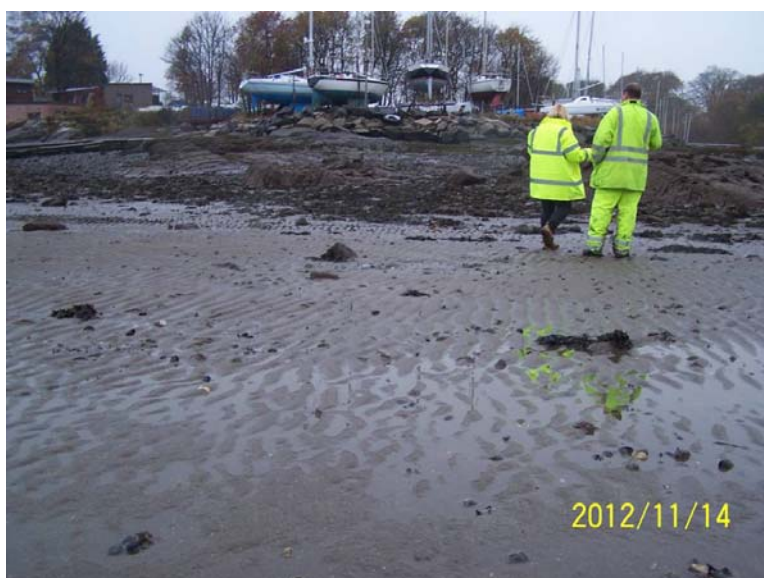
**Figure 15 Silt Ripples between Rock Outcrops**

- Beach Ripples – the surface of the silty channel between rock outcrops was marked by ripples typically 25mm high by 200mm long, aligned across the channel in a ENE/WSW direction, suggesting predominant wave action from the SSE direction immediately preceding the site visit. These ripples only form as the tide ebbs away, and the rock outcrops dominate wave directions more than at high tide, but it still gives an indication of prevailing wave activity, which aligns with the high tide wave crests shown on Fig.15.

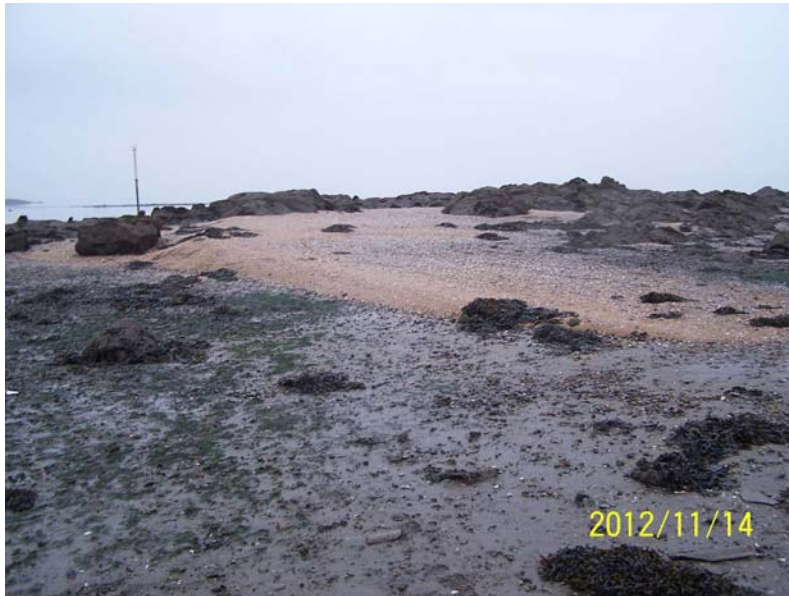
**Figure 17 Coarse Sandbank & Leaning Marker Post**

- Leaning navigation marker post – there is a tubular steel marker post bolted to an insitu concrete base slab to mark the end of the surface water outfall just off the main rock outcrop, as shown on Drg. No. 23218-rr415 – 01. Normally this would have no significance, but it is clear from comparing Figs 16 & 17 that the post has a pronounced lean of 2-3° in a NE direction. The age of this post is unknown, but this lean is very likely to be the result of fatigue loading caused by years of prevailing wave loadings that will obviously be greatest during high tides. The direction of this lean is therefore a stronger pointer to large wave /deep water conditions than the sandbanks and silt ripples, that are generally formed at lower ebbing tide levels.

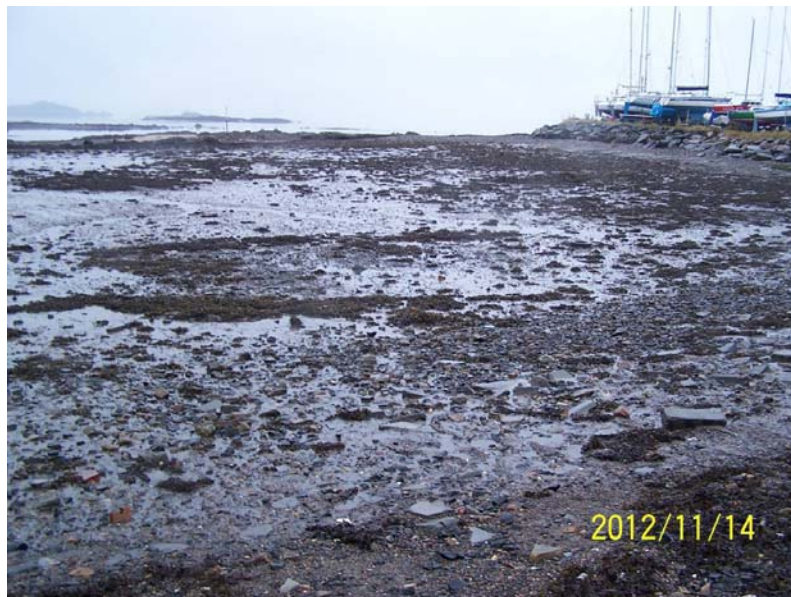
**Figure 18 Debris & Tide Lag in Boatyard Bay**

There is a coarse shingle/gravel upper beach that merges into silty seaweed strewn mudflats also at higher levels than south of Promontory 2. Both the beach and the mud flats are strewn with occasional boulders, cobbles, bricks etc that appear to have been eroded from the sea wall or carried around Promontory 2 from the deeper water. A discrete area was observed containing significant fragments of pottery as shown on Drg No. 23218-rr415 – 01, that as with the roofing material, suggests a discrete batch of this material being eroded or tipped in the past and being sorted into groups of broadly similar density and aspect ratios and thus mobility for any given storm waves.

Groundwater was noted to be weeping out of the beach just below the shingle, suggesting a considerable volume of granular material that fills and empties with saline groundwater on each tide. This phenomena, known as tide lag, was less obvious near the slipways where the sandstone cliff suggests a relatively small “reservoir” of granular material to fill and empty. However the very recent trial pitting on the foreshore had disturbed the beach material, which was clearly still settling back to equilibrium conditions during the November 2012 site visit, and could distort this observation.

Tide lag is not considered a serious potential mechanism for contaminated material to reach the foreshore from reclaimed land behind the armour stone, because the flows would never reach adequate velocities to mobilise significant size particles.

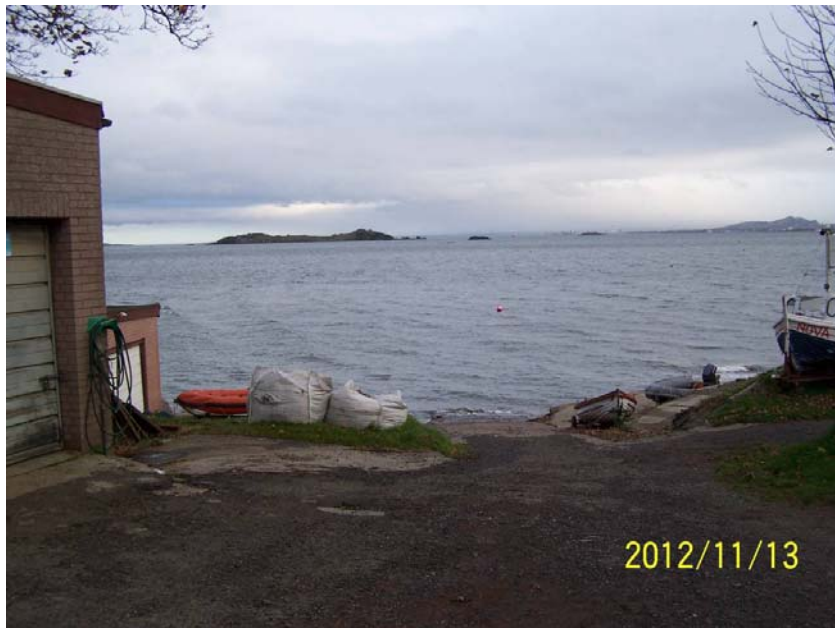
**Figure 19 Jetty high tide - Showing Prevailing S waves shoaling behind Inchcolm**

There is a national Meteorological Office wind recording station at Turnhouse (Edinburgh Airport) approximately 10km south of Dalgety Bay, and approximately 20m above sea level, that could provide more detailed suitably local wind rose data if required, but for the purposes of this report, typical wind speeds up to this value can be anticipated particularly in the prevailing SSW to WSW sector.
