# River Black Devon Hydromorphic Character and Restoration Opportunities

FINAL

June 2012

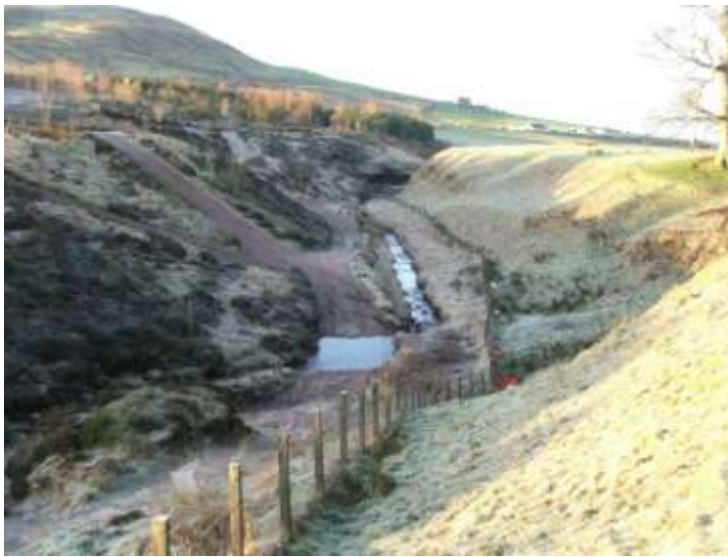
**Figure 1-2: Black Devon near Outh Bridge showing acid grassland (right) and heather/acid grassland mosaic (left) where ungrazed. Photograph also shows vehicle tracks through the river**

The river here is incised within a steep-sided valley that becomes deeper and incised the further downstream you go. The sides of the valley are composed of unimproved grassland towards Outh Bridge but as you move towards West Lethans the sides become steeper, grazing becomes more problematical and many more trees begin to make an appearance on the steeper, rockier valley sides. Here downy birch *Betula pubescens* is the most common species although rowan *Sorbus aucuparia* is also common along with the occasional alder *Alnus glutinosa*. A key feature of the upper Black Devon is the presence of the Knockhill Motor Racing Circuit. This unusual land use for the area has increased the heterogeneity of the land cover in the vicinity of the river and the motor-related activities have impacted on the Black Devon itself, where an off-road vehicle training course crosses and follows the river in a number of locations (see Figure 1-2).

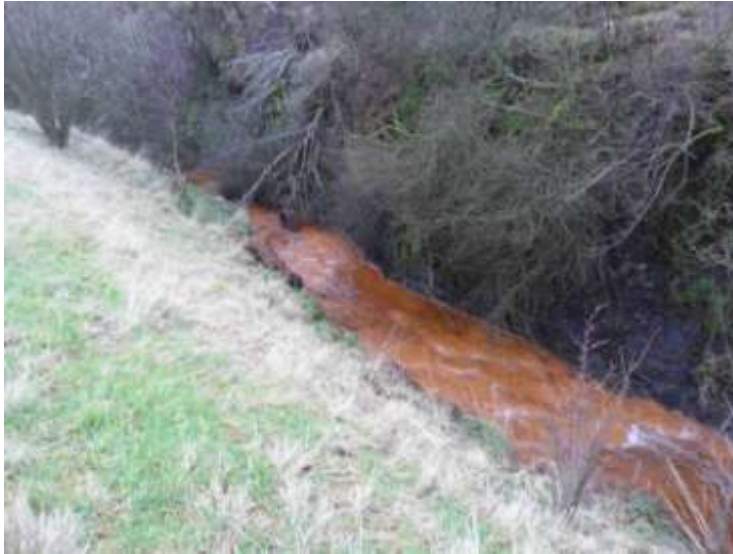
Figure 1-3: Iron Ochre Deposits

The river to the west of Knock Hill is significantly stained by Iron Ochre deposits (Figure 1-3), which is normally associated with acid mine water discharge. The exact source is unknown although there are disused mines within this area and it would be advisable to contact the Coal Authority to determine whether this area is on their priority list. The Iron Ochre is coating the bed material for a significant length of the watercourse. Passive treatment would be advised as close to the source as possible. Once in the watercourse the diffuse pollution could also be treated by planting appropriate wetlands and encouraging flows out across the floodplain through the wetland.

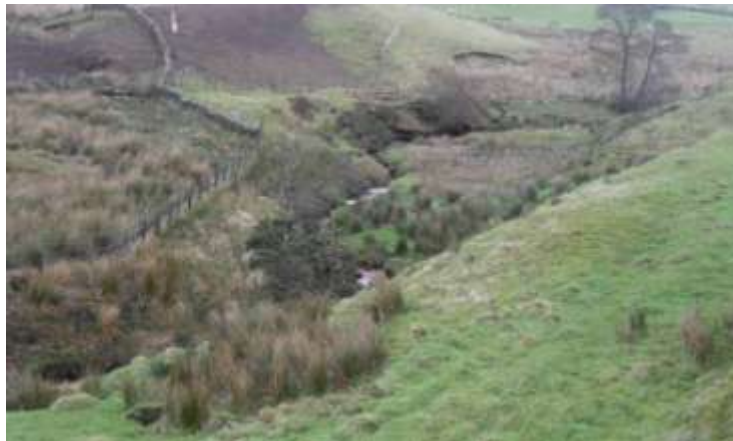
Figure 1-4: Valley and river character upstream of West Lethans

Upstream of West Lethans the reach is not confined and the wooded valley gives way to a more open setting (Figure 1-4). Extensive berm features extend across the valley floor (Figure 1-4). The Knockhill motor racing circuit at the head of the valley is impacting on the river but its effect on sediment delivery is minimal compared with natural sediment sources.

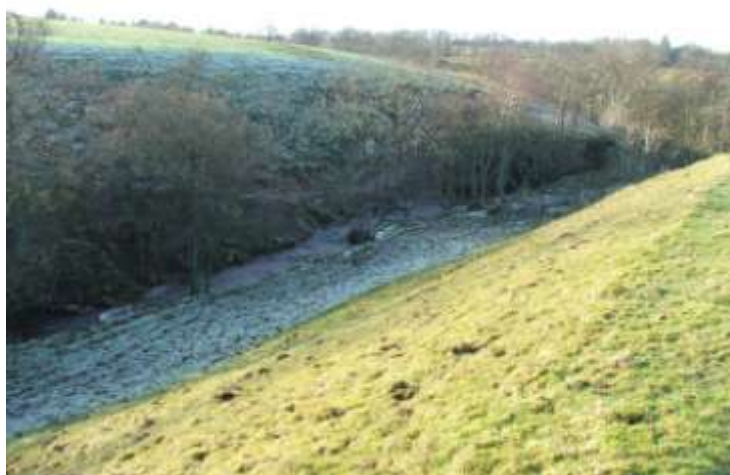
contrast to the improved pastures on the South side (see Figure 1-5), which have benefitted from agricultural improvement and extensive field drainage works.

**Figure 1-5: Unimproved Acid Grassland (foreground) just upstream of Threepsikes with improved grassland on the opposite bank. The photograph also shows the increasingly wooded nature of the river valley as it approached Threepsikes**

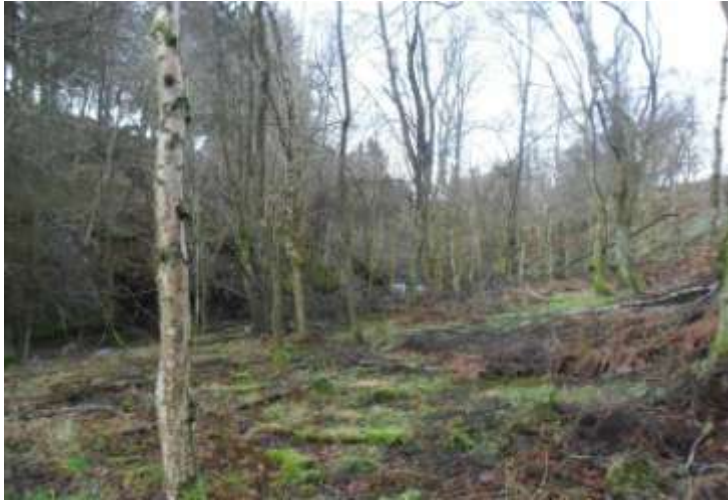
Figure 1-7: Valley side deposits in the confined river valley

The river becomes strongly confined upstream of Threepsikes and displays a consistent in-channel pool-rapid morphology with rapids composed of bedrock or boulder/cobble step features. Incision has generated a number of waterfalls (Figure 1-6). Woody debris is common and traps some mixed sediment to increase hydromorphic diversity. Limited lateral deposits exist along portions of the valley side (Figure 1-7). Valley side sediment supply is strong through this reach including supply from steep bedrock dominated tributaries.

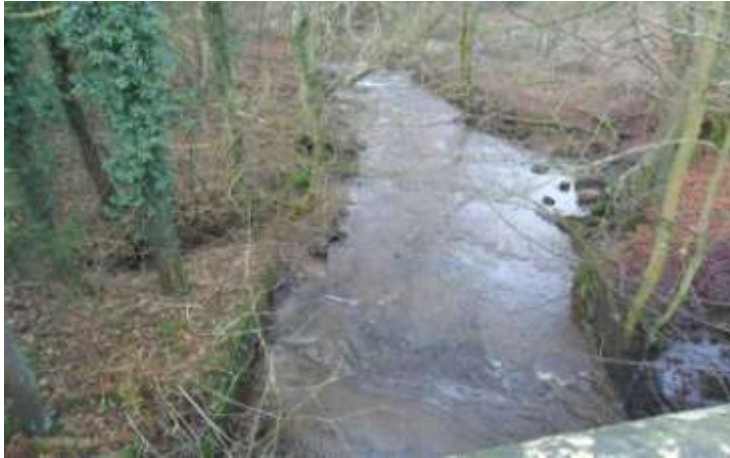
**Figure 1-8: Bedrock cascade at Balgonar**

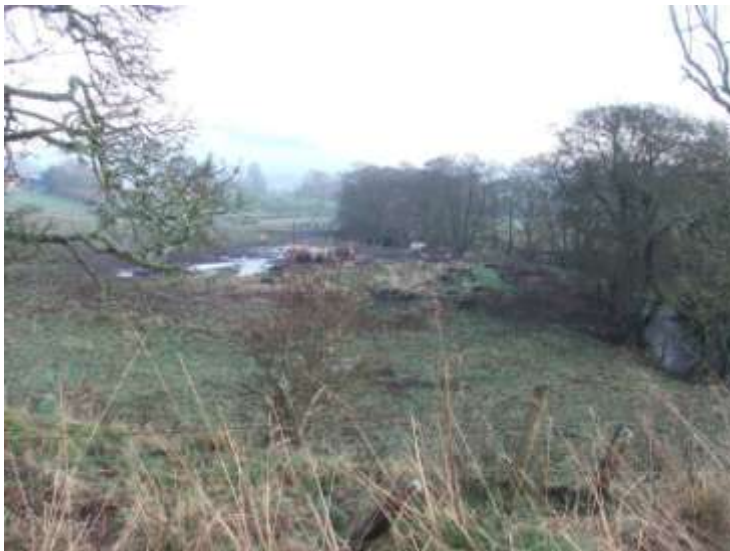
Here the floodplain is broad and wide with only gently sloping valley sides set well back from the river. Once again the land use type is pastoral with herds of suckler cows making an appearance. In places these are left out all winter and fed in-field on silage. This has led to some localised poaching of some of the grasslands near the river channel (see Figure 1-9).

**Figure 1-9: Localised Poaching of Semi-natural Grassland adjacent to the River Channel by Supplementary feeding of Out wintered Cattle**

Further downstream near Devonside, cattle are outwintered on an area of unimproved grassland that is suffering from extreme poaching (Figure 1-9 above) and it is obvious that this has been going on for some time. The proximity of this activity to the watercourse must be having a deleterious effect and the scraping-away of the mounds of uneaten silage and dung into ridges around the feeding site is not best practice and neither is the tipping of rotten baled-silage on nearby unimproved grasslands, although this is at a safe distance from the river.

The extreme poaching observed near Devonside should cease and the stock should be fed on hard-standing areas a good distance from any watercourse.

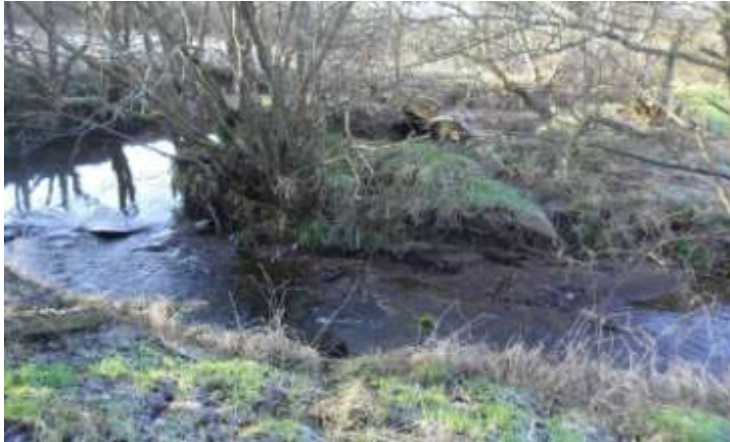
After coming out of the confined section the river continues as an active sinuous single thread channel with well developed pool-riffle-point bar system (Figure 1-10). Channel movement is strong locally and is creating a very diverse in-channel hydromorphology. Floodplain areas are farmed reducing the resistance of the banks to erosion.

**Figure 1-10: The active sinuous single thread channel at Devonside**

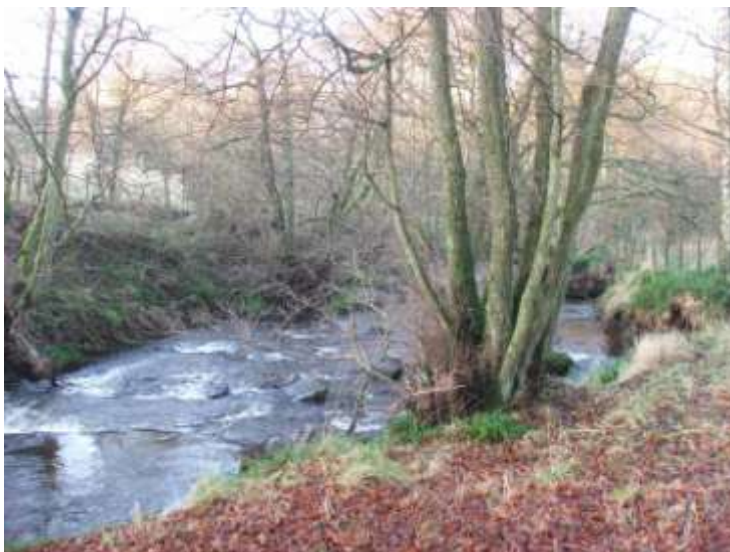
Downstream of this constriction the land once again opens out as the river turns Northwest. The flat nature of the land here has allowed the development of meanders which have been colonised by alders and willows along the river sides and, within the loops, small areas of unimproved grassland remain (see Figure 1-11). On the land either side, the gentle slopes have permitted the development of arable production. This is mixed in with improved grassland, grazed by sheep.

**Figure 1-11: Scattered Alder Stools alongside the Black Devon near Langfaulds**

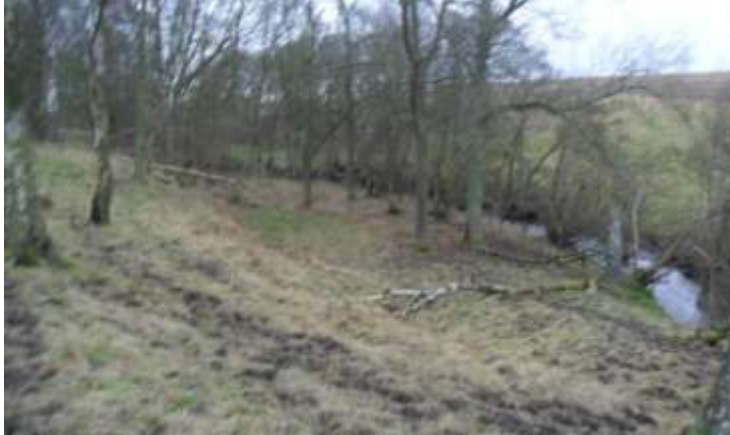
The river here becomes variably confined with extensive bedrock exposures in the bed and banks creating rapid areas. The channel remains locally sinuous and a number of well developed bar features exist where confinement is reduced (Figure 1-12). An old

**Figure 1-12: Well developed bar features in the confined valley upstream of the B913**

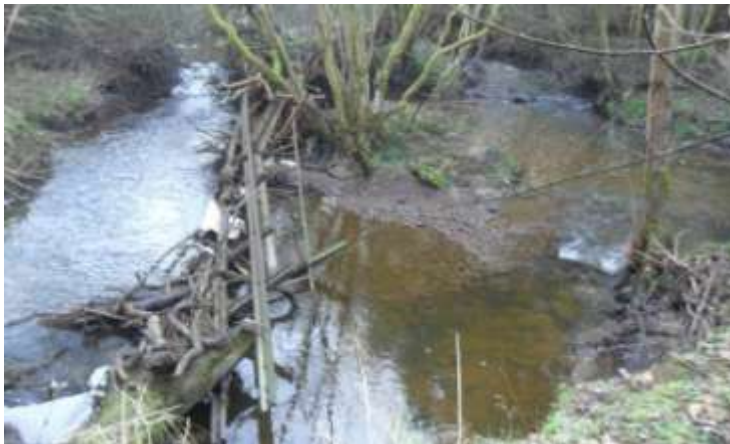
crossing/small weir has created a wider anastomosed reach (Figure 1-13). Woody debris is common throughout the reach.

**Figure 1-13: Anastomosed channel developing around redundant structure**

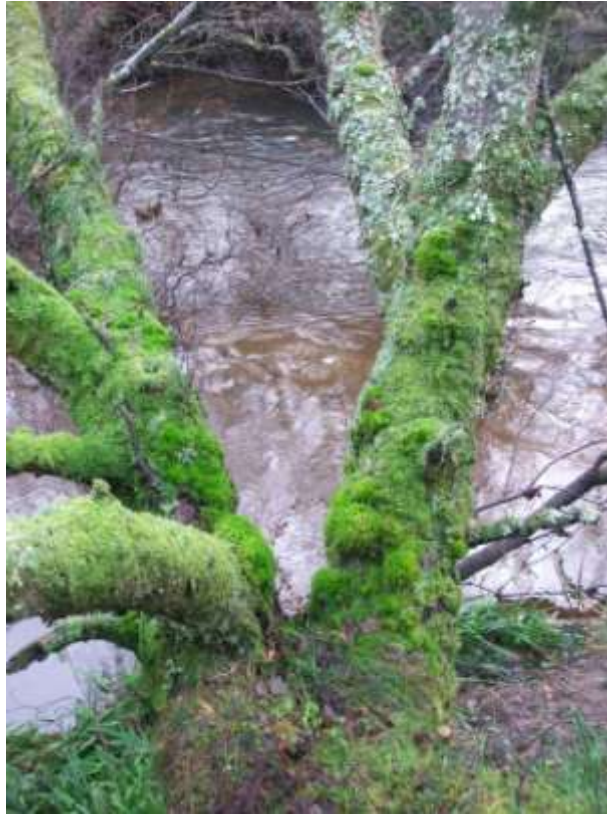
This is a large area of woodland that has been planted on the hillsides as the river once again cuts through an outcrop of harder rock, which is exposed in the bed of the river and in places as the river cuts into the banks. The steep valley sides are clothed in great woodrush and silver birch *Betula pendula* is much the commonest tree here, especially on the steepest slopes where some scree is in evidence. Other species that have clearly been planted include sycamore, beech and ash. At the bottom of the steep sides there is a small area of floodplain some 20m to 30m wide through which the river flows, mostly as a single thread but occasionally with islands and bars in the channel. This part of the woodland is dominated by alder and is wet with a good growth of bryophytes (see Figure 1-14) as well as tufted hair-grass and other wet-loving species, such as soft rush *Juncus effusus*.

Figure 1-14: Riverside Alder Showing Luxuriant Growth of Bryophytes

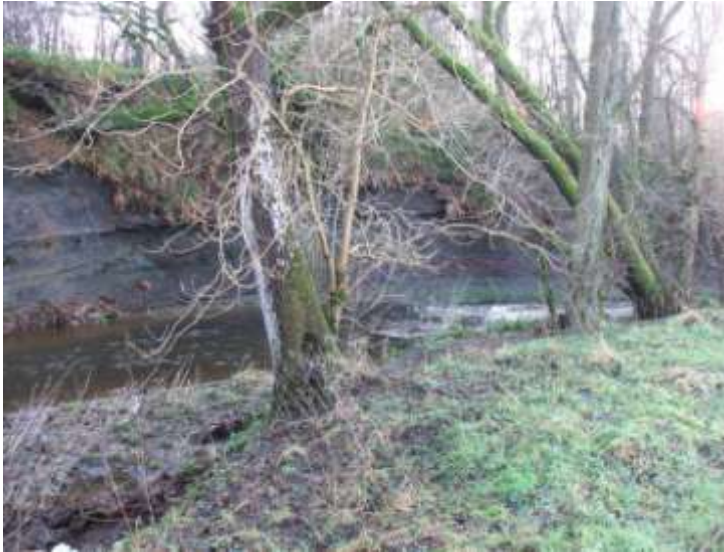
**Figure 1-15: Bedrock Exposed by Erosion Just Upstream of Black Devon Bridge**

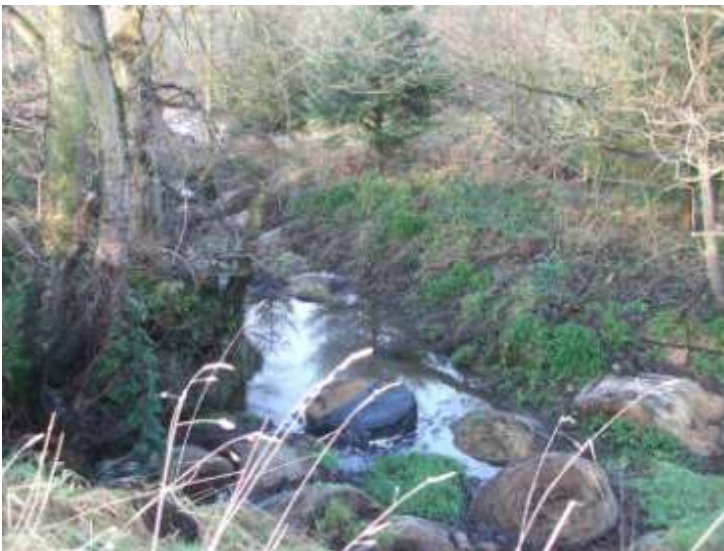
**Figure 1-16: Illegal Dumping in Incised Cut-off Meander - River Black Devon in Background**

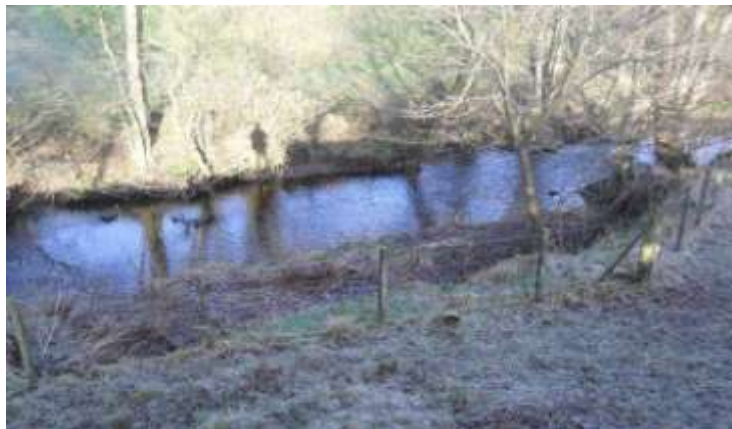
Upstream of the influence of the open cast workings (Meadowhill - OS NGR 2276 6942) the river becomes steeper and slightly more confined, displaying only a very limited floodplain. The channel morphology is predominantly gravel/cobble pool-rapid (Figure 1-16). A set of paleo-channels exist close to the main channel suggesting some straightening of the watercourse (Figure 1-18). A swan neck meander exists close to the B913 which is presently

**Figure 1-17: Gravel/cobble pool-rapid around Garthknowie**

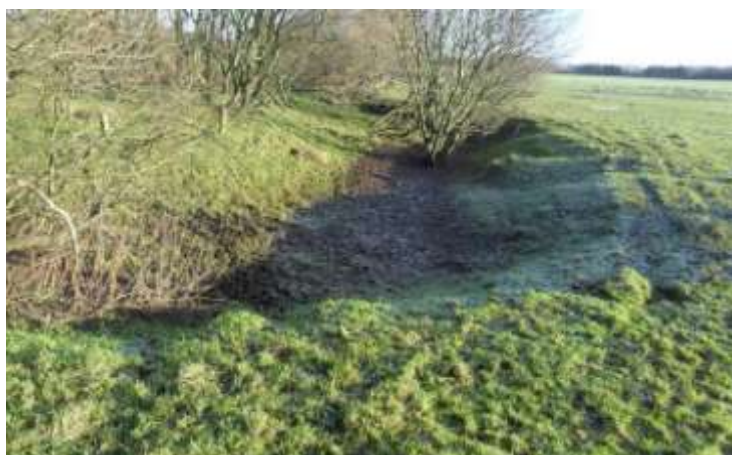
**Figure 1-18: Paleo-channel features created by river straightening**

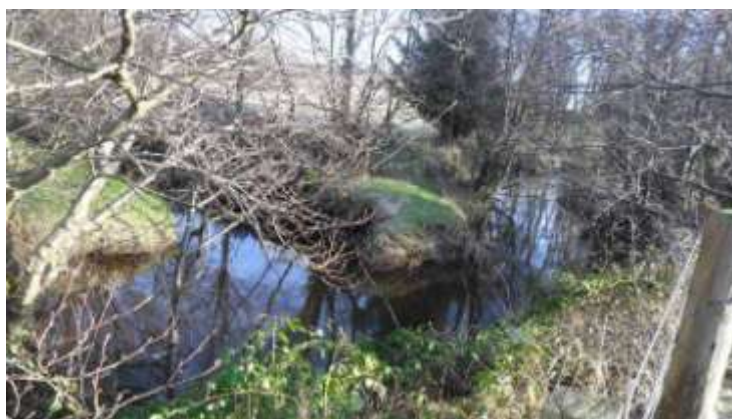
heavily degraded. Channel widening is marked by the development of stable mid-channel bar features creating a diverse hydromorphology (Figure 1-19).

**Figure 1-19: Channel widening and mid-channel bar stabilisation**

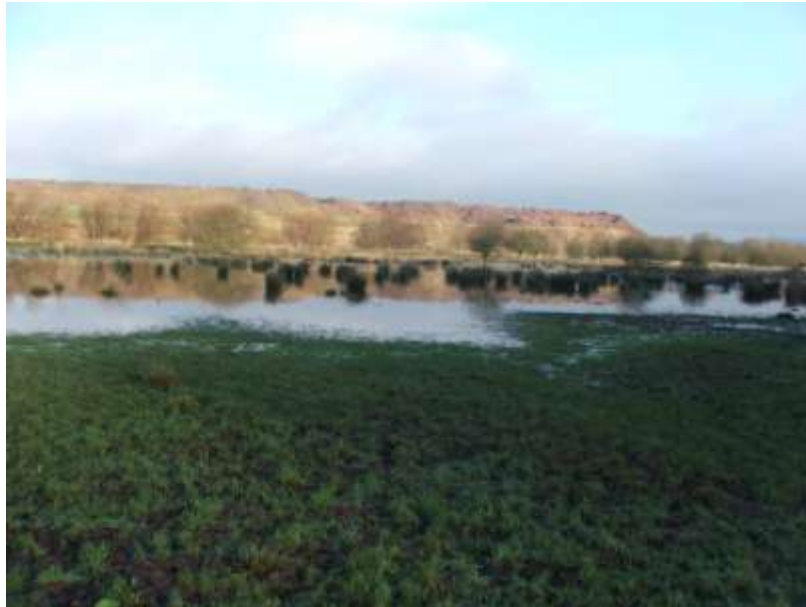
The river is a single thread along which alder and willow trees grow intermittently. The floodplain is wide and there are numerous paleo-channels which are home to patches of rushy pasture in the generally improved grassland landscape on the South side of the river. The ground here is undulating on account of these and has not been ploughed out although some improvement in terms of fertilising and top-dressing with seeds has taken place (see Figure 1-20).

Devon. Here tufted hair-grass is dominant and there are some settling ponds that drain into a channel that makes its way into the river somewhere upstream. A notable species her on a couple of the in-channel sediment bars was reed sweet-grass *Glyceria maxima*, an uncommon species at this latitude in the UK.

**Figure 1-20: Opencast Workings Beyond River Devon (Line of Trees) with Semi-improved Grassland and Rushy Pasture in Paleo-channels in Foreground.**

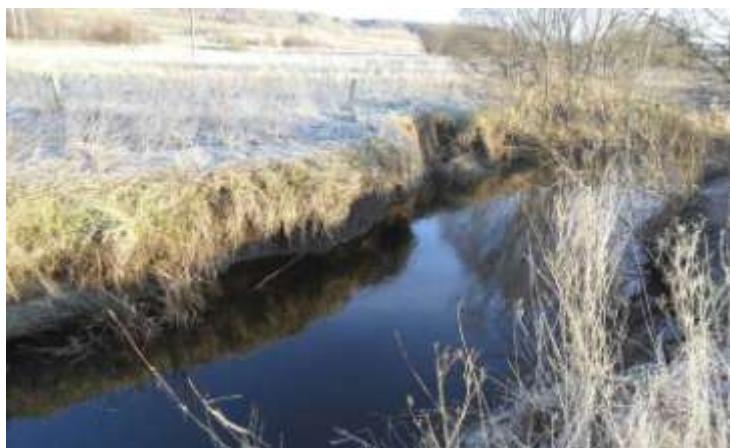
A heavily modified sinuous alluvial single thread channel exists around Knowehead (Figure 1-21). Here the river is over-deep and appears to be backed up displaying only sluggish flow. Occasional woody debris dams (live and dead material) create limited local hydraulic diversity and trap fine sediment to increase the bed elevation of the channel (Figure 1-22). Fine sediment inputs are very high through this reach and have resulted in a degraded sandy/silty bed smothering natural river gravels. The left bank floodplain upstream of the confluence with Roughcleigh Burn is well developed and displays some paleo-channel features.

**Figure 1-21: The heavily modified sinuous alluvial single thread channel around Knowehead**

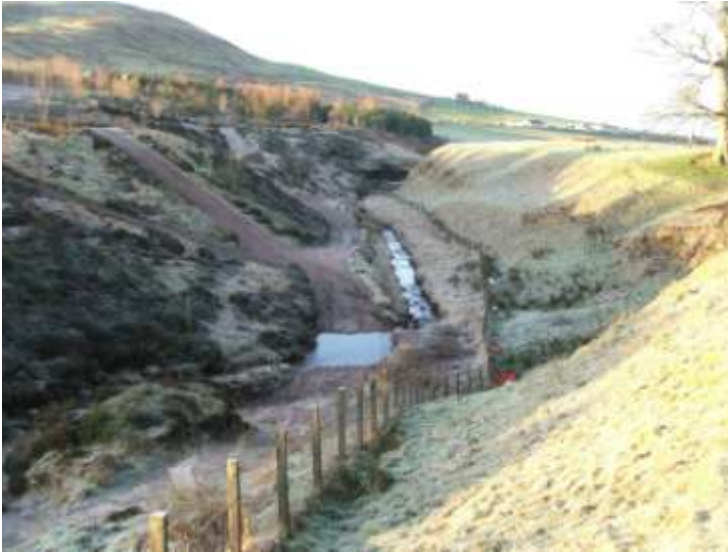
The issues on the Black Devon mainly revolve around agricultural activity and poor practices, although this is not always the case. In the upper reaches of the river near Outh Bridge it can clearly be seen that the left bank of the river generally has a greater variety of trees and a more interesting ground flora than the right bank, which is composed in the main of unimproved acid grassland with scattered patches of rushy pasture. This lack of diversity is related to the fact that the right bank is grazed and, if the grazing pressure is removed, the right bank will be colonised by the same mix of plants that are present on the left bank: in particular birch and rowan trees, great woodrush and heather. The vegetation on the right bank has, over the years, responded to the grazing pressure by simplifying its structure, however, the presence of propagules in the area should allow the rapid colonisation of this bank and the restoration of a wooded cleuch in this location. This will act as a more efficient wildlife corridor from the Swallow Craig Falls woodland to Outh Bridge.

**Figure 1-23: Black Devon near Outh Bridge showing ungrazed and grazed banks of river**

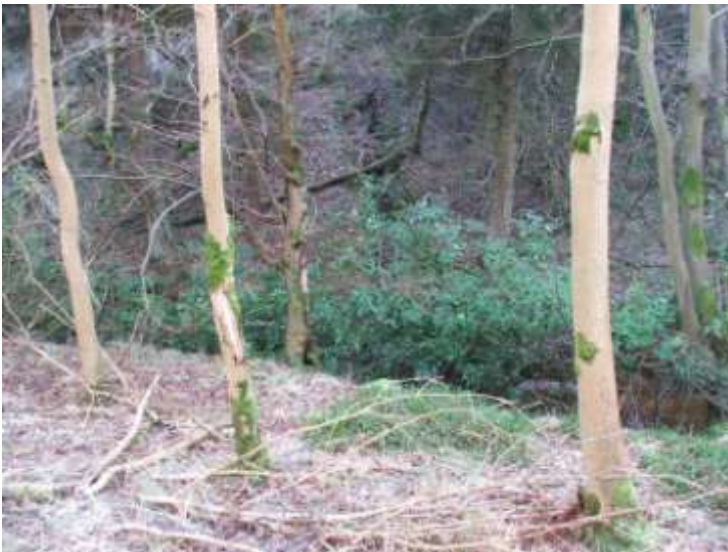
Upstream of Balgonar Bridge there is a large section that is dominated by ash woodland. Here the canopy is dense and all the trees are of the same age-class. Non-native invasive species are not a particular problem on this river, however, at one location within this area of semi-natural woodland there is a large specimen of cherry laurel *Prunus laurocerasus*. This is an invasive, poisonous species and this should be removed as part of the restoration plan.

**Figure 1-24: Cherry laurel upstream of Balgonar Bridge**

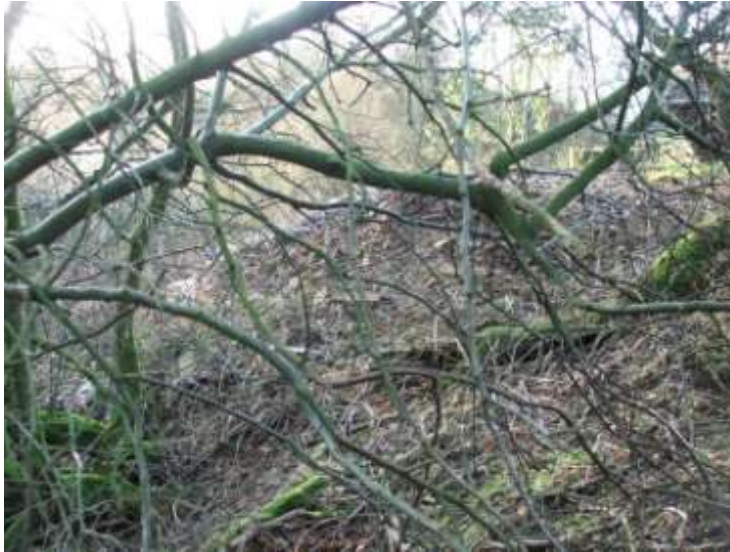
At Balgonar Bridge there are a number of dwelling houses, one of which has been routinely burning and tipping material down the steep valley sides onto the narrow floodplain of the river. Over the years this has changed the shape of the valley sides and the vegetation cover (see Figure 1-25): it is now more rural in nature. An education campaign highlighting that this activity is damaging to the riparian habitat is recommended as is a clear-up of the tipped material and the planting-in of native tree species to aid the recovery of this area (see Figure 1-26).

**Figure 1-25: Tipped material (some burned) building up on the slopes above the Black Devon at Balgonar Bridge**

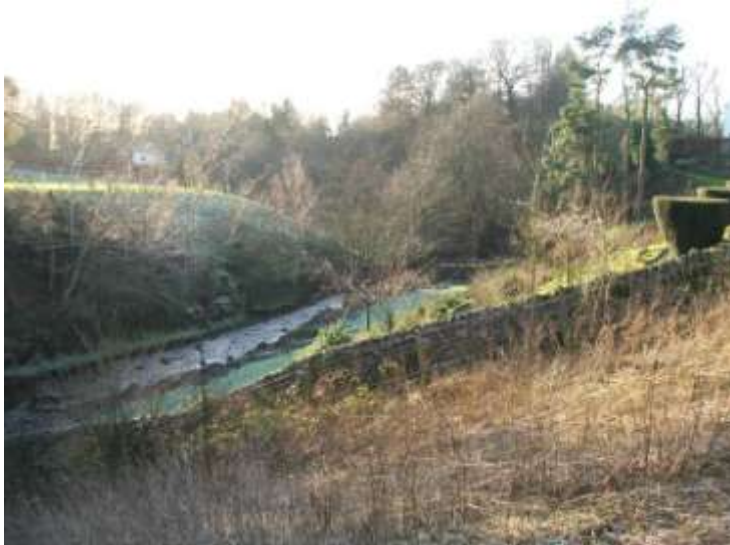
**Figure 1-26: Ruderal vegetation at Balgonar Bridge resulting from tipping operations and a change in the nutrient status of the underlying soil**

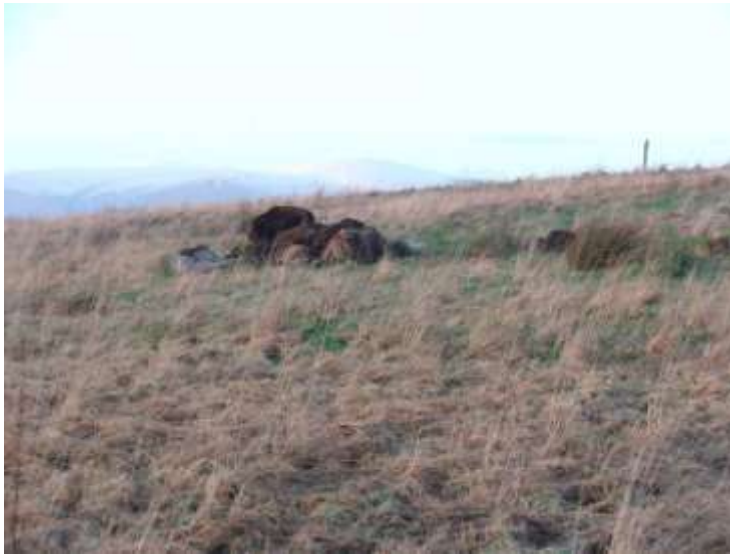
**Figure 1-27: Rotting silage dumped on unimproved grassland**

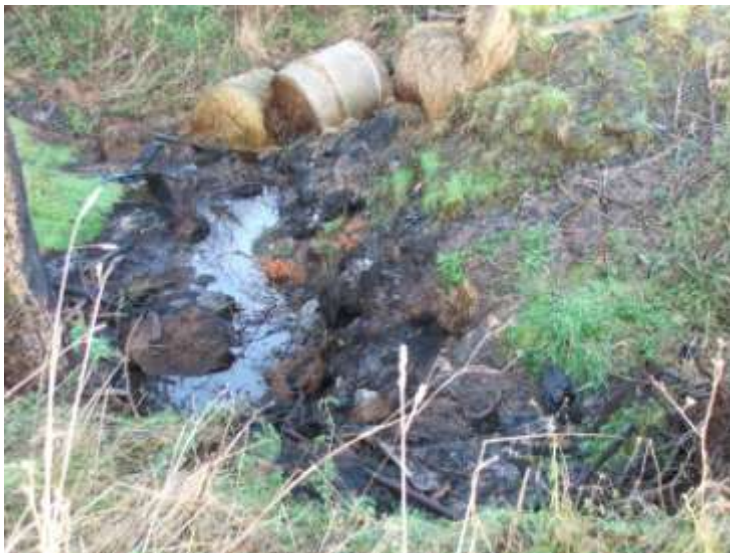
**Figure 1-28: Illegal dumping in a cut-off meander near Knowehead**

It is important that this dumping cease and the existing material be removed to restore this meander to good ecological status. Habitats such as this are quite rare and are ideal sheltering and laying-up locations for fish.

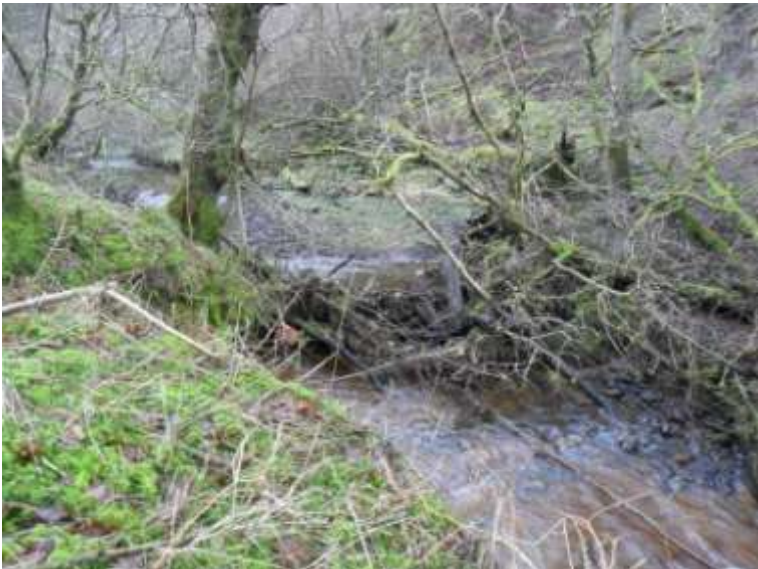
<p>Location : 15</p> <p>Description: Waterfall. Iron ochre deposits.</p> <p>OS NGR: 30312 69432</p> <p>Notes:</p>

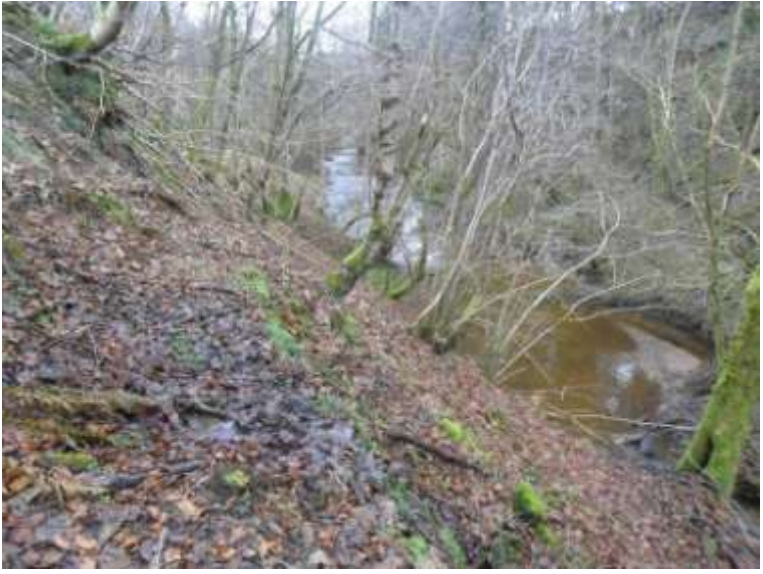
<p>Location : 36</p> <p>Description: Strongly confined reach</p> <p>OS NGR: 30251 69408</p> <p>Notes: Bedrock pool - rapid</p>

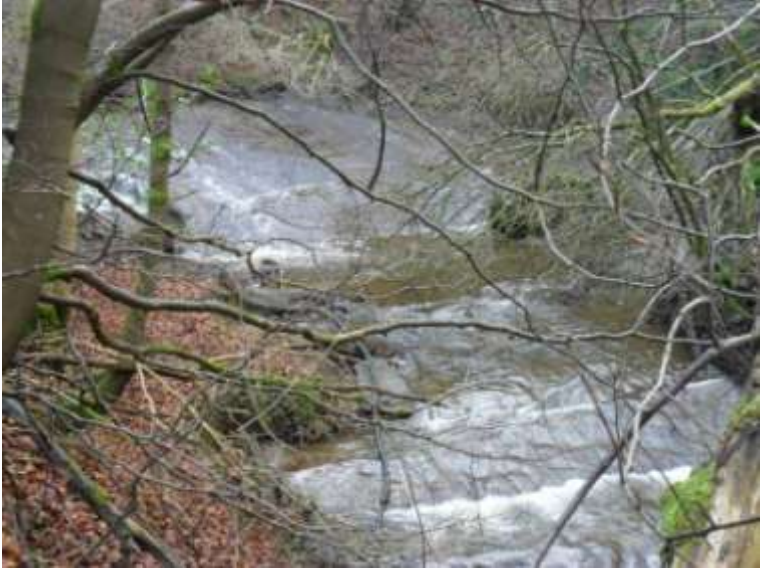
<p>Location : 37</p> <p>Description: Strongly confined reach</p> <p>OS NGR: 30249 69404</p> <p>Notes: Bedrock cascade</p>

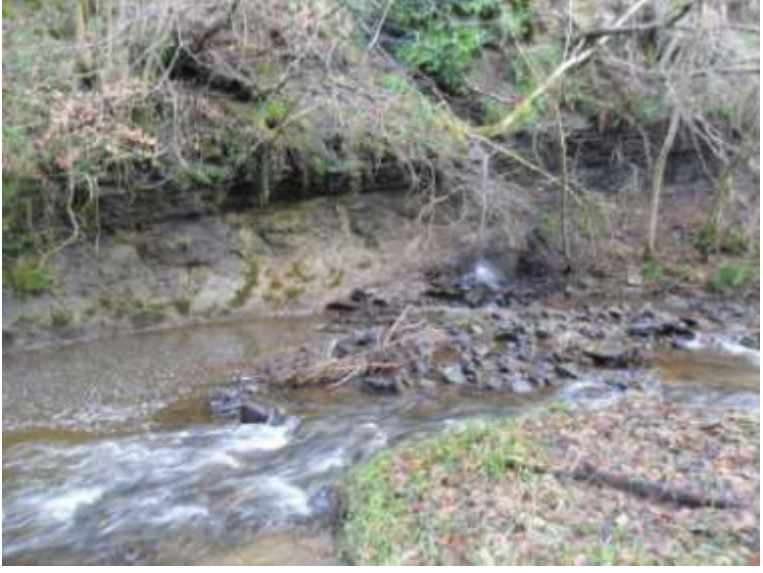
<p>Location : 38</p> <p>Description: Strongly confined reach</p> <p>OS NGR: 30247 69399</p> <p>Notes: Local bedrock collapse creating boulder rapid</p>

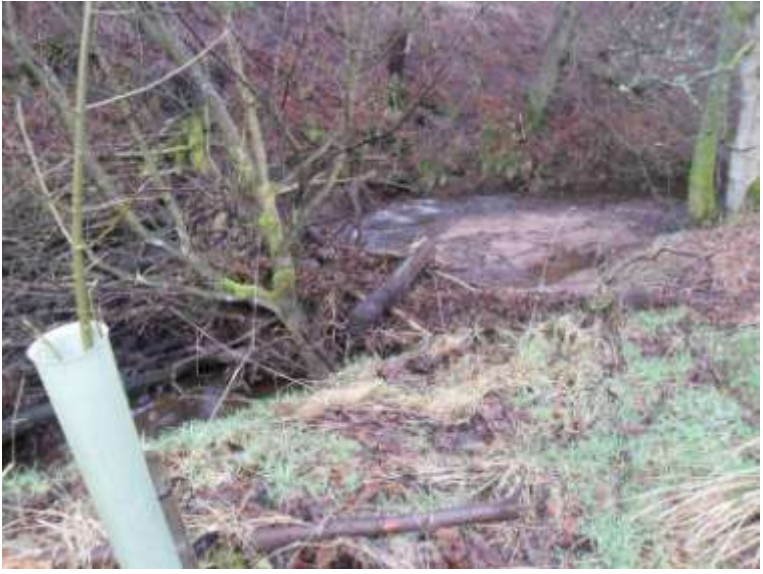
<p>Location : 42</p> <p>Description: Large woody debris dam</p> <p>OS NGR: 30238 69388</p> <p>Notes: Woody debris creating local flow and sediment diversity</p>

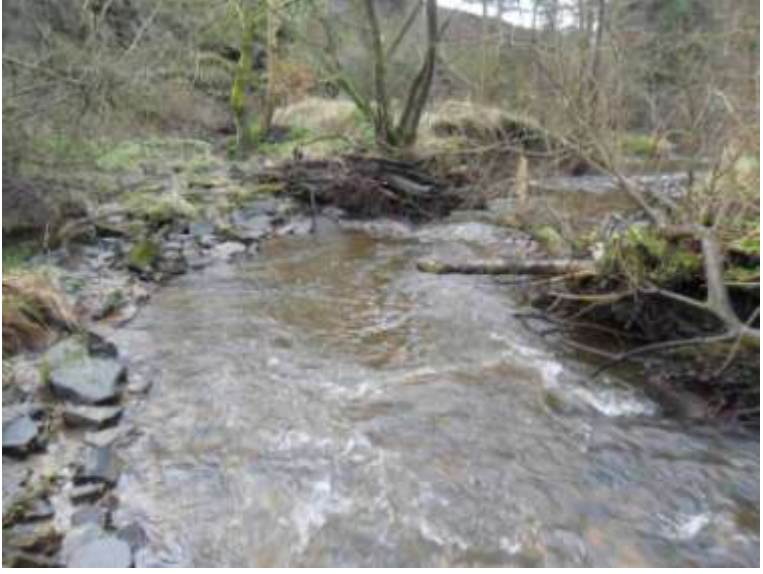
<p>Location : 43</p> <p>Description: Bedrock / cobble rapid</p> <p>OS NGR: 30237 69383</p> <p>Notes:</p>

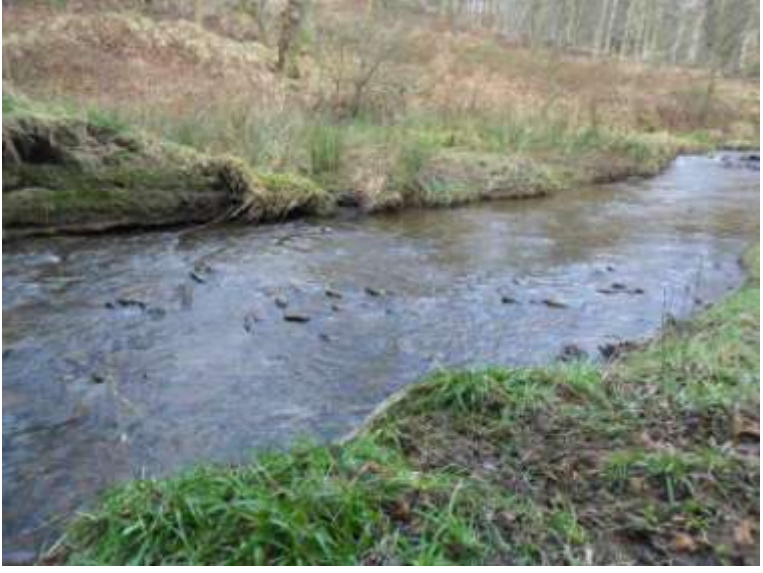
<p>Location : 44</p> <p>Description: Cobble riffle</p> <p>OS NGR: 30232 69381</p> <p>Notes: Cobble riffle in plane-bed – riffle reach</p>

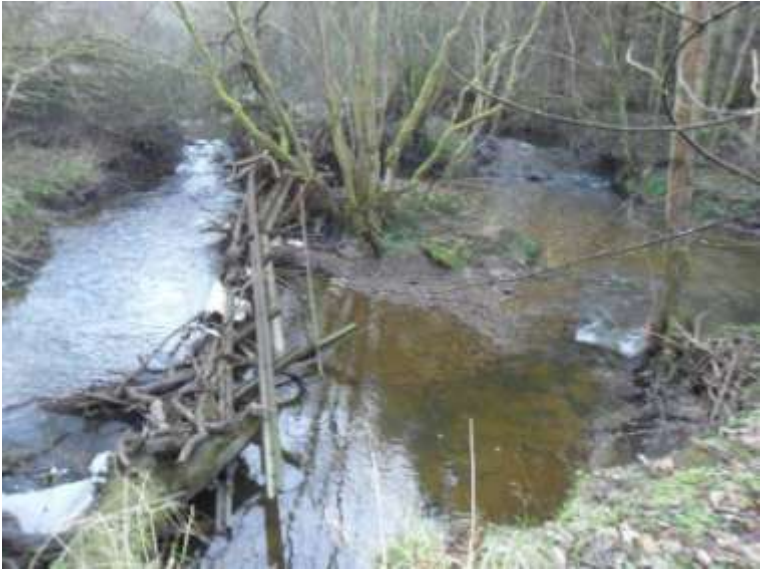
<p>Location : 67</p> <p>Description: Old Weir / bridge crossing</p> <p>OS NGR: 29975 69406</p> <p>Notes:</p>

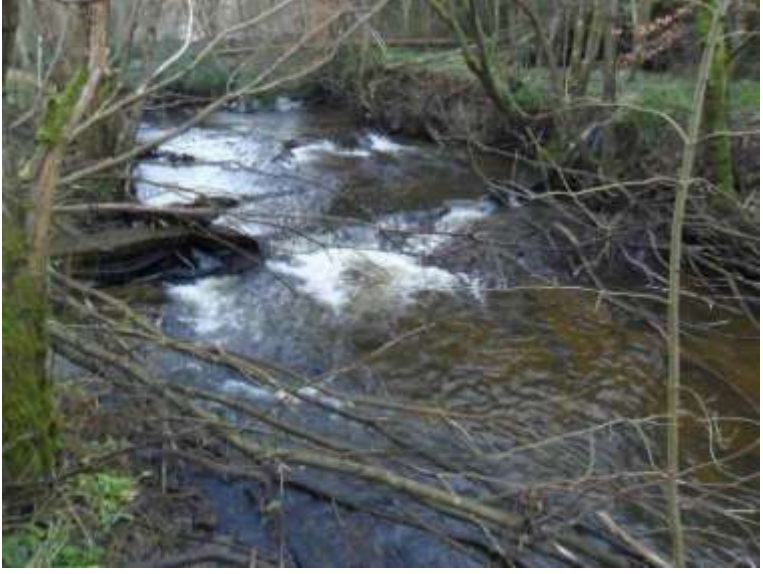
<p>Location : 68</p> <p>Description: Bedrock rapid</p> <p>OS NGR: 29963 69408</p> <p>Notes:</p>

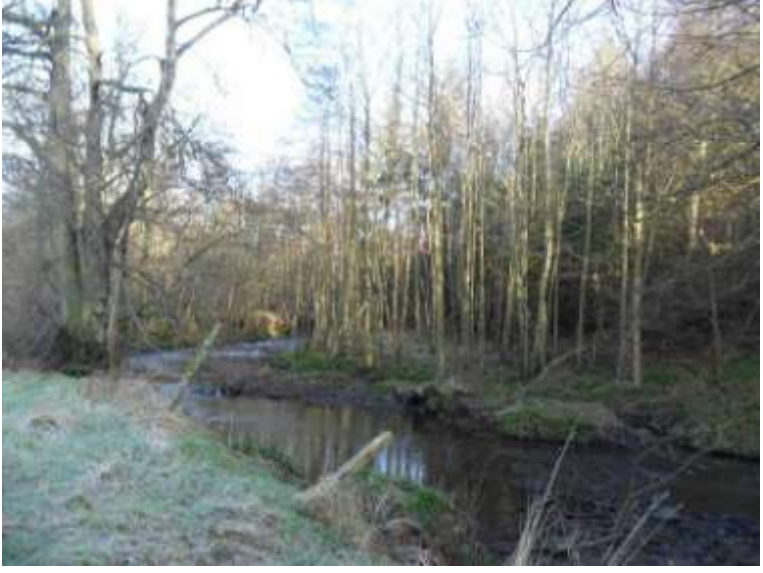
<p>Location : 69</p> <p>Description: Well developed lower berm.</p> <p>OS NGR: 29915 69391</p> <p>Notes:</p>

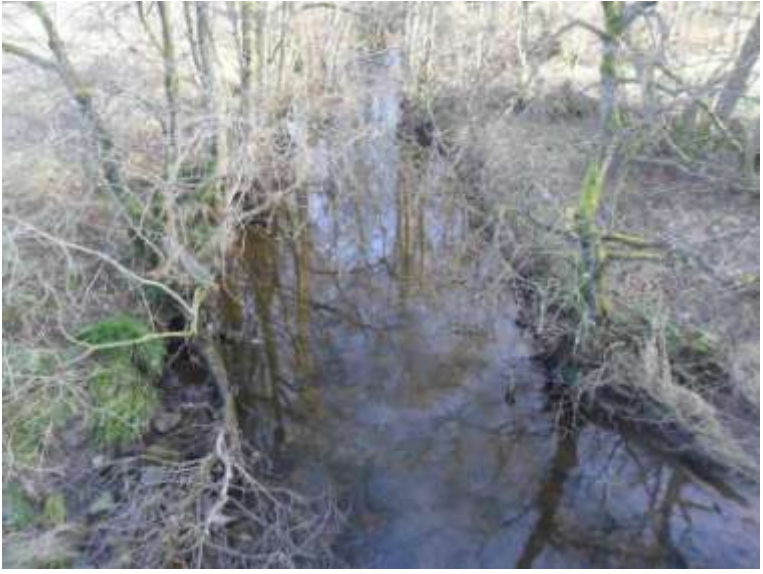
<p>Location : 70</p> <p>Description: bedrock influenced channel.</p> <p>OS NGR: 29898 69386</p> <p>Notes:</p>

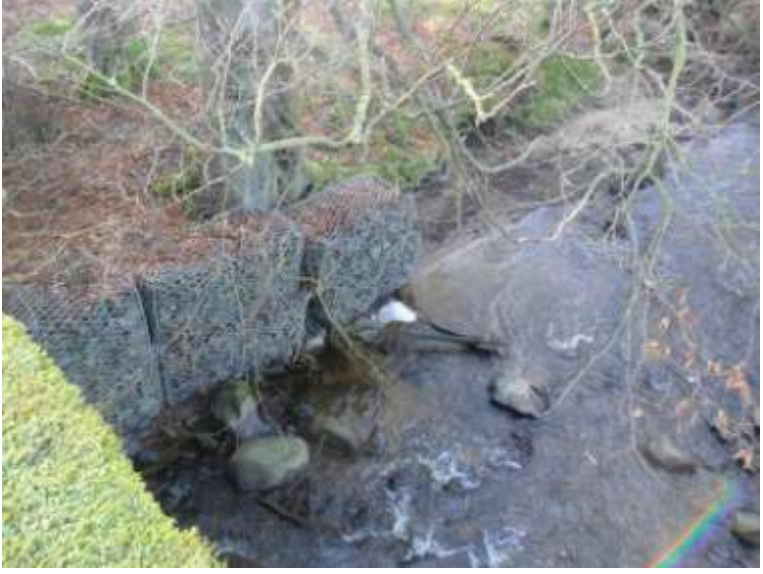
<p>Location : 71</p> <p>Description: Black Devon Bridge.</p> <p>OS NGR: 29880 69383</p> <p>Notes: Poor state gabion baskets.</p>

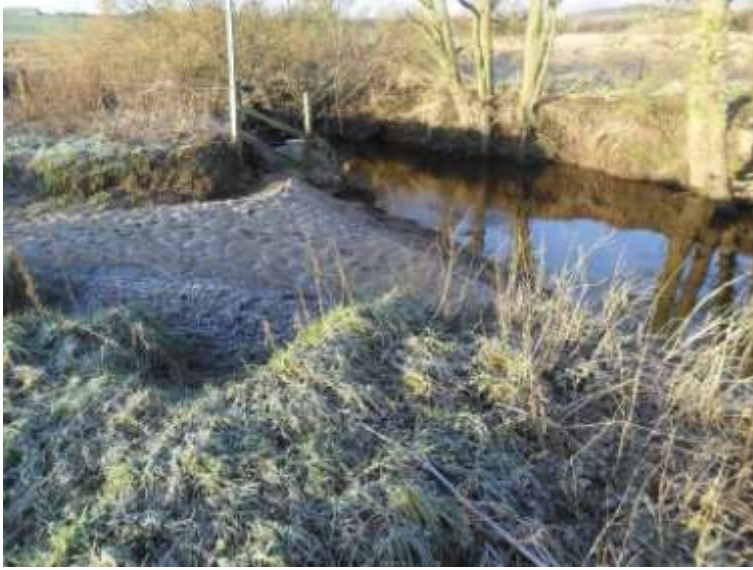
Location : 87

Description: Degraded channel
