Catchment Scale Restoration on the River Peffery

Summary

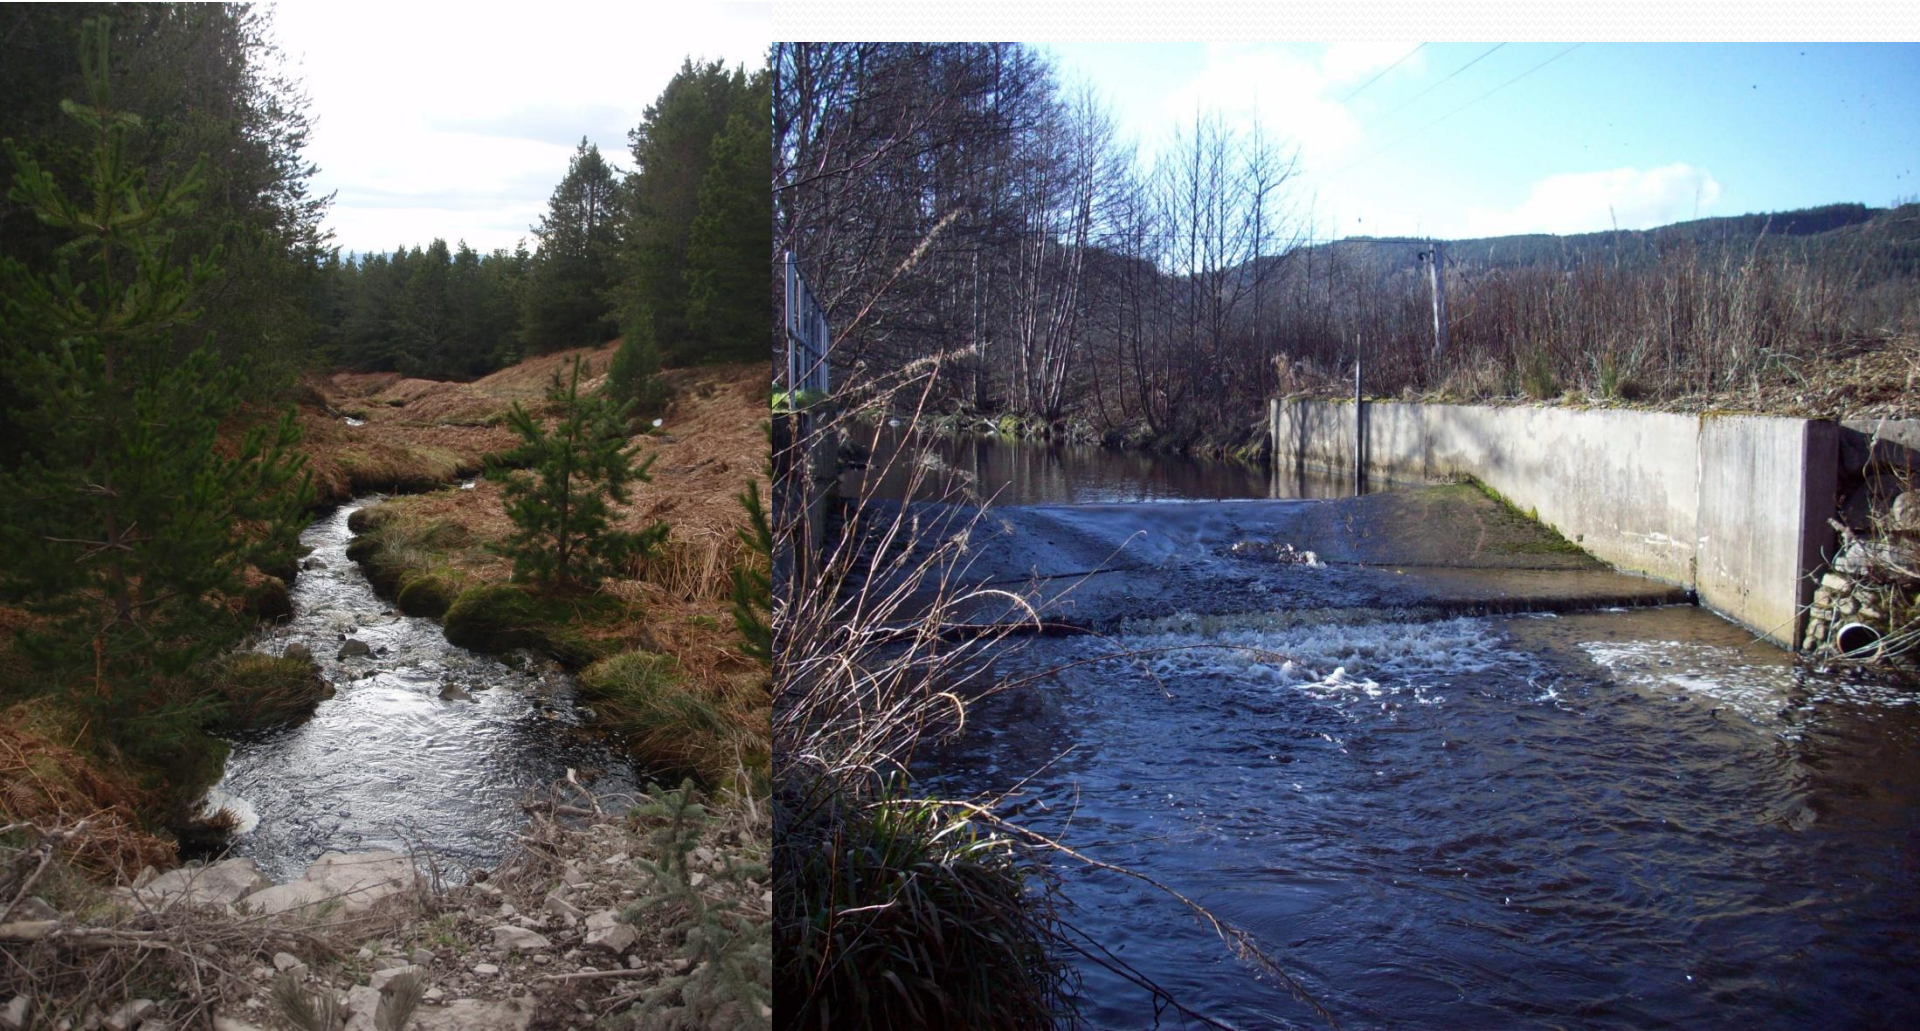
Catchment Pressures

- An opportunity for catchment scale management / restoration
- Can be achieved through the Area Advisory Groups (AAG)
 - River Basin Management Planning
- Peffery classified as Moderate (2008)
 - Morphological Alterations
 - Weir
 - Forestry
 - Agriculture – realignment and Channelization

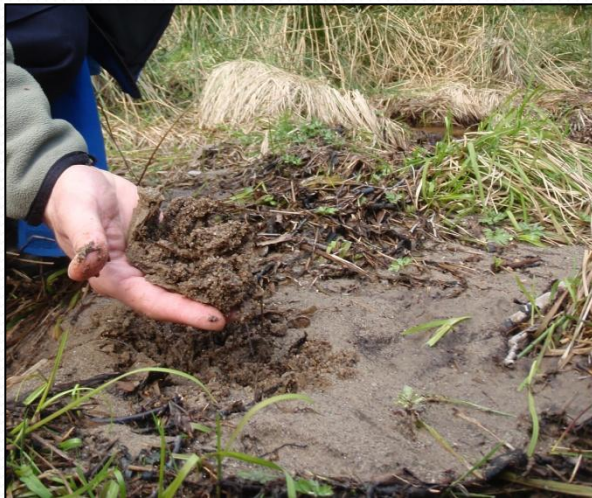
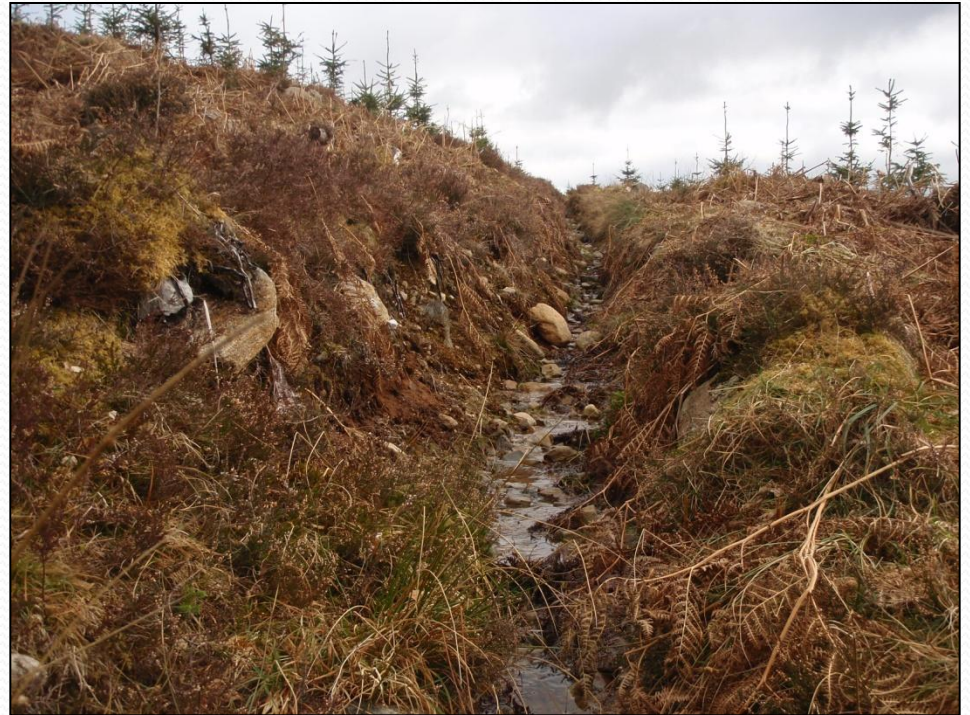
Forestry Pressures

- Acidic run off
- Source of silt
- Flash flooding
- Limited diversity

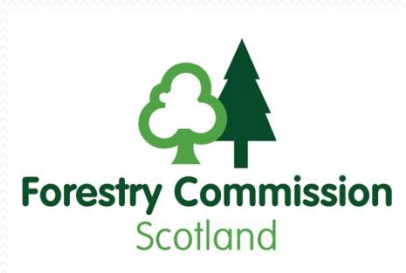
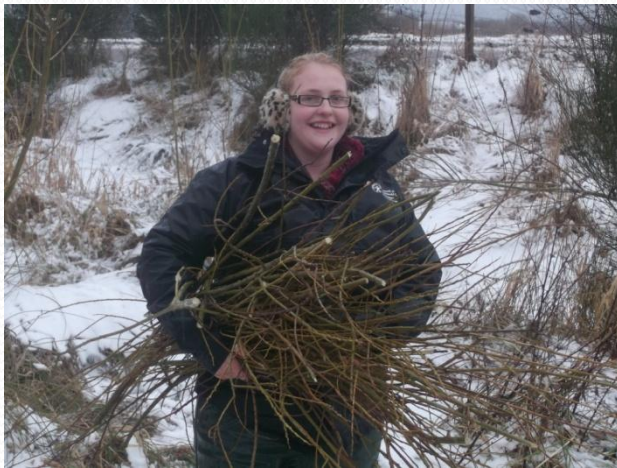
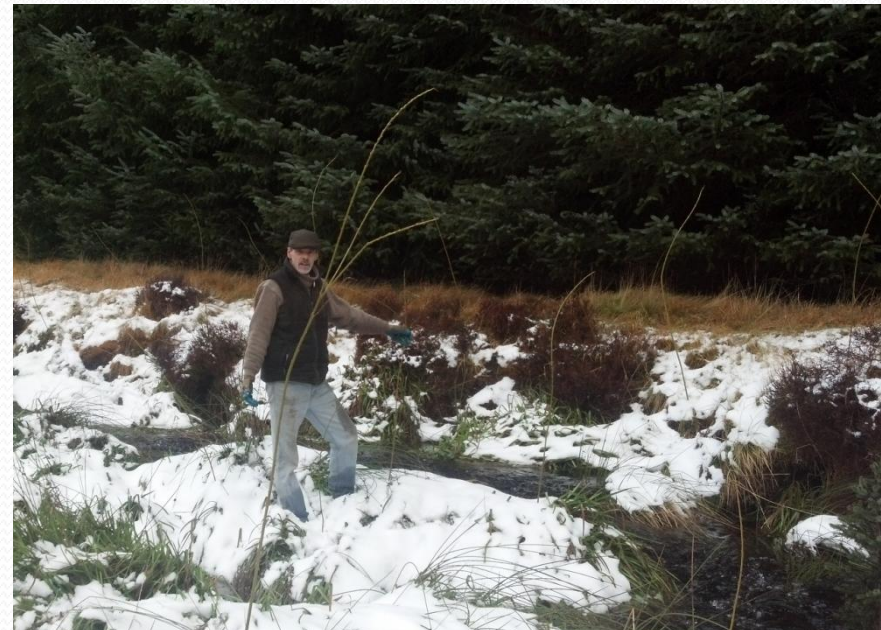
Improved Forestry Management

- Achieved through AAG
 - Riparian planting
 - Blockage of forestry drains
 - Large Woody Debris Trials

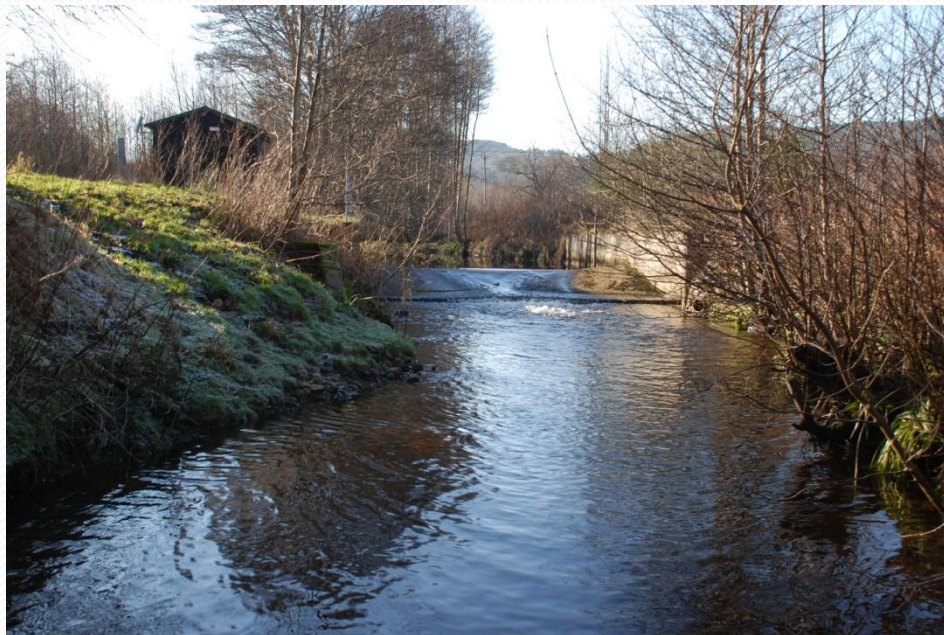
Barriers

- Scottish Water gauging weir (sewage works)
- Negotiated via SEPA for barrier easement in 2013

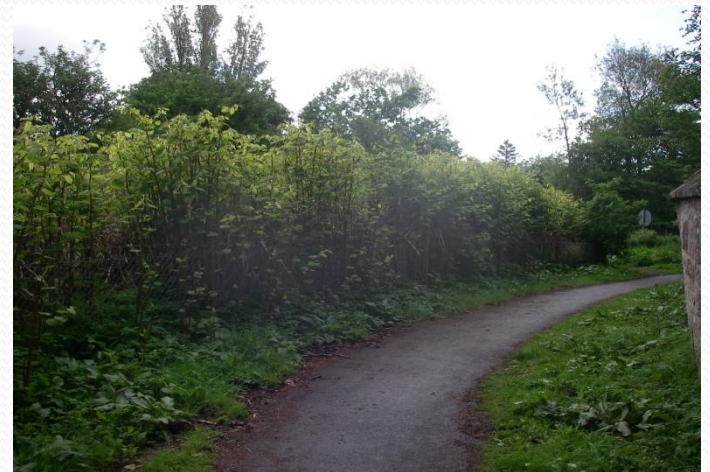
Invasive Non Native Species

- Limiting bank side biodiversity
- Reducing amenity value
- Removed as part of larger RAFTS project
- Followed by bank side planting with local willow cuttings and alder saplings

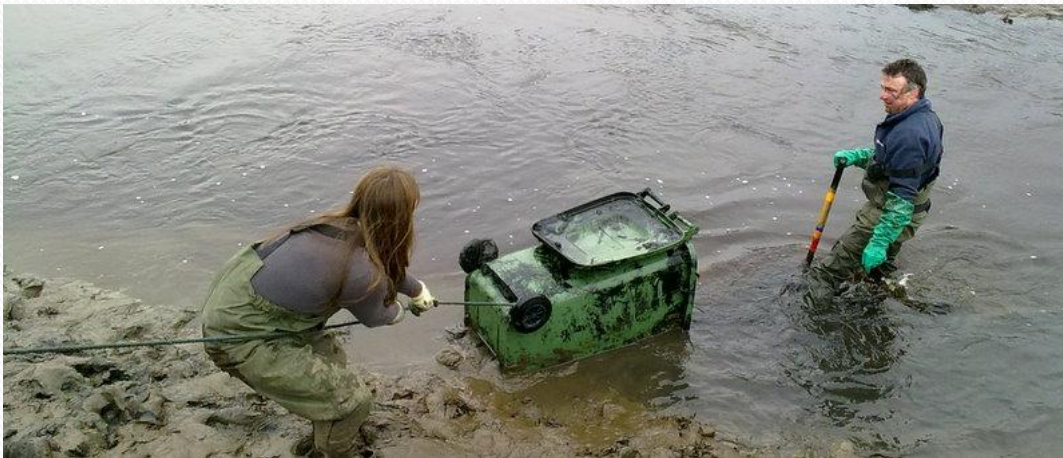
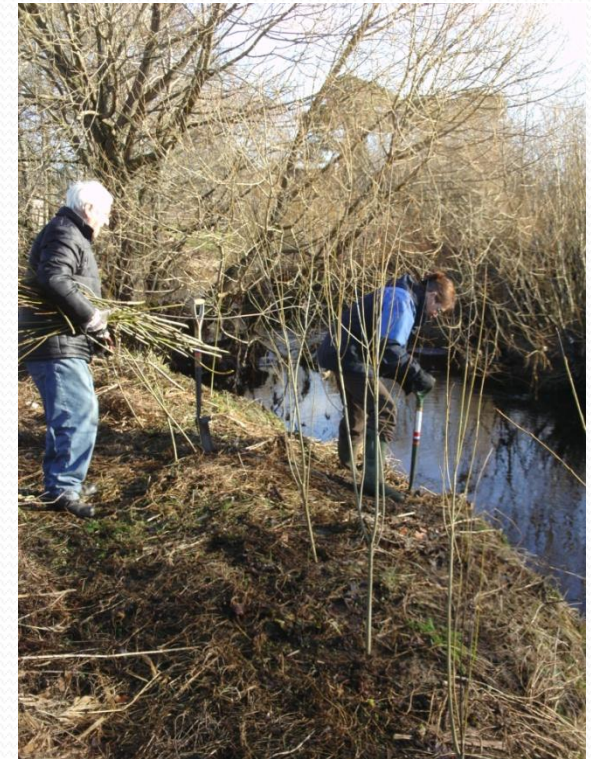
Amenity Value

- Work to improve amenity value in Dingwall
 - Rubbish removal
 - Tree planting
 - INNS Removal

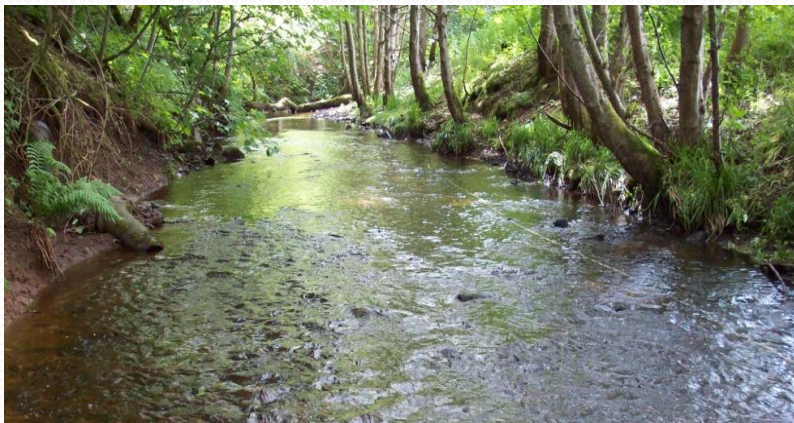
Morphology

- Historically straightened (1740s ?)
- Constrained between flood banks
- Limiting natural river processes
 - Over widened / incised
 - Shallow uniform depth
 - Compacted bed
 - Lacking in stream diversity

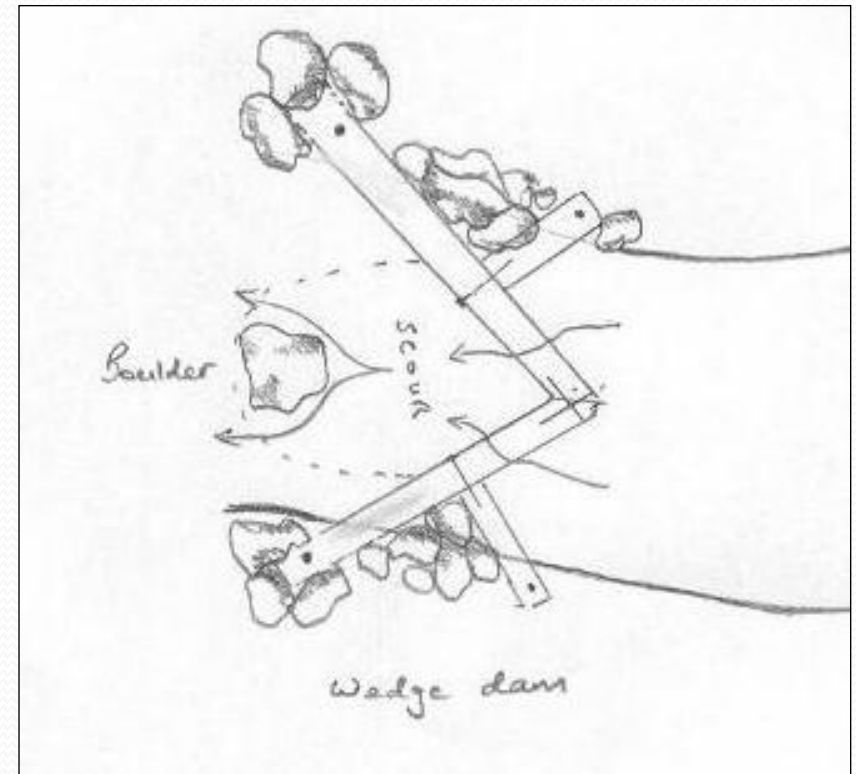
In-stream habitat restoration

- Large Woody Debris (LWD) – perceived flood risk
- Used bed level anchored structures from WTT
 - Local Materials
 - No machinery
 - Don't cause flooding
 - Cheap
 - Installed by volunteers

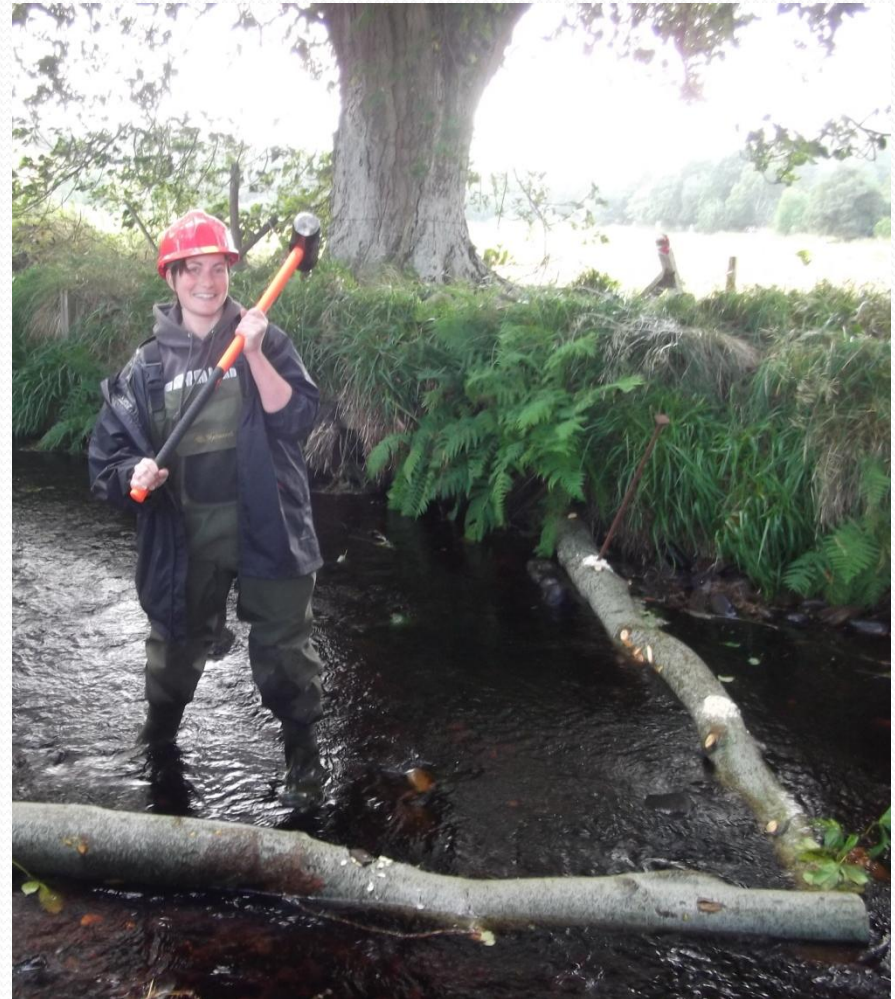
Peffery Project

- 15 In stream structures
 - 84 pins
 - 33 logs
 - 30 + tonnes of stone??
 - 91 volunteer days
 - 39 staff days
