**APPENDIX C**

RECONNAISSANCE SURVEY FINDINGS

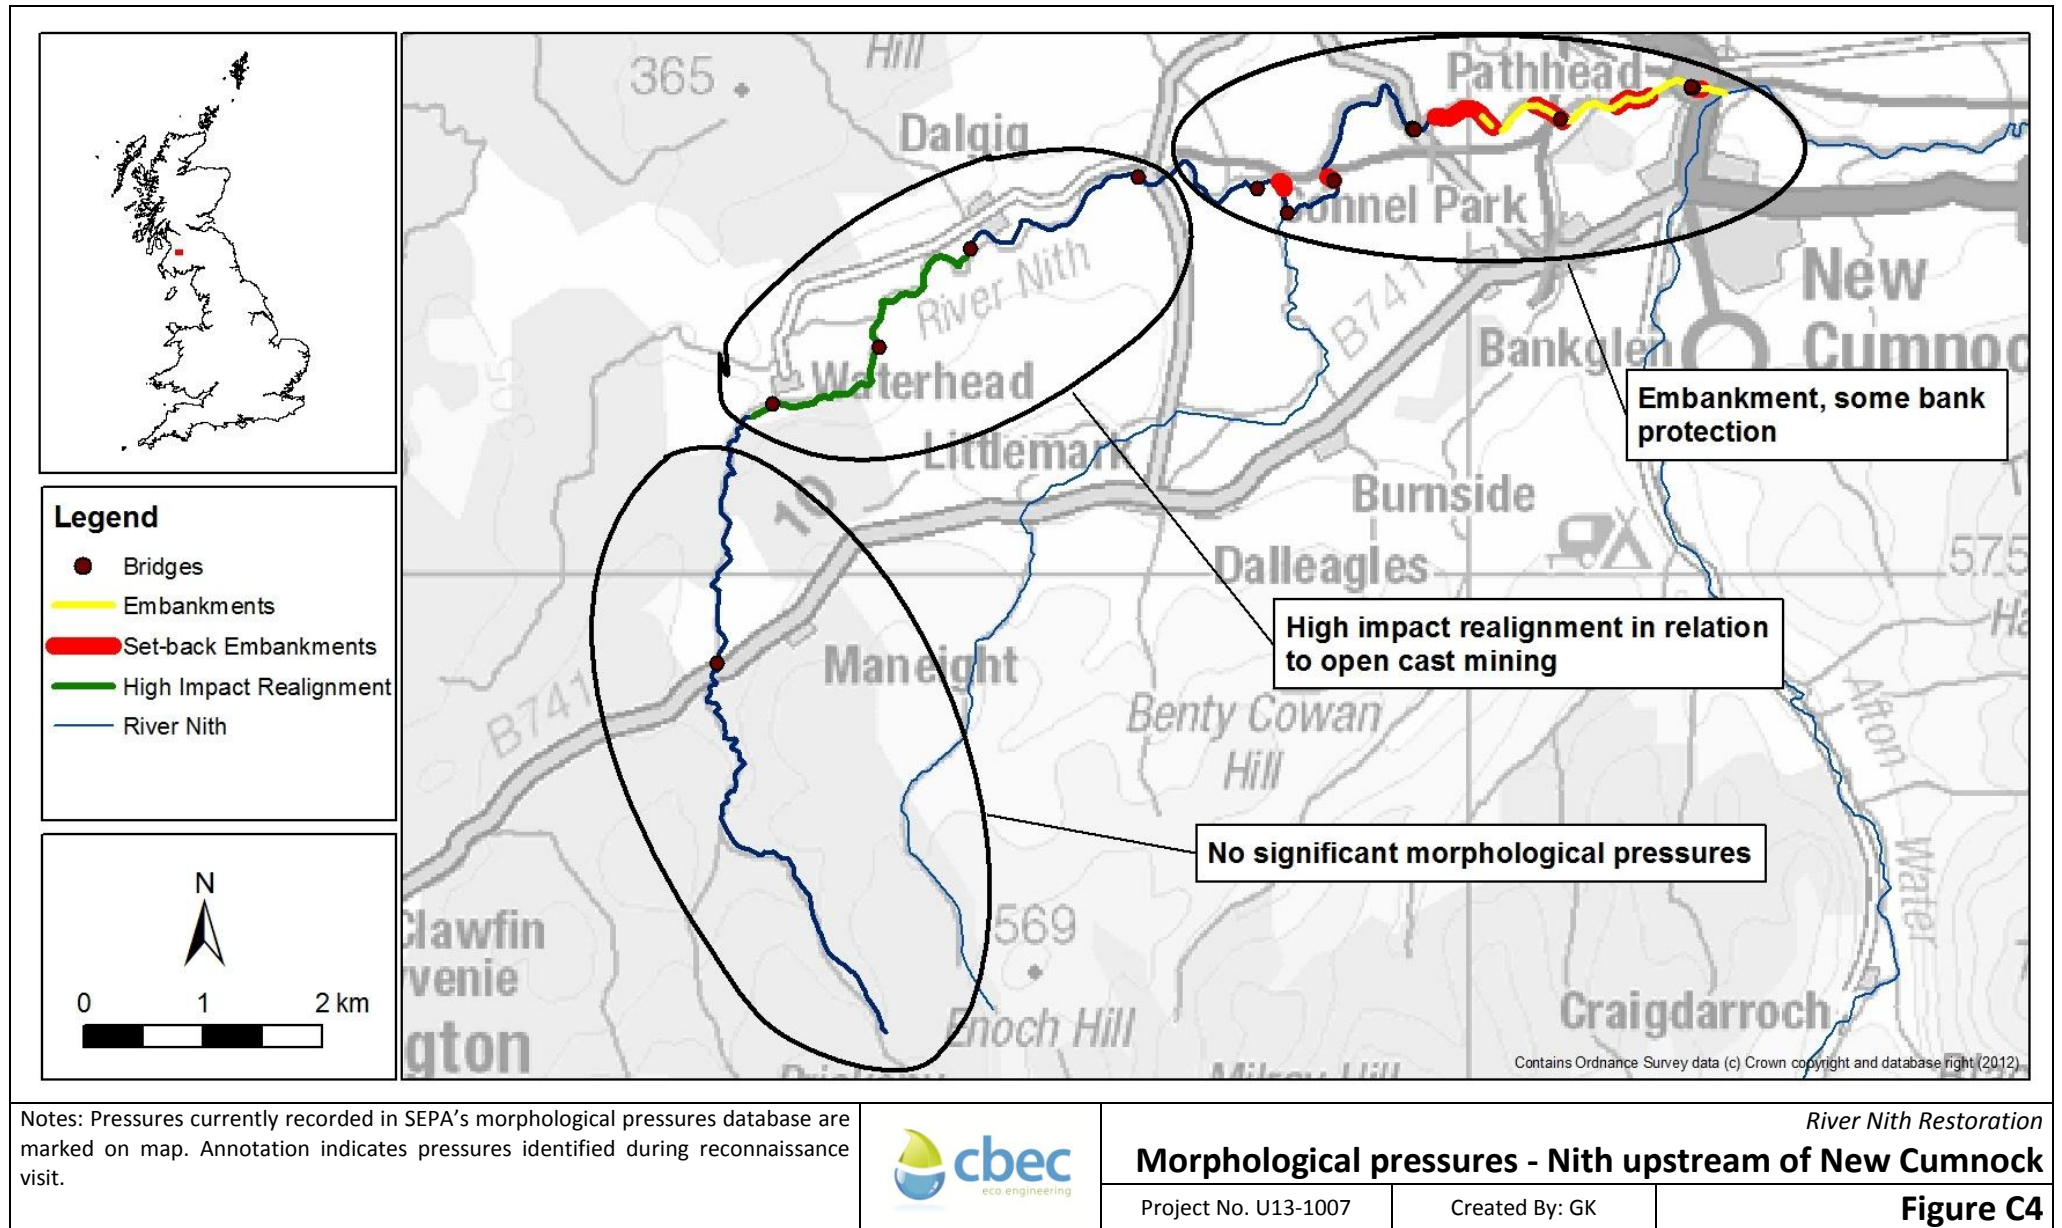
The Nith upstream of New Cumnock can be divided into three broad sections based on morphological characteristics and pressures (Figure C4). The downstream-most section is between New Cumnock and Dalricket Mill. SEPA's morphological pressures database indicates that the river downstream of the minor road bridge near Ford Mouth is affected by embankments and set back embankments. The reconnaissance survey confirmed the presence of embankments in this section (Figure C1). Reach type was passive meandering (type F), becoming active meandering (type D) and then plane-riffle (type C) further upstream. Rates of bank erosion increased upstream, with bank protection becoming increasingly prevalent upstream in relation to this (Figure C1). Minor stock pressure on banks was also observed. Upstream of the minor road bridge the valley becomes more confined with increased incidences of hillslope erosion. Embankments were observed to be minor and intermittent upstream of the minor road bridge and are not recorded in SEPA's morphological pressures database.

The central section of the water body is between Dalricket Mill and the southwestern extent of the mine workings. This section of the river has been severely impacted by open-cast mining. The river has been realigned twice in order to allow mining within its valley (Figure C1). This is recorded in SEPA's morphological pressures database as an approximately 3 km long reach of high impact realignment. Access to this reach was not possible during the reconnaissance visit because of restrictions in relation to the mining operations. However, the realignment of this section of river has been documented elsewhere. Given the large scale of the realignment works in this section of river, and the fact that this work is being overseen by SEPA already, the pressures are not considered further within the appraisal of restoration options on the Nith undertaken in this study.

The upper section of the water body extends upstream from the boundary of the mine workings. No pressures are recorded within SEPA's morphological pressures database for this section. The reconnaissance survey also found little evidence of morphological pressure. The river through the downstream part of this section (downstream of the B741 bridge) is typically plane-riffle or active meandering, becoming steeper upstream of the bridge with wandering sections interspersed with plane bed or step-pool reaches. Throughout the section there was evidence of high rates of morphological activity. Frequent bank and terrace erosion, bar deposition and evidence of avulsions were observed (Figure C1). Land use throughout much of the section was commercial forestry. However, trees were typically more than two metres back from top of bank and are therefore not considered to be impacting on the channel (based on the rules/assumptions used in MImAS).

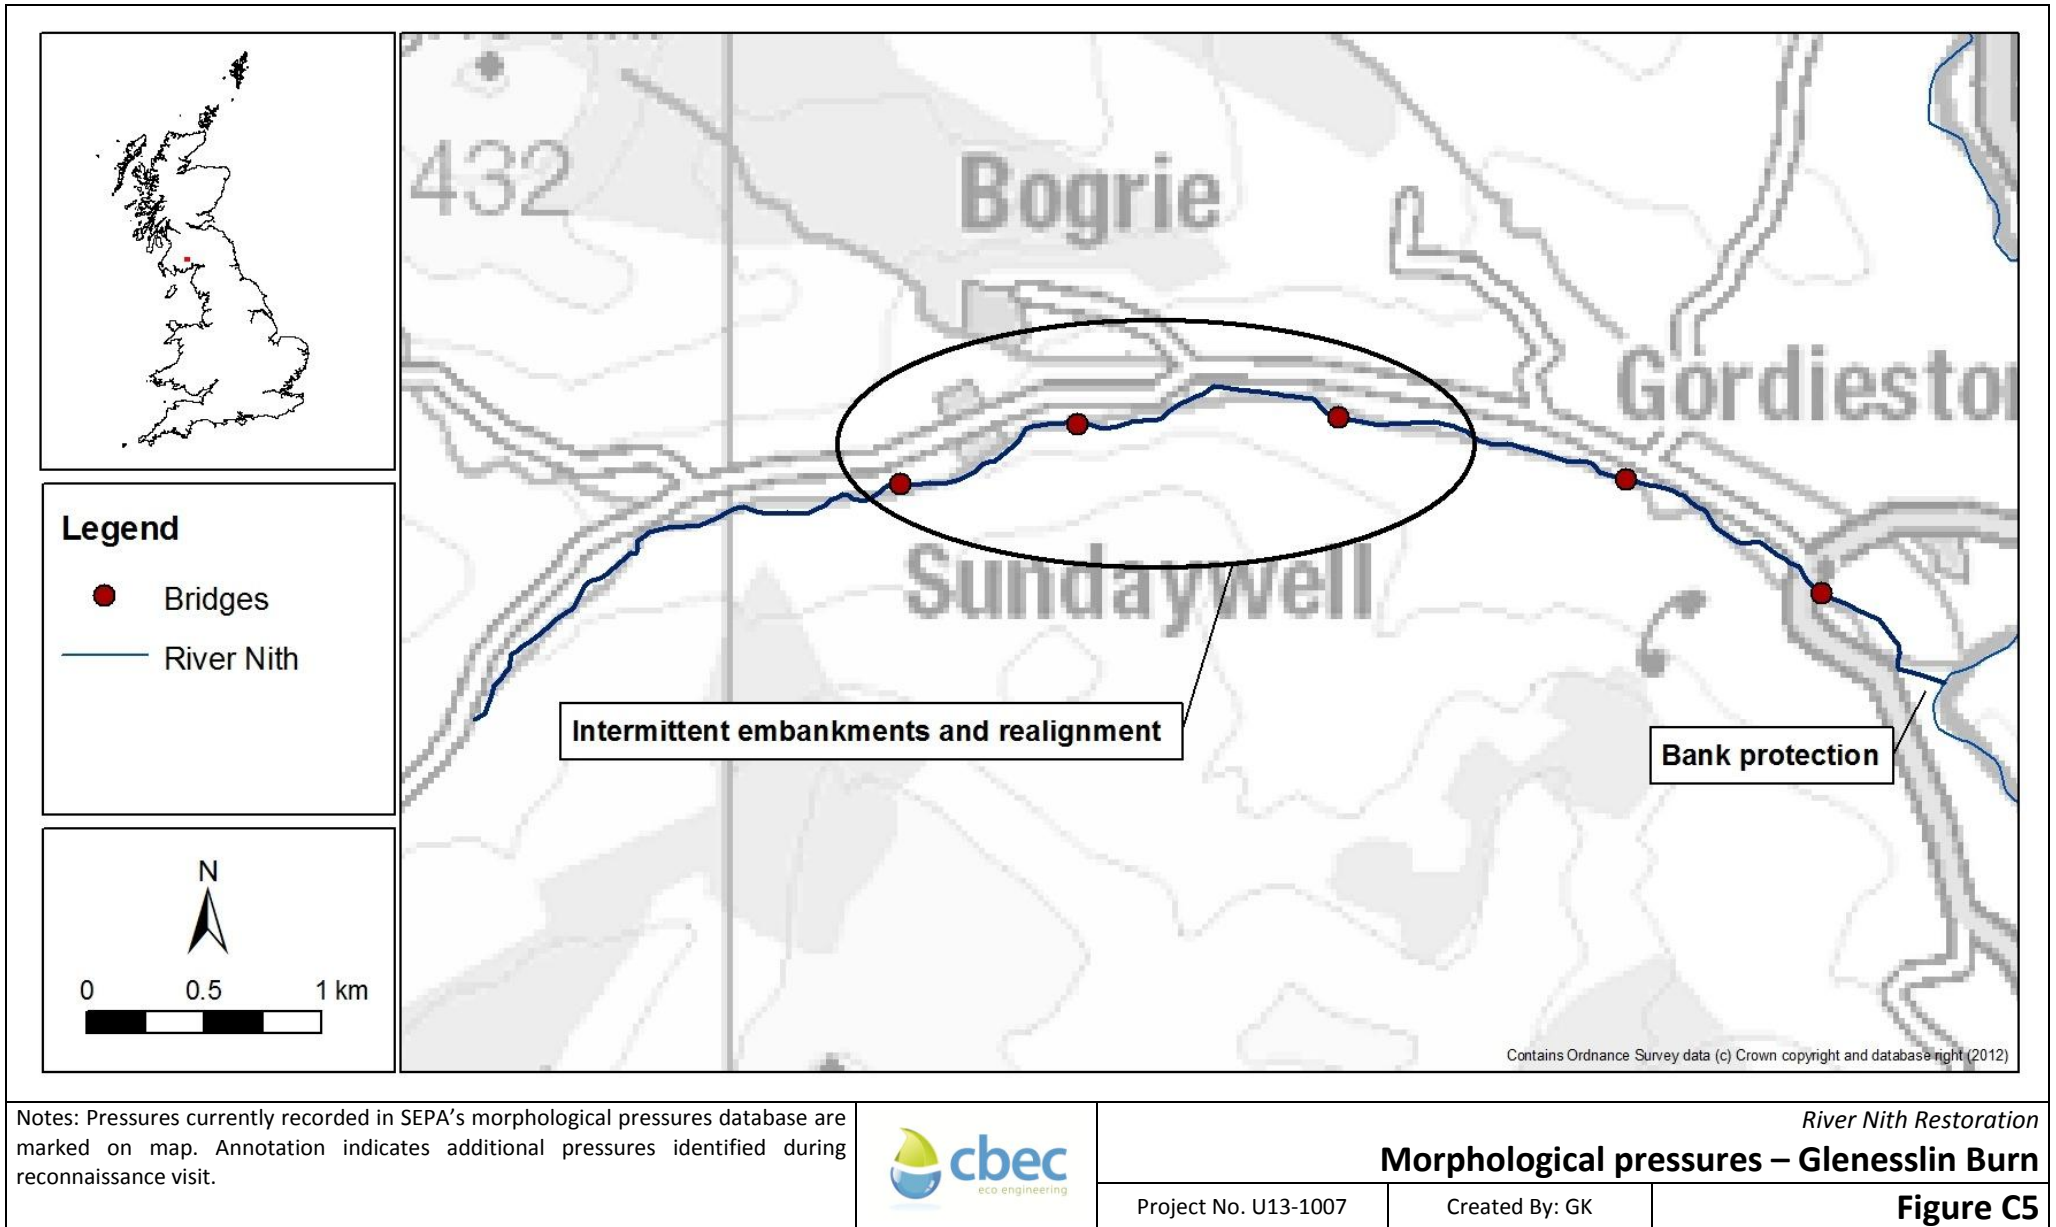
Morphological pressures for this water body within SEPA's morphological pressures database are restricted to several bridges. The reconnaissance survey indicated the presence of additional pressures. Embankments were found intermittently between approximately NX 805 841 (near Whiteside) and NX 836 843 (near Milton) (Figure C2, C5). Evidence of high impact realignment was also observed in some locations within this extent.

Reach type for almost all of the water body was plane-riffle, becomes active meandering close to its confluence with Cairn Water. Point bar development and bank erosion were observed within the active meandering reach (around NX 850 833) and some extents of boulder bank protection were also located here (Figure C5).

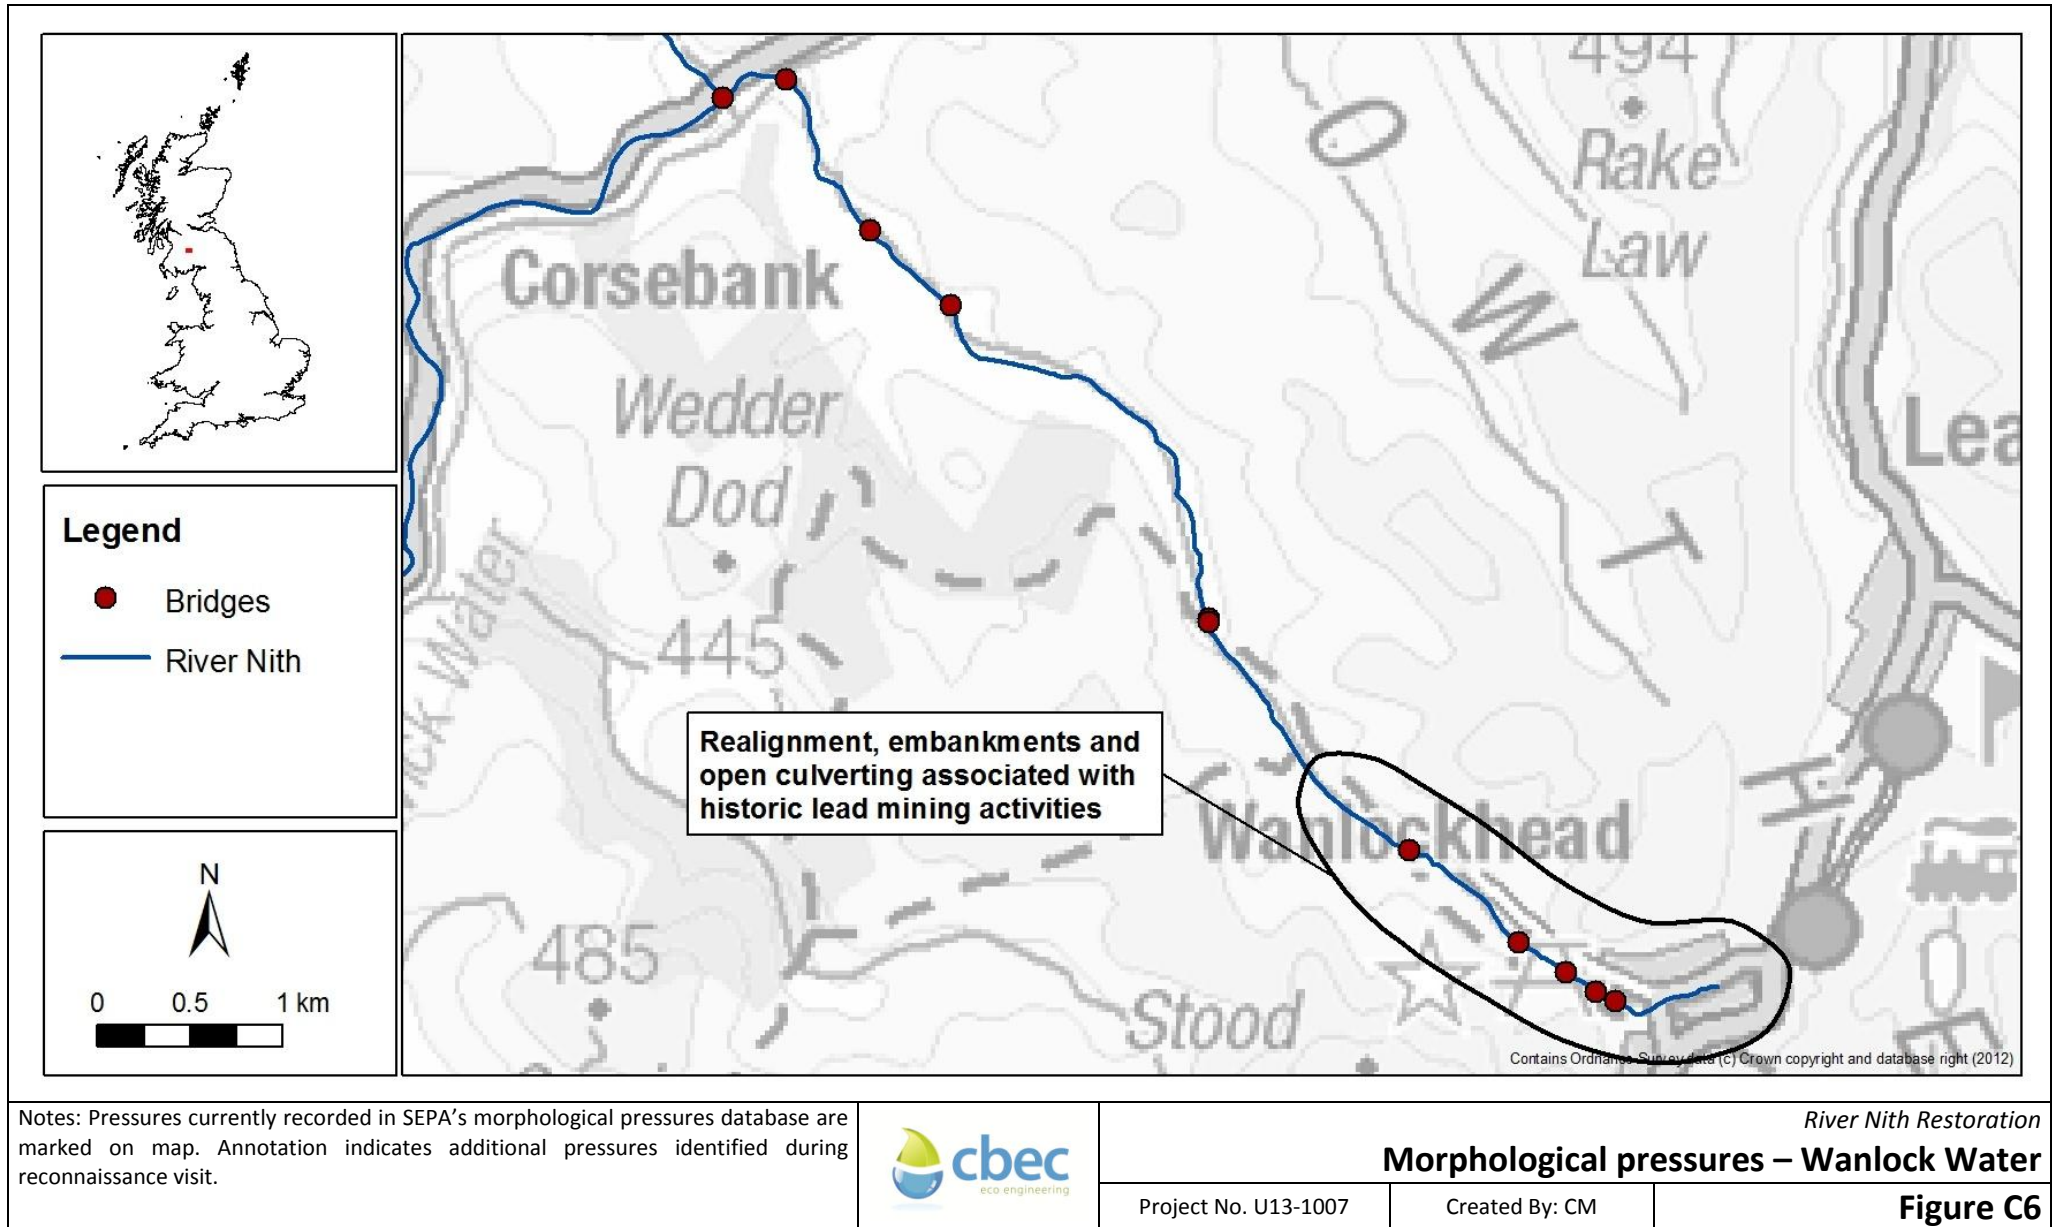
- The burn flowed through a culvert beneath the road through Wanlockhead and a short open culverted section then led to a second closed culvert.
- Downstream of here the reach type became plane riffle. The burn had been realigned to the left hand side of the valley (high impact realignment) and embanked on its right bank (Figure C3). (There appeared to be some recent alteration to the upstream end of the embankment.) Further downstream the burn had been diverted around the valley side (Figure C3).

- At the time of visit (during low flow) the entire flow in the burn was observed to seep into the bed at around NS 869 132, with the channel downstream being completely dry. However, the presence of exposed, unvegetated gravel in the dry channel suggests that it becomes active during high flows.

- Downstream of this point the reach type became active meandering and not directly impacted by morphological pressures, other than riparian vegetation loss. Evidence of possible minor dredging and a minor weir were observed close to the downstream extent of the water body.
