## Boghead Burn Hydromorphic Character and Restoration Opportunities

**FINAL**

June 2012

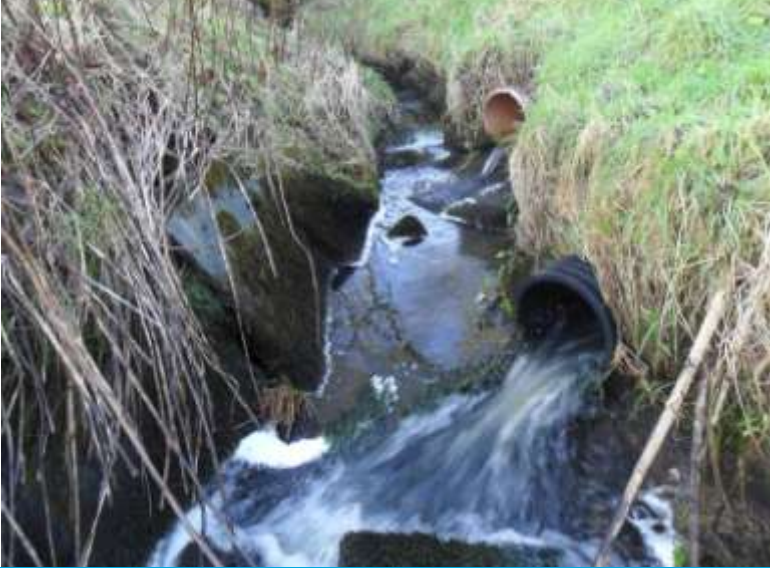
| | <p>Location : 4</p> <p>Description: Flow inputs from Hall Torbane Farm pond.</p> <p>OS NGR: 29505 66670</p> <p>Notes:</p> |

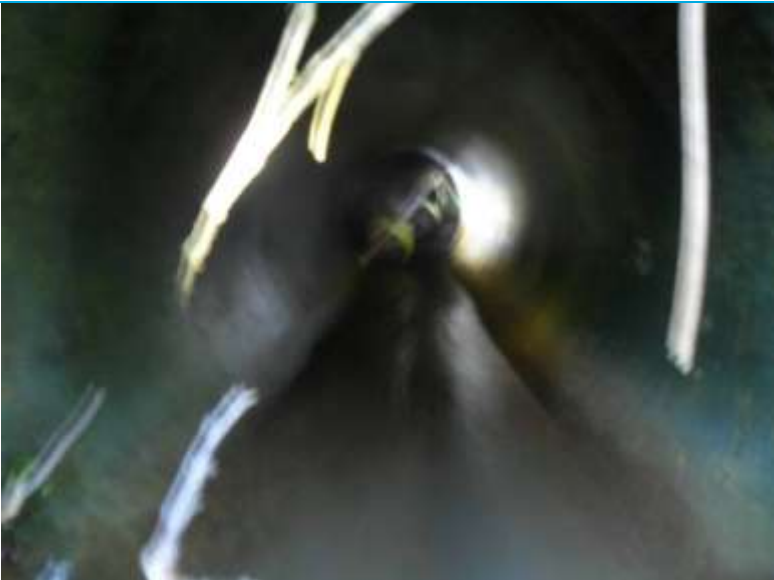
| | <p>Location : 5</p> <p>Description: Culvert offtake to Half Loaf Pond</p> <p>OS NGR: 29536 66681</p> <p>Notes:</p> |

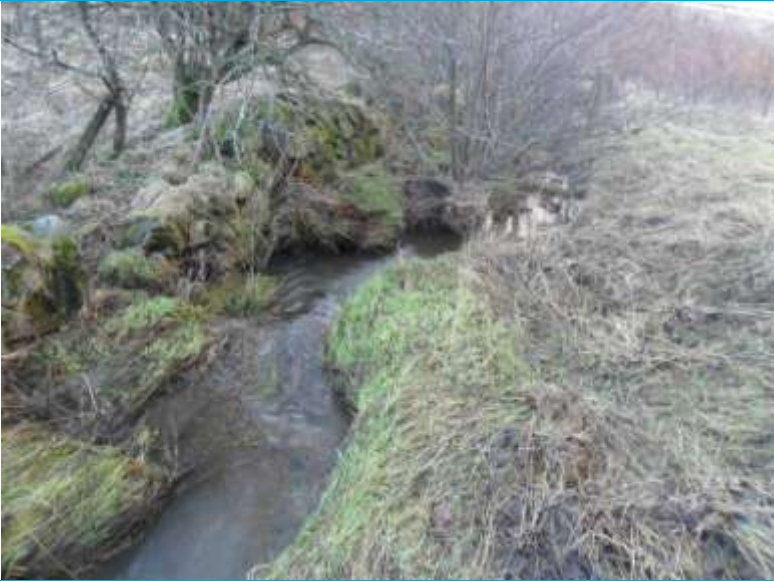
| | <p>Location : 8</p> <p>Description: Developing local channel sinuosity</p> <p>OS NGR: 29561 66692</p> <p>Notes:</p> |

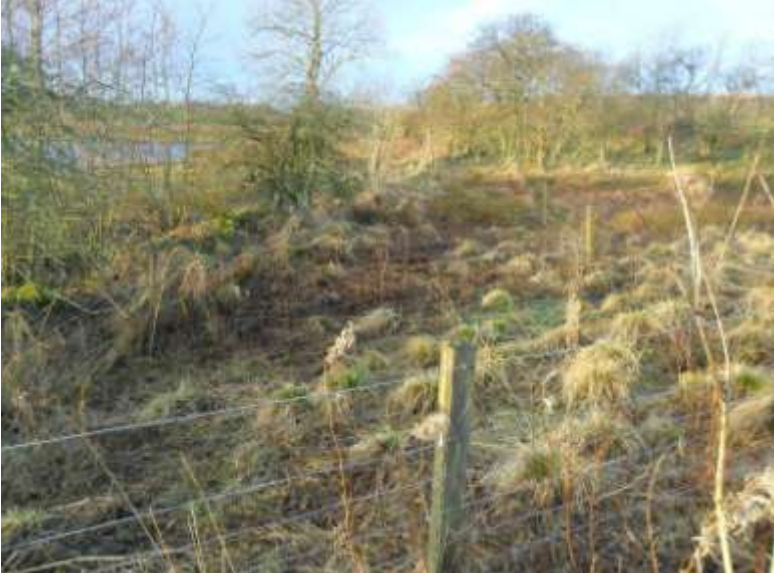
| | <p>Location : 9</p> <p>Description: Upstream of A801</p> <p>OS NGR: 29569 66693</p> <p>Notes: Detail of developing riparian</p> |

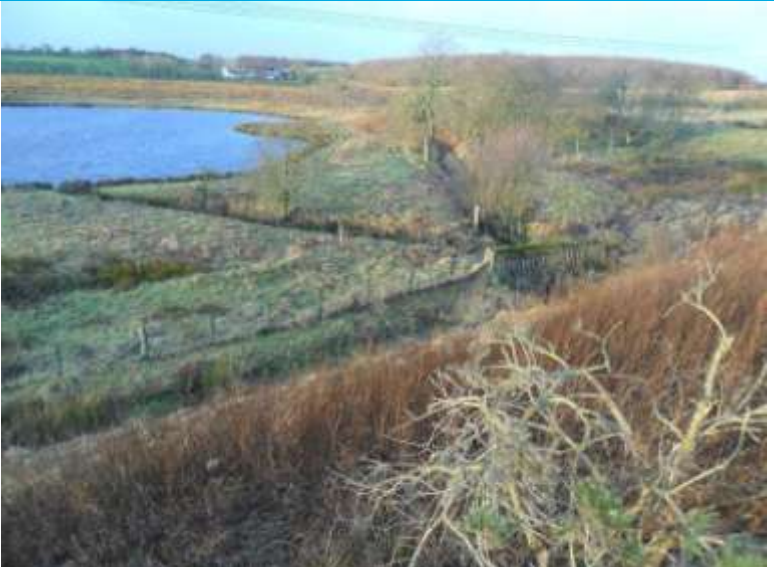
| | <p>Location : 9</p> <p>Description: Upstream of A801</p> <p>OS NGR: 29569 66693</p> <p>Notes: developing riparian on left bank</p> |

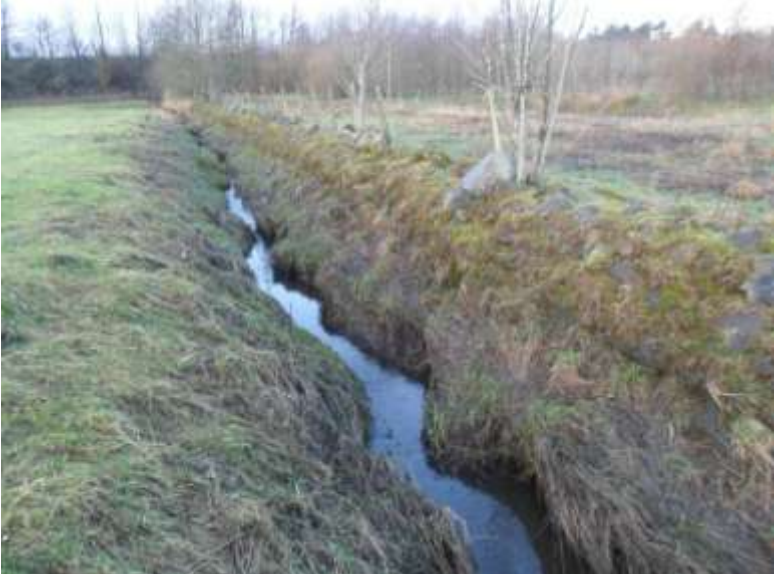
| | <p>Location : 13</p> <p>Description: Local channel activity increasing sinuosity</p> <p>OS NGR: 29587 66695</p> <p>Notes: Left bank flood wall also present</p> |

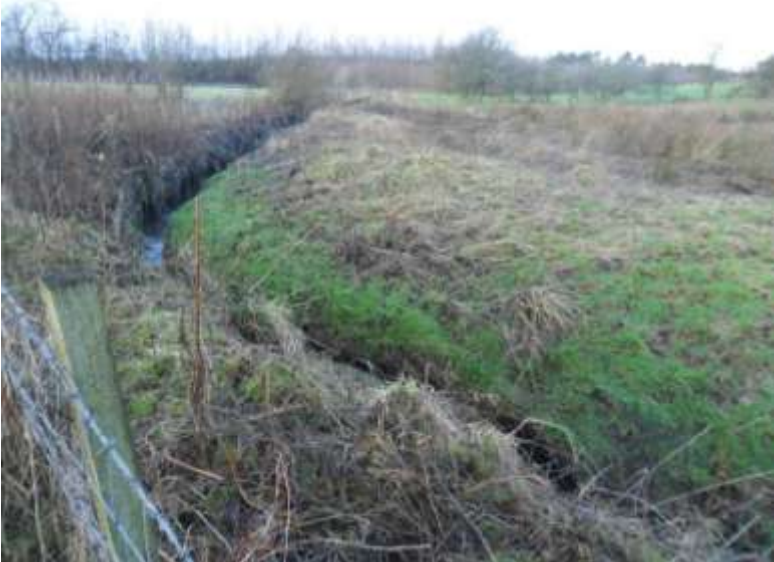
| | <p>Location : 14</p> <p>Description: Flood banks on left bank of Boghead Burn</p> <p>OS NGR: 29593 66694</p> <p>Notes:</p> |

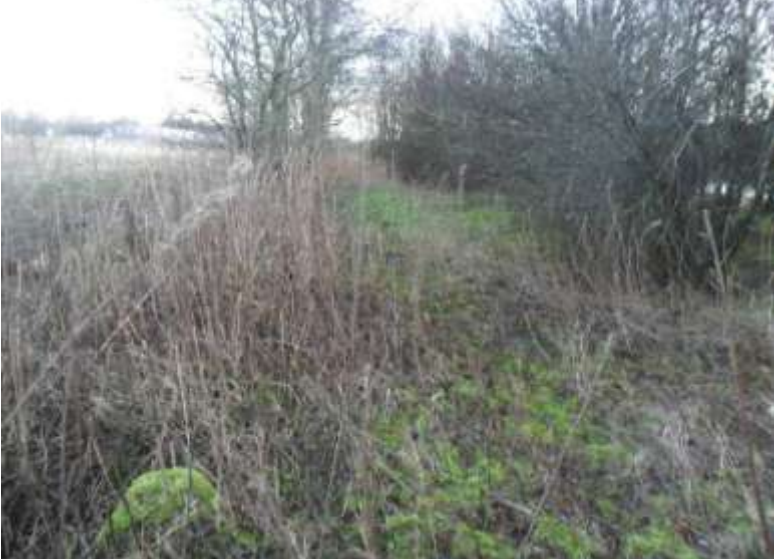
| | <p>Location : 15</p> <p>Description: Alder lined channel margin</p> <p>OS NGR: 29603 66700</p> <p>Notes:</p> |

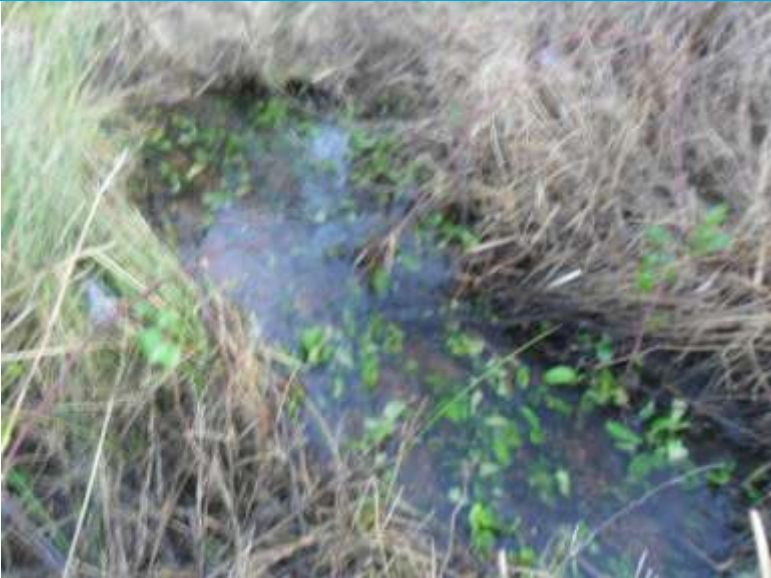
| | <p>Location : 16</p> <p>Description: Outflow from Half Loaf Pond</p> <p>OS NGR: 29606 66701</p> <p>Notes:</p> |

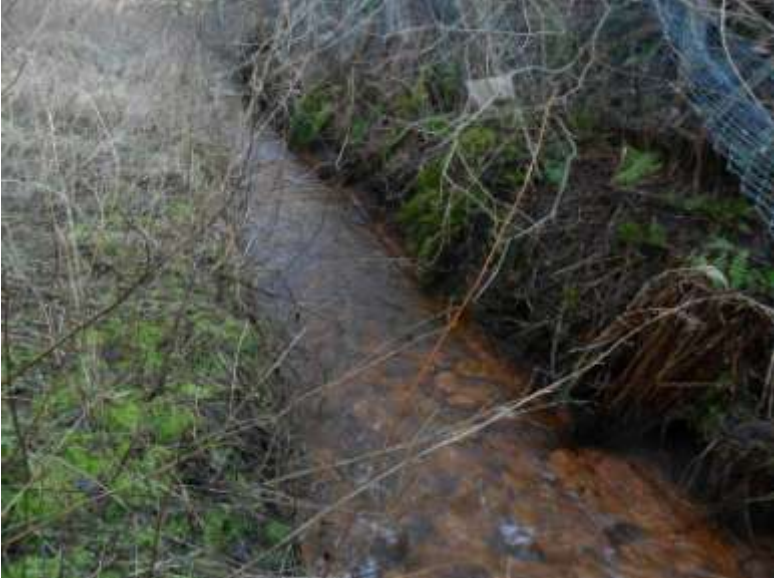
| | <p>Location : 20</p> <p>Description: Lined channel after Standhill depot culvert</p> <p>OS NGR: 29649 66703</p> <p>Notes:</p> |

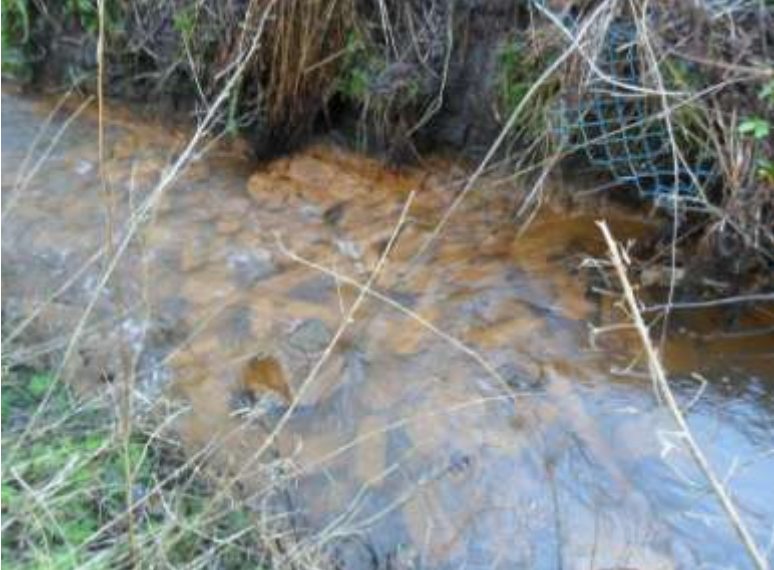
| | <p>Location : 21</p> <p>Description: Lined bed and banks to the channel</p> <p>OS NGR: 29657 66704</p> <p>Notes:</p> |

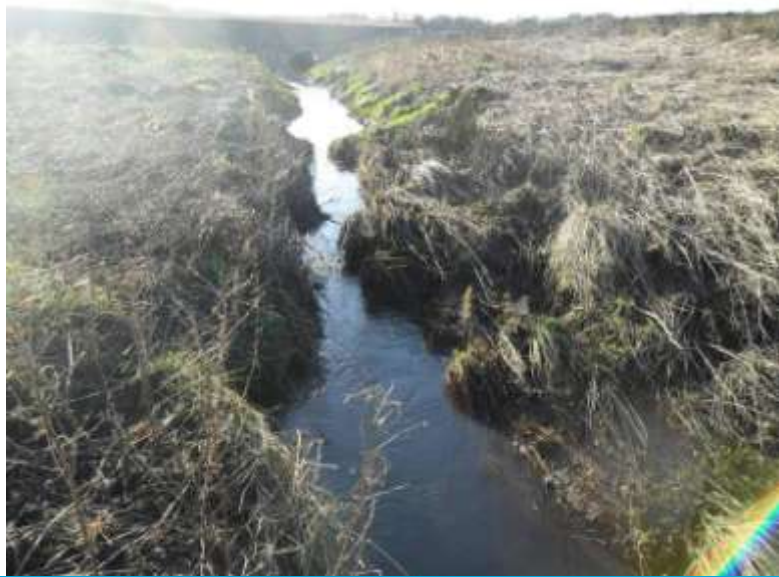
| | <p>Location : 27</p> <p>Description: Straightened but well connected channel across the floodplain</p> <p>OS NGR: 29704 66777</p> <p>Notes:</p> |

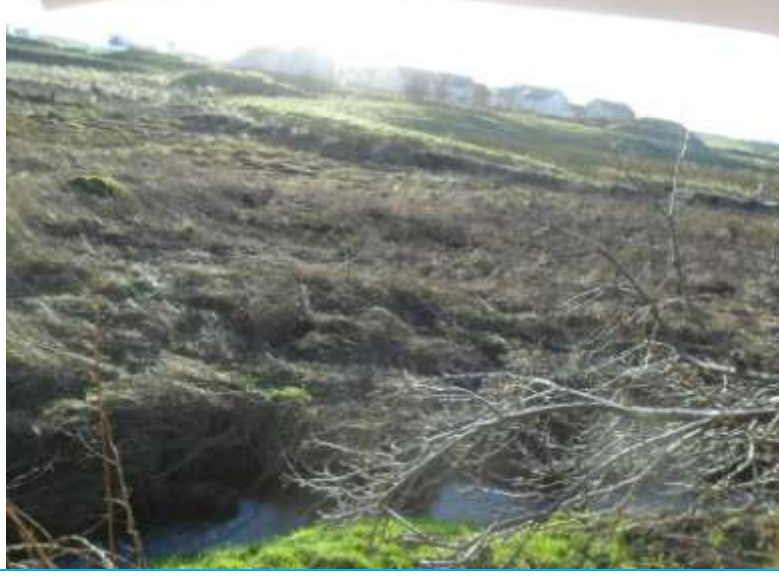
| | <p>Location : 29</p> <p>Description: Floodplain area west of Whiteside</p> <p>OS NGR: 29733 66771</p> <p>Notes:</p> |
