Back Burn Hydromorphic Character and Restoration Opportunities

FINAL

June 2012

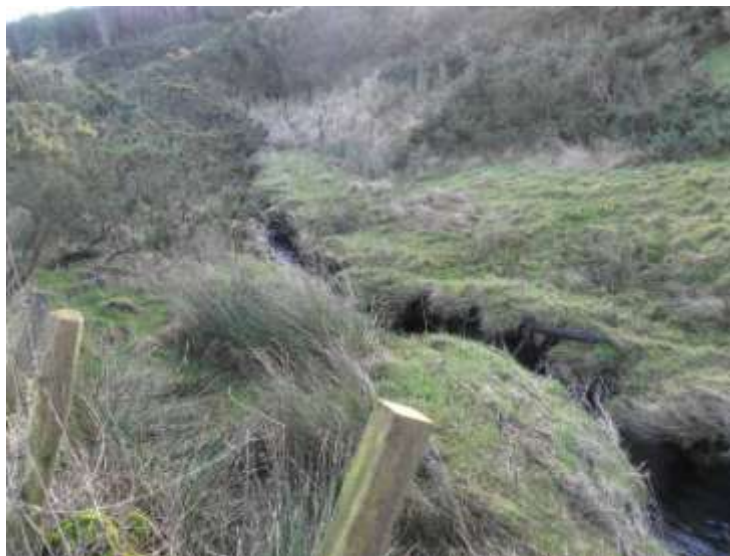
Figure 1-2: Slightly confined step - pool channel with restricted valley bottom deposits

The upper watercourse is characterised by a single thread pool - rapid channel dominated by boulder sized steps and rapids (Figure 1-2). The valley is quite confined and valley floor deposits are limited in lateral extent comprising of a mix of fluvial berms and stable valley side fan deposits that are slowly being reworked. Limited lateral activity is evident in the channel with dry stone walling collapsing into the channel in several places. Overall the hydromorphological character of the reach is natural and good. Some planting opportunities exist along the valley bottom and sides.

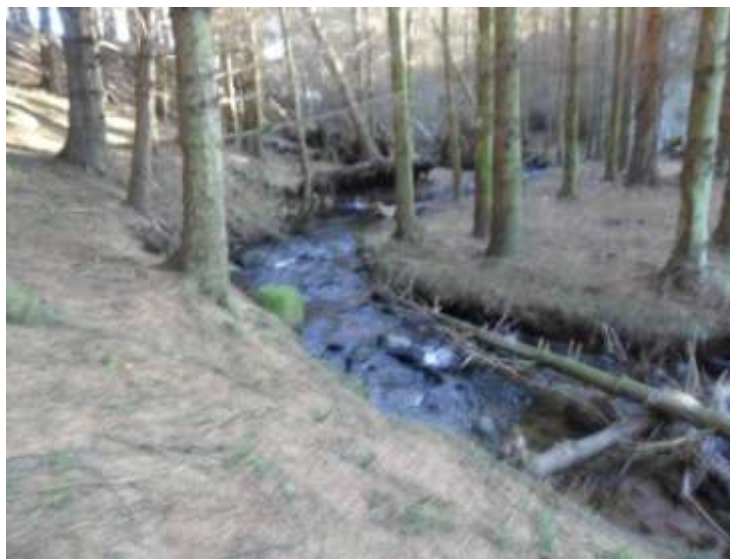
Figure 1-4: Boulder / cobble channel with limited but well developed wooded floodplain

Hairyholes Plantation (owner unknown) is a significant feature of the landscape in and around the watercourse. The land surrounding the burn is privately owned farmland. Shown on the 1940s Ordnance Survey map the plantation is mature and composed of Sitka spruce *Picea sitchensis* that is now mature and beginning to suffer from wind throw in places. Here and there large trees have fallen across the burn and form woody debris dams. In general though the plantation has had negative effect on the ecology of the burn as needle fall and deep shade have led to the almost complete absence of any ground flora, which is still plentiful immediately upstream and downstream of the plantation.

In the first reach a key recommendation would be to remove the Sitka spruce from the extension of the Hairyholes Plantation from the banks of the burn. This should be for a distance of 20m on either side (more so on the left bank) of the burn to allow light to enter the stream and encourage the growth of a riparian margin.

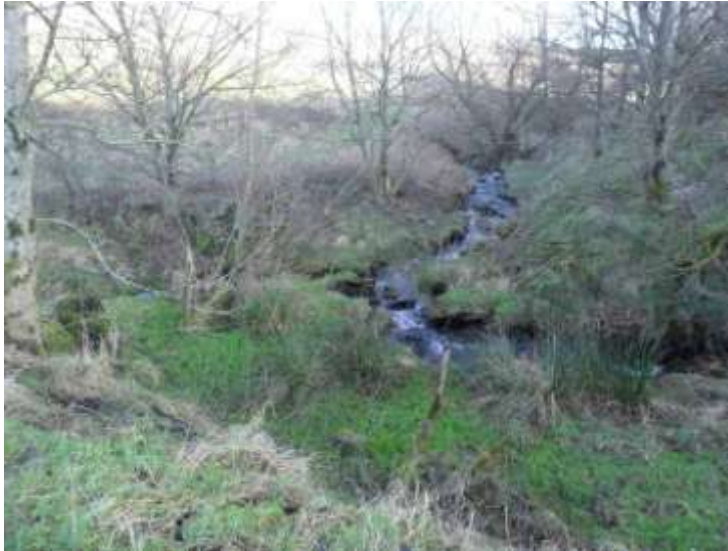
Figure 1-7: Diverse bedrock / boulder / cobble pool - rapid - riffle sequence

The natural channel remains steep and confined with a well developed boulder / cobble pool - rapid in-channel morphology. Valley floor development continues to be limited (Figure 1-7 and Figure 1-8). This natural pattern is significantly disrupted at the weir structure controlling flow into Coul reservoir (Figure 1-9). Mixed sediment has accumulated behind the weir and is now passing over the structure and downstream (Figure 1-10).

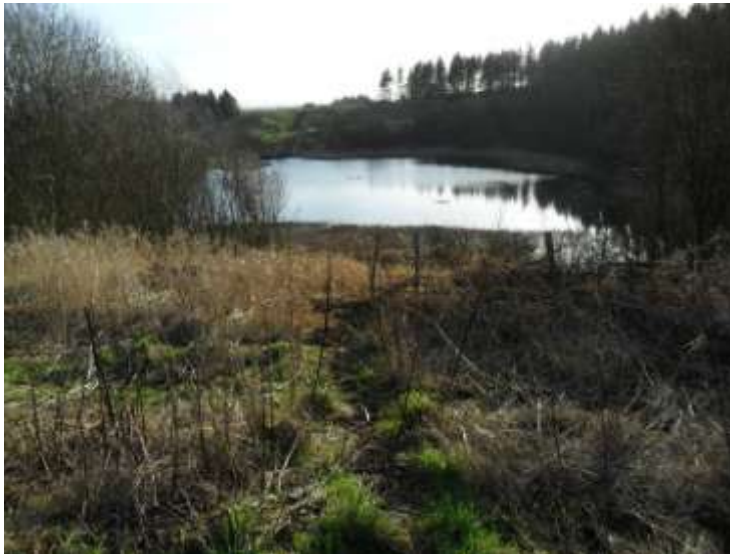
Figure 1-11: Overview of Coul Reservoir

The reservoir was originally constructed in 1890 for the Markinch and Wernyss Distillery (Figure 1-11) and a long lined raceway (Figure 1-12) transferred flows past the reservoir when it was full. The reservoir is now a redundant structure and is part of a Local Nature Reserve known as Coul Den. The land is privately owned.

The most interesting restoration project for the burn would be at the Coul Reservoir. Here it is a recommendation that the existing cast-iron sluice gate at the start of the raceway be removed (or if protected, closed) to allow water to once again flow into the former channel occupied by the burn. This would dramatically improve the ecology of this steep valley and would increase the throughput of water into the reservoir and ensure that the outflow channel flows all year round.

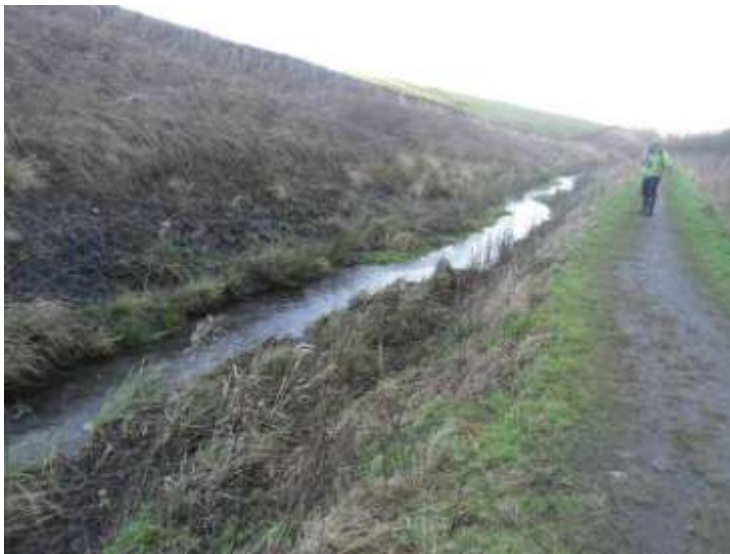
Figure 1-12: The raceway around Coul Reservoir

This raceway is steep and uniform and has a lined bed free of stored coarse sediment. It is currently a major barrier to fish due to the weirs at the top and bottom end (Figure 1-14) and the uniform high velocity flow created along the engineered channel. The reservoir wall was breached in 1998 and water levels were lowered and the limited flow in the original channel has now created a semi-confined boulder pool - rapid channel (Figure 1-14) grading into a wet woodland anastomosed channel (Figure 1-15) across sediment accumulated in the reservoir.

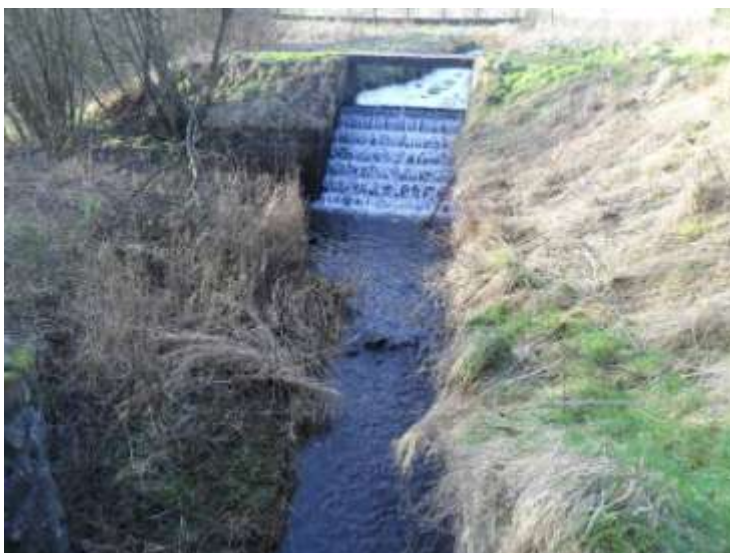
Figure 1-13: Walled reach at the exit weir from the raceway and gabion lined reservoir outflow channel

On the downstream side the overflow channel is lined with gabion baskets and it being invaded by willow saplings. This is quite a steep channel and at the time of the visit was virtually non-flowing. Once this leaves the reservoir it is met on the left bank by the redirected water which has flowed around the reservoir via the raceway and then downhill through a long stone-lined race that will only allow passage for eels *Anguilla anguilla*. Adjacent to this race is another plantation, this time composed mainly of English oak, *Quercus robur*. The further downhill you go, the more the oak thins out until, where it meets the now reconstituted burn, the ground flora is dominated by bracken *Pteridium aquilinum* with only a few isolated hawthorn *Crataegus monogyna* bushes present. Here, in the damper areas, less favoured by bracken, butterbur *Petasites hybridus* is common.

This section of channel offers an excellent opportunity for restoration reducing the flow split into the raceway and creating a more natural confluence with the original channel through the gabion lined exit channel (Figure 1-13).

In order to aid this, work will need to be undertaken on the outflow channel to increase its naturalness whilst at the same time ensuring that the residual amount of water in the loch is safely impounded, thus retaining the areas of fen carr at the back of the reservoir which support important bird populations that utilise the reservoir. This would have the advantage of effectively reconstituting the original course of watercourses and improve the connectivity of the burn with the valley sides as well as increasing the opportunities for migratory fish to

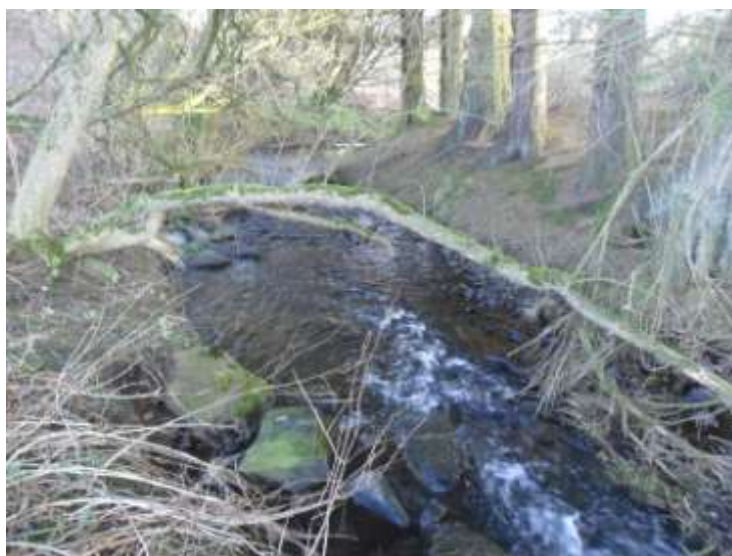
Figure 1-16: Mixed sediment pool - rapid - riffle reach

After the channel leaves the raceway and is joined by intermittent flows from Coul Reservoir (Figure 1-13) it flows through an area of farmland (arable & improved grassland) with opportunities for riparian planting. It then enters a well wooded confined reach displaying pool - rapid - riffle sequences (Figure 1-16). Some fine sediment was seen in the channel bed indicating an increase in diffuse inputs. Elsewhere the wooded riparian supplies ample material for debris jams (Figure 1-17) creating local hydromorphic diversity.

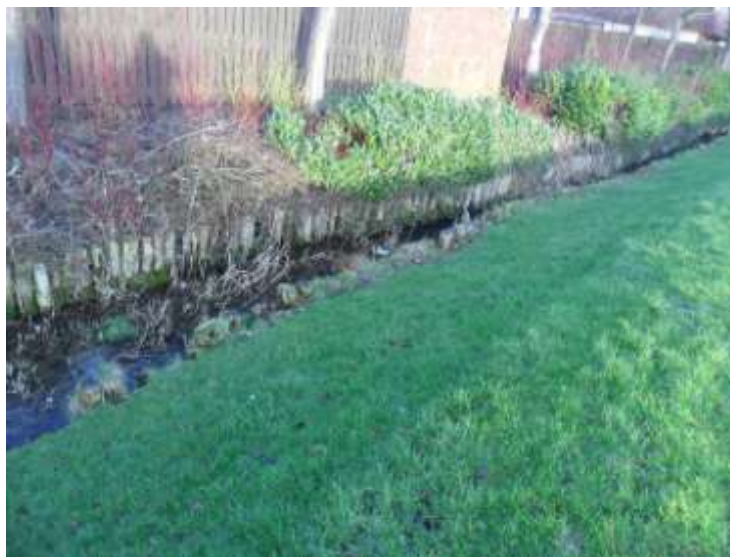
Figure 1-21: Ornamental channel section through the Balfarg housing estate

After this the river is majorly modified through the housing estate with a narrowed section and numerous flow obstructions. It emerges periodically into shrubberies and small, wooden-lined channels on the roadside. This eventually widens out and flows under a stone bridge where the channel is situated within a stretch of amenity grassland and hawthorn scrub. Here a line of Leyland cypress *Chamaecyparis leylandii* has recently been felled opening up the channel which has been diverted around the property, leaving a dry, grass and leaf-filled channel a few metres to the south (Figure 1-22). The original channel course has been abandoned in several places in favour of ornamental reaches (Figure 1-21) through and adjacent to houses and gardens. This is most notable close to the A92(T) where restoration is possible (Figure 1-22).

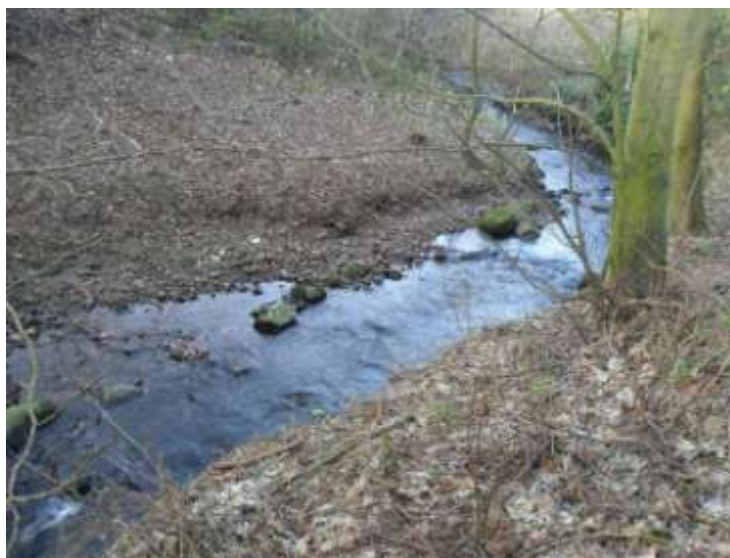
Figure 1-23: Semi-confined cobble / gravel pool - riffle - rapid reach.

The stream here is over-engineered and has the odd patch of water crowfoot *Ranunculus aquatilis* in the channel and very little else, barring some acrocarpous mosses on the channel linings.

On the other side of the A92 the burn is once again in good health with its flow restored. Here there are a number of obstructions in the watercourse, such as weirs, culverts and a redundant gauging weir. These structures and the associated gabion baskets should be removed so that the stream can have a more natural relationship with the surrounding woodland. In one place defences are required due to the presence of a buried water main, which forms a bank with manholes parallel to the burn. This has become infested with snowberry, a non-native species, and this should be removed to restore the woodlands to a more natural state and promote the growth of ground flora.

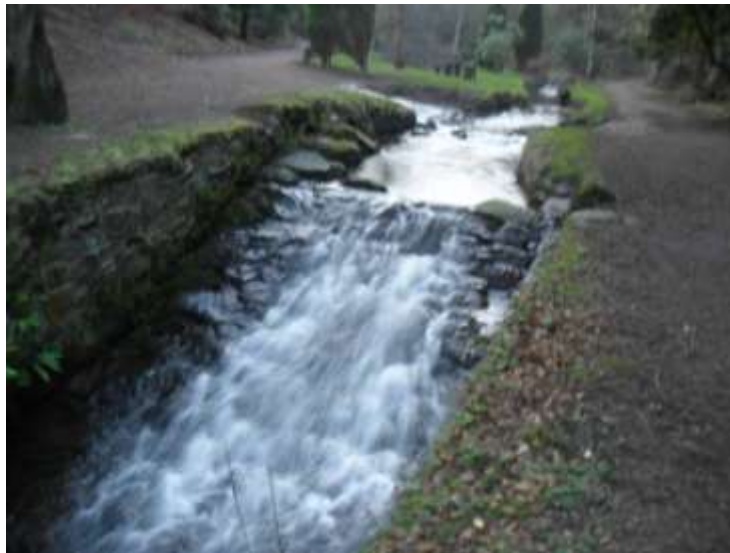
Figure 1-26: Ornamental weir structure.

The river is extensively modified after the Balbirnie House Hotel with further weirs (Figure 1-26) and channel bank lining (particularly past the Balbirnie Park Golf Course). Gradient change linked to the weirs has led to the river forming plane-bed - riffle areas. All should be considered for removal / modification.

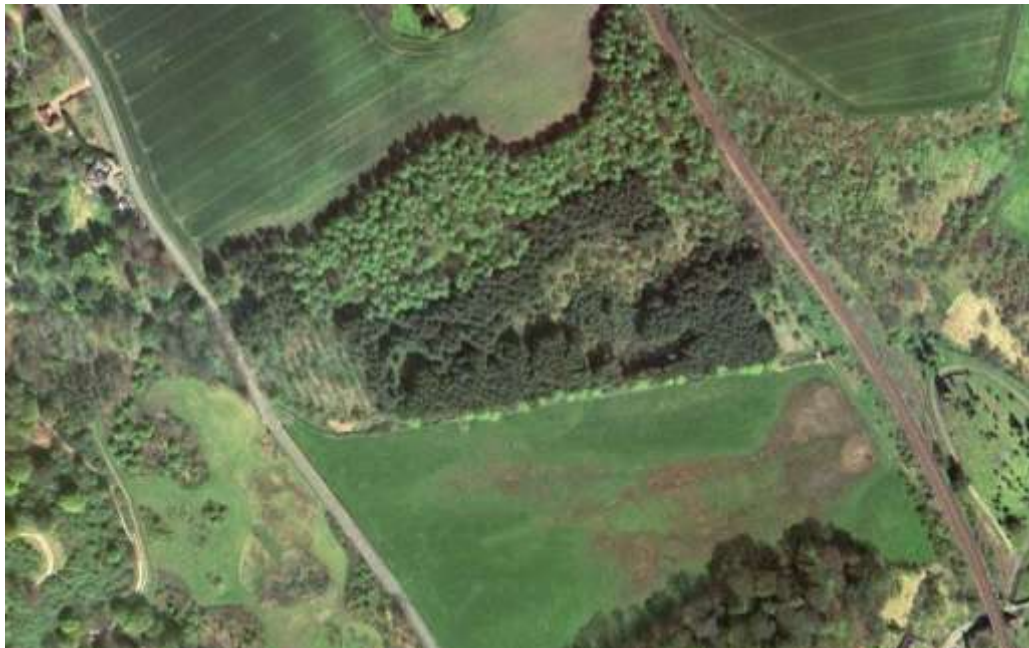
Figure 1-28: Aerial view of the floodplain between Stub Cross Road and the railway line
(copyright Google Earth 2012, getmapping plc 2012)

The character of the channel changes again as it exits the confined wooded valley close to Stob Cross Road. Here the river has been straightened (Figure 1-27) having originally flowed in channels to the south and north of the current river. The channel route to the south, although older than the northern channel, is evident from line of rush (Figure 1-28) and offers a significant opportunity for restoration and wetland creation close to the railway crossing.

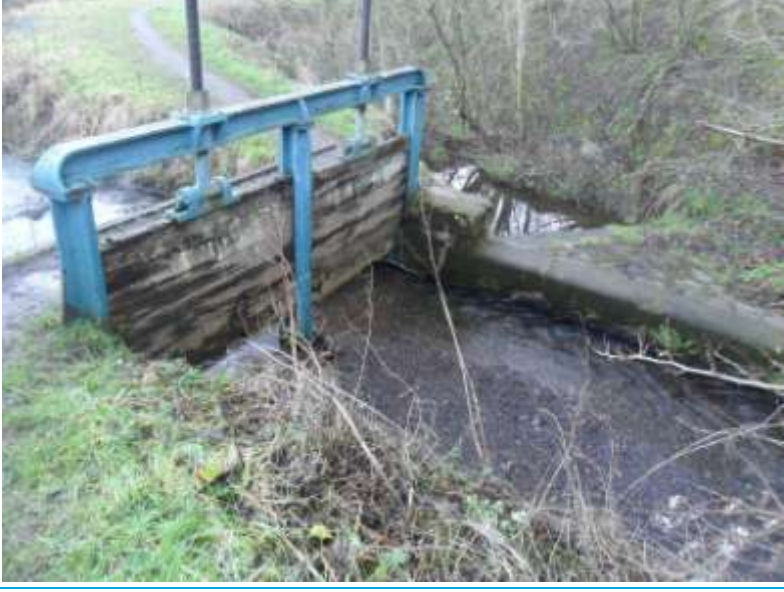
<p>Location : 9</p> <p>Description: Weir exit into raceway at Coul Reservoir</p> <p>OS NGR: 32656 70401</p> <p>Notes:</p>

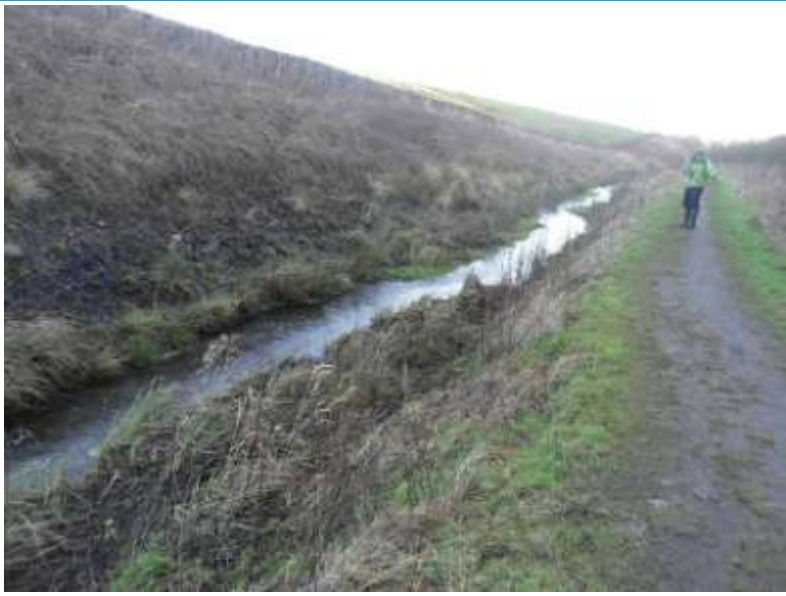
<p>Location : 9</p> <p>Description: Old sluice gates controlling reservoir / raceway flow split</p> <p>OS NGR: 32656 70401</p> <p>Notes:</p>
 	<p>Location : 9</p> <p>Description: Mixed gravels accumulated above the raceway weir</p> <p>OS NGR: 32656 70401</p> <p>Notes:</p>

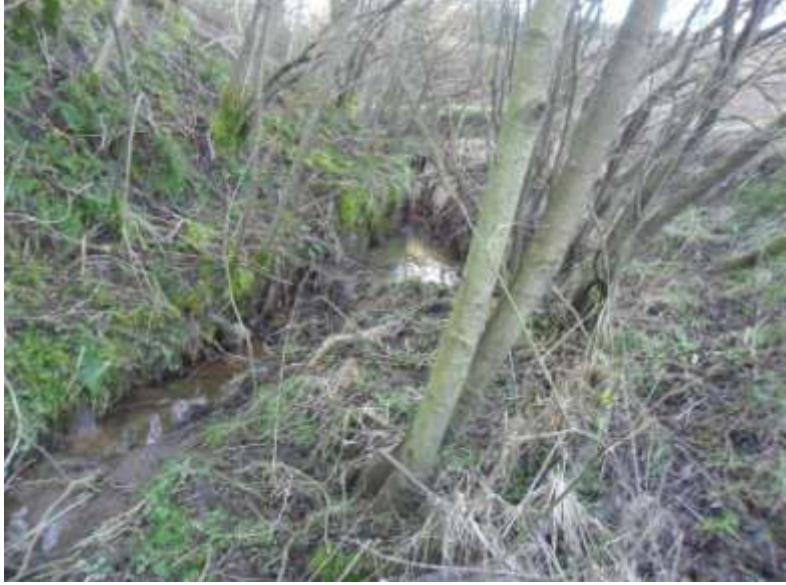
<p>Location : 10</p> <p>Description: Artificial uniform raceway on lower gradient</p> <p>OS NGR: 32682 70397</p> <p>Notes: Some marginal berm development</p>

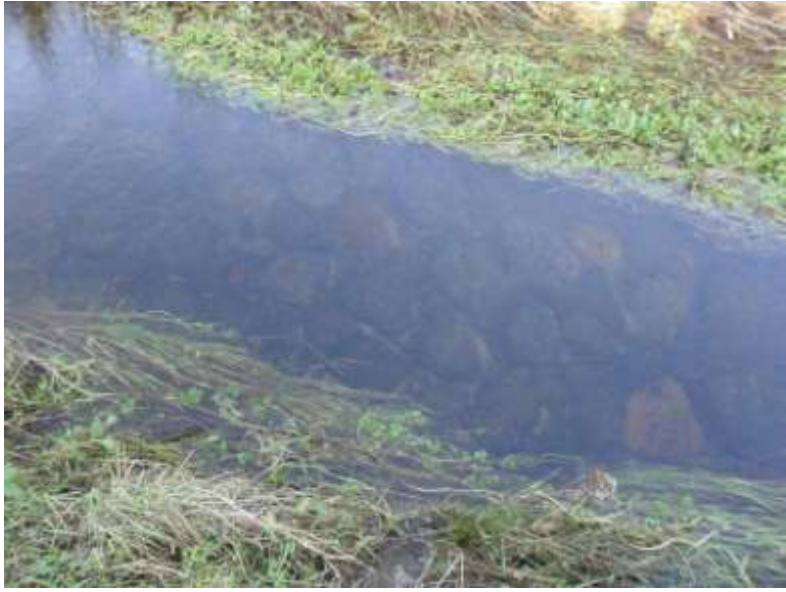
<p>Location : 13</p> <p>Description: Willow carr</p> <p>OS NGR: 32688 70385</p> <p>Notes:</p>
 	<p>Location : 14</p> <p>Description: Overview of Coul Reservoir</p> <p>OS NGR: 32696 70382</p> <p>Notes:</p>
 	<p>Location : 15</p> <p>Description: Raceway</p> <p>OS NGR: 32694 70400</p> <p>Notes:</p>

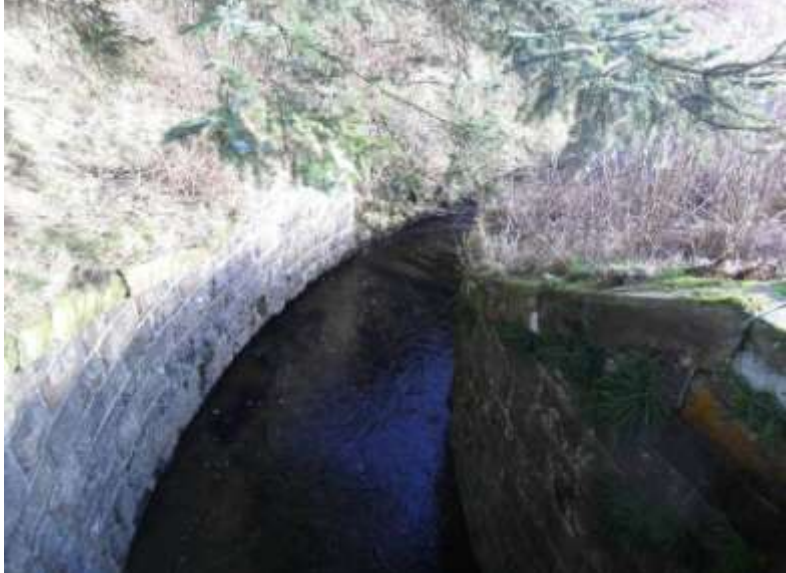
<p>Location : 16</p> <p>Description: Cobble lined raceway</p> <p>OS NGR: 32698 70401</p> <p>Notes:</p>
 	<p>Location : 17</p> <p>Description: Weir at raceway exit</p> <p>OS NGR: 32705 70392</p> <p>Notes: reservoir outflow channel on right bank (gabion lined)</p>

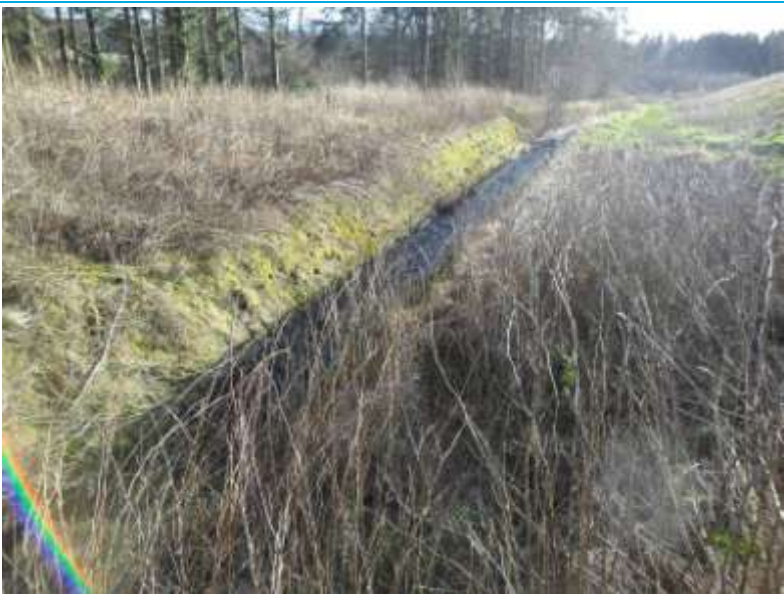
<p>Location : 18</p> <p>Description: Walled exit to raceway</p> <p>OS NGR: 32708 70379</p> <p>Notes:</p>

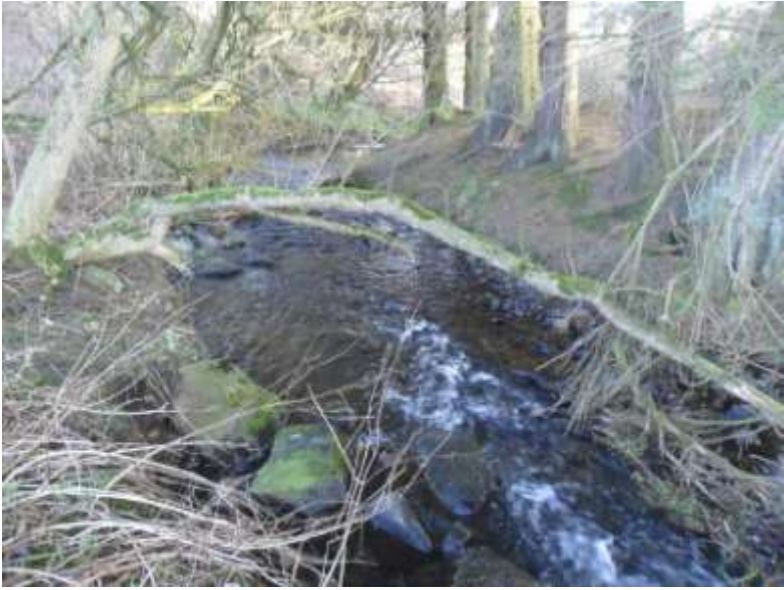
<p>Location : 19</p> <p>Description: Lined raceway</p> <p>OS NGR: 32708 70378</p> <p>Notes:</p>

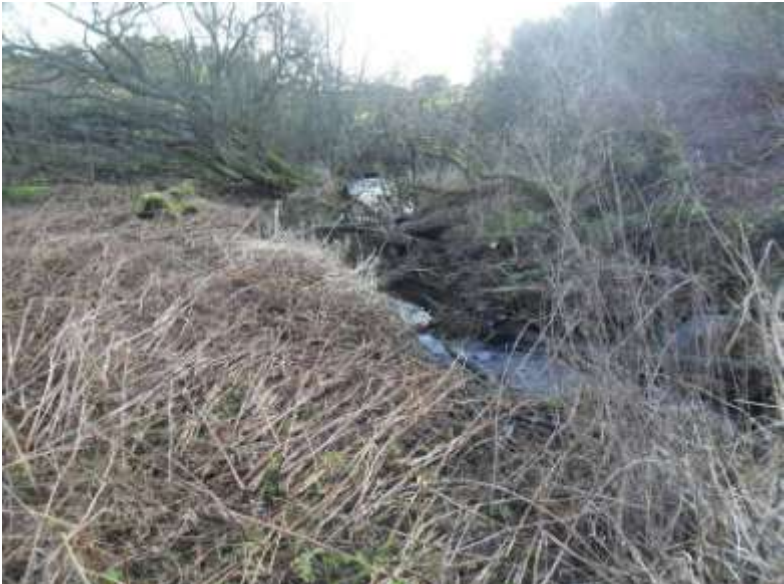
<p>Location : 20</p> <p>Description: Gravel / cobble plane-bed riffle – rapid channel</p> <p>OS NGR: 32714 70378</p> <p>Notes:</p>

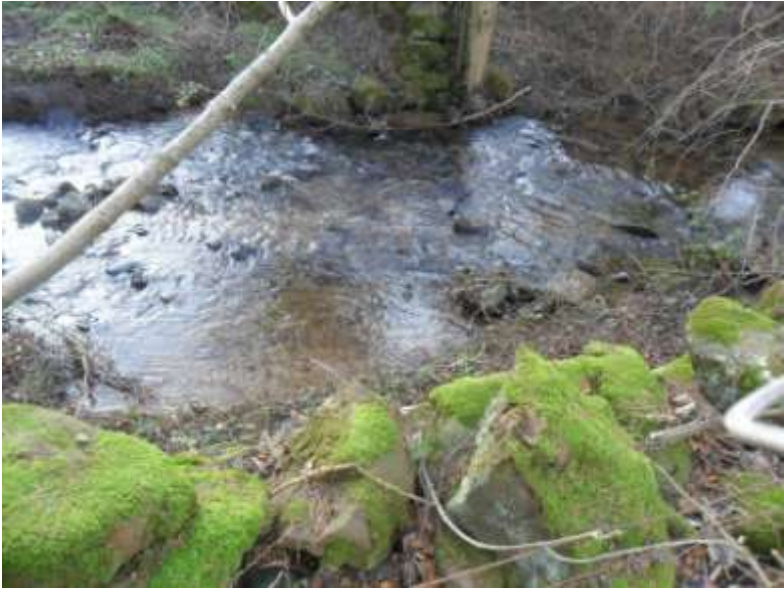
<p>Location : 21</p> <p>Description: Woody debris dam</p> <p>OS NGR: 32748 70360</p> <p>Notes:</p>

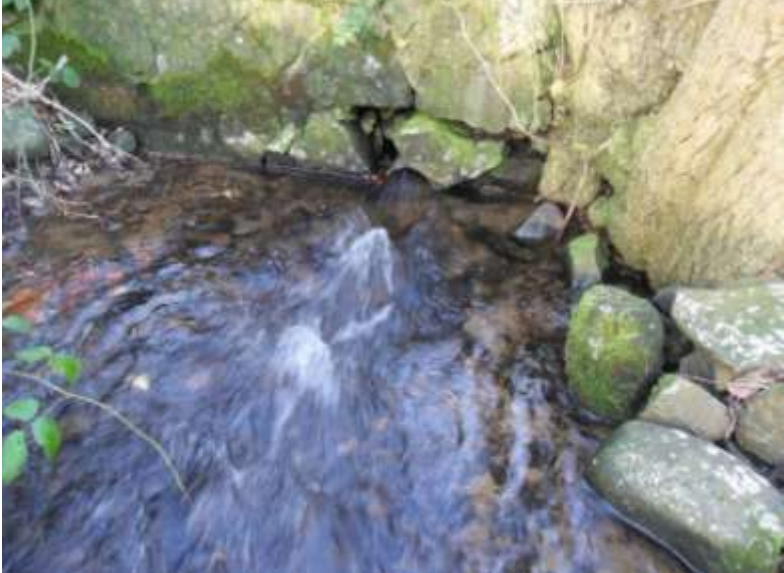
<p>Location : 23</p> <p>Description: Flume entrance to road culvert</p> <p>OS NGR: 32802 70335</p> <p>Notes:</p>

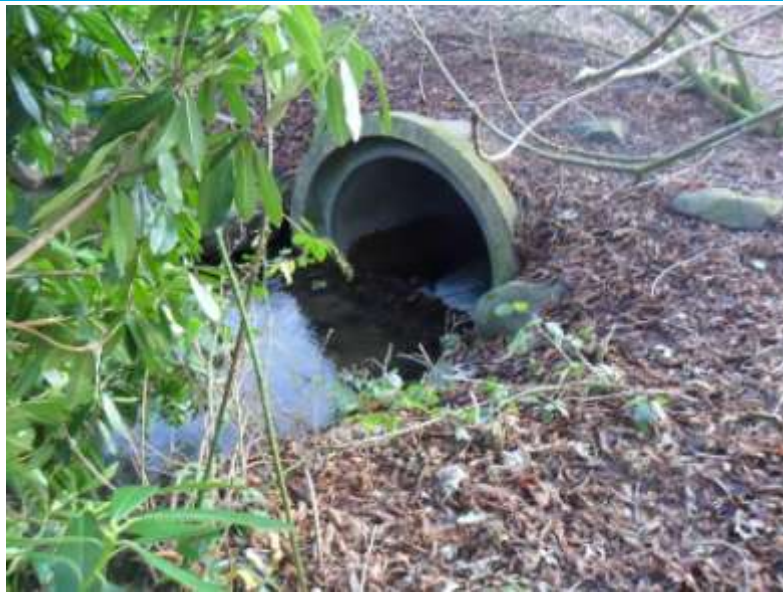
Location : 34

Description: Piped culvert

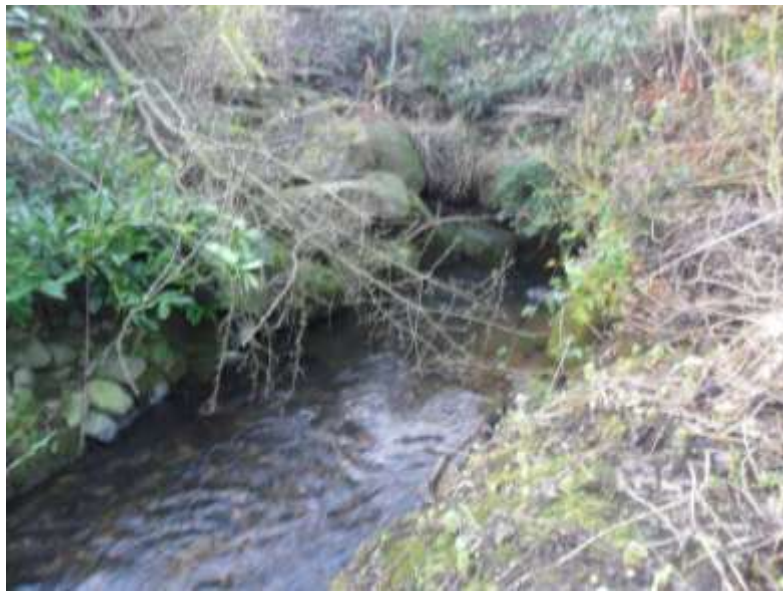
Location : 35

Description: Boulder
blockstone bank
protection

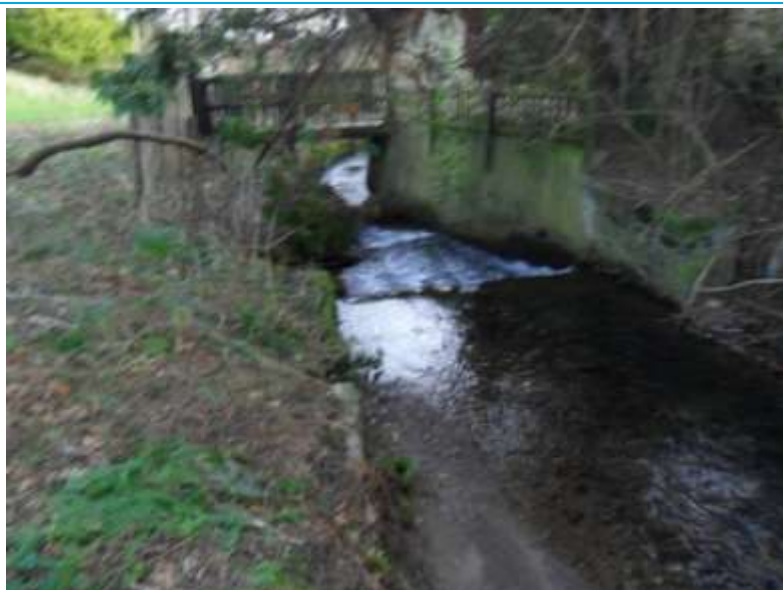
Location : 36

Description: Small weir,
bridge and lined channel
banks

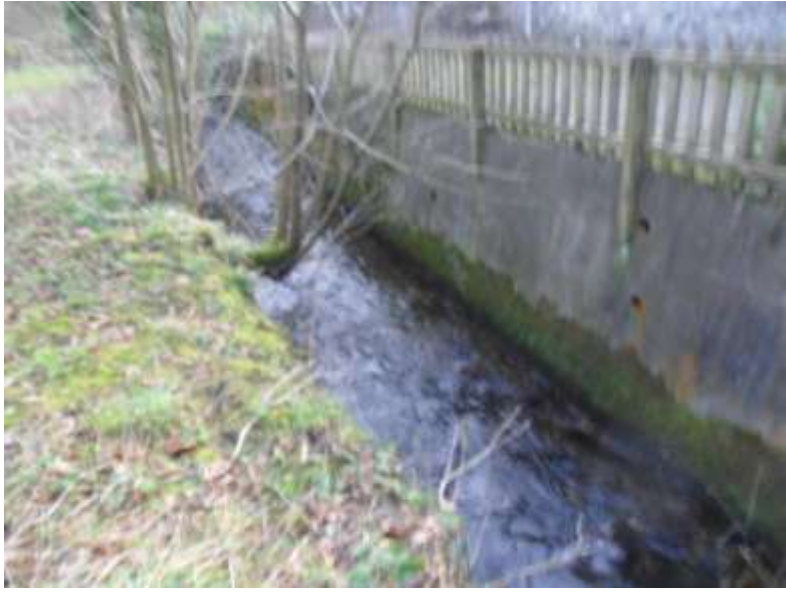
<p>Location : 37</p> <p>Description: Lined channel banks</p> <p>OS NGR: 32864 70285</p> <p>Notes:</p>

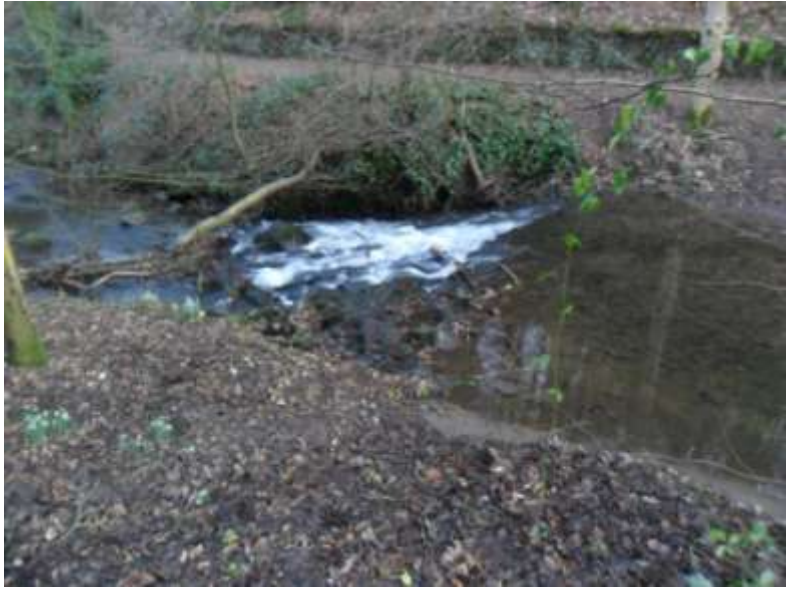
<p>Location : 38</p> <p>Description: Boulder weir structure</p> <p>OS NGR: 32869 70268</p> <p>Notes: Extend boulder area downstream if removal not possible</p>

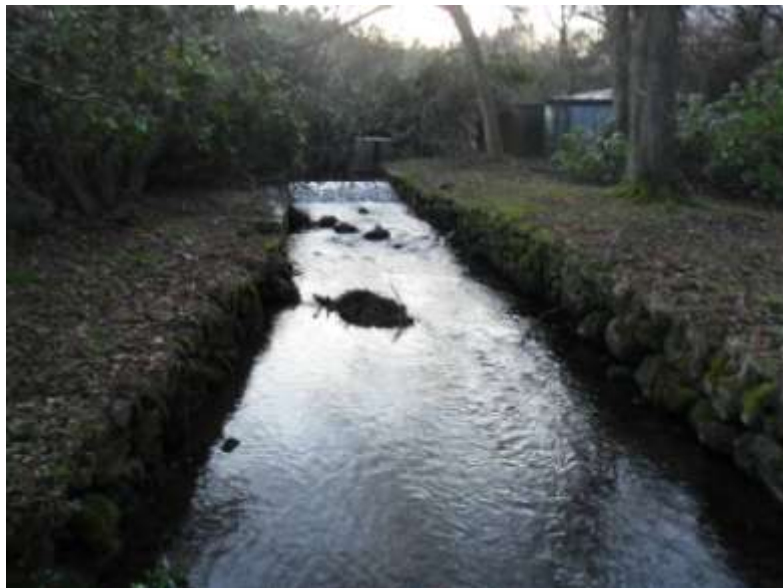
Location : 41

Description: Small weir backing up water for the golf course

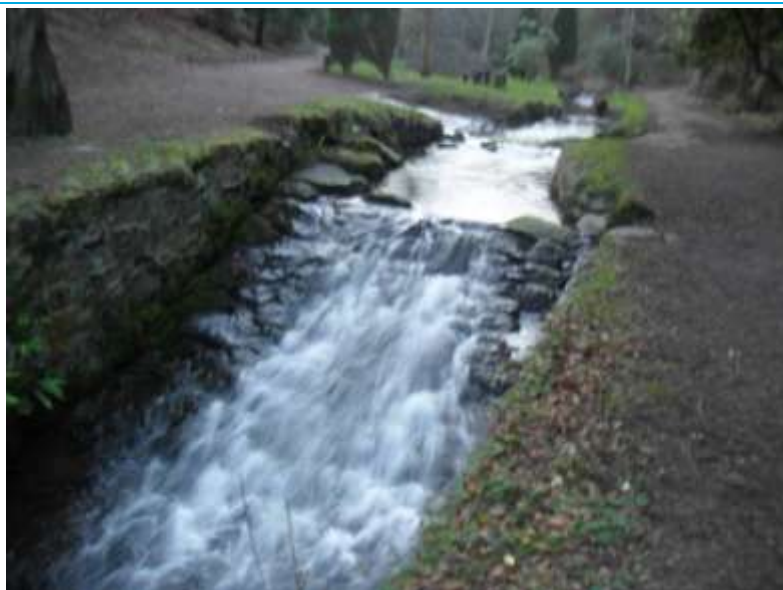
Location : 42

Description: Boulder weir and lined channel
