Some thoughts on channelized streams, salmonid fish and their management in arable eastern Scotland.

David Summers

Tay District Salmon Fisheries Board

September 2013

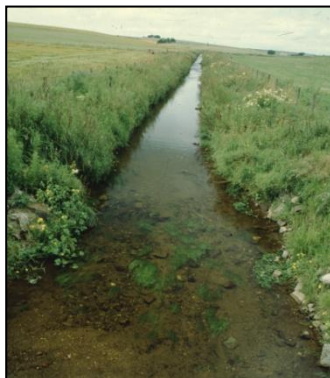
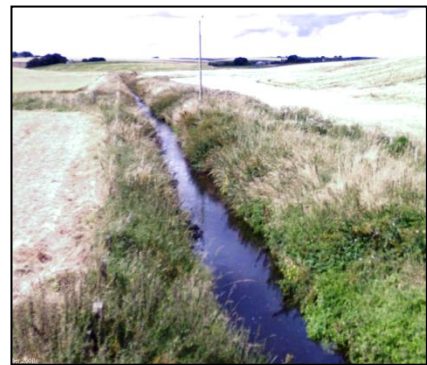
Figure 1.9 Fedderate Water, tributary of South Ugie Water, Aberdeenshire, just downstream of Figure 1.8.

Left photo taken *ca.* 1990 following maintenance dredging. Right photo, recent image from Google Street View, facing opposite direction. Note type of substrate, gradient and velocities in early photo. Note also degree of encroachment by vegetation in recent photograph. Clearly a very stable channel in the absence of dredging.

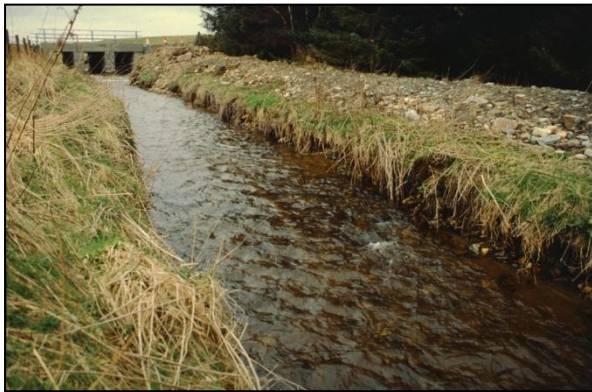
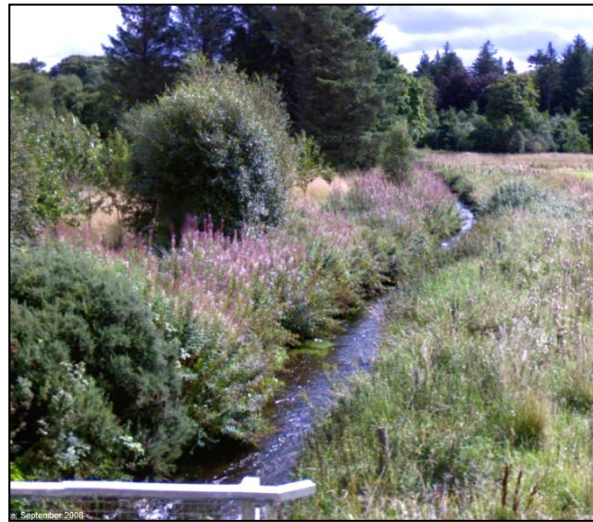
Figure 1.10. Tributary of North Ugie Water, Aberdeenshire.

Left photo taken *ca.* 1990 following maintenance dredging. Right photo recent image from Google Street View. Again this channel appears highly stable in the absence of maintenance dredging.

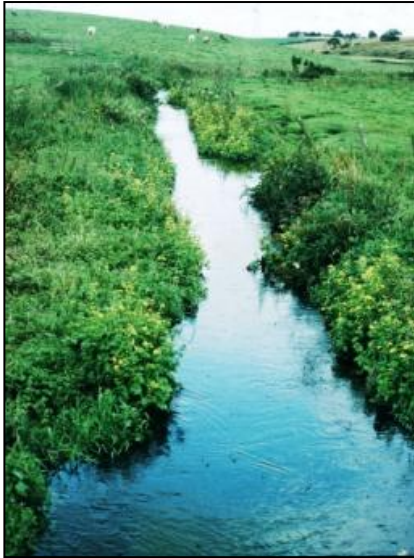
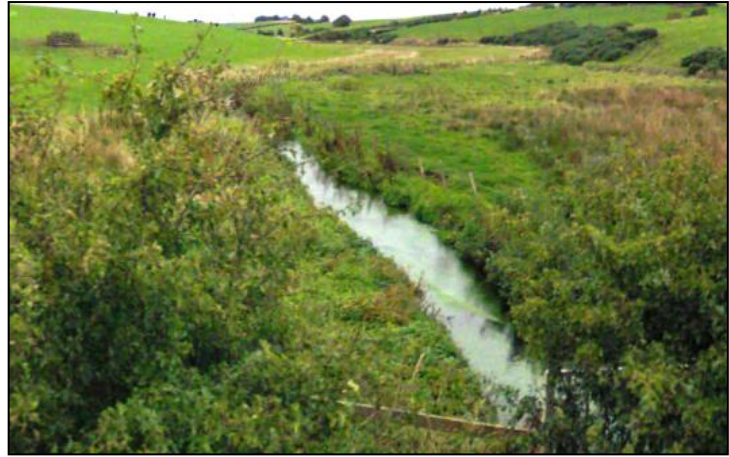
Figure 1.16. Little Water, tributary of River Ythan, Aberdeenshire.

Photo on left taken *ca.* 1992. Right photo, recent image from Google Street View. Again, clearly a stable channel, but benefit of fencing clearly demonstrated.

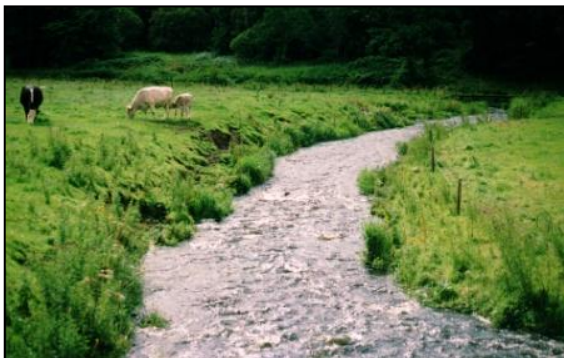
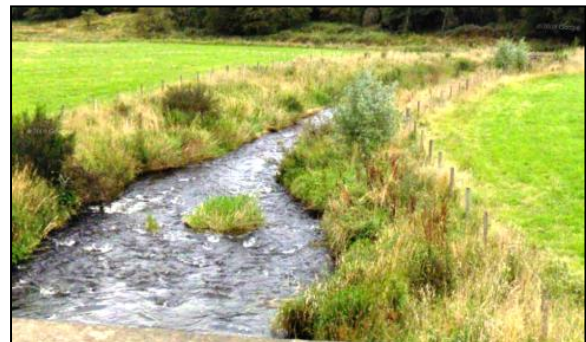
Figure 1.17. Cruick Water, tributary of River North Esk.

Photo on left taken *ca.* 1992. Right photo, recent image from Google Street View. Again, clearly a stable channel.

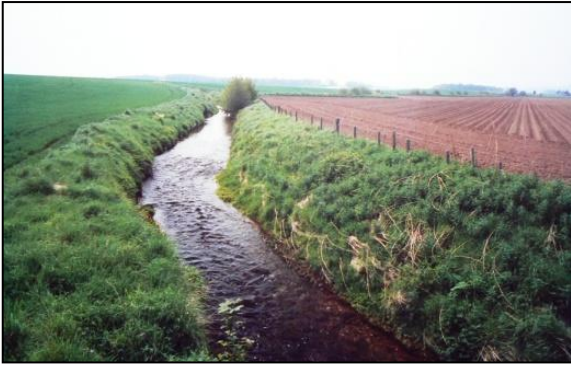
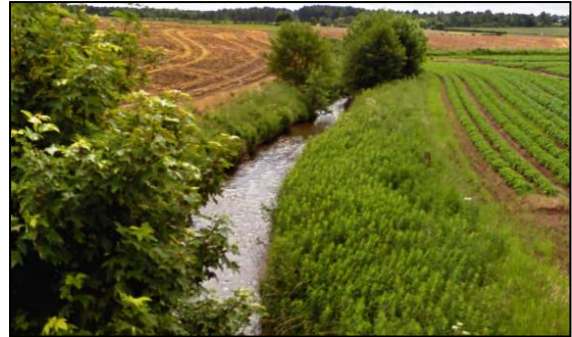
Figure 1.18. River Ythan, Fyvie, Aberdeenshire.

Photo on left taken *ca.* 1992. Right photo, recent image from Google Street View. Again, clearly a stable channel.

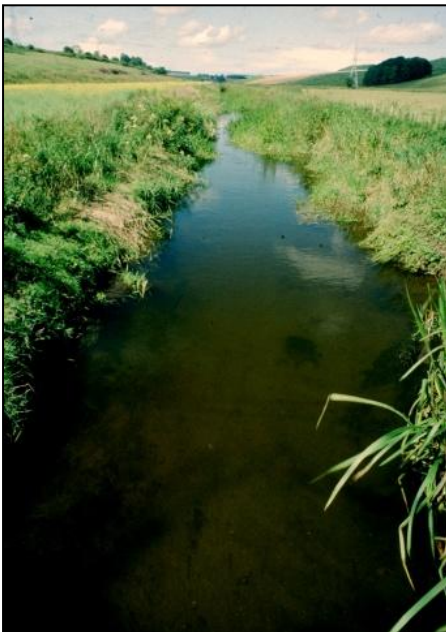
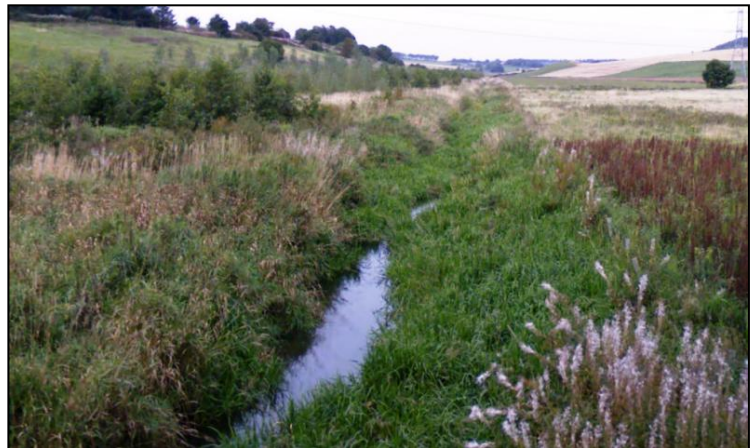
Figure 1.19. River Ythan, Fyvie, Aberdeenshire.

Photo on left taken *ca.* 1992. Right photo, recent image from Google Street View. Again, clearly a stable channel.

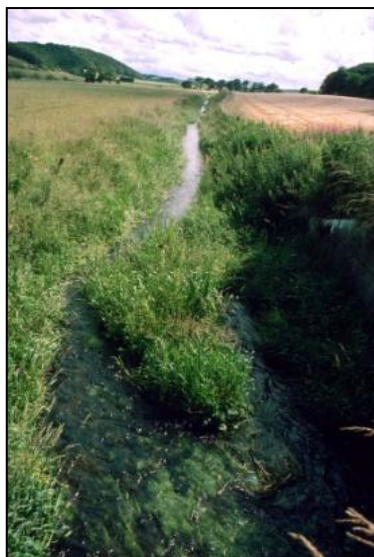
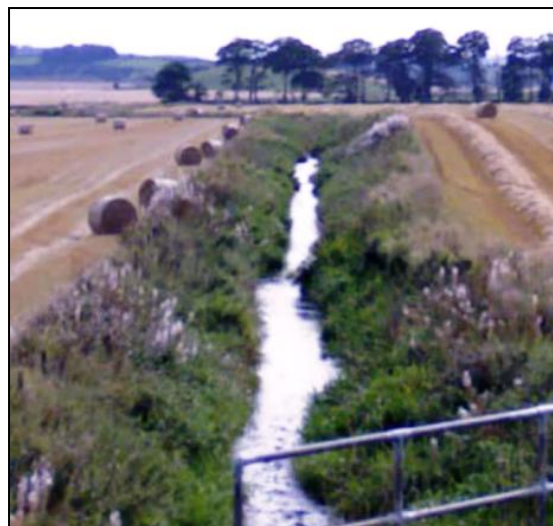
Figure 1.20. River Ythan, Fyvie, Aberdeenshire.

Photo on left taken *ca.* 1992. Right photo, recent image from Google Street View. Again, clearly a stable channel. Note clear benefit of fencing.

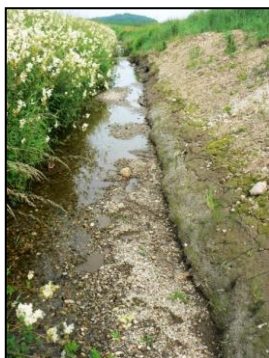
By July 2013 there was some recovery of vegetation but the stream was still very open, lacking in cover, depth of water, variety of substrate etc. It was also more prone to heating (see Appendix 7). In time, if left alone, the stream will improve until dredged again. Ironically since the rules were relaxed there has been a lot of this recently.

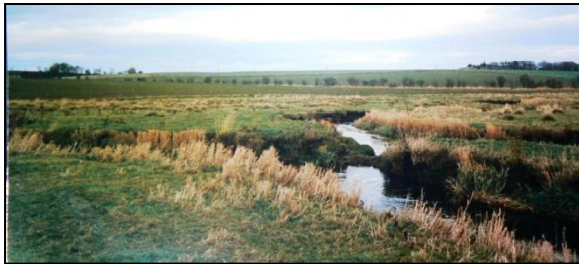
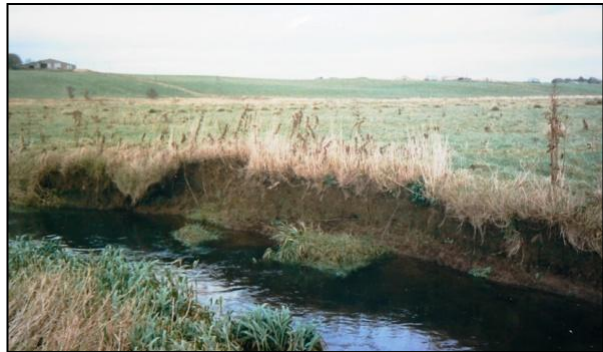
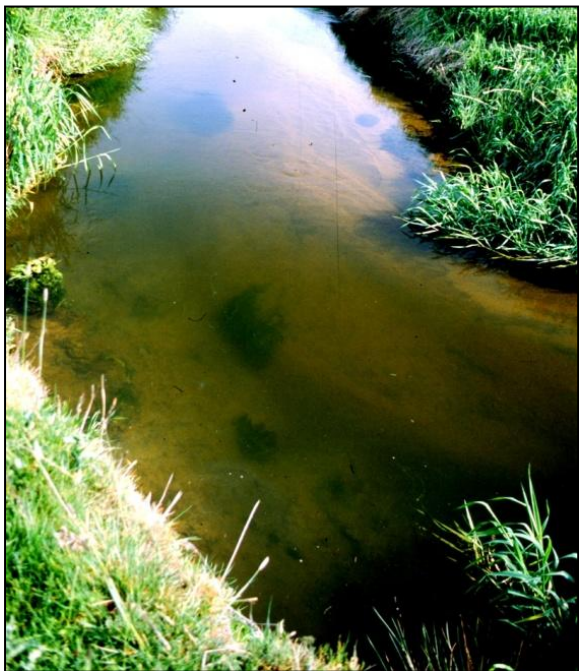
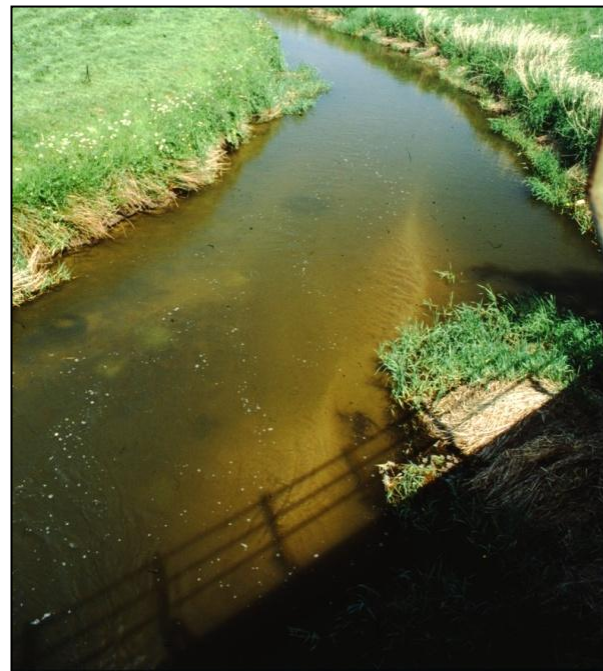
Close detail of the channel can be seen in the four photos overleaf. The two upper photos show the South Ugie water just upstream of Longside *ca.* 1987. The stream is narrow, tortuous, and relatively deep with steady smooth flow. Banks are cohesive silt/clay. Note incipient formation of cut-off and oxbow (the dried oxbow can be seen on recent aerial photos). No classic pools and gravel riffles exist in this reach. The gradient is simply too low.

The lower two photos are of the South Ugie just downstream of Longside, *ca.* 1990, taken in clear water conditions.

Sand / finer sediments clearly cover the bed, forming ripples and dunes. The gradient / current velocity is too low to prevent the temporary deposition of sediment during its passage downstream.

I imagine that, historically, there would have been less sand, which is a product of land erosion upstream. While probably never a prime habitat for the youngest stages of salmonids – particularly salmon – I would hypothesise the presence of all this sand has made it even worse.

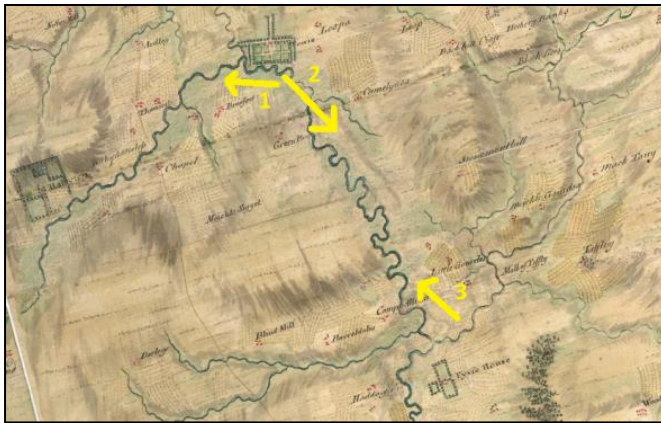
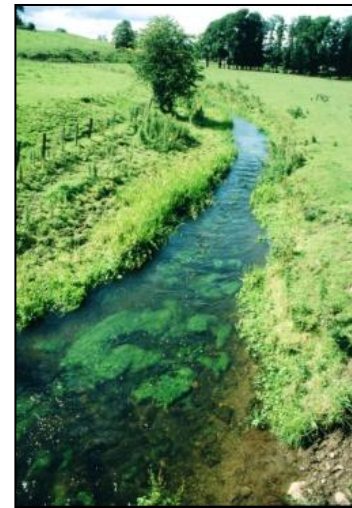
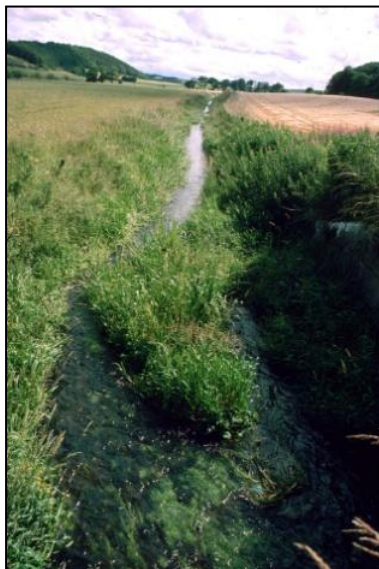
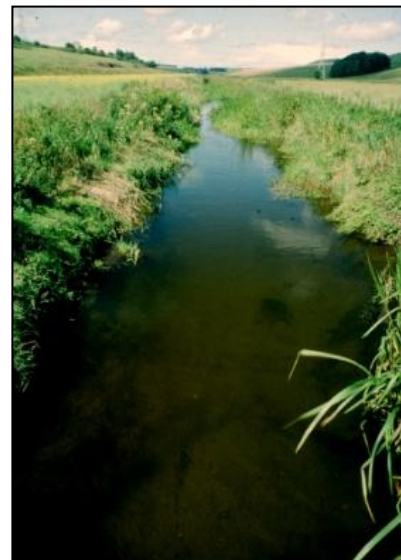
Example 1. River Ythan, Fyvie, Aberdeenshire.

The River Ythan upstream of Fyvie flows through a low gradient flood plain. The Roy Map of the 1750s indicates the river had tortuous meanders (top left photo below). Arrows on the Roy Map show approximate positions of photographs taken in 1992. 1 is the top right photo, 2 is the bottom left photo and 3 is the bottom right photo.

These photos show that the river has been totally straightened. In the top right photo, the river is now relatively shallow with run / riffle and coarse substrate. The bottom left photo also indicates a relatively fast current, but by the bottom right, the valley gradient is so low that even, with meanders removed, current velocities are still low and a fine substrate dominates.

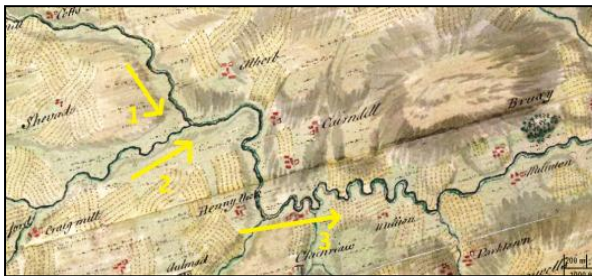
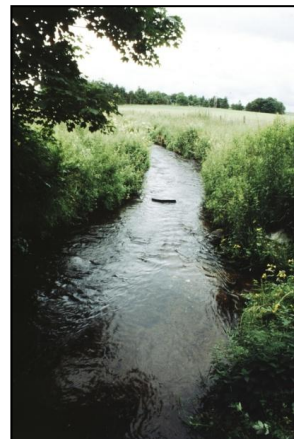
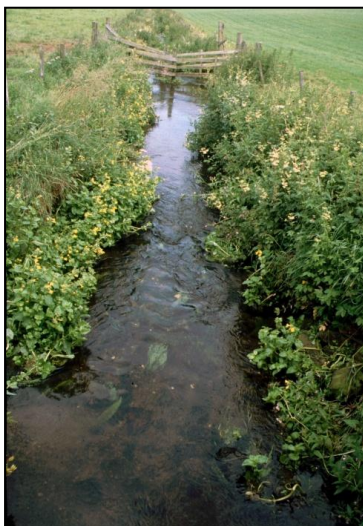
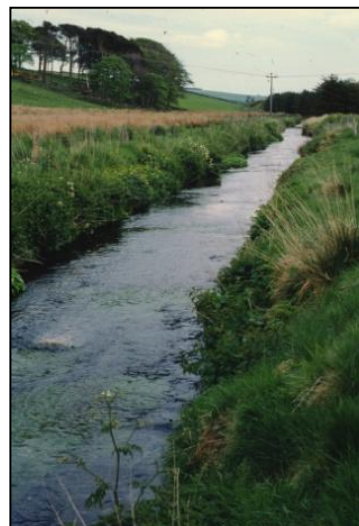
Example 2. South Ugie Water, Maud, Aberdeenshire.

The Roy Map of the 1750s (top left photo below) indicates that the South Ugie Water in the vicinity of the present village of Maud had areas of tortuous meanders, similar to the lower South Ugie at present. The top right photo, location indicated by arrow 1 on the Roy Map, was probably always in a steeper zone with less meandering. However, it has been clearly channelized and deepened. The main flow type now is riffle / run, mainly relatively shallow with a cobble substrate. Good numbers of trout (sea trout) fry particularly were found here in the past at least (up to 2.61 per m²).

The stream indicated by arrow 2 is shown in the bottom left photo. It is clearly straight and currently is a mix of pool habitats and shallower faster riffles with coarser substrates. Good densities of juvenile trout were found here in the past too (see Figure 1.5). The bottom right photograph is typical of the area where there were tortuous meanders (arrow 3). The river is now straight, relatively shallow and has a reasonable velocity with a predominantly gravel substrate (see Figure 1.11). Note also the growth of *Ranunculus* which does not grow in slow water. Electrofishing has revealed reasonable salmonid densities here in the past.

Based on both the look of the habitat and actual fish data, these three sections, though not perfect, are much more suitable as habitats for juvenile salmonids, particularly spawning and early stages, than the habitat in the lower South Ugie where it is still meandering.

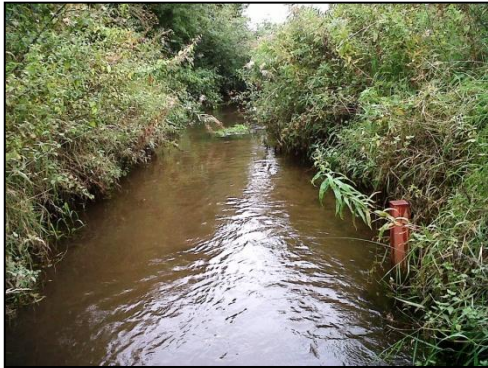
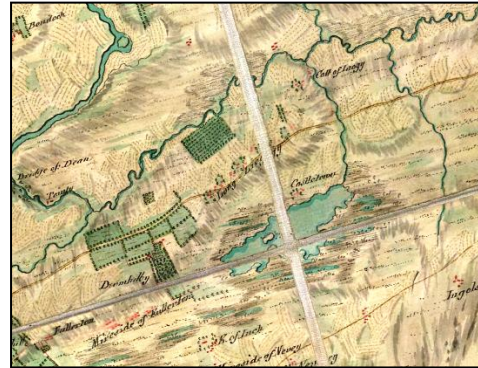
Example 3. Castleton Burn, tributary of River Isla, Perthshire.

In this instance, the burn, despite being channelized, has a low gradient and is relatively slow and silty (left photo below). On electrofishing, a low density of salmonids was found. However, on investigation it turns out this stream was actually a loch 250 years ago (right photo below). Thus, where even after channelization, streams still are slow and pooly, there must just be no valley gradient.

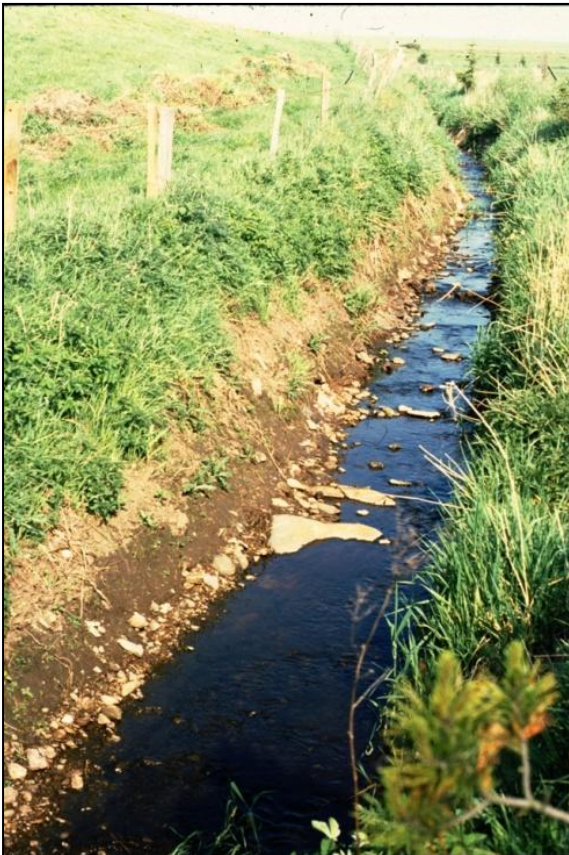
The photo opposite encapsulates some of the main features of channelization.

The stream gradient has increased. In this instance the gradient is such that the stream has basically been turned into a shallow riffle.
