Braid Burn Hydromorphic Character and Restoration Opportunities

FINAL

June 2012

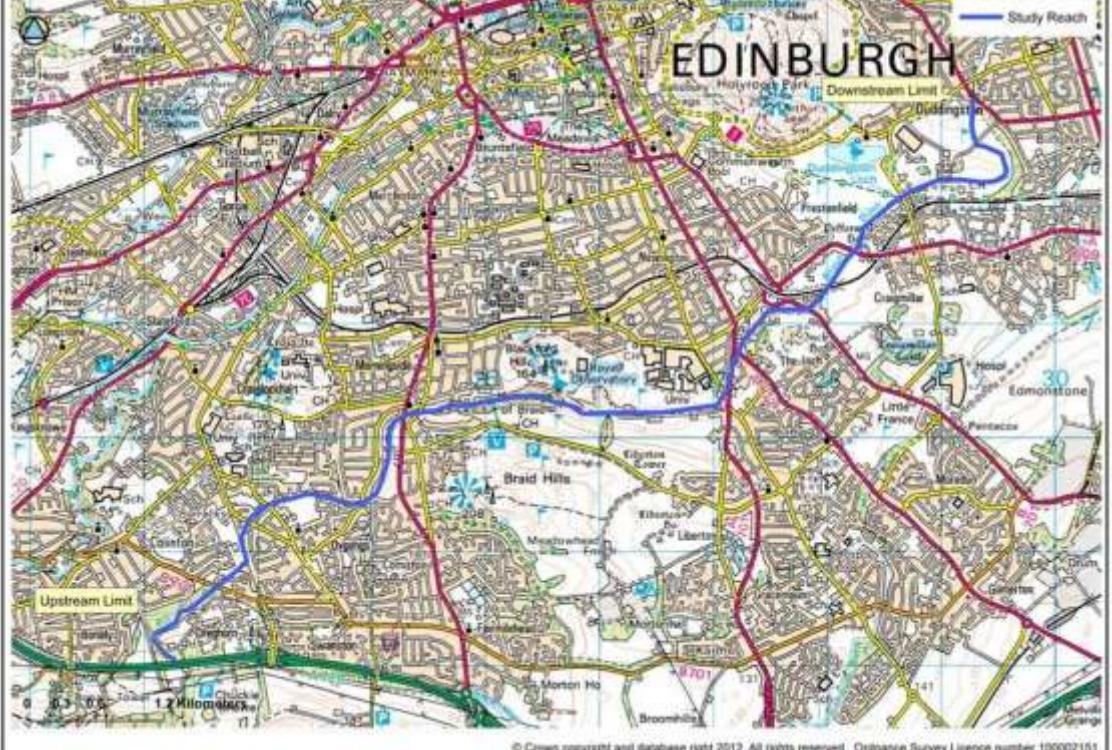
The Braid Burn was subject to walkover survey in January 2012 from the Edinburgh Bypass (A72) through Dreghorn, Colinton Mains, the Braid Burn Valley, the Hermitage of Braid, West Mains, Peffermill and Duddingston (Figure 1-1).

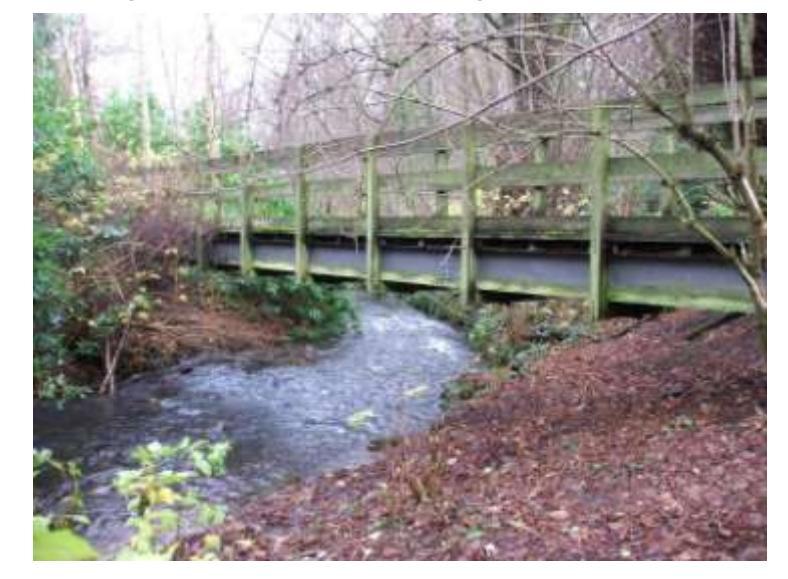
Figure 1-2: Footbridge over the Braid Burn showing invasive Rhododendron ponticum

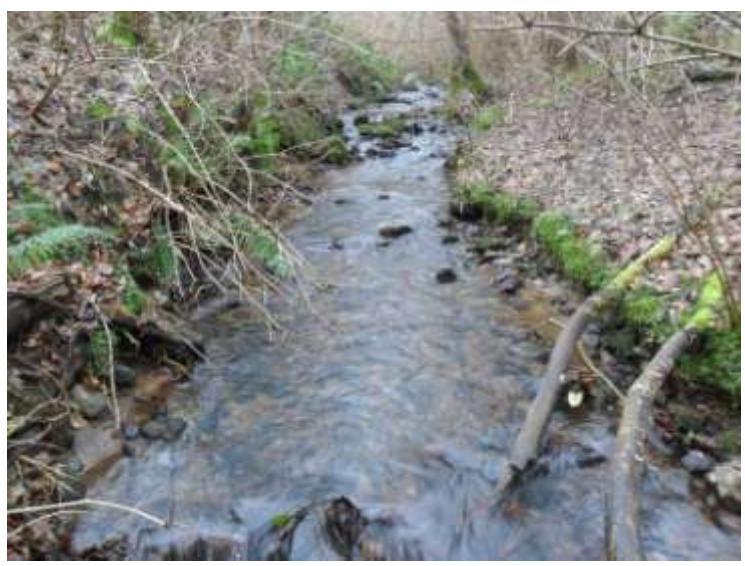
Figure 1-3: General character of the upper Braid Burn

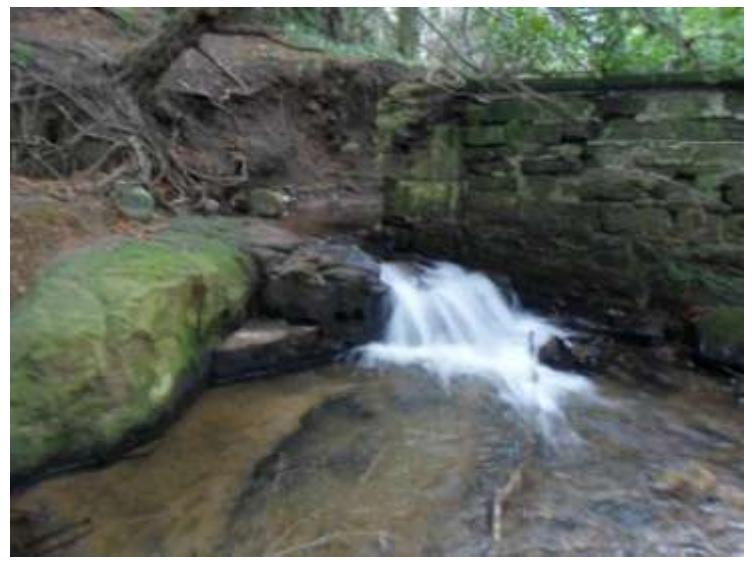
Figure 1-4: Broken weir on the upper Braid Burn

| Issue | Unique ID | Action | Location Description | OS NGR | Pressure | Pros | Cons | Cost (£k) | Movement towards GES - Capacity released |
|--|---|---|--|--|---|---|---|---|--|
| ISSUE 2: Broken weir causing local bank stability | Bra_WRe_1 | Remove weir | Upper reaches of Hermitage of Braid | 322067E 668184N | Morphological | Restored biotic and sediment continuity. Improved local morphology. | Potential for minor temporary release of fine sediment impacting on downstream gravels and aquatic ecosystem. Local bank and bed destabilisation probable without appropriate morphological reinstatement local to weir site. | 10.5 | None - capacity not assessed for weir removal |

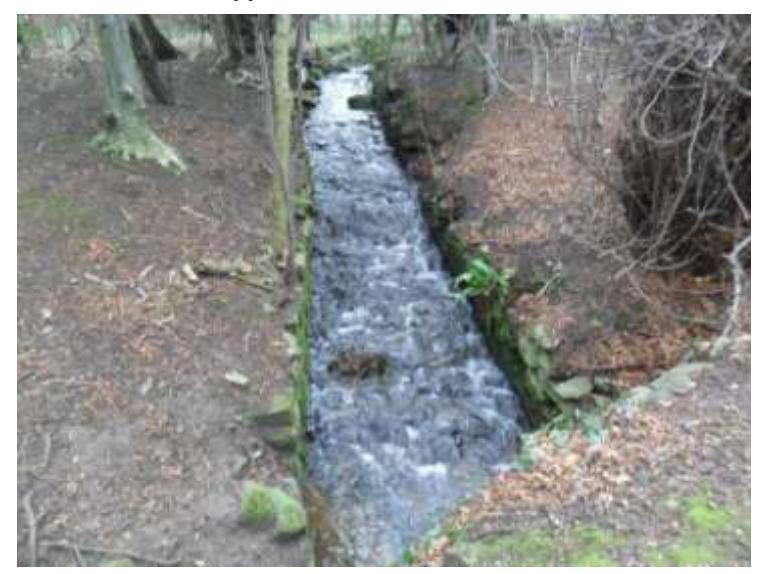
Figure 1-5: Lined reach of the upper Braid Burn

| Issue | Unique ID | Action | Location Description | OS NGR | Pressure | Pros | Cons | Cost (£k) | Movement towards GES - Capacity released |
|--|---|---|--|--|---|---|---|---|--|
| ISSUE 1: Lined channel | Bra_LCRe_1 | Remove lined channel | Upper reaches – downstream of A720 | 322188E 668054N to 322153E 668079N | Morphological | Restoration of natural gravel / cobble bed with associated habitat gains for fish and invertebrates. Exposure of natural banks allowing fluvial processes to operate and revealing bank side habitat. | Potential for local bank erosion. Presently unknown substrate condition, sediments may be contaminated. | 16.4 | None |

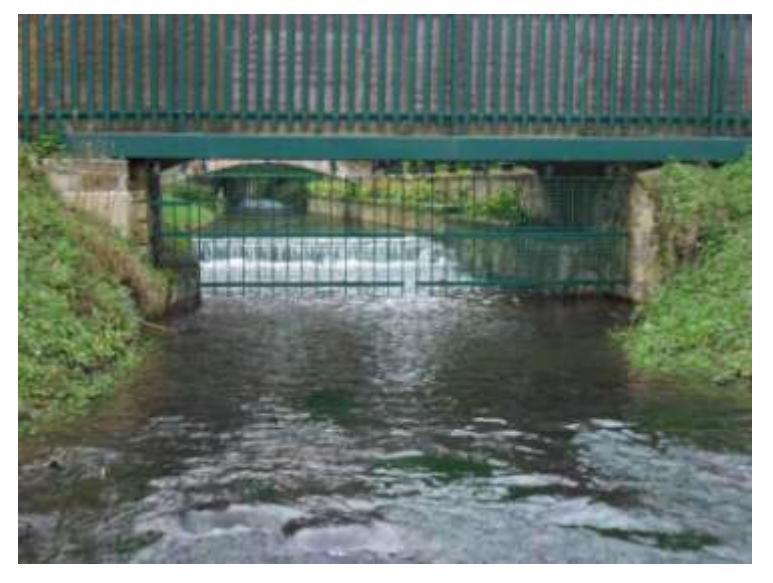
The river flows over a weir and through a culvert under Redford Road before entering a modified section with lined banks and an ornamental weir (Figure 1-6). It then flows as a pool - riffle channel through an active floodplain area with good hydraulic connectivity along the left bank (Figure 1-7). The floodplain area is composed of damp grassland dominated by Yorkshire fog *Holcus lanatus* with wetter areas containing tufts of soft rush *Juncus effusus*. Here some minor planting has taken place along the streamside but this has been of hawthorn *Crataegus monogyna*, rather than the more suitable alder *Alnus glutinosa* which has self-seeded here in places (Figure 1-8).

Figure 1-6: Ornamental weir on the Braid Burn

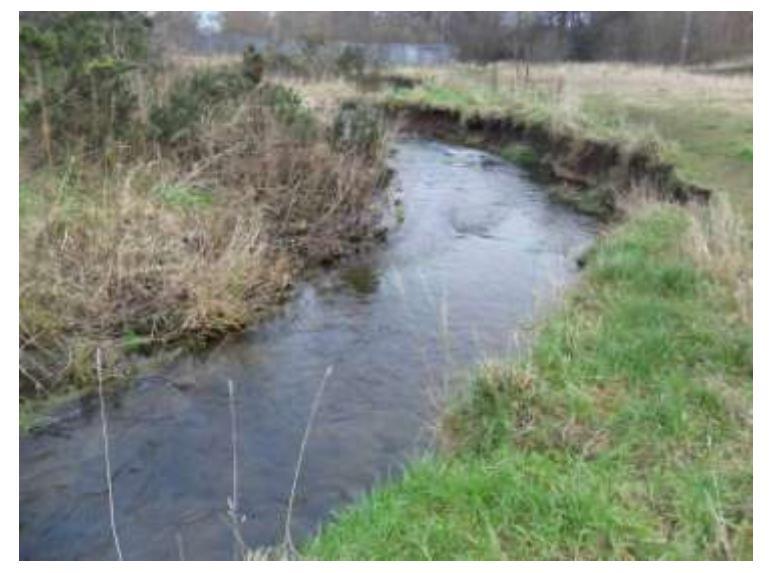
Figure 1-7: Bankside Erosion on the Braid Burn

| Issue | Unique ID | Action | Location Description | OS NGR | Pressure | Pros | Cons | Cost (£k) | Movement towards GES - Capacity released |
|--|---|---|--|--|---|---|---|---|--|
| ISSUE 7: Bank erosion and deposition further downstream | Bra_VP_1 | Planting to improve riparian strip | Downstream of Redford Road; adjacent to Colinton Primary School | 322844E 668873N to 322885E 668933N | Morphological | Improved riparian habitat quality. Low cost of implementation. | Altered aesthetics. Improvements benefit small area of burn environment. | 2.9 | None – capacity not assessed for improvements through riparian planting |

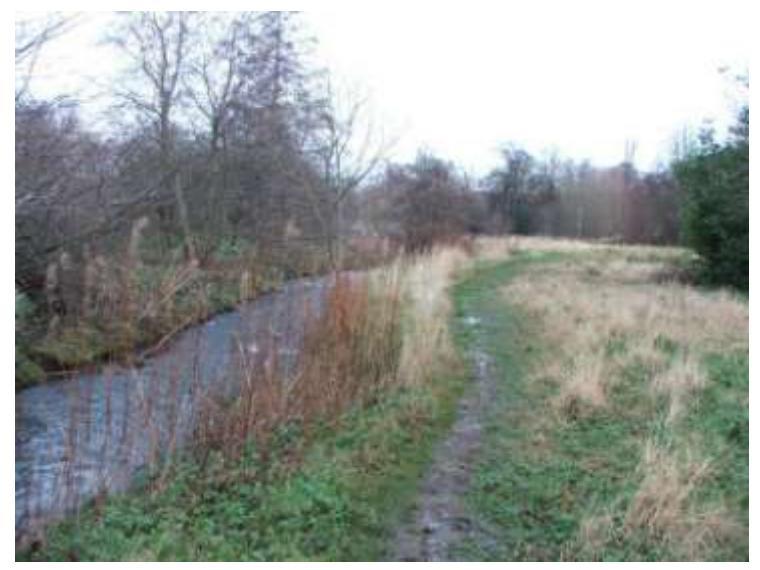
Figure 1-8: Braid Burn near Colinton showing wet grassland on right bank and Alder trees on the left bank

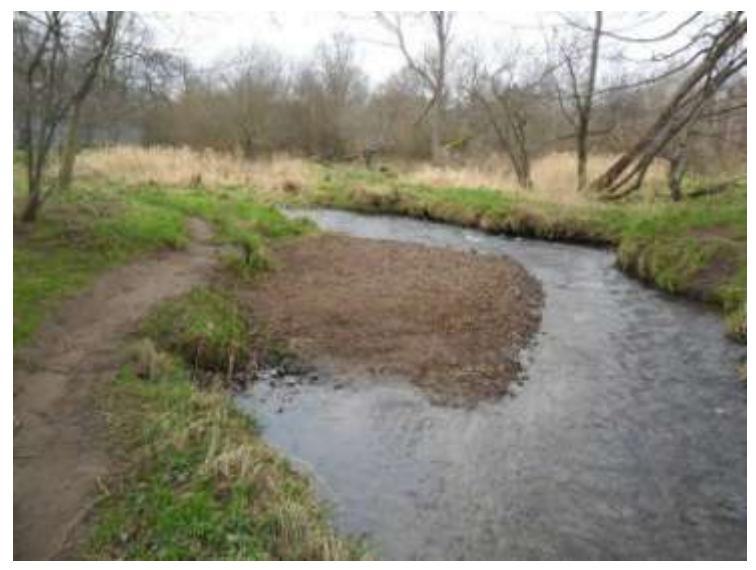
Some flow bifurcation occurs around a transverse bar - island feature along this morphologically active reach (Figure 1-9) and the floodplain riparian margin is well developed. Downstream in this section, there is a footbridge and a stockade metal fence that is presently inhibiting morphologic development (Figure 1-10). This separates another area of the floodplain which contains evidence of anastomosing channels and has large crack willow trees *Salix fragilis* along the burn side.

Figure 1-9: Flow bifurcation and morphologic unit development

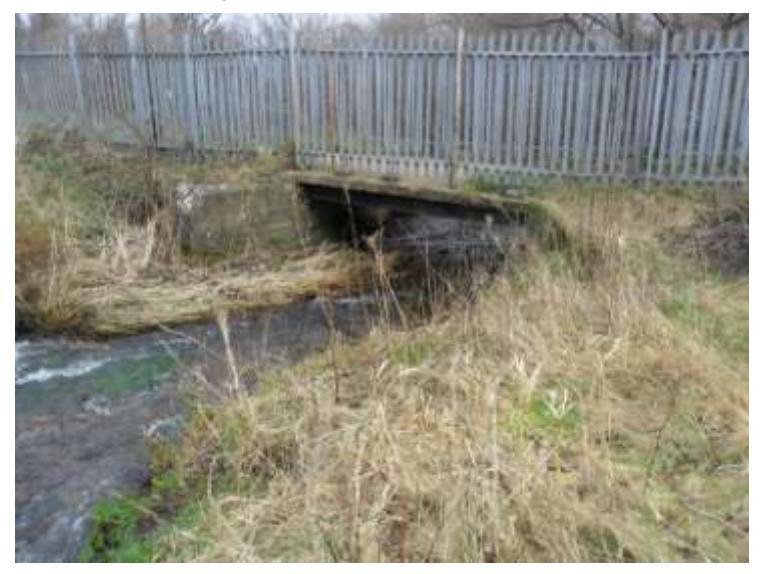
Figure 1-10: Concrete footbridge over the Braid Burn

| Issue | Unique ID | Action | Location Description | OS NGR | Pressure | Pros | Cons | Cost (£k) | Movement towards GES - Capacity released |
|--|---|---|--|--|---|---|---|---|--|
| ISSUE 6: Footbridge is constraining channel and restricting floodplain connectivity | Bra_BrRp_1; Bra_FRe_1 | Replace / widen footbridge; remove fencing | Downstream of Redford Road | 322803E 668841N | Morphological | Improve floodplain hydraulics and allow local channel migration. Increase in floodplain connectivity and ease of flows through reach. | Potential for local bank erosion. | Initial costs = 5.2, requires further assessment to estimate full costs. | None |

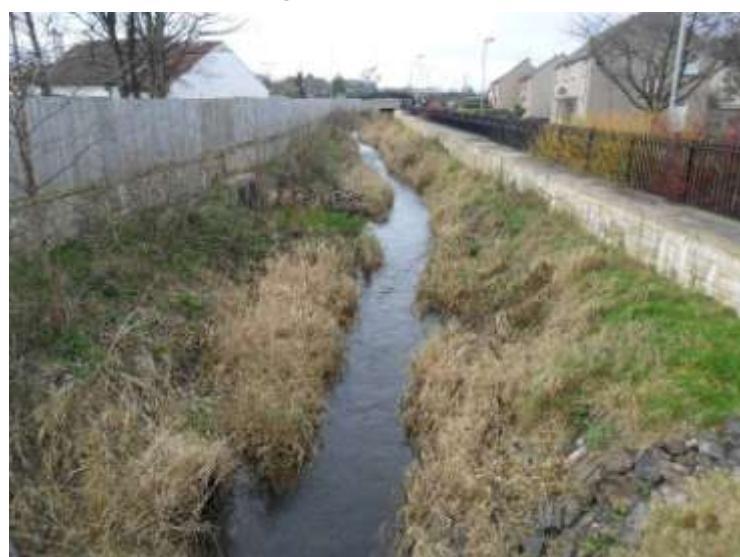
As the river enters Colinton Mains it is artificially straightened and confined between recently constructed flood walls and here there is little if any ecology with floodwalls adjacent to the stream or, when they are set back, the area in between is covered in amenity grassland of low ecological interest (Figure 1-11). The river retains some gradient and has begun to increase its sinuosity locally with some minor berm development. The thin riparian margin is presently monotonous with limited planting, however, the species chosen have been entirely unsuitable and they include butterfly bush *Buddleia davidii*, hawthorn and Leyland cypress *Chamaecyparis leylandii*. The channel morphology is generally pool-riffle with occasional artificial rapids. The reach also suffers from general debris accumulation.

Figure 1-11: Confined channel through Colinton Mains

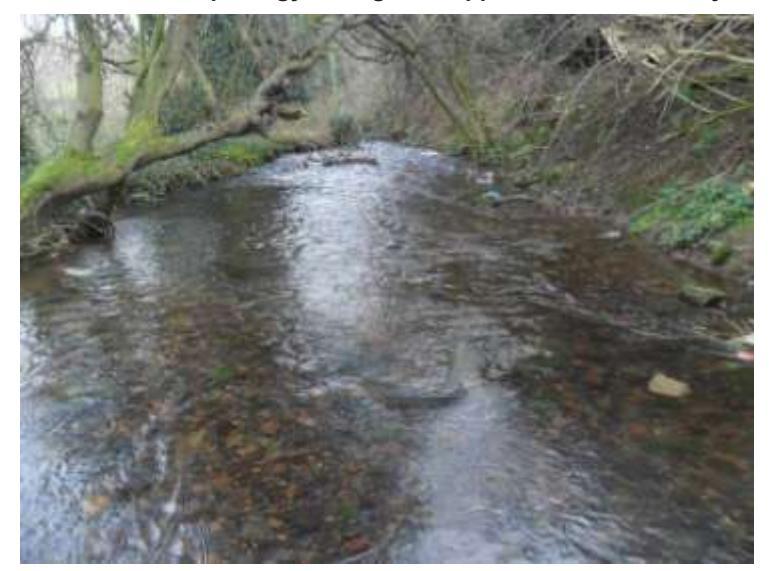
Figure 1-12: Plane - riffle morphology through the upper Braid Burn Valley

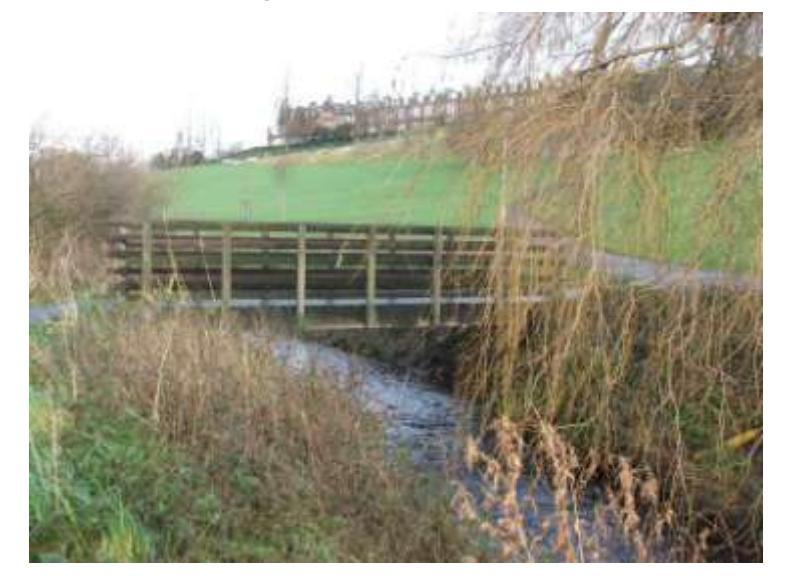
Figure 1-13: Braid Burn at Braidburn Valley showing amenity grassland surroundings and limited streamside vegetation, with the occasional crack willow

| ISSUE 8: Debris on banks both from upstream sources and illegally dumped there. | Bra_DRe_1, Bra_DRe_2 | Remove debris; conduct an education programme. | Upstream and downstream of Colinton Mains Drive | 322861E 669177N to 322897E 669219N – Bra_DRe_1 322997E 669357N – Bra_DRe_2 | Point source pollution | Improved bed and bank habitat quality. Improved general aesthetics, removed hydraulic obstructions. Increase in public knowledge and awareness of waterway health. | No negative effects, ongoing commitment needed. | 16.7 + education costs. | None |
|---|---|--|---|---|--|--|--|---|--|
| ISSUE 11: Degraded riparian vegetation | Bra_VP_4 | Improve riparian strip with planting | Braidburn Valley | 324044E 669476N to 324273E 670171N | Morphological | Improved bank habitat quality. Improved bank strength. Measure will improve a large section of the burn which is regularly used for leisure. Increase in public awareness and knowledge of healthy waterways. | Altered aesthetics. | 20.8 | None – capacity not assessed for improvements through riparian planting |

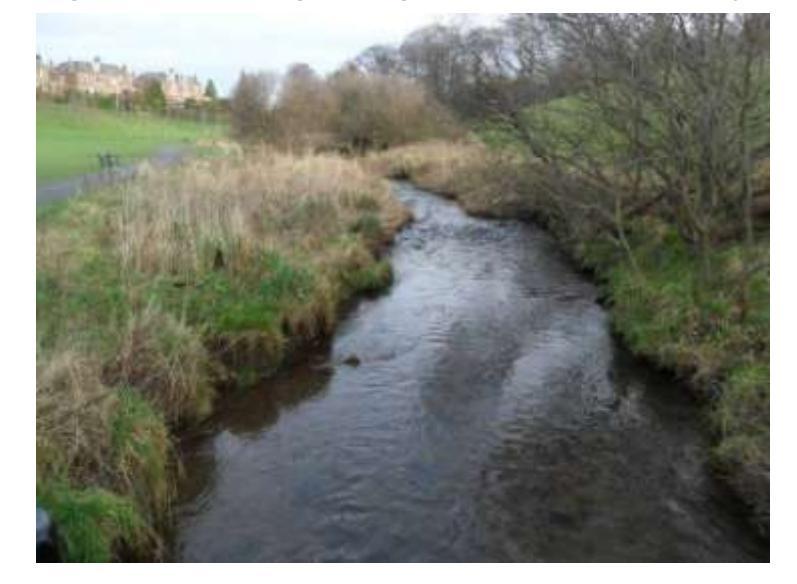
Figure 1-14: Degraded riparian margin through the lower Braid Burn Valley

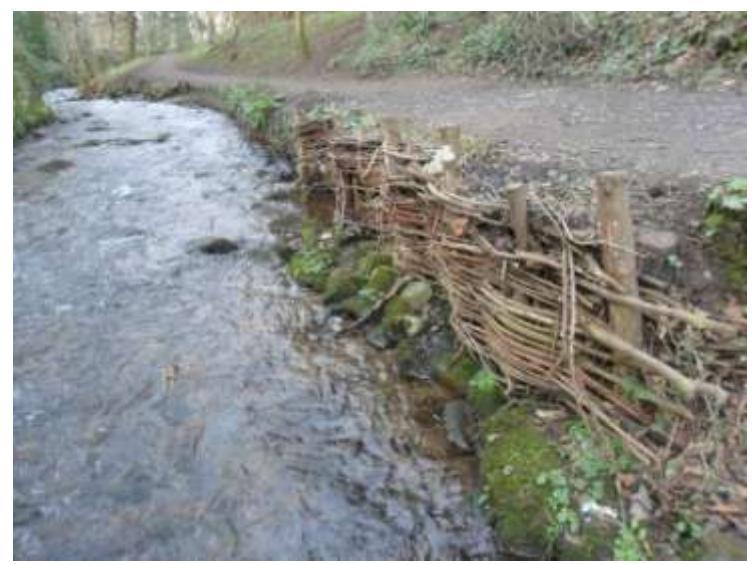
Willow spiling lines the bank after the culvert and this has generally failed to take hold (Figure 1-15). The moderately steep confined valley through the Hermitage of Braid is well wooded and this is reflected in an increase in woody debris in the channel. The river exhibits a plane bed with some coarser riffle and rapid areas. Small weirs are completely filled with sediment upstream (Figure 1-16). A long (>100 m) culvert exists around the Hermitage.

Figure 1-15: Willow spiling along the Braid Burn

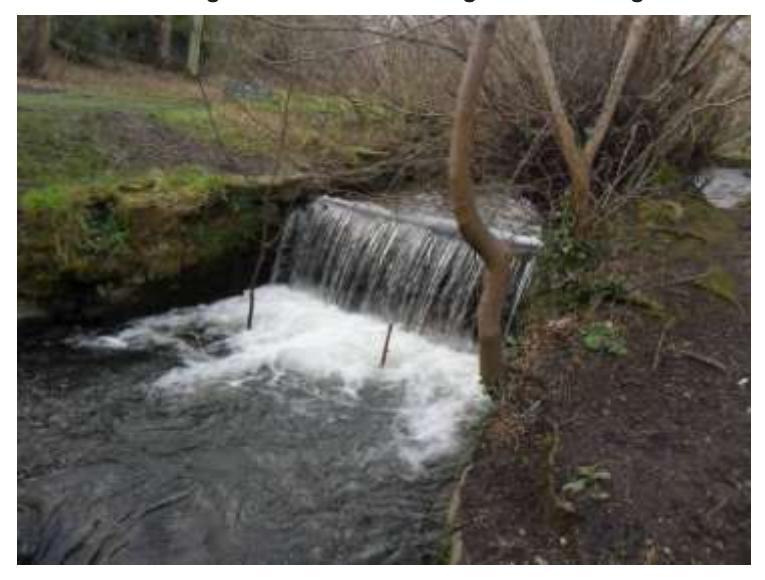
Figure 1-16: Small weirs along the Braid Burn through the Hermitage of Braid

| ISSUE 8: Debris on banks both from upstream sources and illegally dumped there. | Bra_DRe_1, Bra_DRe_2 | Remove debris; conduct an education programme. | Upstream and downstream of Colinton Mains Drive | 322861E 669177N to 322897E 669219N – Bra_DRe_1 322997E 669357N – Bra_DRe_2 | Point source pollution | Improved bed and bank habitat quality. Improved general aesthetics, removed hydraulic obstructions. Increase in public knowledge and awareness of waterway health. | No negative effects, ongoing commitment needed. | 16.7 + education costs. | None |
|---|---|--|---|---|--|--|--|---|--|
| ISSUE 14: Redundant weir and degraded rapids | Bra_WRe_5, Bra_ChR_2 | Remove weir and restore rapids downstream | Hermitage of Braid | 324834E 670243N to 324920E 670261N | Morphological | Improvement in fish passage and aquatic ecology. | Potential for minor short term release of sediment, impacting downstream gravels and aquatic ecosystem. | 43 | None |

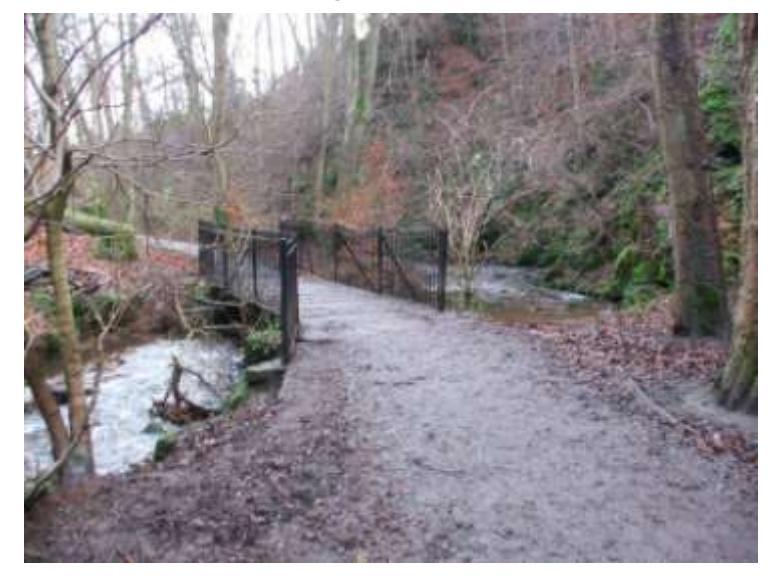
The slopes above the narrow valley bottom are dominated by ancient semi-natural woodland, dominated by sycamore *Acer pseudoplatanus* and silver birch *Betula pendula* (Figure 1- 17).

Figure 1-17: Narrow section of Hermitage of Braid

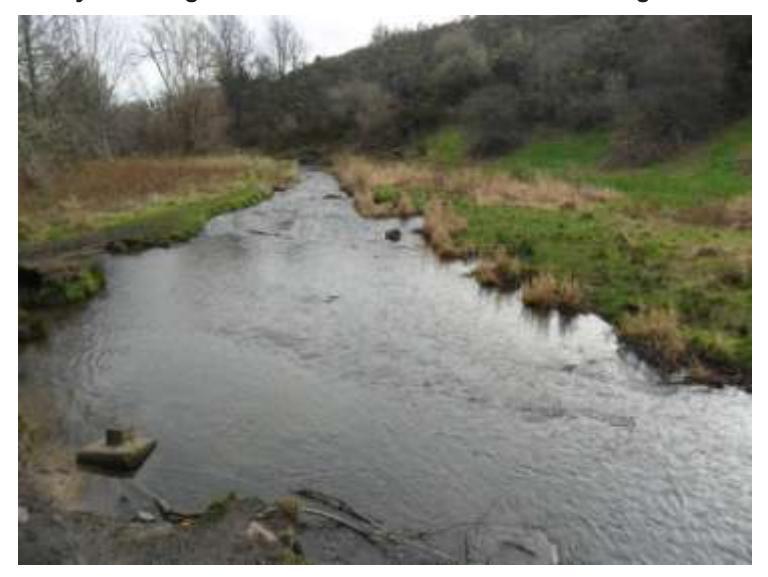
As the valley opens up past the wooded valley more bedrock is seen in the channel as rapids and general morphologic and ecological diversity increases (Figure 1-18). A golf course dominates the right bank. Significant low terrace areas exist along both sides of the channel with many opportunities for habitat improvement (Figure 1-19).

Figure 1-18: Valley widening at the downstream end of the Hermitage of Braid

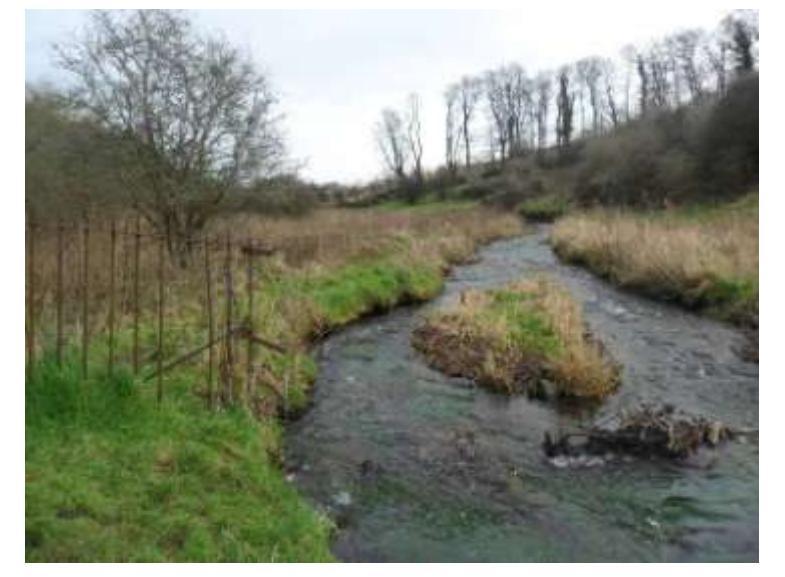
Figure 1-19: Low terraces along the lower reaches of the river through the Hermitage of Braid

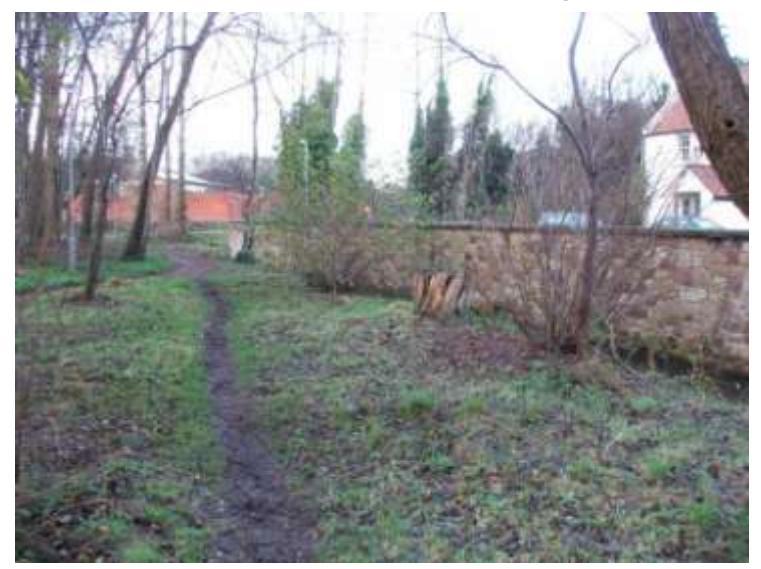
and Gilmerton Road there is a small area of trees through which the burn flows adjacent to a large floodwall. There is a slight levee on the opposite bank to the floodwall here and the wet woodland in this area has traces of anastomosing channels (Figure 1-20).

Figure 1-20: Small wet woodland near Cameron Toll showing floodwall and low levee

The small woodland upstream of the shopping centre should be reconnected to the burn via a number of anastomosing channels in this low energy area and the trash in the burn should be removed.

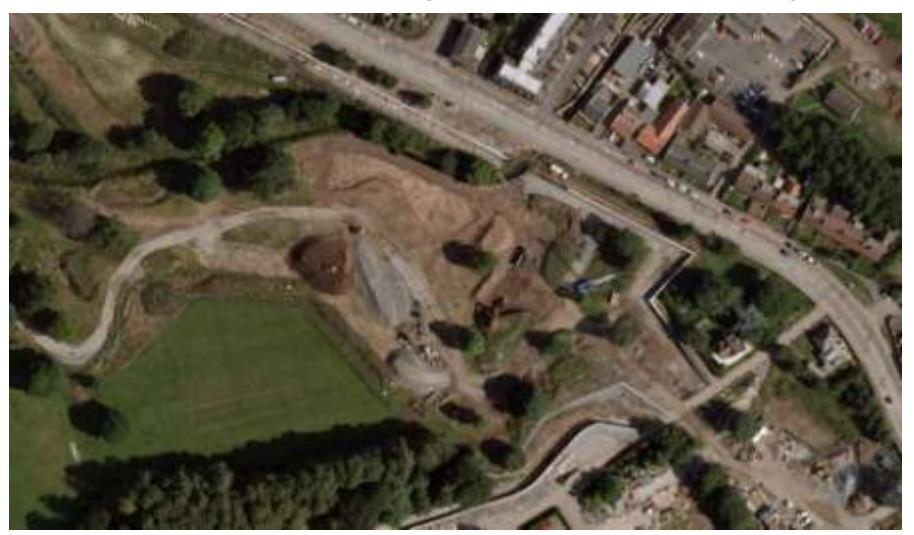
At Inch Park work has already taken place to reconnect the river to its floodplain and this has been successful with a large wetland area with soft rush and reed canary grass *Phalaris arundinacea*. The restoration has exposed boulder clay in the bed of the sinuous reach and debris build up in the multi-thread reach is significant (Figure 1-24). This area is utilised by ducks and a heron *Ardea cinerea* was seen on the date of the visit, however, the area is spoiled by the large build-up of trash at the entrance to the culvert under the Old Dalkeith Road. The park itself is dominated by improved grassland but now acts as a flood storage reservoir on account of the new floodwalls along the Old Dalkeith Road (Figure 1-22).

Figure 1-22: Floodwalls and wetland being constructed in Inch Park (Google Maps 2012)

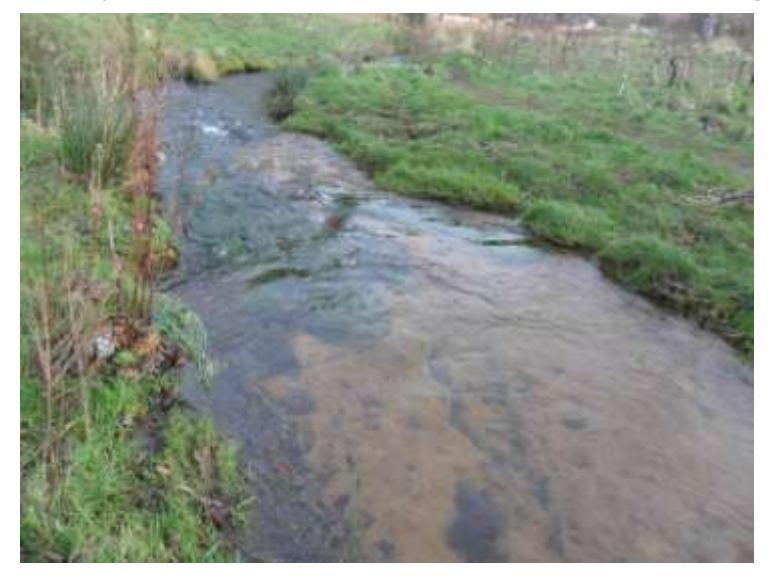
Figure 1-23: Partially restored sinuous reach after the Cameron Toll Shopping Centre

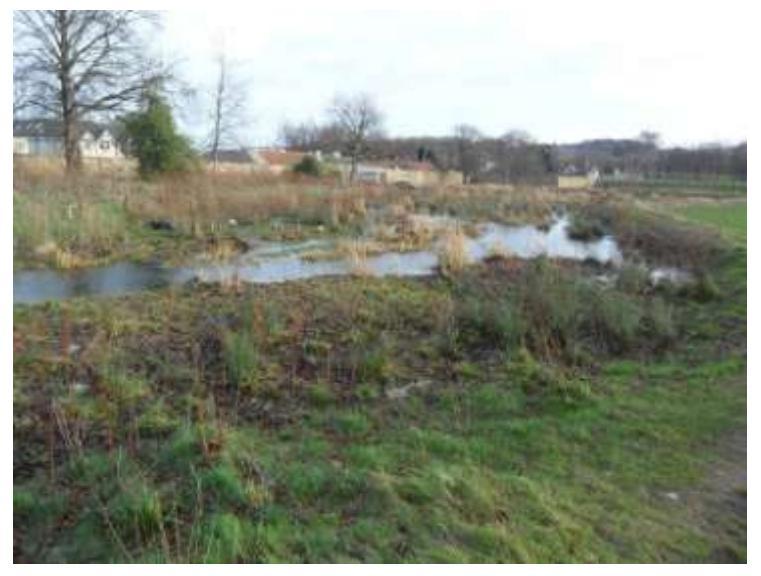
Figure 1-24: Partially restored multi-thread reach after the Cameron Toll Shopping Centre

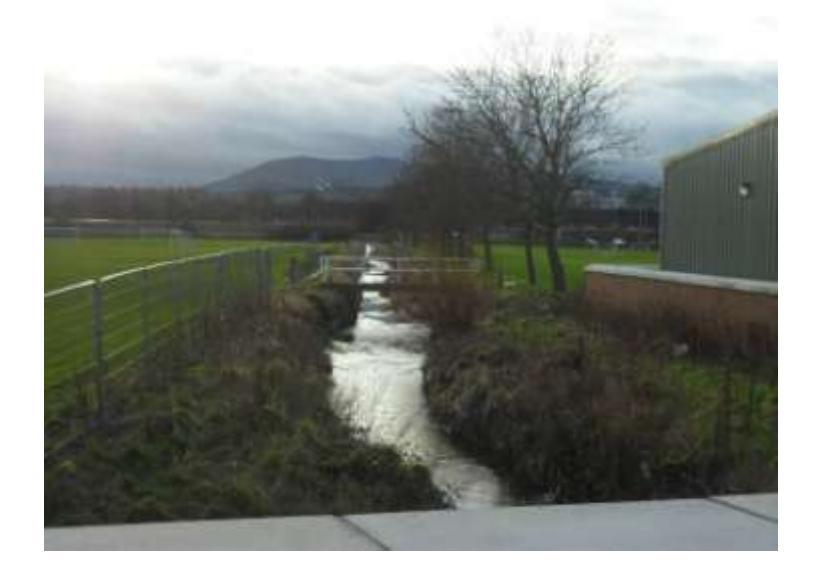
Initially it runs through a floodwall lined channel between houses until it emerges into the playing fields at Peffermill (south) where the land use is amenity grassland on the right bank and housing with high floodwalls on the left bank. The river is straightened and embanked, disconnecting the floodplain. It also has no natural riparian margin. The embankments could be set back here (Figure 1-25). After crossing Peffermill Road the river becomes over-deep and suffers from debris accumulation.

Figure 1-25: Degraded reach of the Braid Burn after the A7

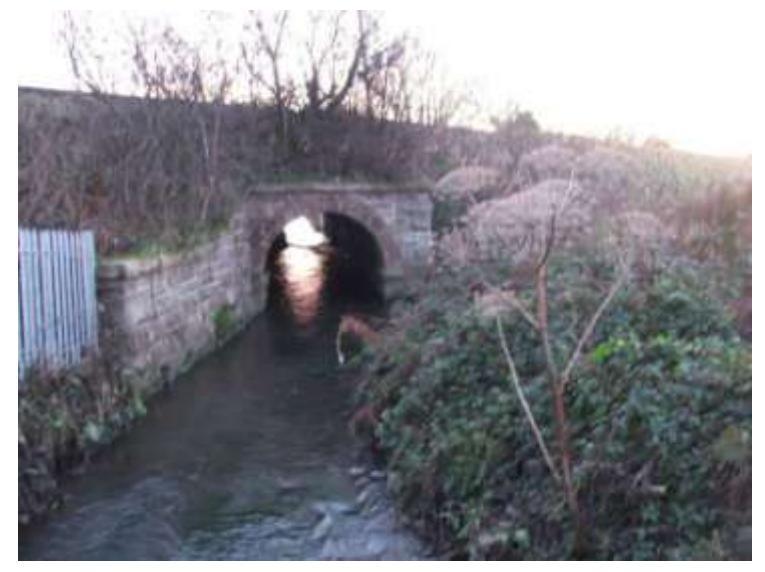
From here the burn passes under the railway and joins a large drain on the left bank before crossing more playing fields (Peffermill North). At the confluence with the drain there is an infestation of giant hogweed *Heracleum mantegazzianum* (Figure 1-26) that continues along the tributary drain (Pow Burn) all the way to Cameron Toll Roundabout. This drain is quite flashy and exhibits trash lines on the overhanging foliage.

Figure 1-26: Railway culvert at Peffermill with giant hogweed on the left bank, where the drain joins the main channel

Here the channel is engineered straight and there is no semi-natural habitat on the banks. To rectify this, south of the railway, the floodbank should be broken on the right bank and a sinuous course created. This will allow the development of a more natural hydromorphology which will be colonised by marginal species. North of the railway the situation is similar and the floodbanks should be broken on both sides of the burn to create a similar habitat. Upstream of this, where the large drain joins the burn immediately north of the railway embankment, the bank constraining this drain should also be removed and the drain channel altered to create a more natural watercourse. A small wetland, again similar to that at Inch Park, should be moved 20m downstream of the present location. Finally the giant hogweed here should be sprayed out prior to works commencing.

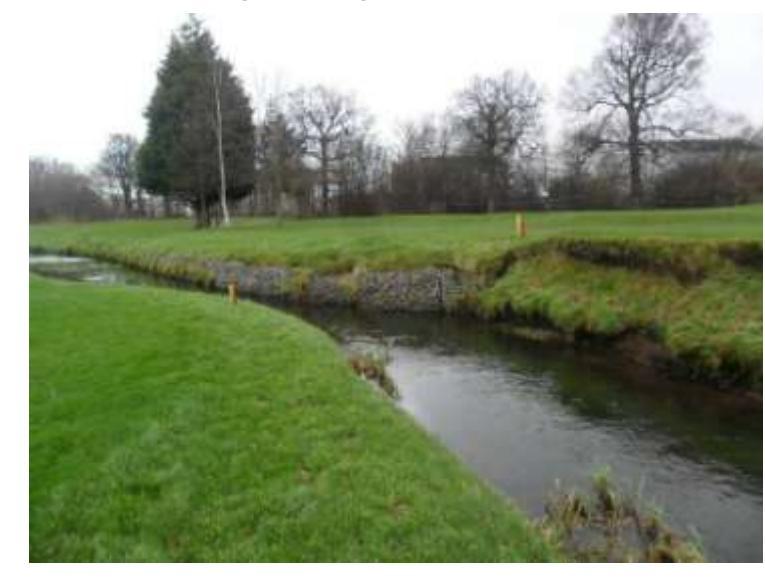
Figure 1-28: Lined banks through Duddingston Golf Course

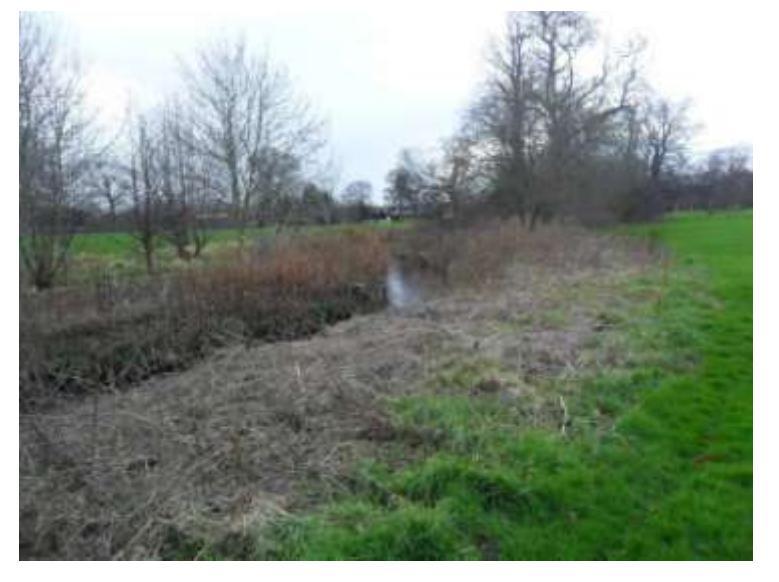
Figure 1-29: Unmanaged river margins through Duddingston Golf Course

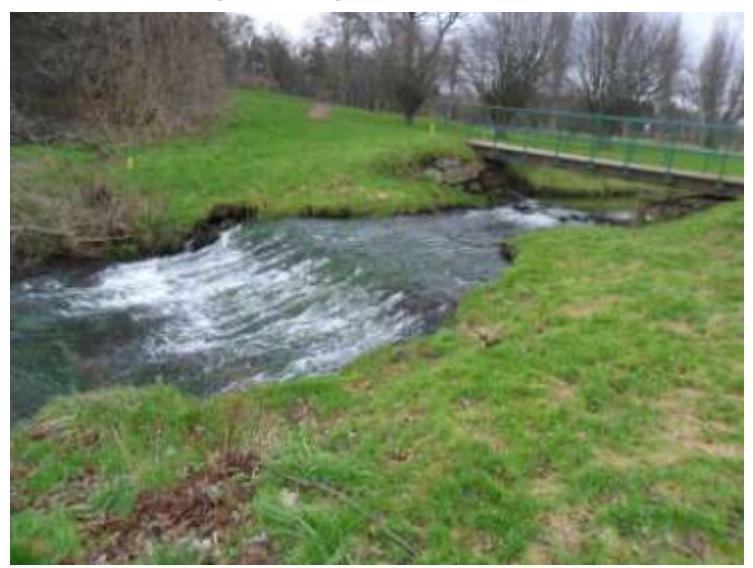
The river is extensively trained through the golf course. The bed exhibits well developed pools and riffles with a mobile gravel bed. The banks, however, are generally lined creating an overdeep channel (Figure 1-28). Some un-mown margins exhibit an improved riparian margin (Figure 1-29). A series of small weirs control the gradient locally and could be considered for removal (Figure 1-30).

Figure 1-30: Minor weirs through Duddingston Golf Course

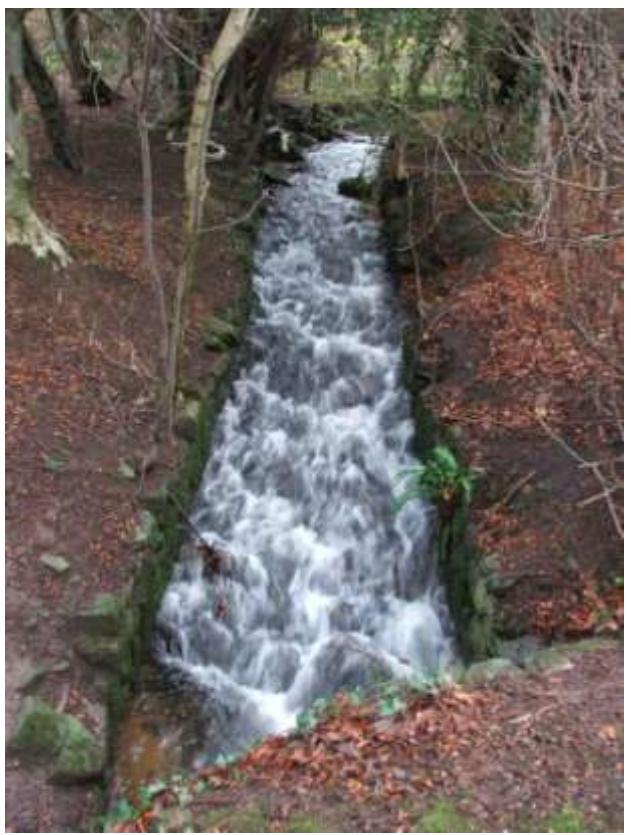
Figure 1-32: Lined section isolating the burn ecologically from the surrounding woodland

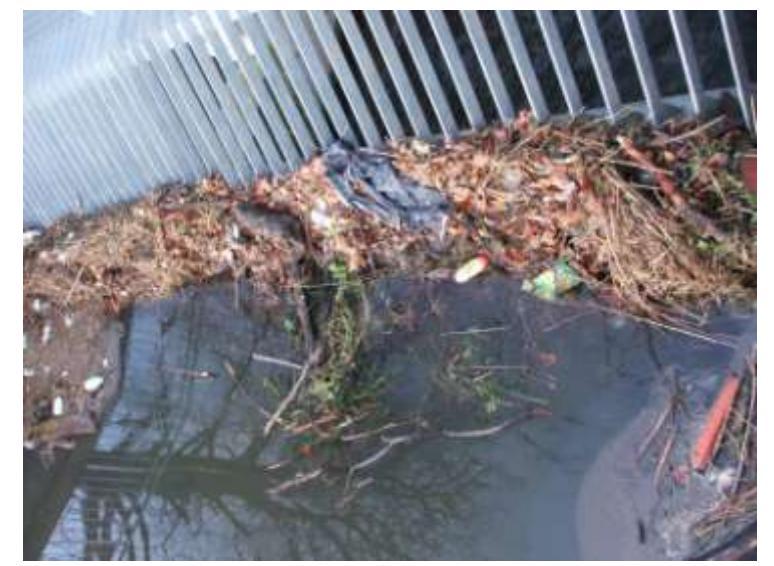
The works here have been partially successful but the build-up of rubbish on the culvert screen is unsightly and a potential risk and should be removed (Figure 1-33).

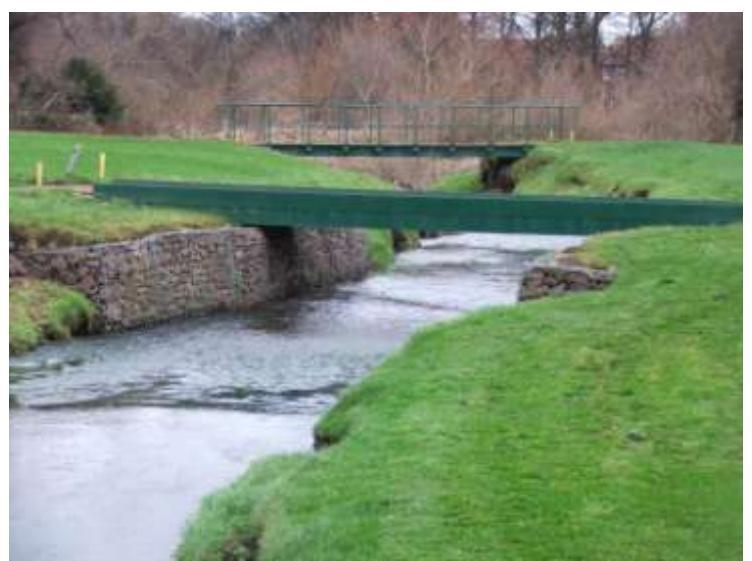
Figure 1-34: Gabion baskets lining the Braid Burn in Duddingston Park
