Bathing water profile:

Collieston

<p>EU bathing water ID number: UKM1102 01670</p>	
<p>Location of bathing water: UK/Scotland/Aberdeenshire (Map1)</p>	
<p>Year of designation: 2014</p>

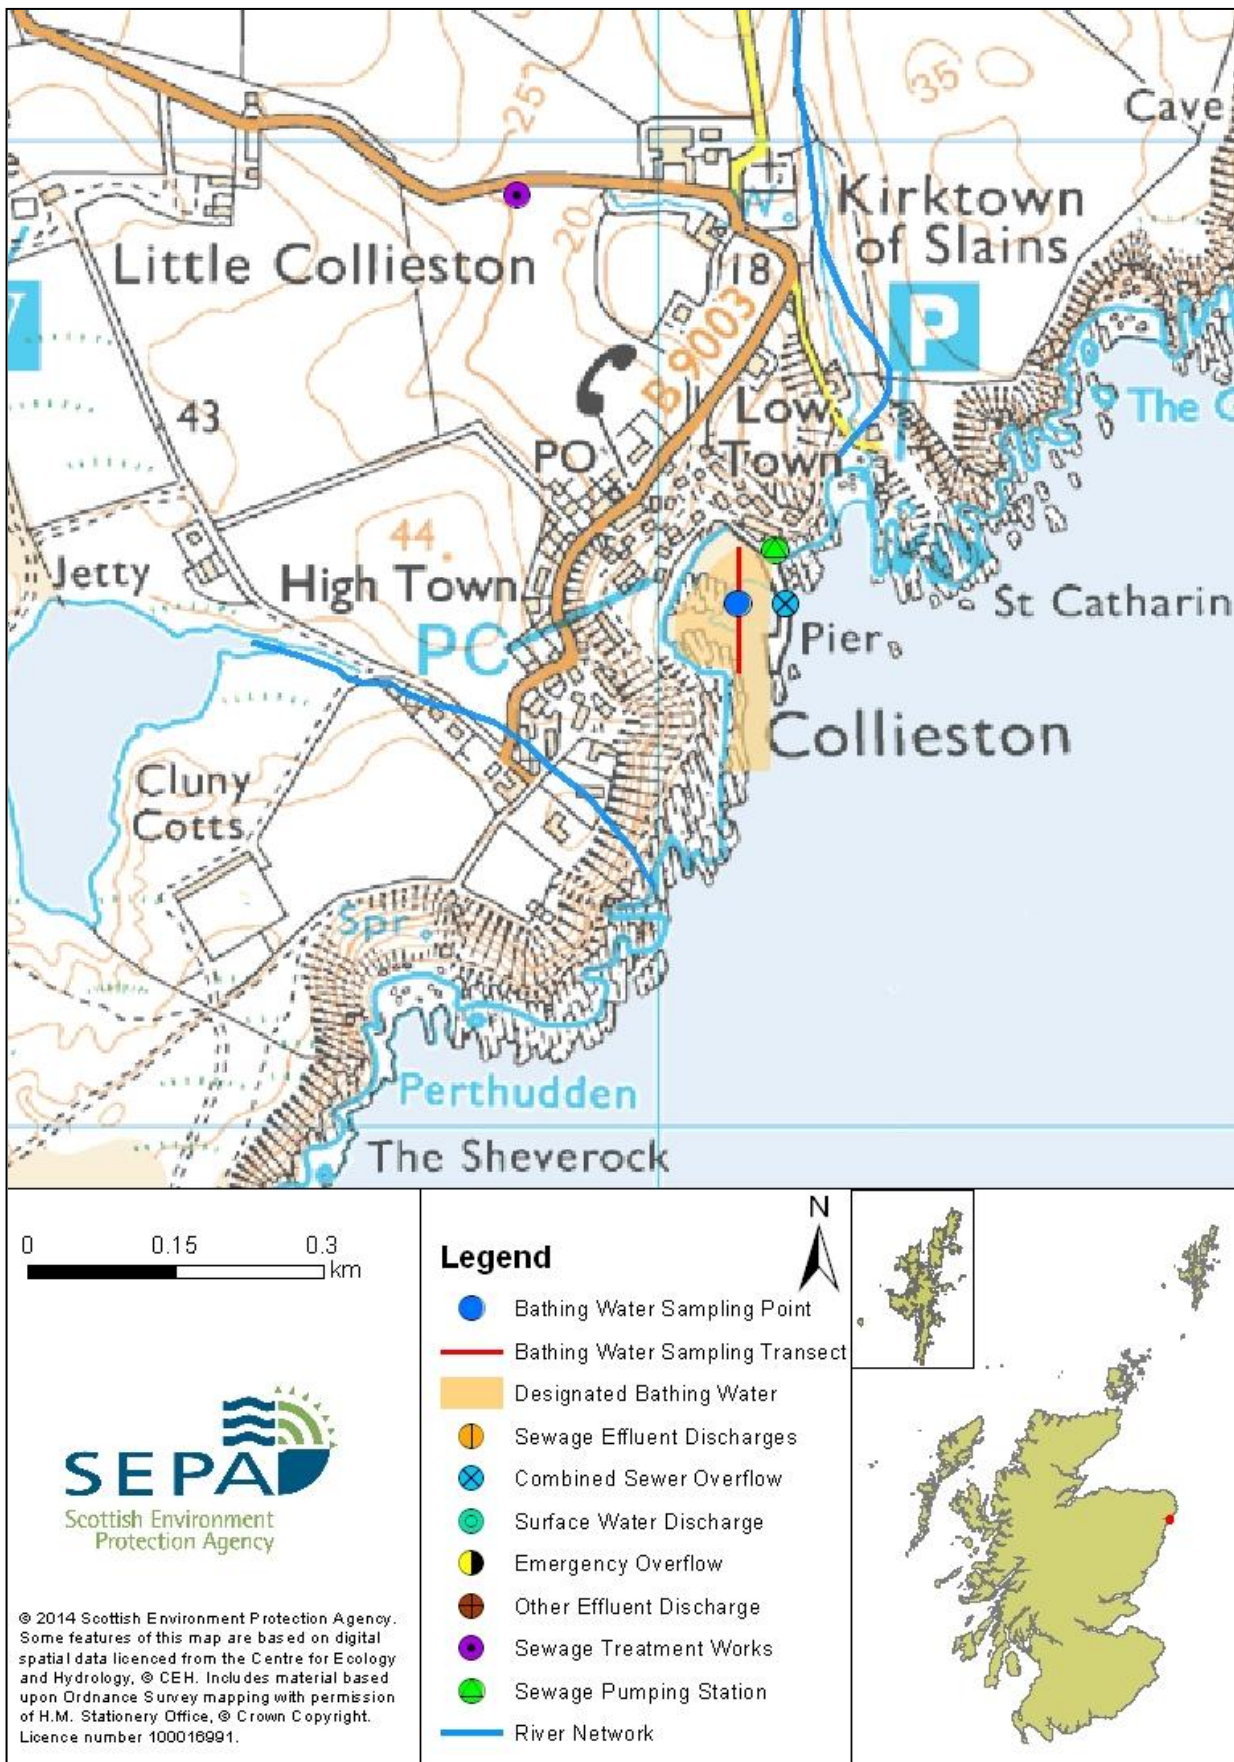
Map 1: Collieston bathing water

The monitoring point used by SEPA for taking water quality samples is located in the centre of the designated area (Grid Ref NK 04080 28530) as shown on Map 1.

The potential relevant pollution sources at, or near, this bathing water are highlighted on Map 1.

There is a licenced discharge from the Combined Sewer Overflow and from the wastewater treatment plant serving Collieston which utilises the same outfall as the CSO (Map 1) near the bathing water. The outfall discharges on the north side of the harbour wall away from the bathing beach but, depending on tides, there is potential for the discharges to impact on the bathing water quality.

Collieston bathing water is a small sandy bay surrounded by the former fishing village of Collieston and its harbour. It is situated on the east coast of Aberdeenshire and lies between Cruden Bay to the North and Newburgh to the South (Map 1).

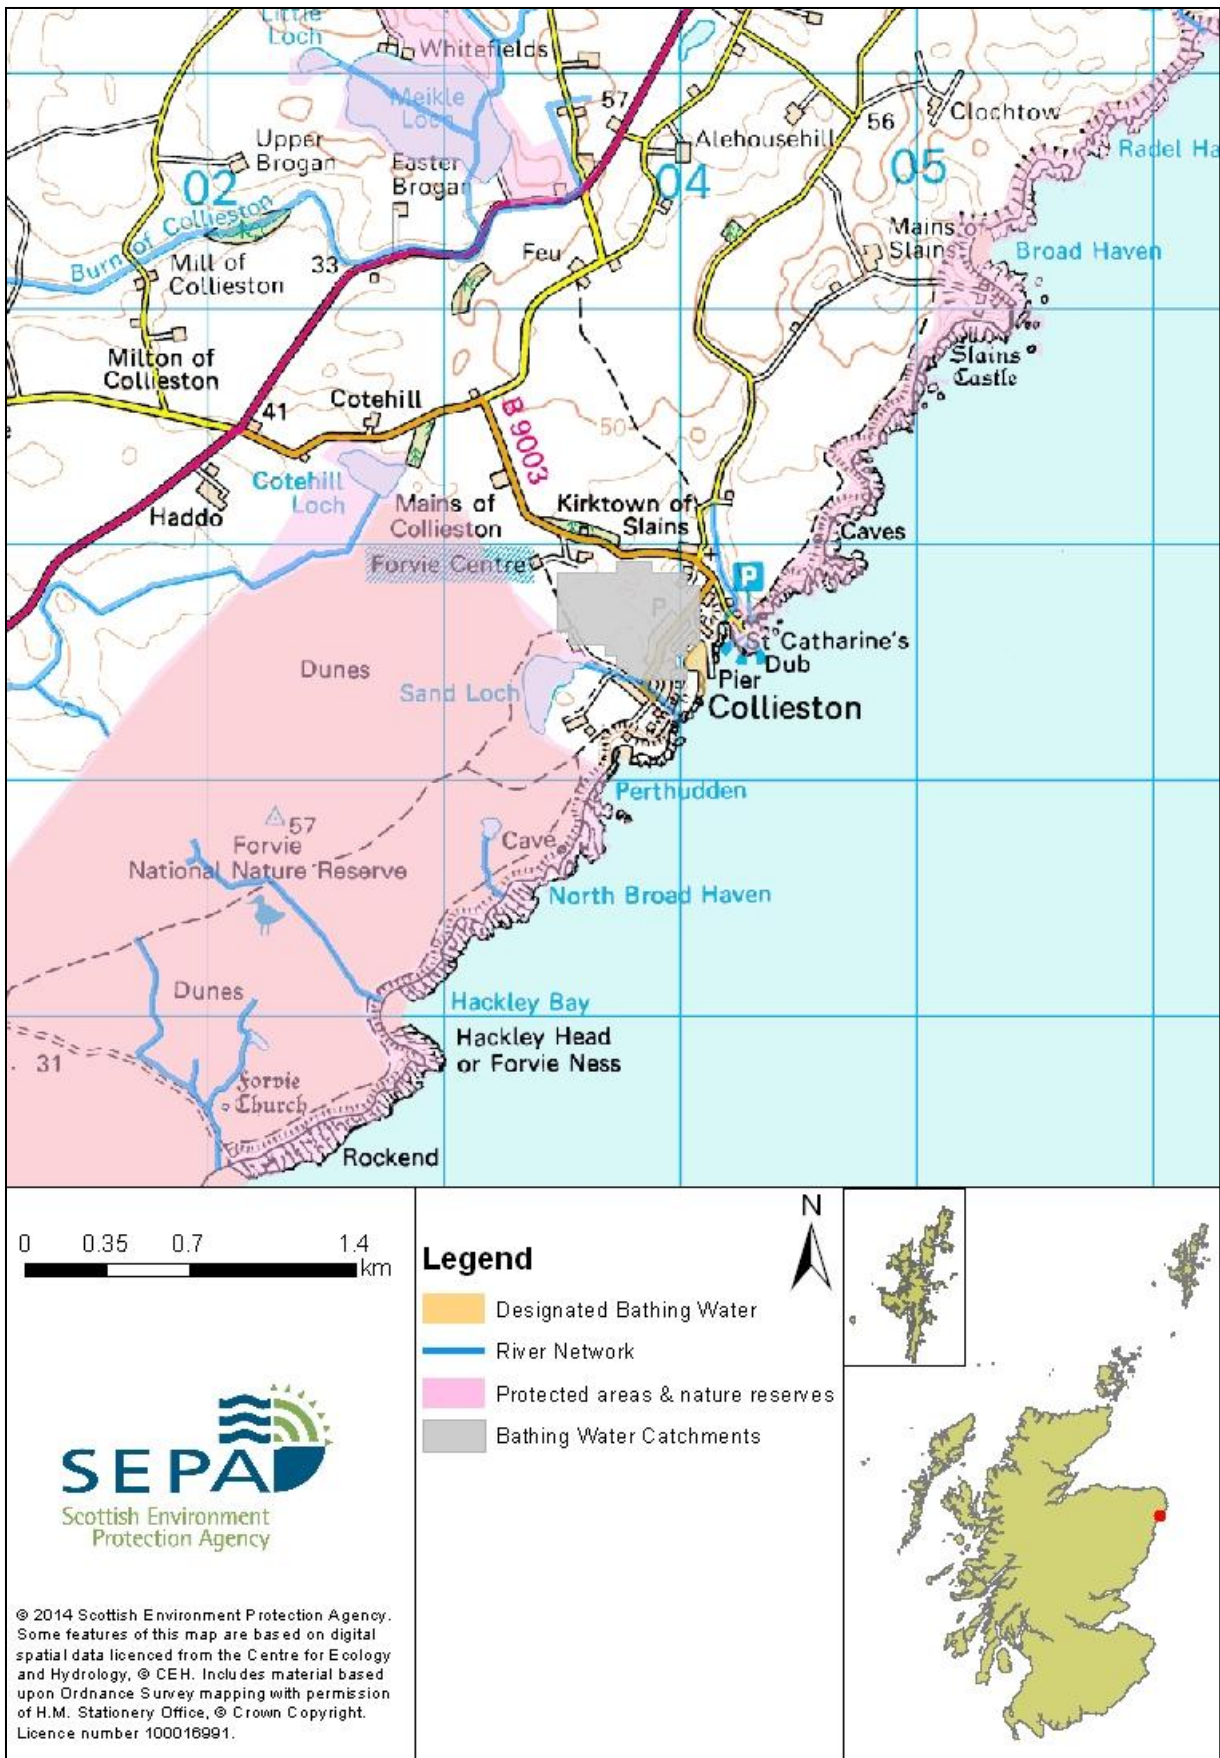
Map 2: Catchment draining into Collieston bathing water

The catchment draining into the Collieston bathing water extends to 0.225km², the wider Buchan Coastal Catchment (between Forvie Burn and Water of Cruden) is 35.7km². The majority of the catchment is flat lying land with an average elevation of approximately 40m. Collieston bathing water is in a small sandy bay within a coastline of steep cliffs and rocky outcrops.

Sandy Loch and the small burn to the north of the village (near St. Ternan's well) drain into the bathing water beach. Surface water run-off from the village, mainly from the combined sewer overflows that drain the area, could potentially affect the bathing water.

There are several protected areas either within or in the vicinity of the bathing water and its catchment (Map 2), such as the Sands of Forvie and Ythan Estuary which is designated as a SSSI, SPA and SAC due to the internationally important bird populations it supports, its saltmarshes and geology. Some of these protected areas have the potential to influence water quality at the bathing water, specifically:
