Bathing Water Profile for Luss

Luss, Scotland

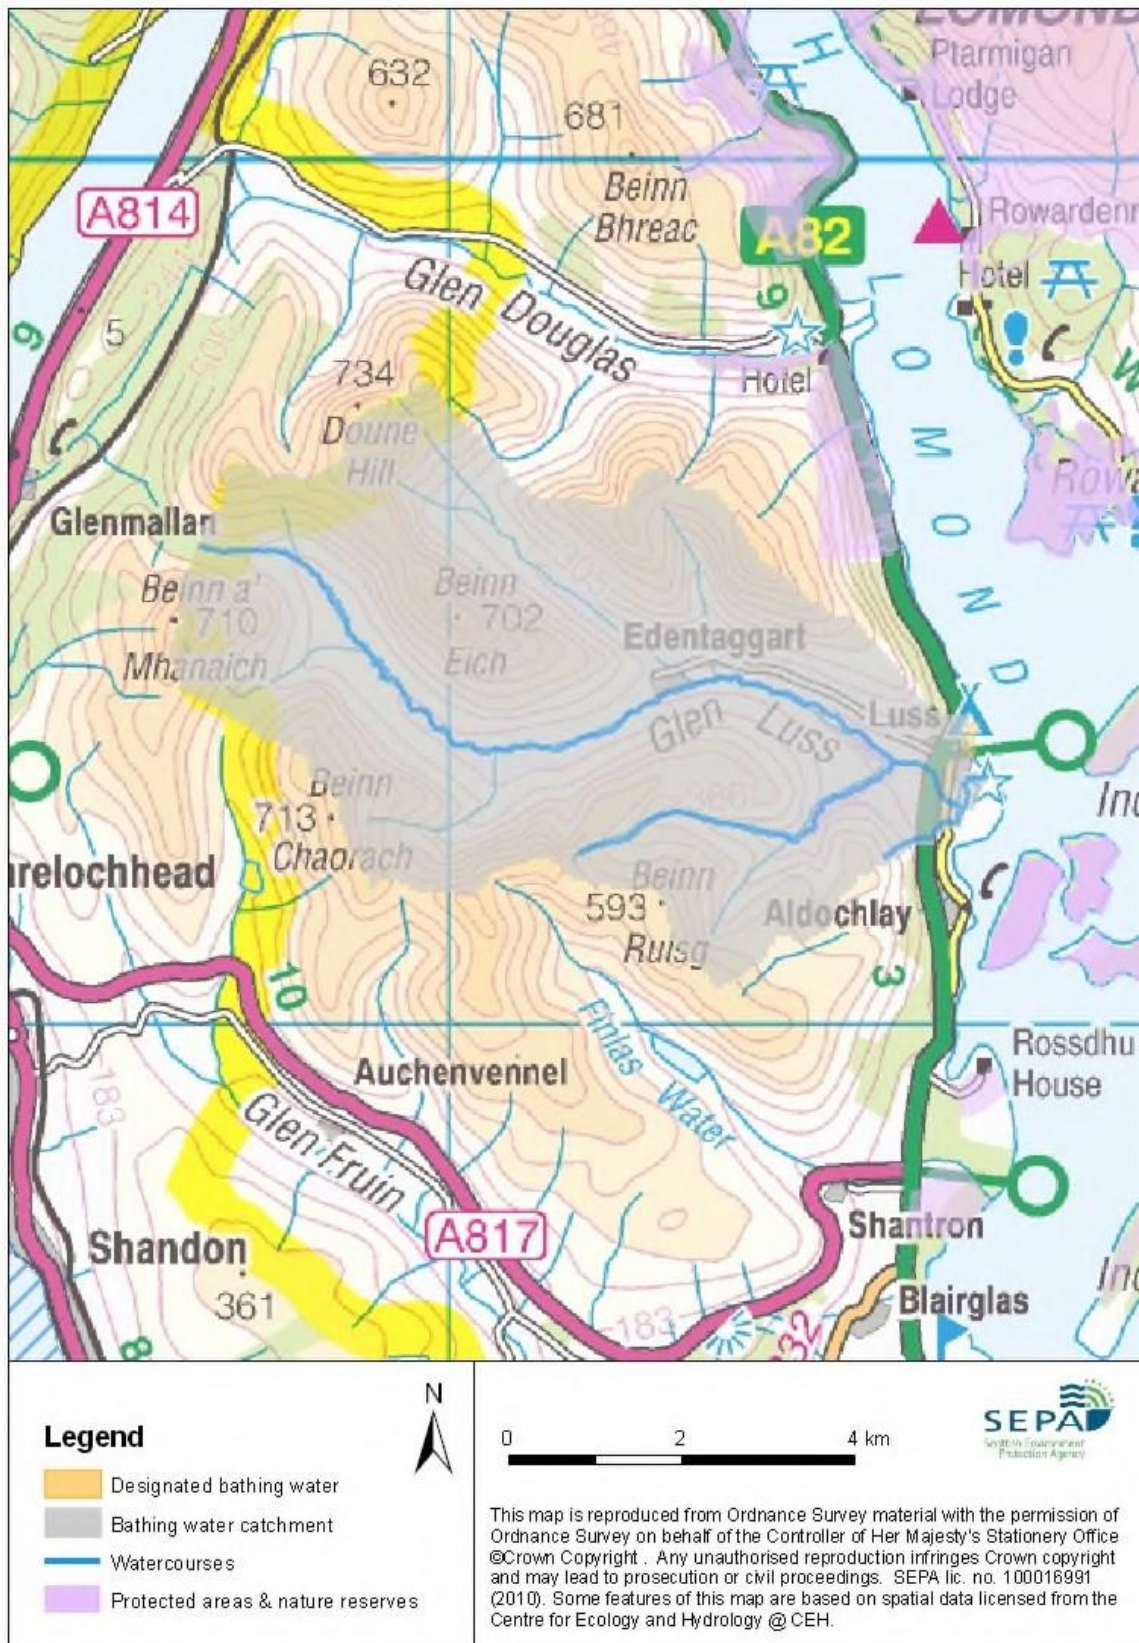
Map 2: Catchment draining into Luss bathing water

The catchment draining into the bathing water extends to 37 km². The area is mountainous with the highest peaks in the catchment being Beinn Eich at 703 metres in the north-west and Deinn Chaorach at 713 metres to the west of the bay. These two peaks form the steep valley along which Luss Water flows towards the bathing water.

The main rivers within the bathing water catchment are the Luss Water, Auchengavin Burn, Sron an La oighn Burn and Molloch Burn.
