Bathing Water Profile for Arbroath (West Links)

Arbroath, Scotland

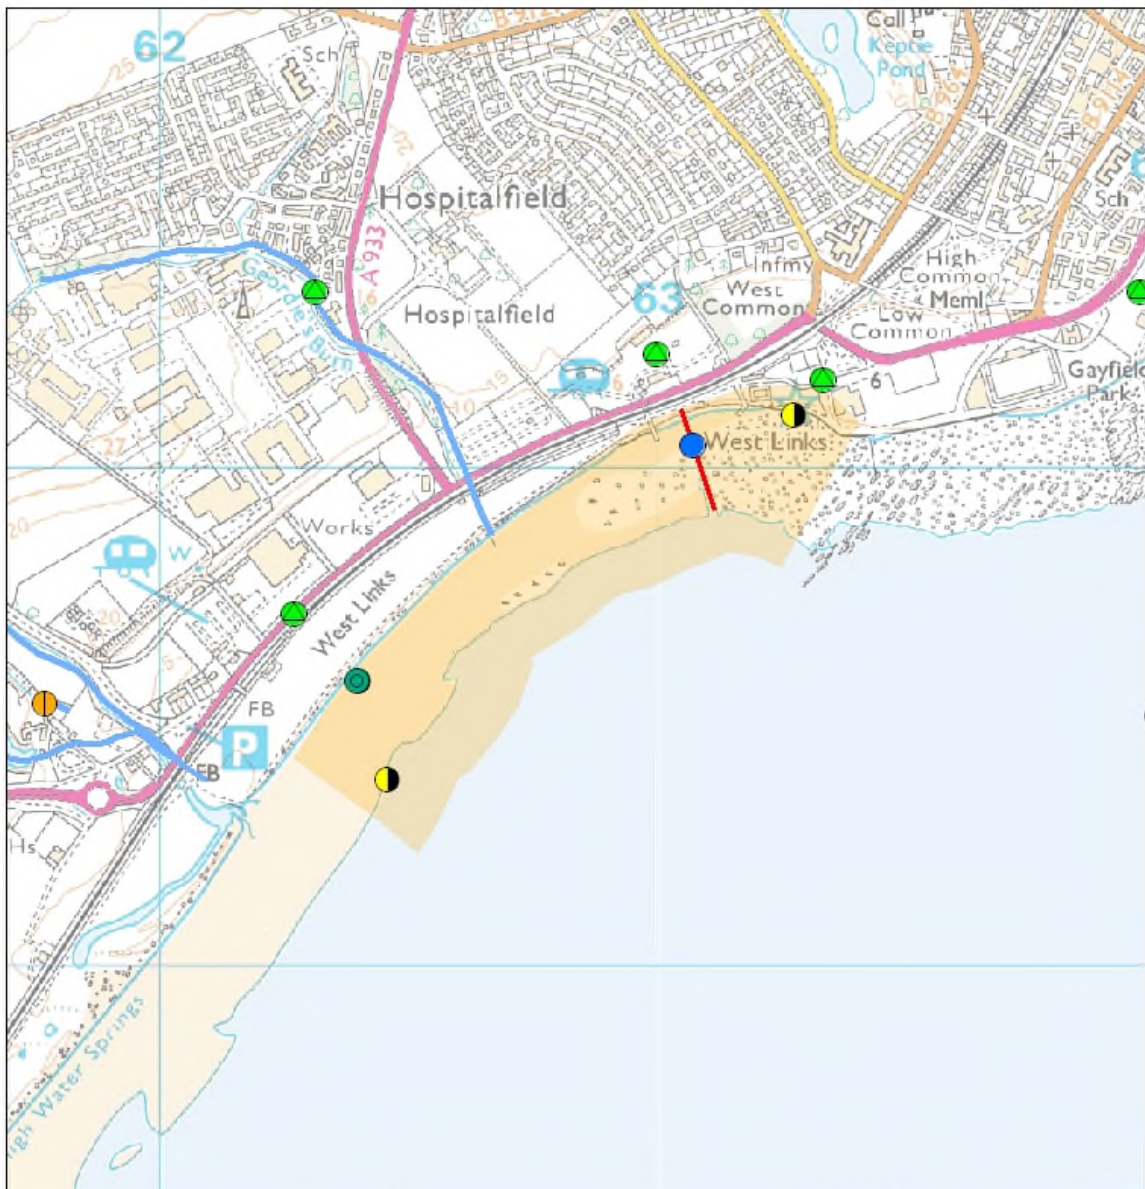
Map 1: Arbroath (West Links) bathing water

-   Designated bathing water
-   Bathing water sampling point
-   Bathing water sampling transect
-   Sewage effluent discharge
-   Emergency overflow
-   Surface water discharge
-   Sewage pumping station
-   Water courses

Sewage is pumped to Hatton sewage treatment works. Inchcape pumping station provides storage for storm sewage storage. There are combined sewage overflows and/or emergency overflows at four other smaller pumping stations in the area.

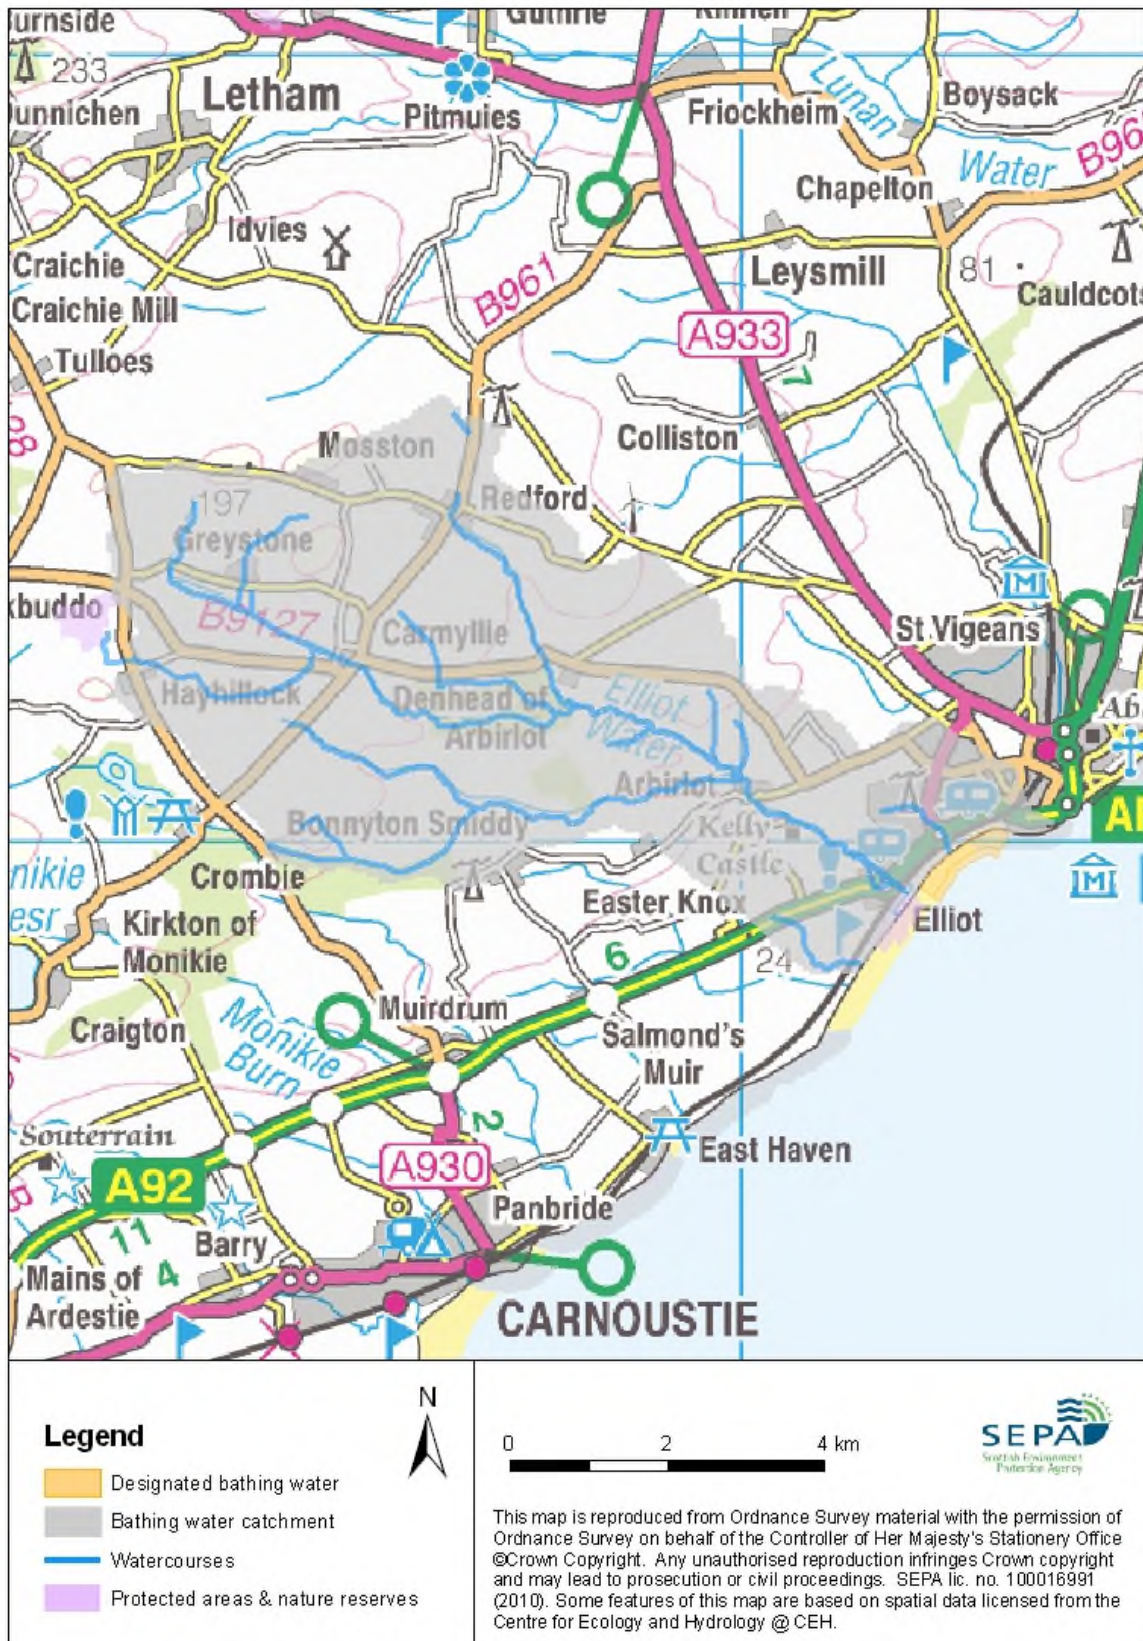
Map 2: Catchment draining into Arbroath (West Links) bathing water

The catchment draining into Arbroath (West Links) bathing water extends to 44 km². It varies in topography from low-lying areas along the coast to low hills in the west. The catchment is predominantly rural (96%) with arable agriculture the major land use. There is also some beef and sheep farming in the area. Approximately 4% of the bathing water catchment is urban; the main urban area being the town of Arbroath. There are also a number of other small settlements within the catchment.

The main rivers within the bathing water catchment are the Elliot Water, the Geordies Burn and Brothock Water.
