Bathing Water Profile for Balmedie

Balmedie, Scotland

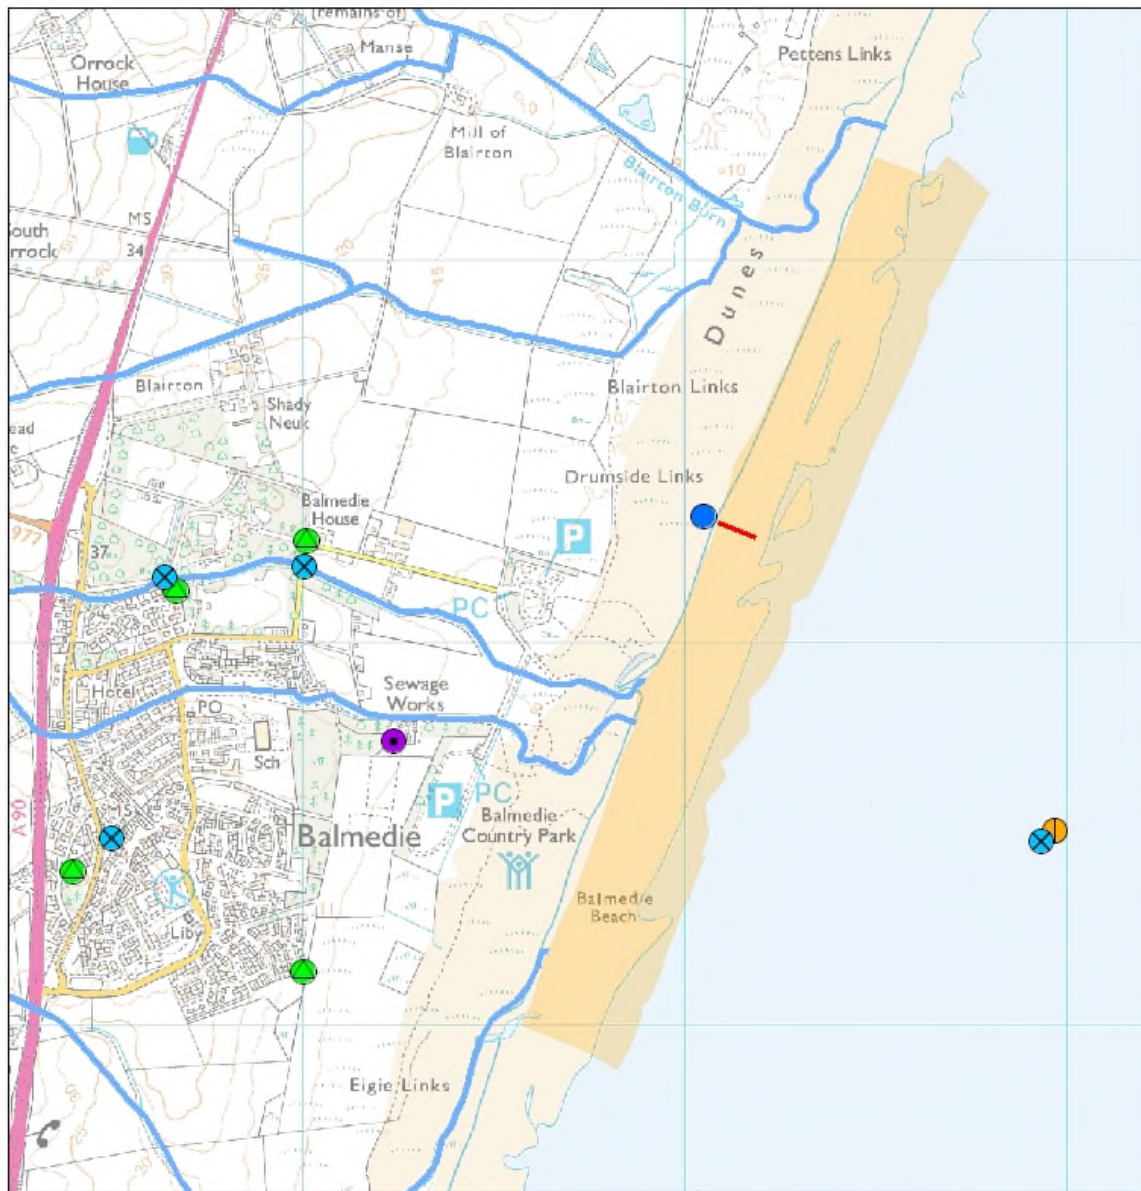
Map 1: Balmedie bathing water

-   Designated bathing water
-   Bathing water sampling point
-   Bathing water sampling transect
-   Sewage effluent discharge
-   Combined sewer overflow
-   Sewage pumping station
-   Sewage treatment works
-   Watercourses

The catchment draining into Balmedie bathing water extends to 23 km². The area varies in topography from gently rolling hills in the west to the low-lying plains along the coast. The main rivers within the bathing water catchment are the Eigie Burn and Potterton Burn. The Eigie Burn enters the sea approximately 1 km from the southern end of the designated bathing area and the Potterton Burn enters at the southern end.
