Bathing Water Profile for Balmedie

Balmedie, Scotland

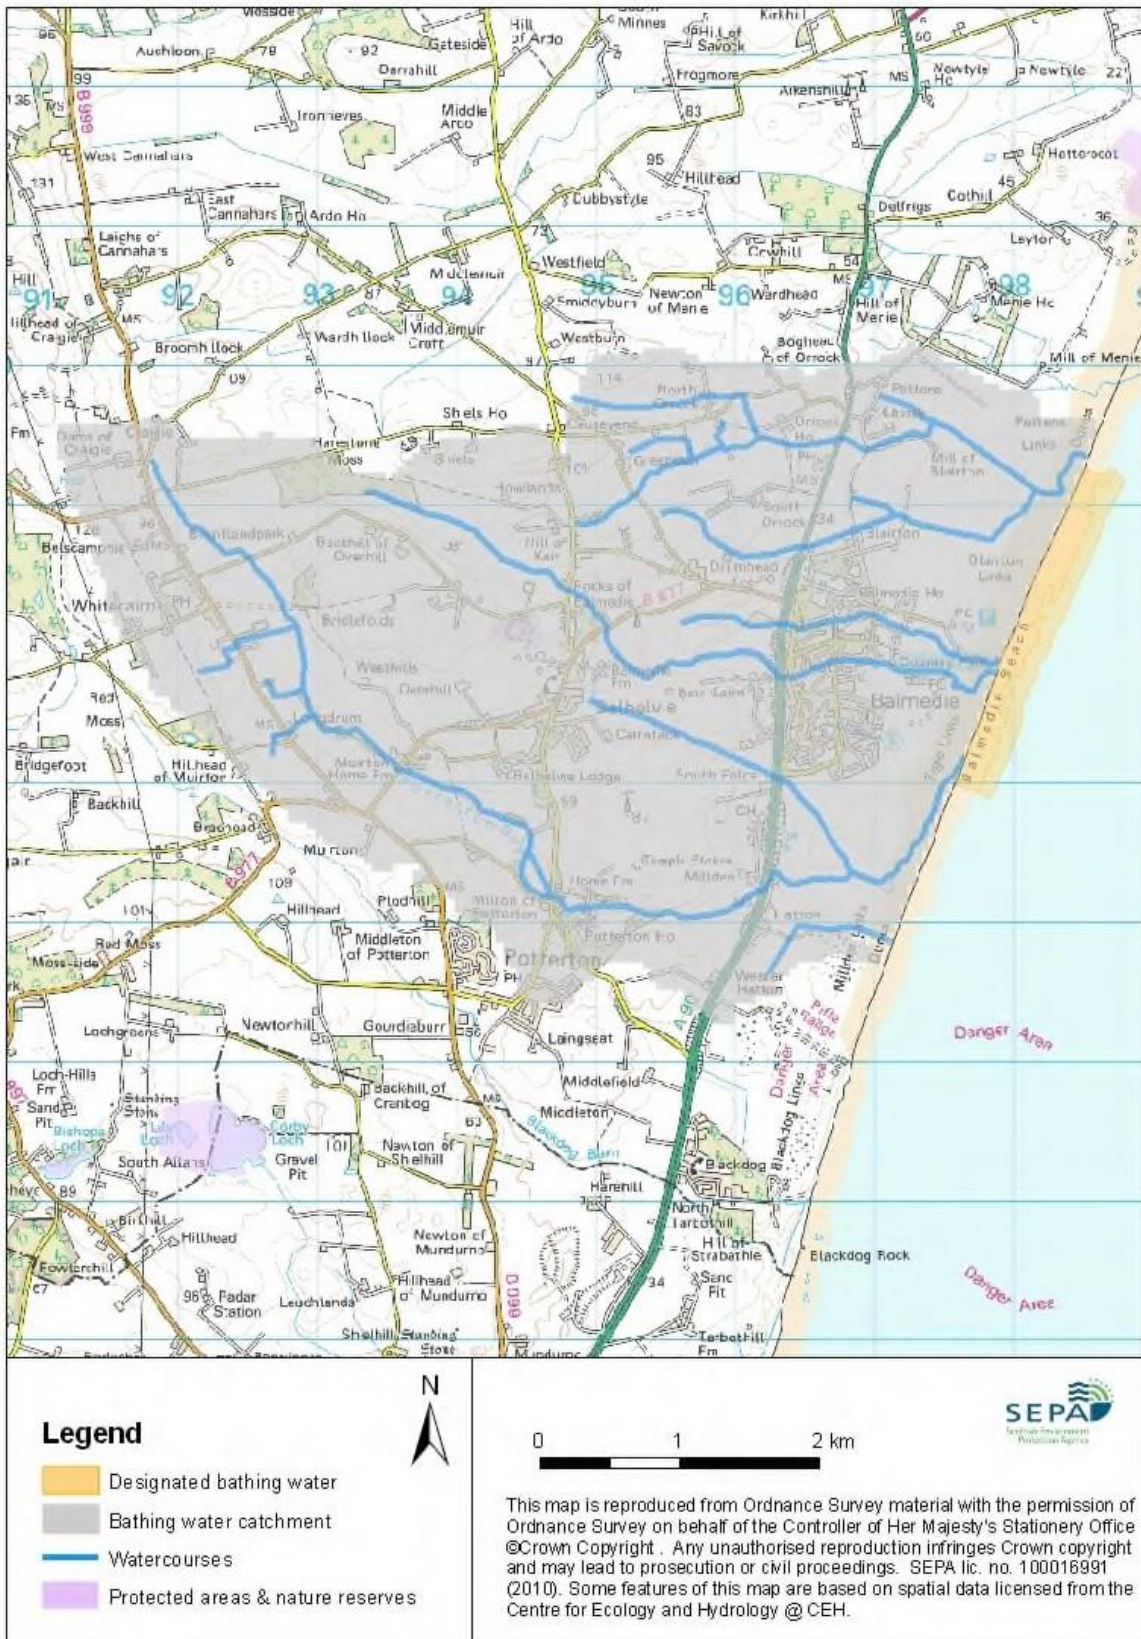
Map 2: Catchment draining into Balmedie bathing water

The catchment draining into Balmedie bathing water extends to 23 km². The area varies in topography from gently rolling hills in the west to the low-lying plains along the coast. The main rivers within the bathing water catchment are the Egie Burn and Potterton Burn. The Egie Burn enters the sea approximately 1 km from the southern end of the designated bathing area and the Potterton Burn enters at the southern end.
