Bathing Water Profile for Brighthouse Bay

Kirkcudbright, Scotland

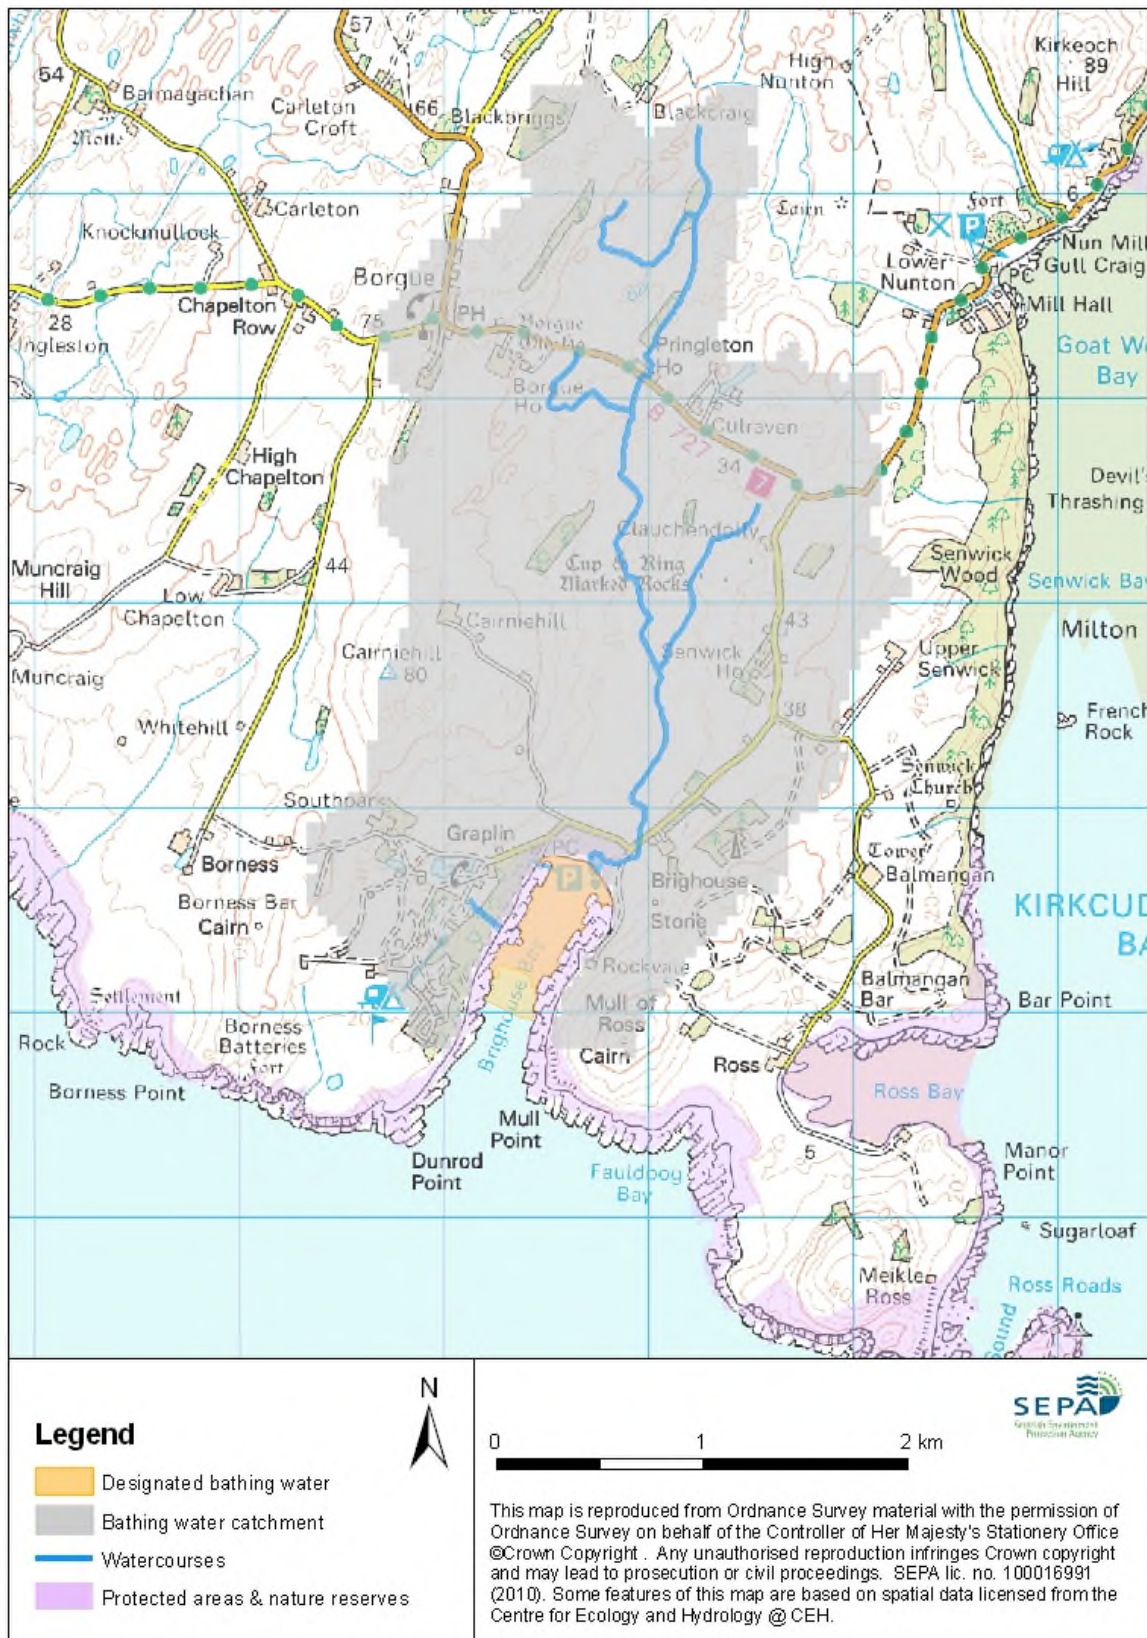
Map 2: Catchment draining into Brighthouse Bay bathing water

A catchment area of 8.4 km² drains into Brighthouse Bay bathing water. It is a hilly catchment that includes Cairniehill and the Mull of Ross to the south east of the bay. Brighthouse Burn enters the bay midway along the beach.

Agriculture is the major land use in the catchment. There are several dairy farms with the surrounding land being used as pasture. Urban land use is concentrated around the Borgue and Kirkcudbright population centres.
