Bathing Water Profile for Carnoustie

Carnoustie, Scotland

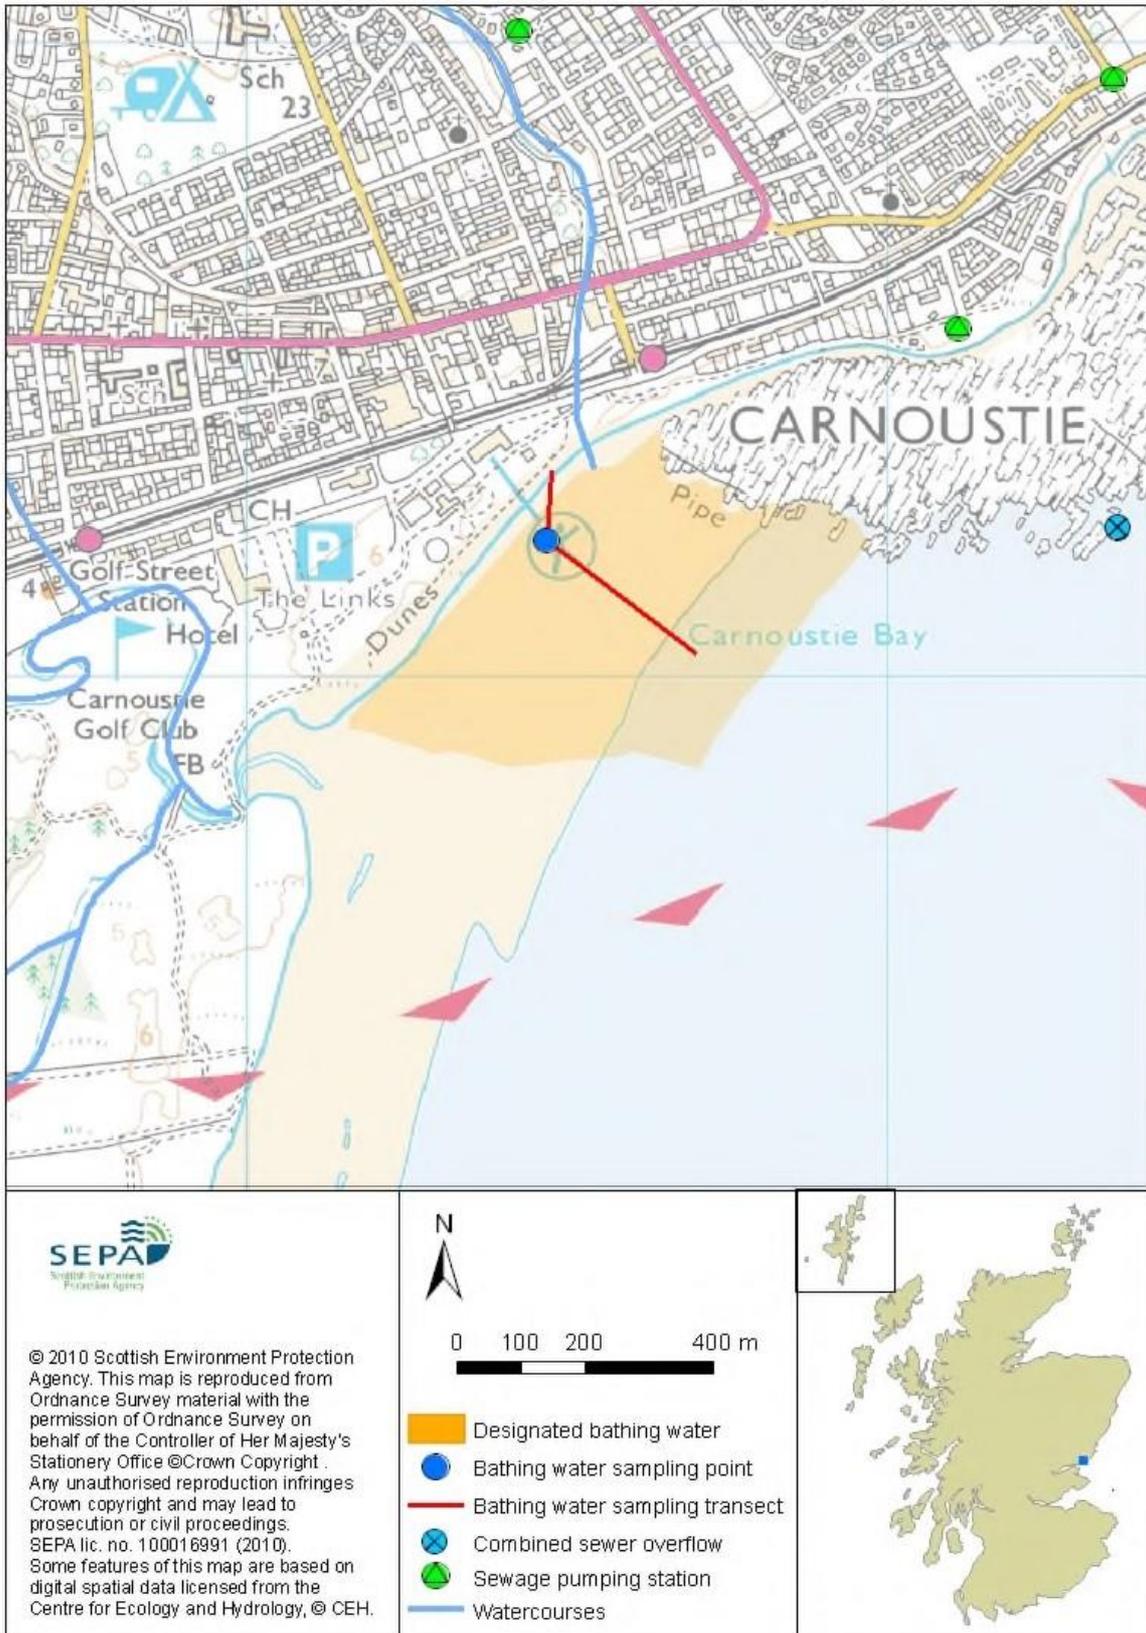
Map 1: Carnoustie bathing water

The Carnoustie bathing water is situated to the south of the town of Carnoustie. It is in a relatively small and shallow bay about 0.7 km in length that slopes gently towards the water.

There are two watercourses within the bathing water catchment. Barry Burn flows into the south west area of the bathing water, and Lochty Burn, which flows directly into the bathing water.

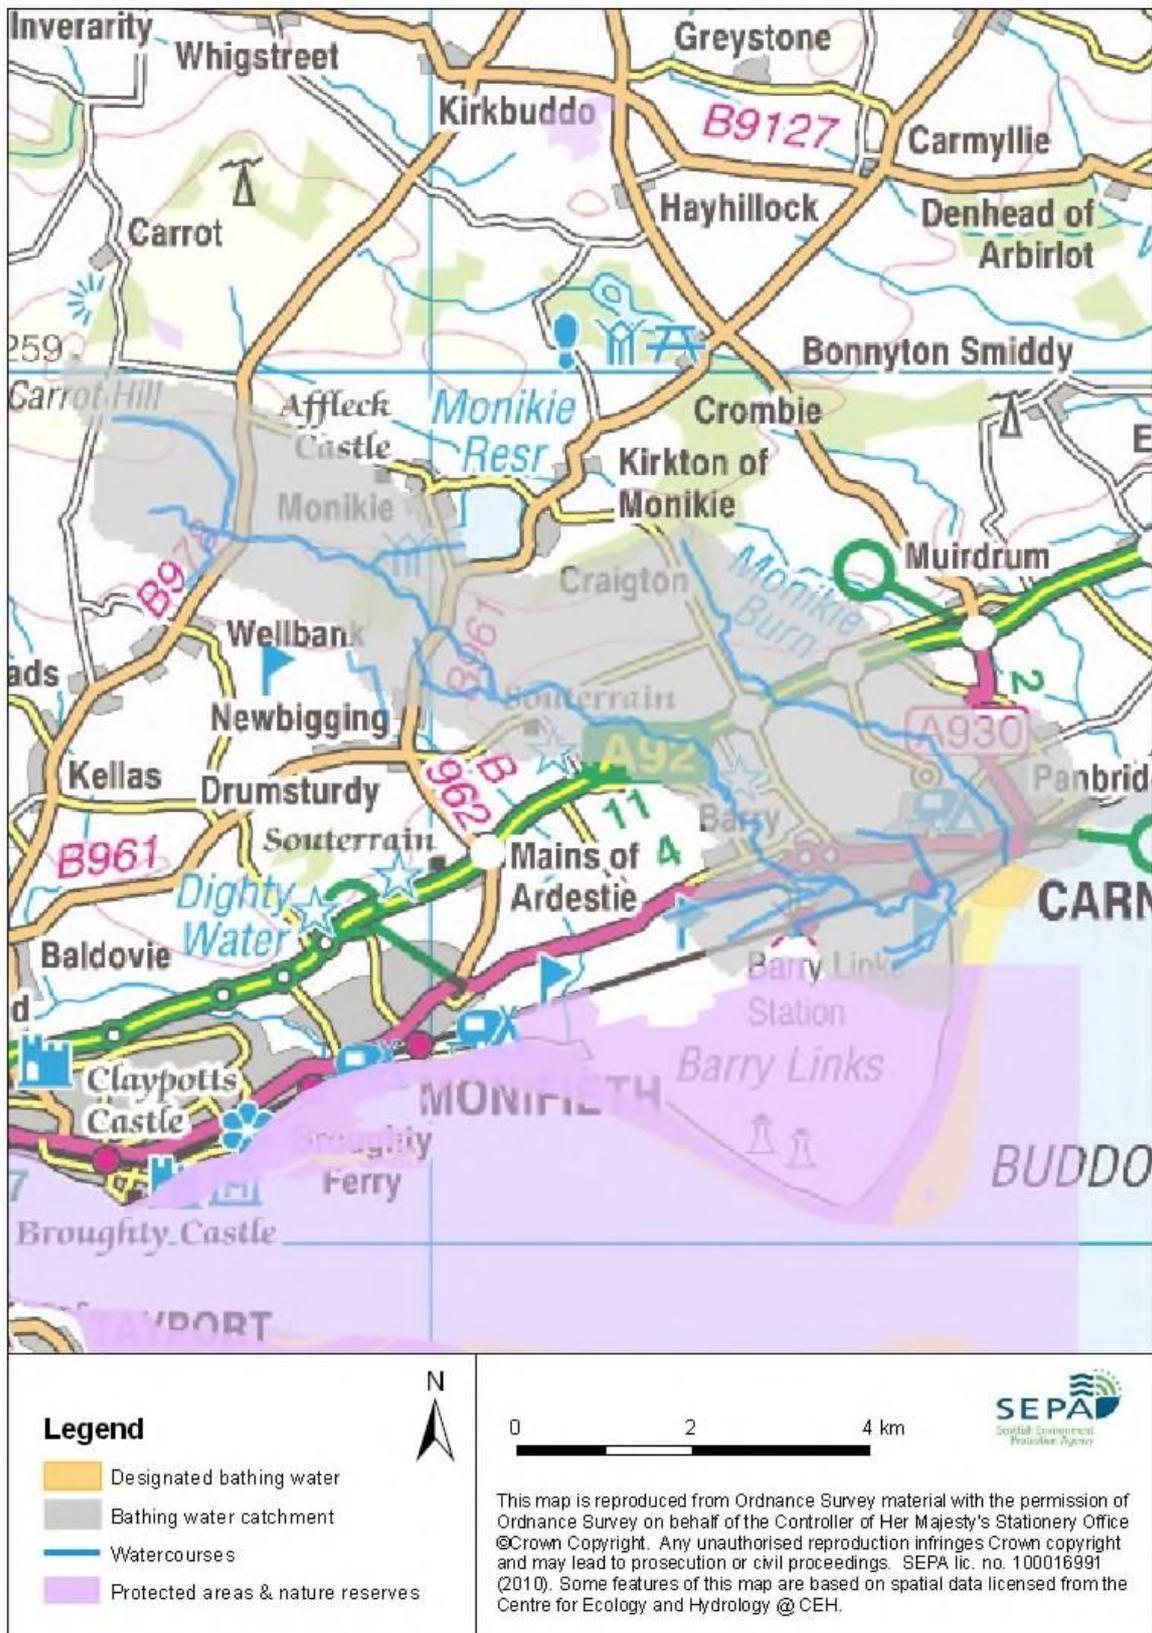
Map 2: Catchment draining into Carnoustie bathing water

The catchment draining into the Carnoustie bathing water extends to 31 km². The area varies in topography from low hills in the west to the low-lying plains along the coast.

The catchment is predominantly rural (91%). The major land use is arable agriculture with some soft fruit and livestock production. Approximately 9% of the bathing water catchment is urban and includes the town of Carnoustie. Population density outside of the town is generally low.

Sewage from Carnoustie is pumped to Hatton sewage treatment works. It undergoes treatment before discharging to the Firth of Tay via a long sea outfall. Monikie sewage treatment works and combined sewers discharge to the Barry Burn. Treatment at the Monikie works includes bio-filters and humus tanks.

A number of septic tank from the Clayholes and Carlogie areas no longer discharge to the Lochty Burn. The complexity and age of the sewer system in the area means that it requires continued vigilance and investigative effort.
