## Bathing water profile:

# Carrick

<p><b>EC bathing water ID number:</b> UKS7616010</p>	
<p><b>Location of bathing water:</b> UK/Scotland/Dumfries and Galloway (Map1)</p>	
<p><b>Year of designation:</b> 1999</p>

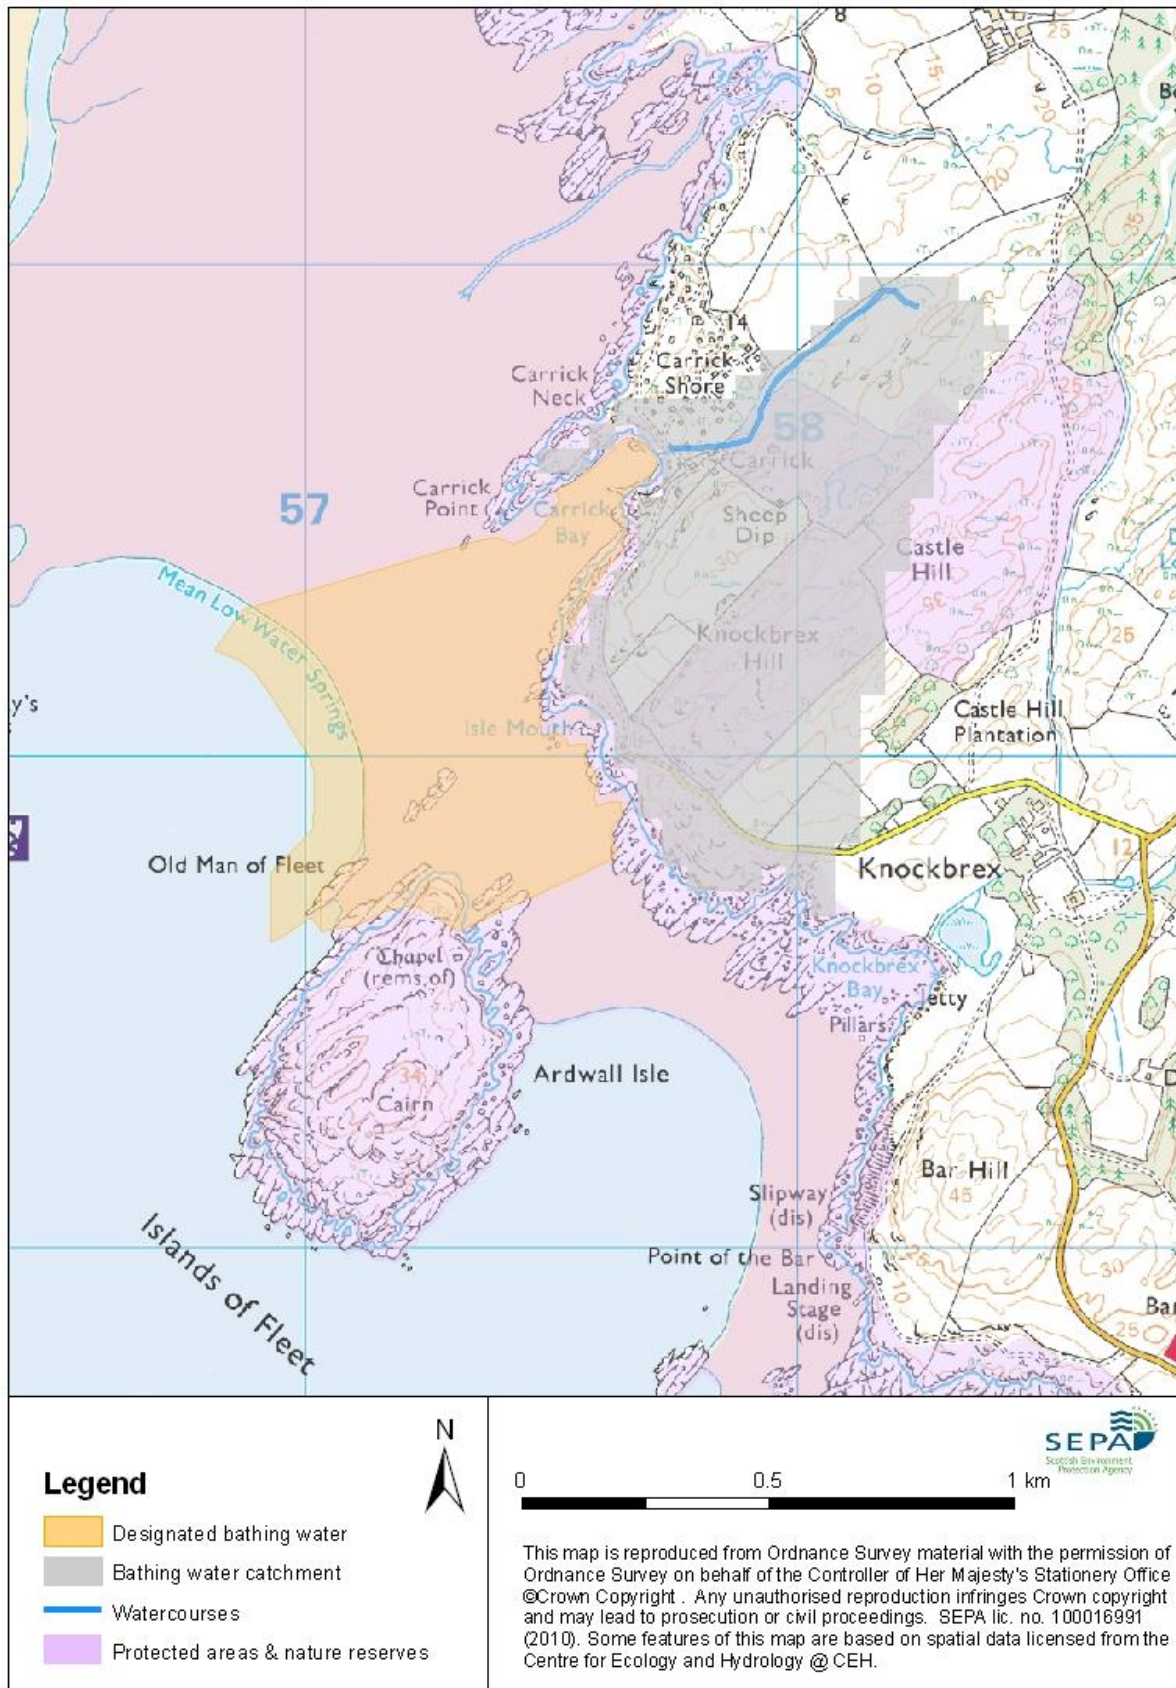
**Map 2: Catchment draining into Carrick bathing water**

The immediate catchment draining into the Carrick bathing water extends to only 600 m<sup>2</sup>. The maximum elevation within the catchment is 35 metres at Castle Hill, which lies to the east of the bathing water.

There is only one small unnamed tributary within the bathing water catchment. This enters the bathing water at Carrick Bay.

The bathing water lies entirely within the Borgue Coast Site of Special Scientific Interest (Map 2). The area is used by indigenous greater black-backed and common gull colonies, Canada geese (for their late summer moult) and several species of wading birds and could potentially influence water quality at the bathing water. See Scottish Natural Heritage's [information service website](#)<sup>3</sup> for more information.
