Bathing Water Profile for Cullen Bay

Cullen, Scotland

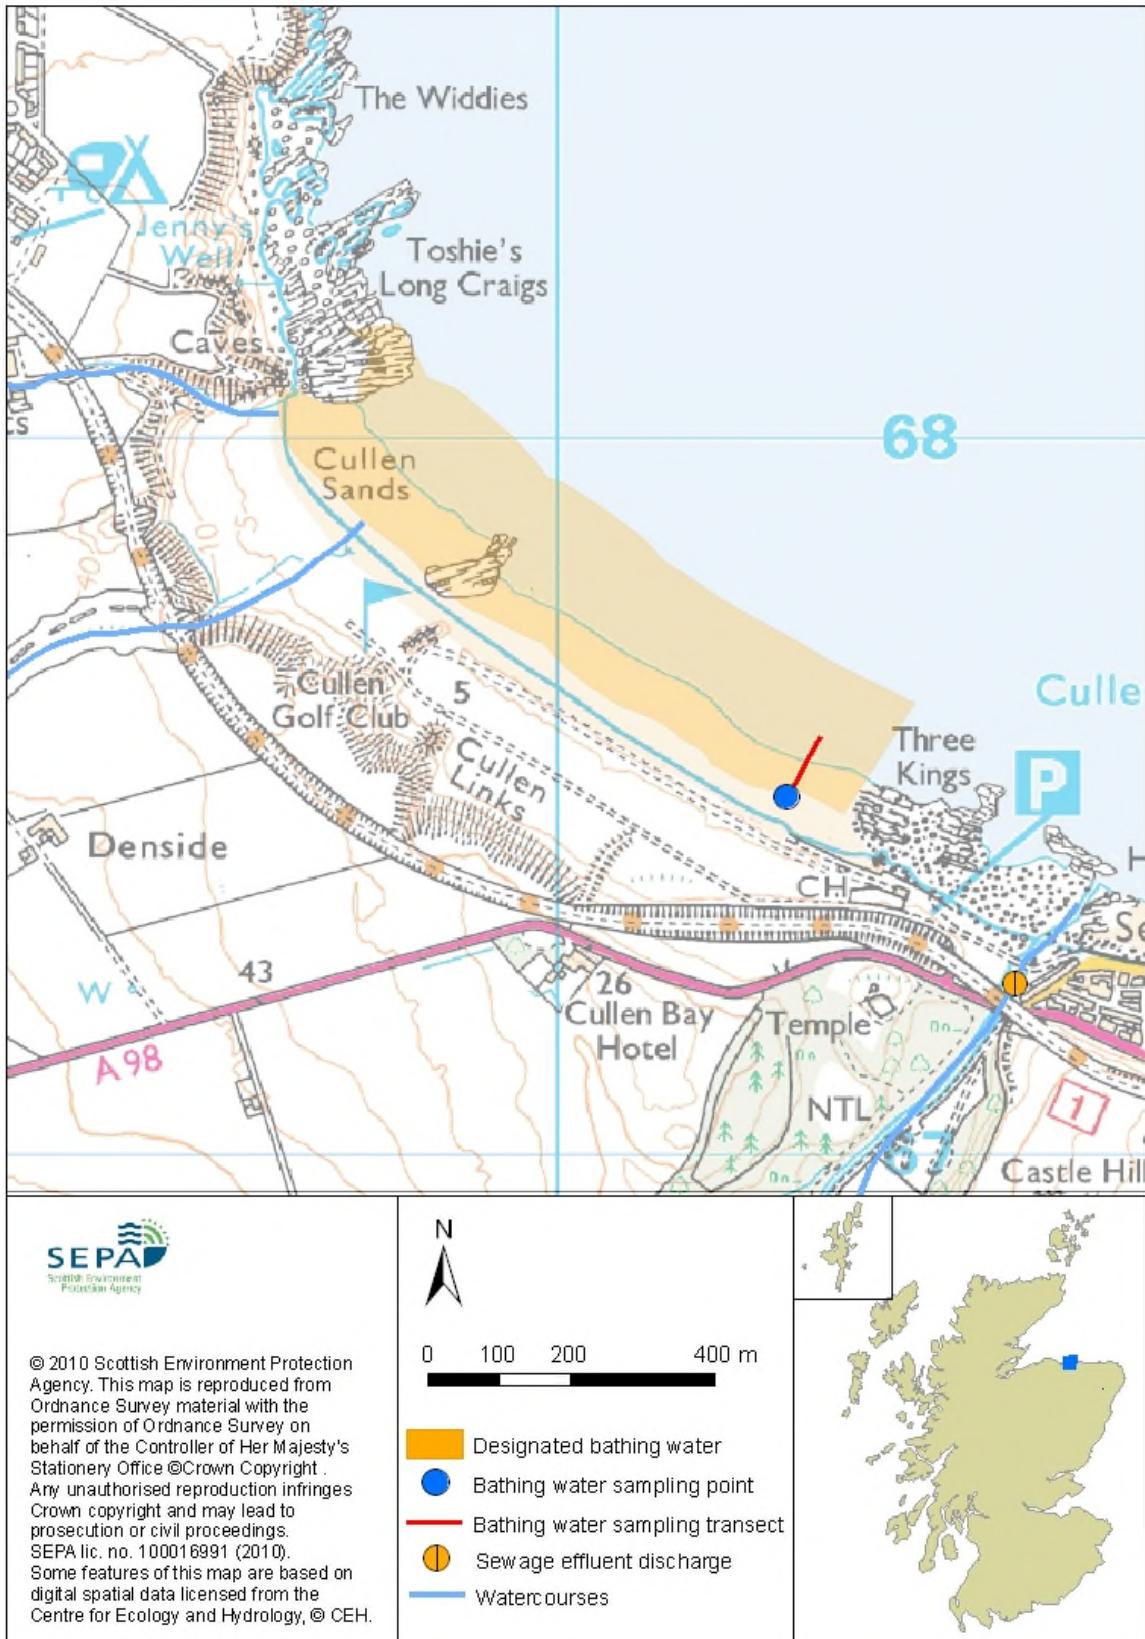
Map 1: Cullen Bay bathing water

Description Cullen Bay bathing water is an attractive sandy beach approximately 1km in length, situated on the north coast of Moray. It lies between the villages of Cullen and Portknockie and is backed by Cullen Links golf course.

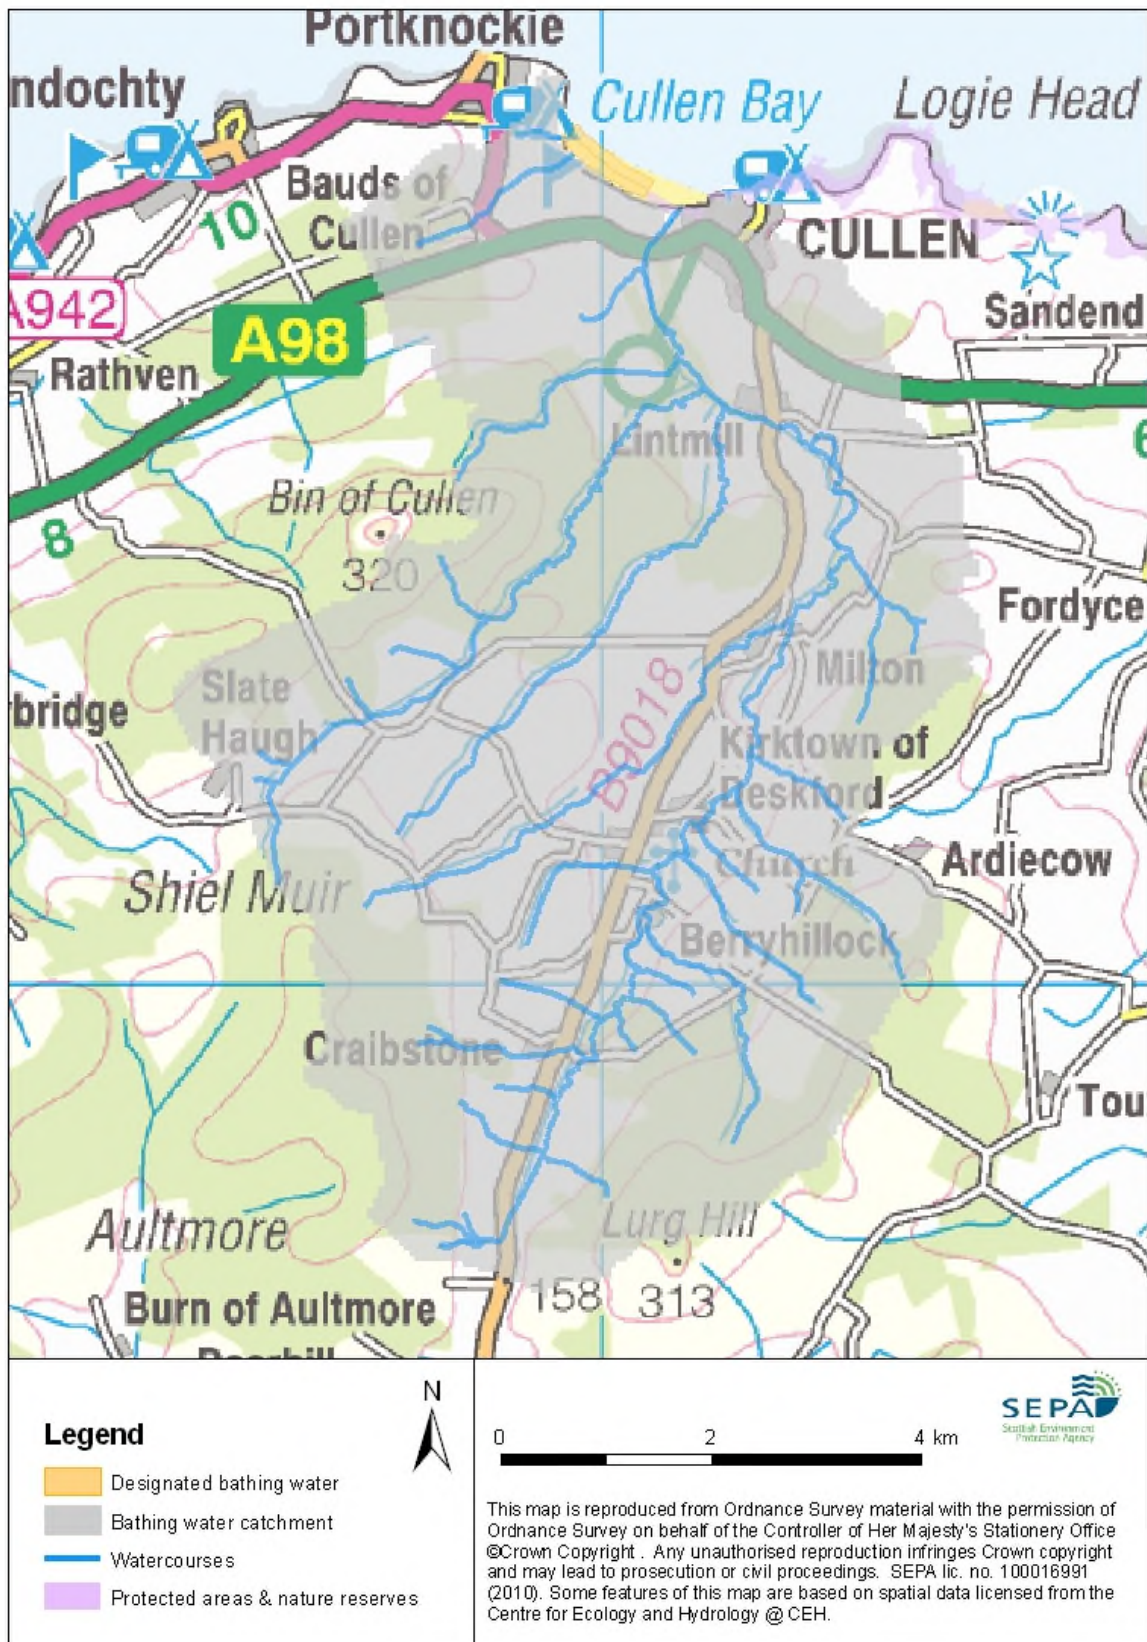
Map 2: Catchment draining into Cullen Bay bathing water

The catchment draining into the Cullen Bay bathing water extends to 54 km². The area varies in topography from gentle hills to low-lying plains along the coast.

The main river within the bathing water catchment is Deskford Burn which flows into the sea at the eastern end of the bay.

The area is predominantly rural (99%) with agriculture the major land use. Of the agricultural areas, 35% is given over to arable farming and 23% to grassland. In general, the arable areas are located in the lower catchment with livestock farming further inland. The rest of the rural area is woodland (38%).
