# Bathing Water Profile for Eyemouth

Eyemouth, Scotland

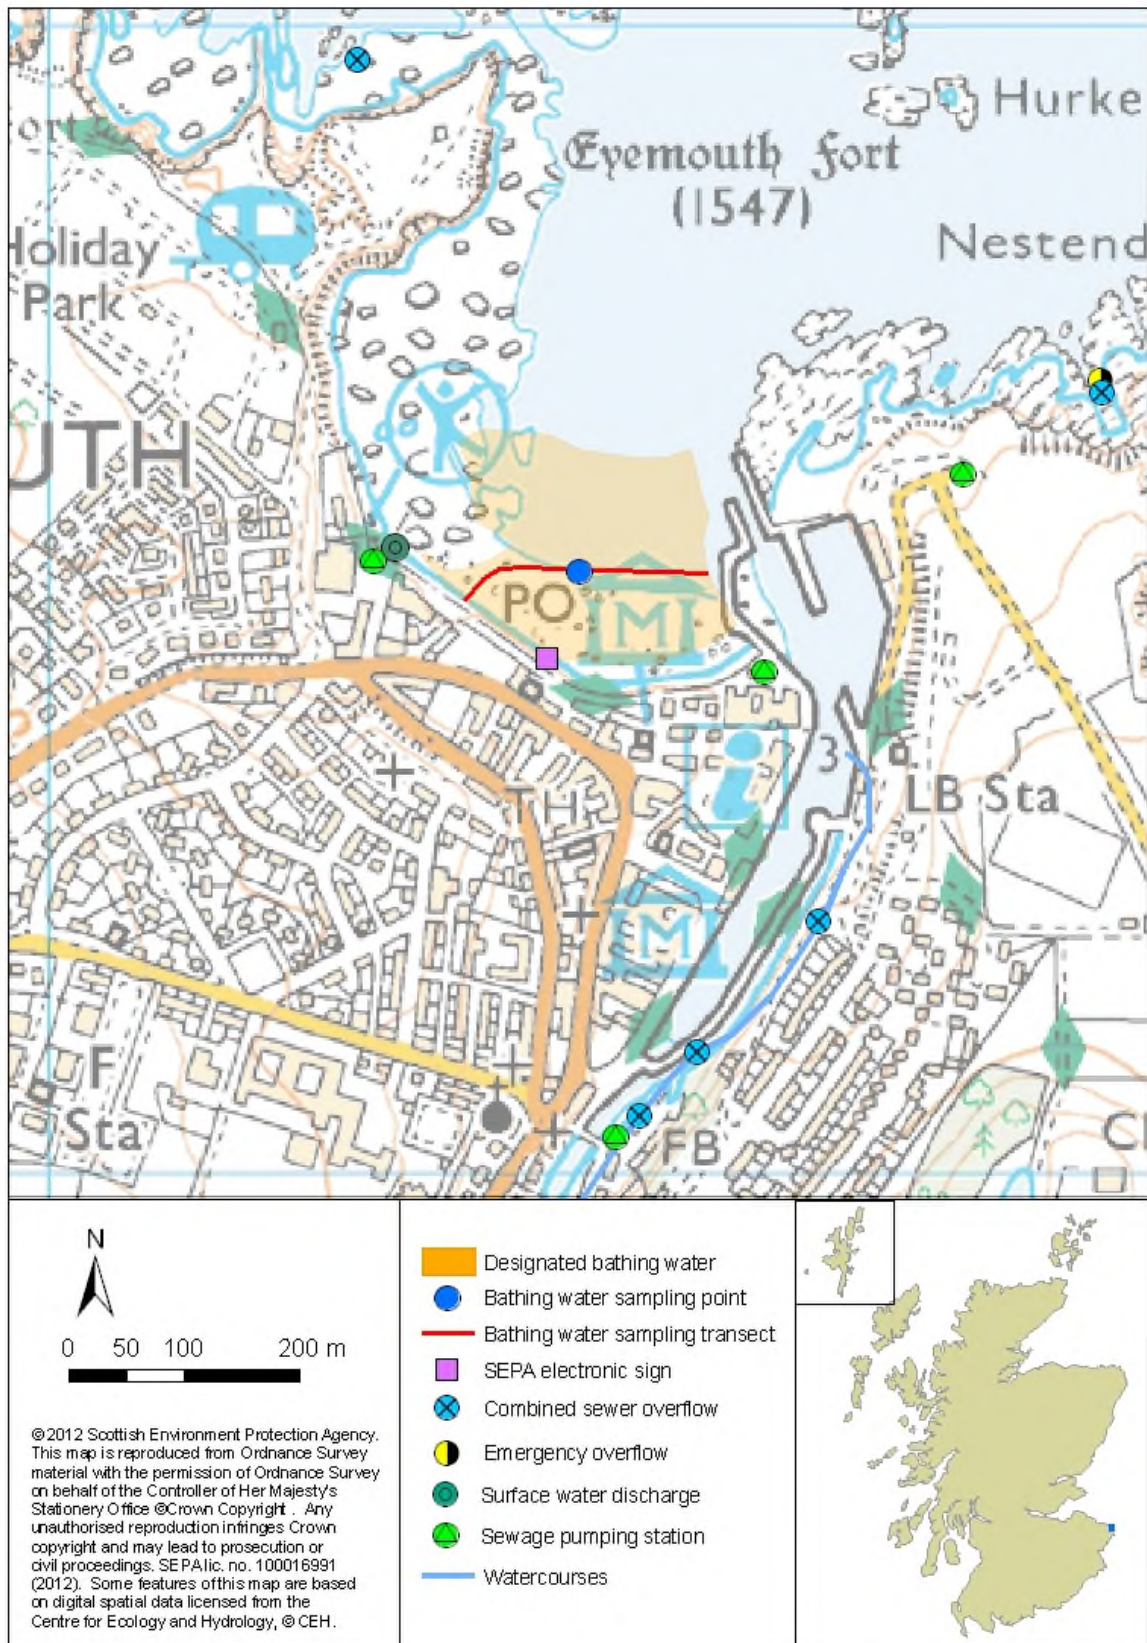
Map 1: Eyemouth bathing water

This bathing water is subject to short term pollution when heavy rainfall washes bacteria into the sea. Pollution risks include agricultural run-off and combined sewer overflows. These are highlighted on Map 1.

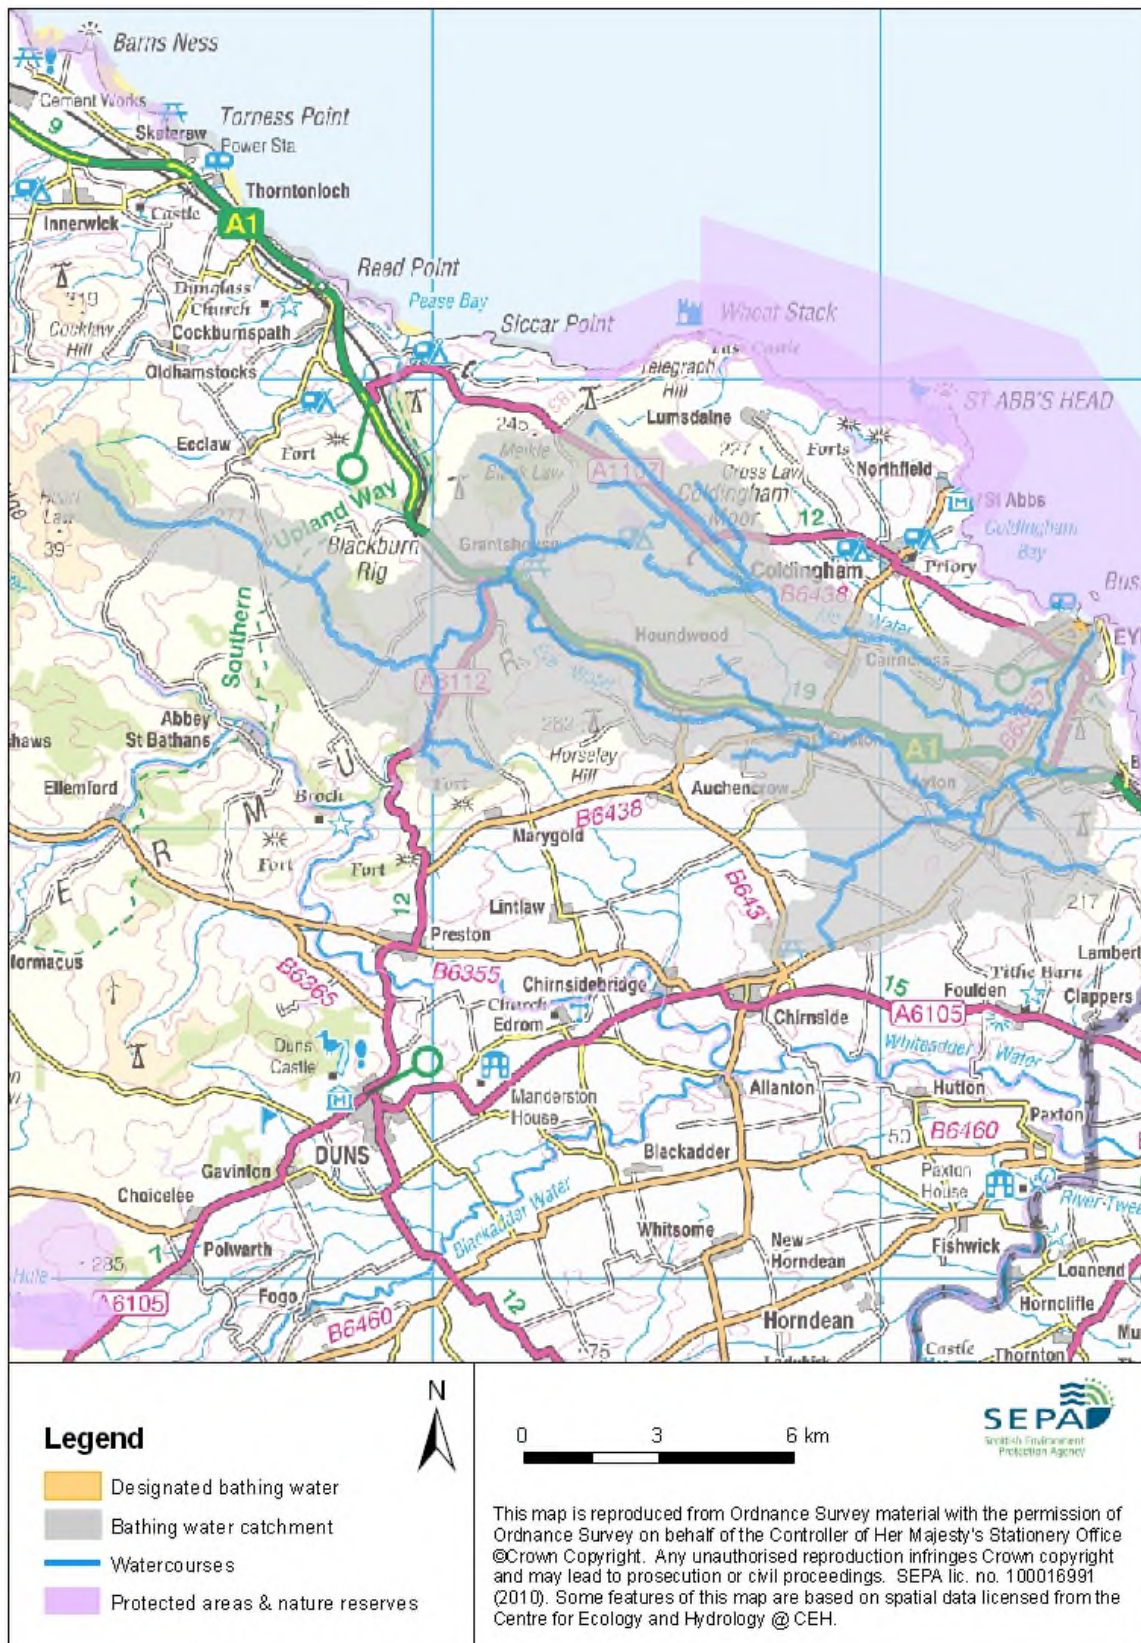
Map 2: Catchment draining into Eyemouth bathing water

A catchment area of 120 km<sup>2</sup> drains into Eyemouth bathing water. The main rivers in the bathing water catchment are the Eye Water, Ale Water, Horn Burn and the North Burn.
