## Bathing Water Profile for Eyemouth

Eyemouth, Scotland

**Description** The bathing water is situated next to Eyemouth town in the Scottish Borders. It is a small, shallow sandy bay of about 0.3 km in length. The beach is popular with families during the summer months.

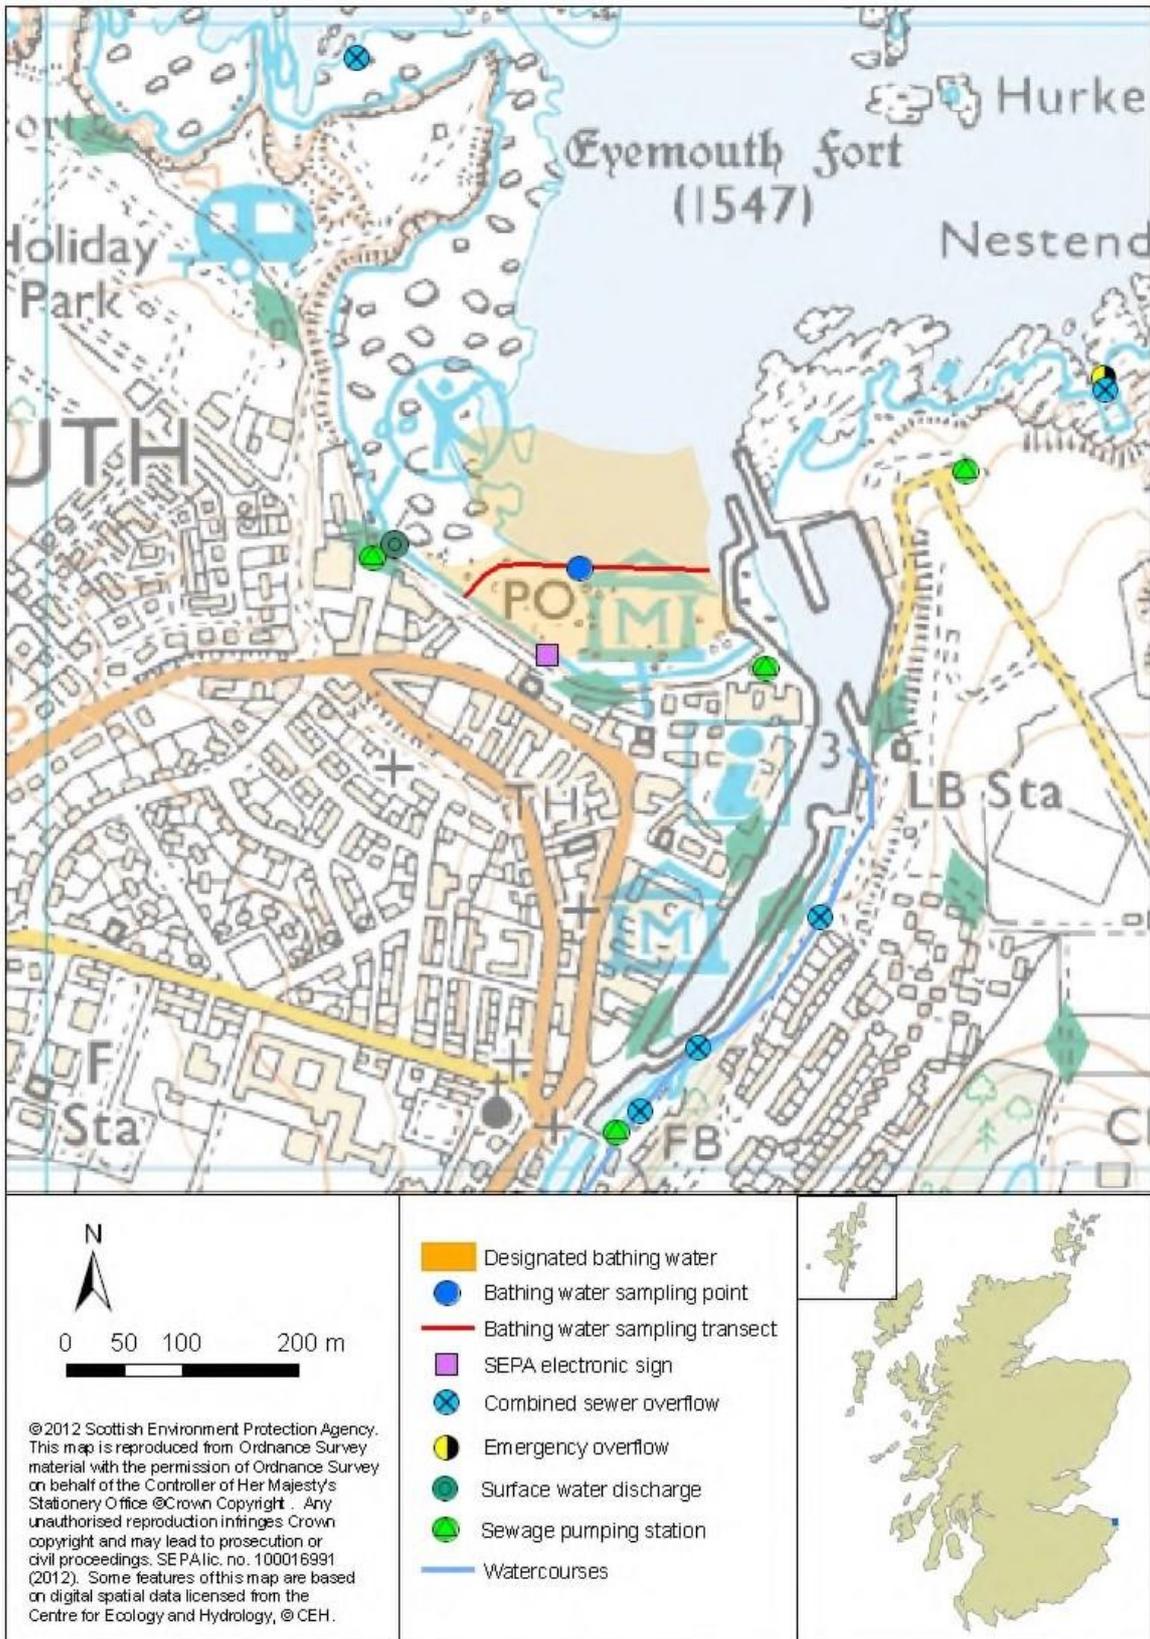
Map 1: Eyemouth bathing water

This bathing water is subject to short term pollution when heavy rainfall washes bacteria into the sea. Pollution risks include agricultural run-off and combined sewer overflows. These are highlighted on Map 1.

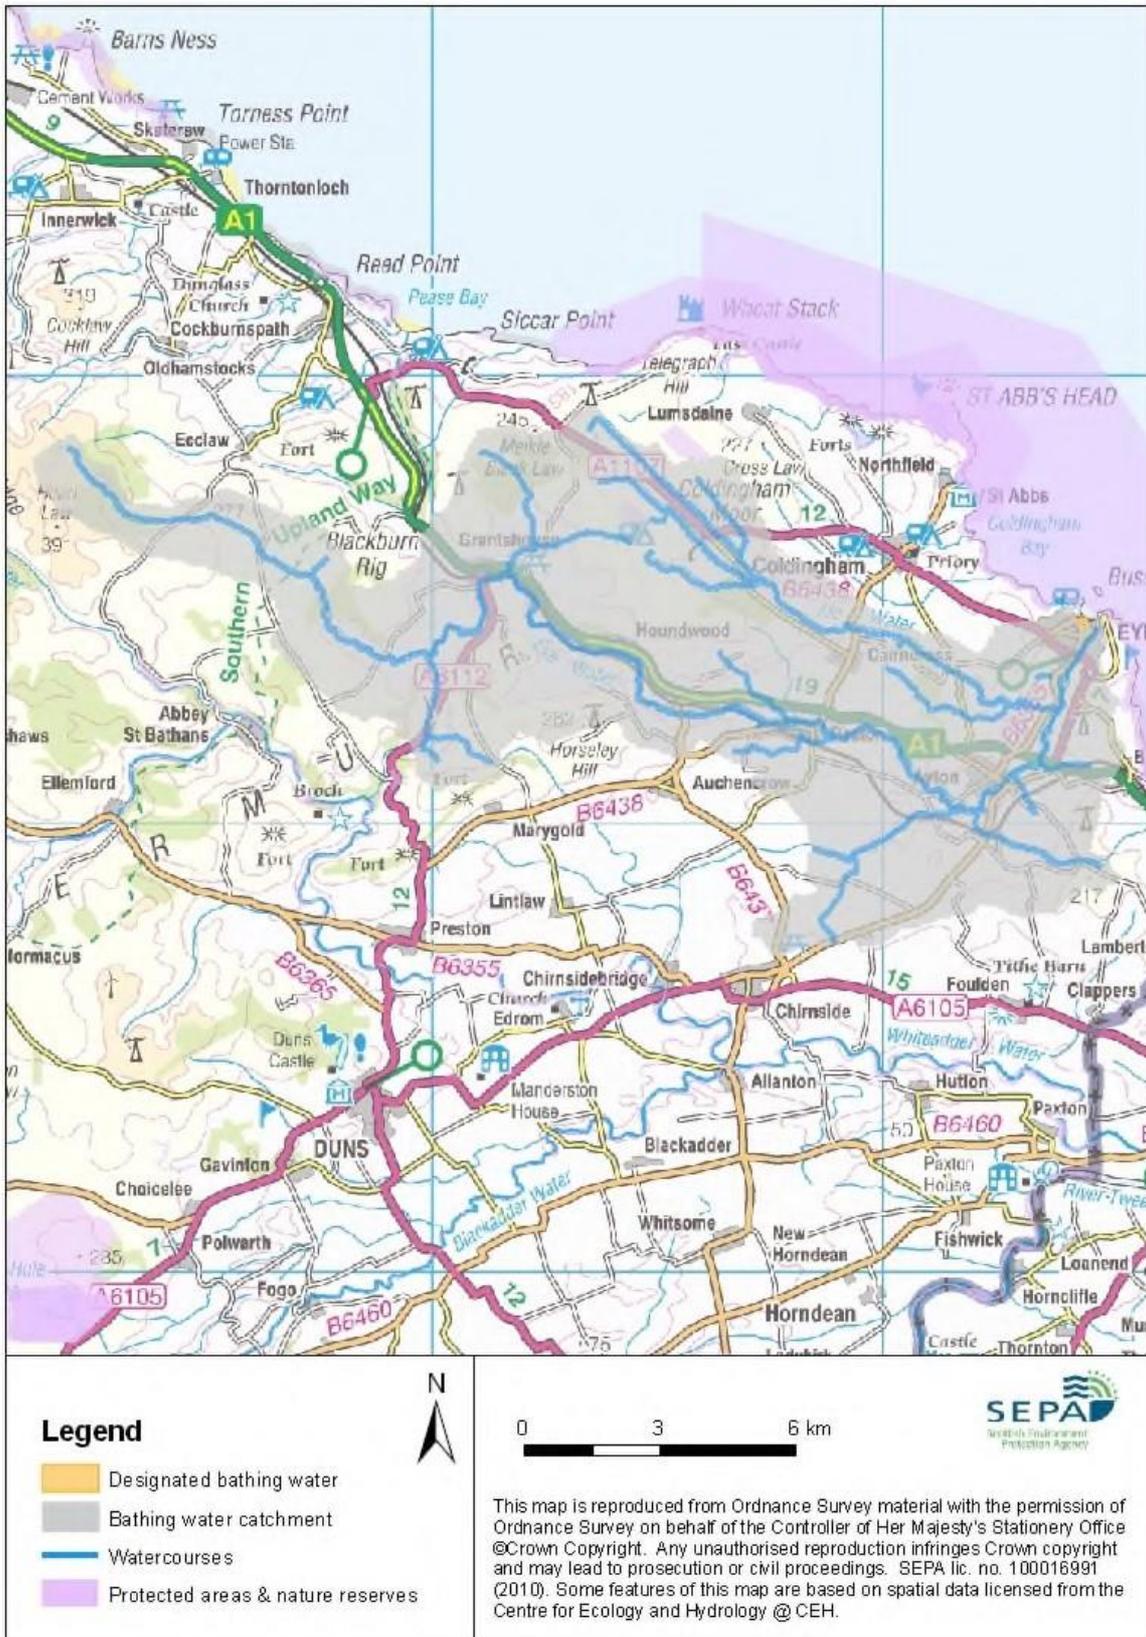
Map 2: Catchment draining into Eyemouth bathing water

A catchment area of 120 km<sup>2</sup> drains into Eyemouth bathing water. The main rivers in the bathing water catchment are the Eye Water, Ale Water, Horn Burn and the North Burn.
