Bathing Water Profile for Irvine

Irvine, Scotland

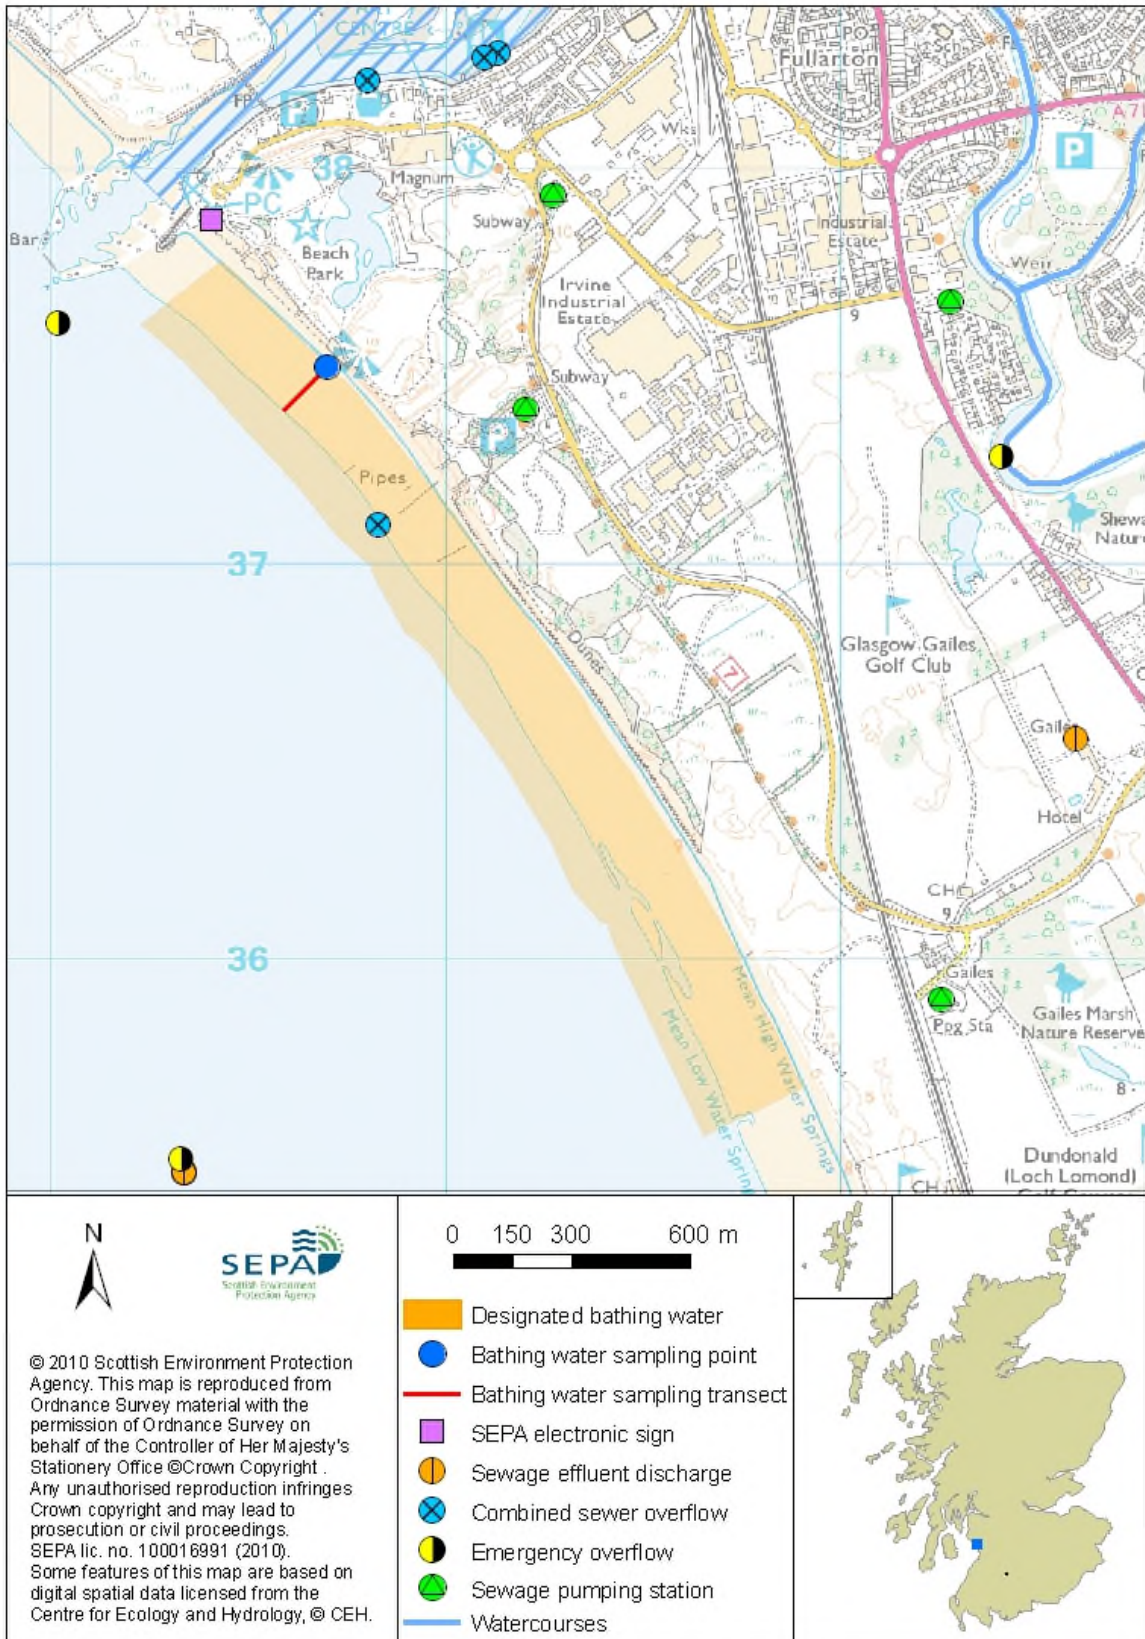
Map 1: Irvine bathing water

This bathing water is subject to short term pollution when heavy rainfall washes faecal pollutants into the sea. Pollution risks include agricultural run-off, sewer overflows and surface water discharges. See Map 1.
