Bathing Water Profile for Kinghorn (Harbour Beach)

Kinghorn, Scotland

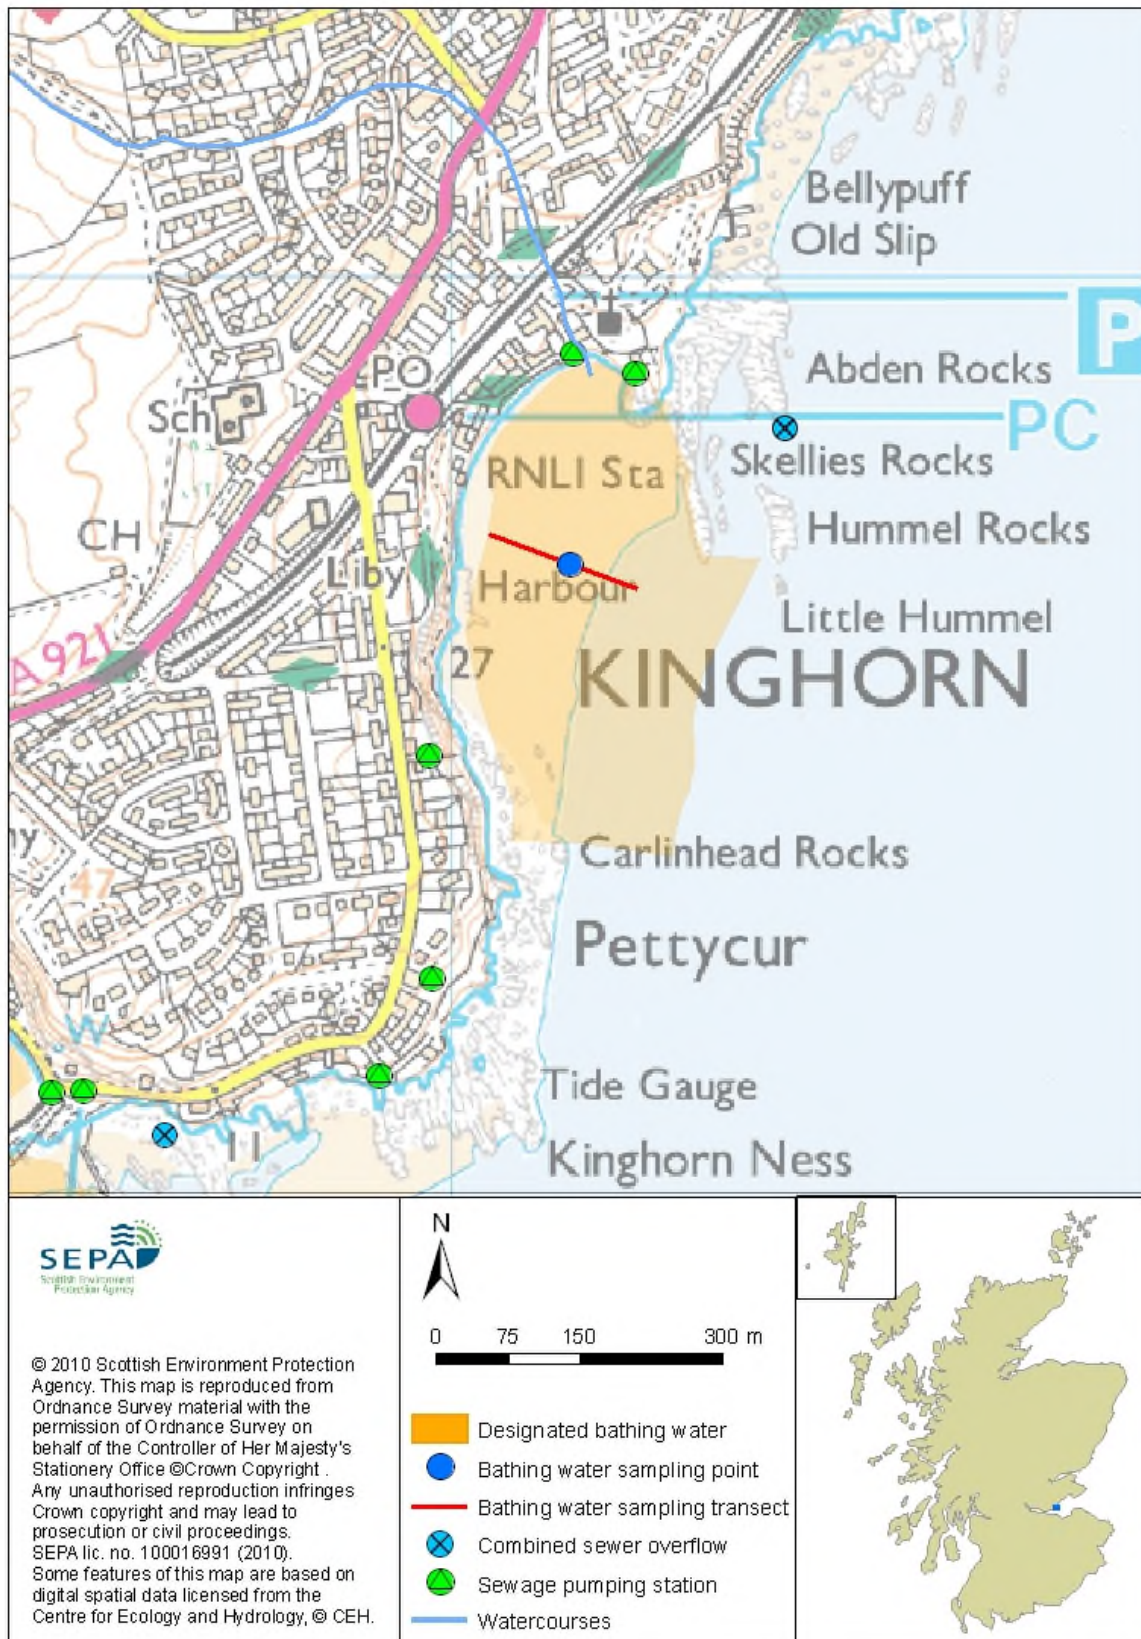
Map 1: Kinghorn (Harbour Beach) bathing water

This bathing water is subject to short term pollution when heavy rainfall results in high bacterial concentrations. Pollution risks include combined sewer overflows and treated sewage effluent. These are highlighted on Map 1.

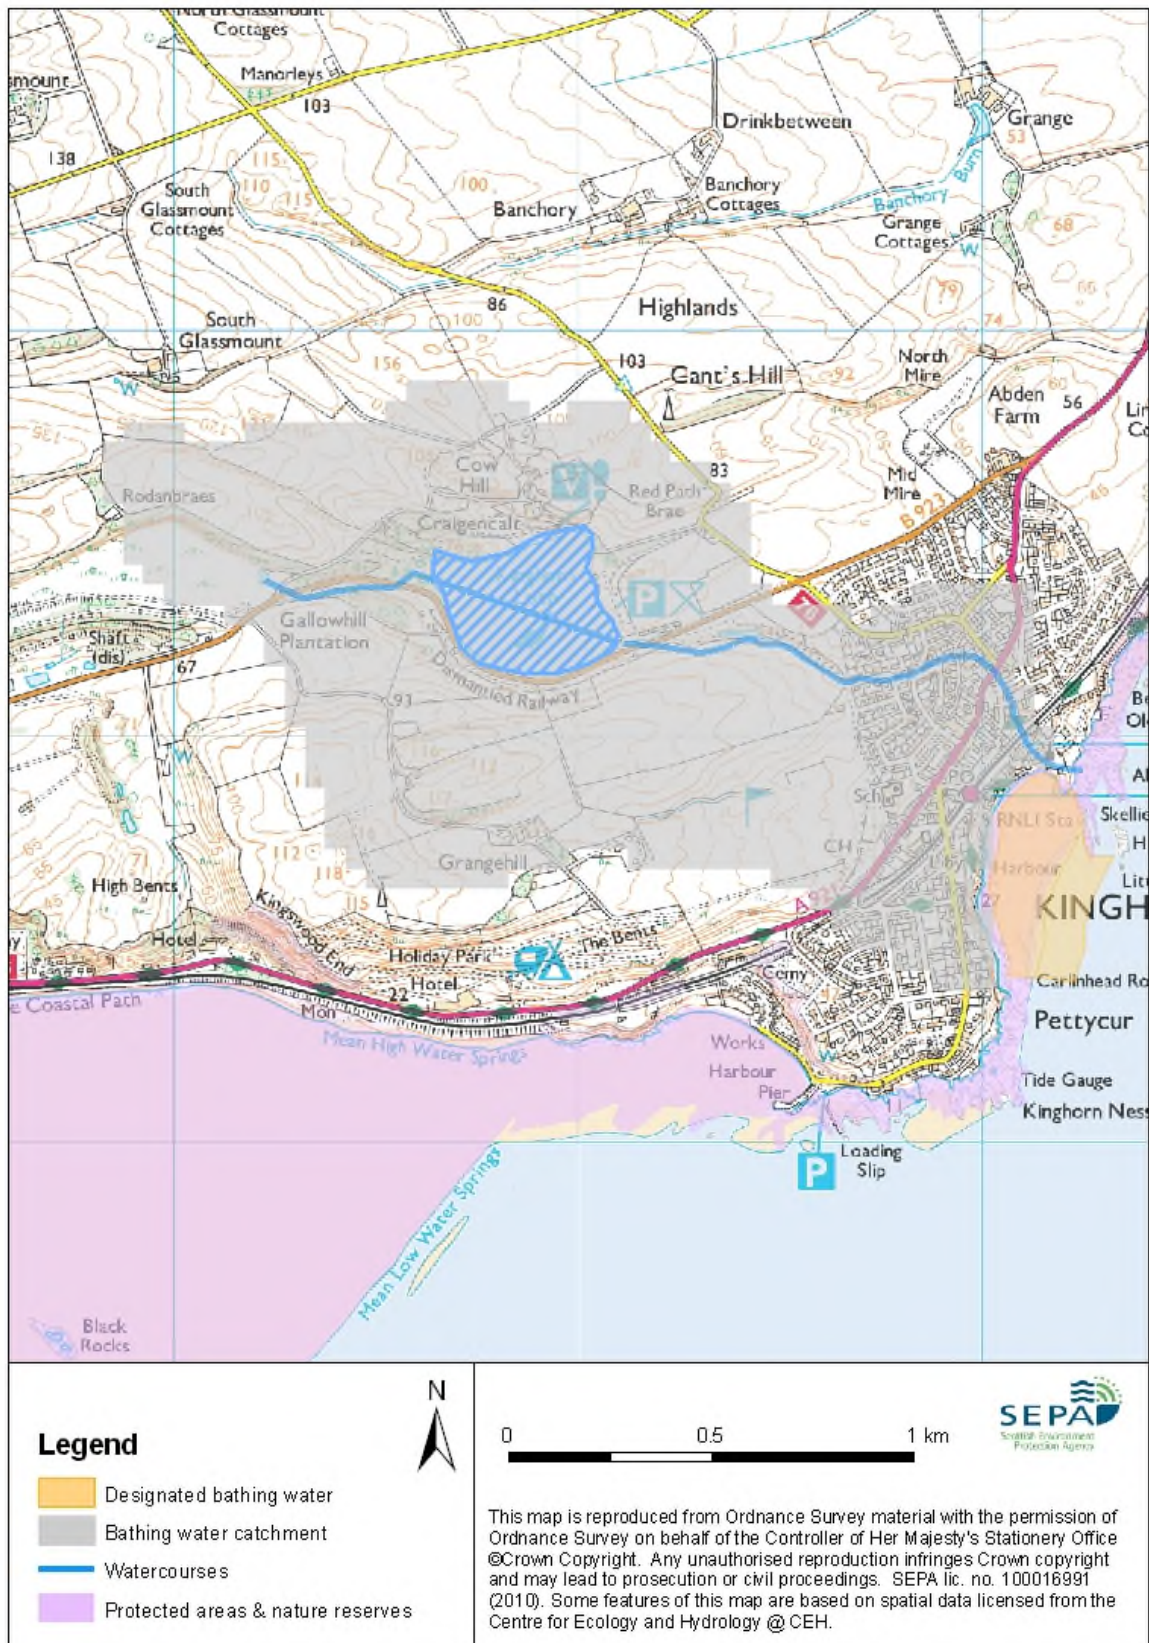
Map 2: Catchment draining into Kinghorn (Harbour Beach) bathing water

A catchment area of 2 km² drains into Kinghorn (Harbour Beach) bathing water. Kinghorn Burn and Lady Burn are the main watercourses within the bathing water catchment.
