Bathing Water Profile for Leven

Leven, Scotland

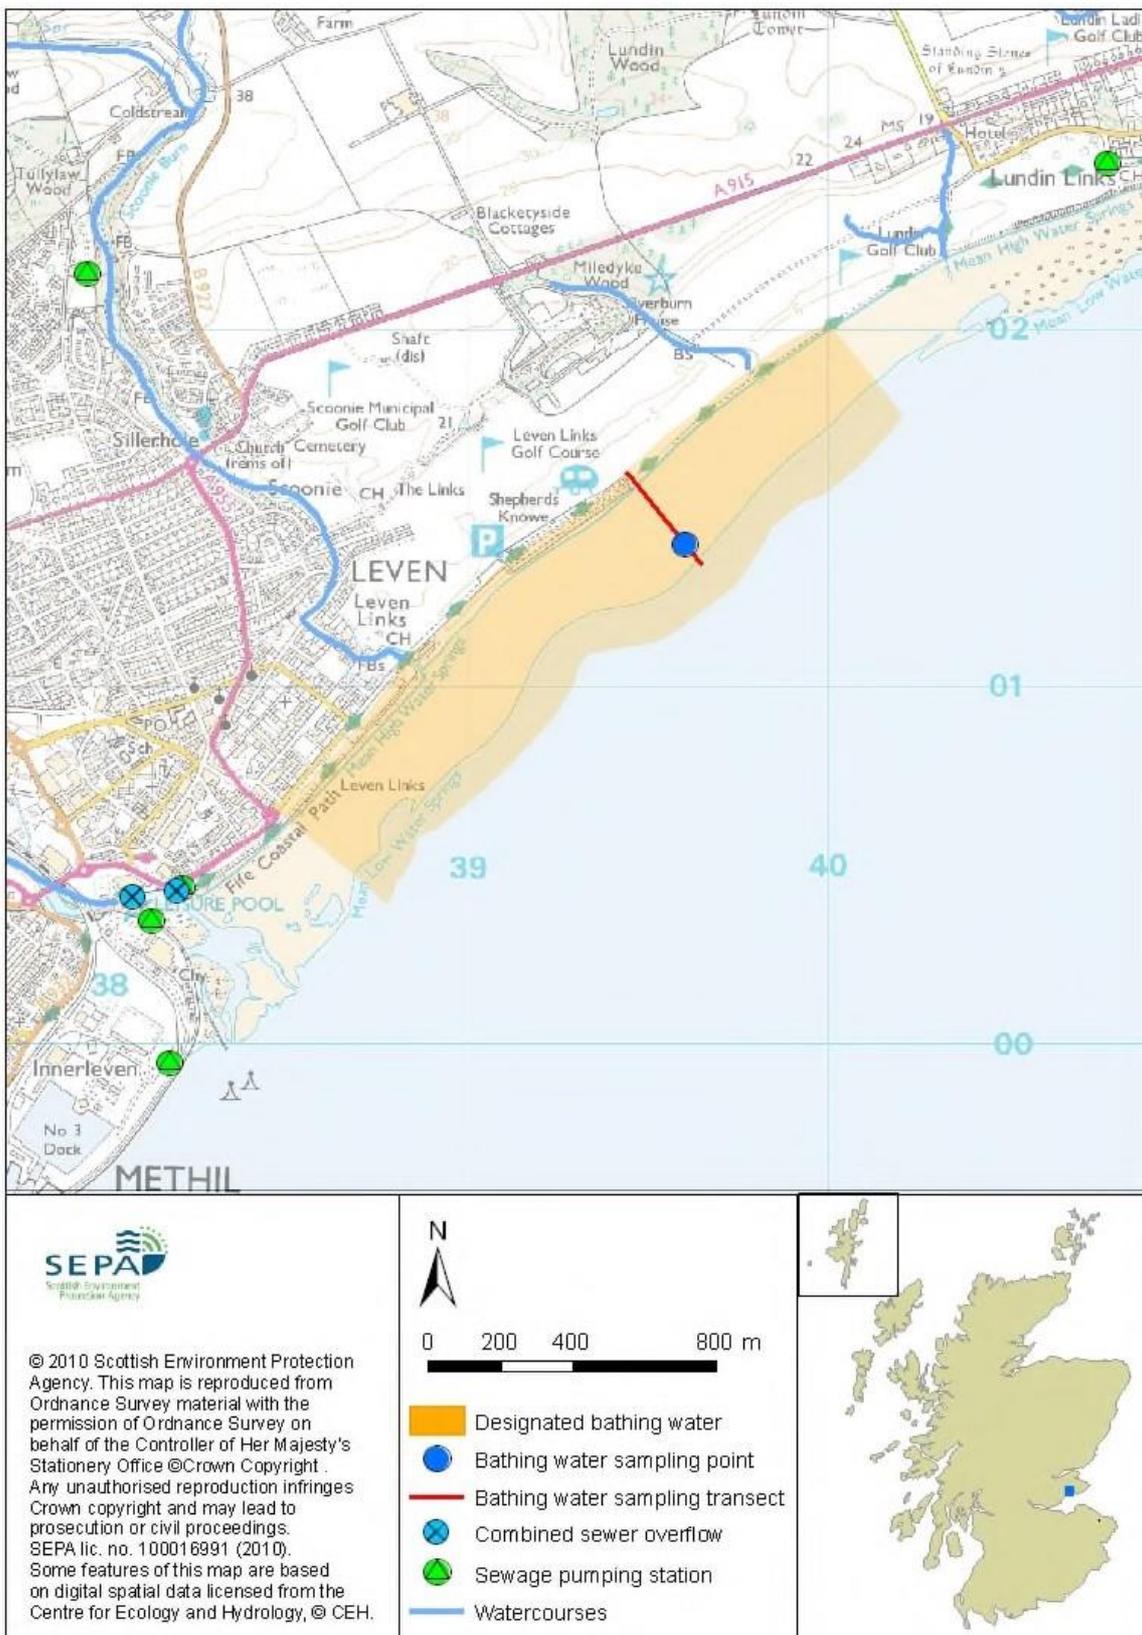
Map 1: Leven bathing water

Leven bathing water is located to the east of the town of Leven in Fife. It is a roughly 2 km long sandy beach. The beach is bordered by a promenade and a golf course.

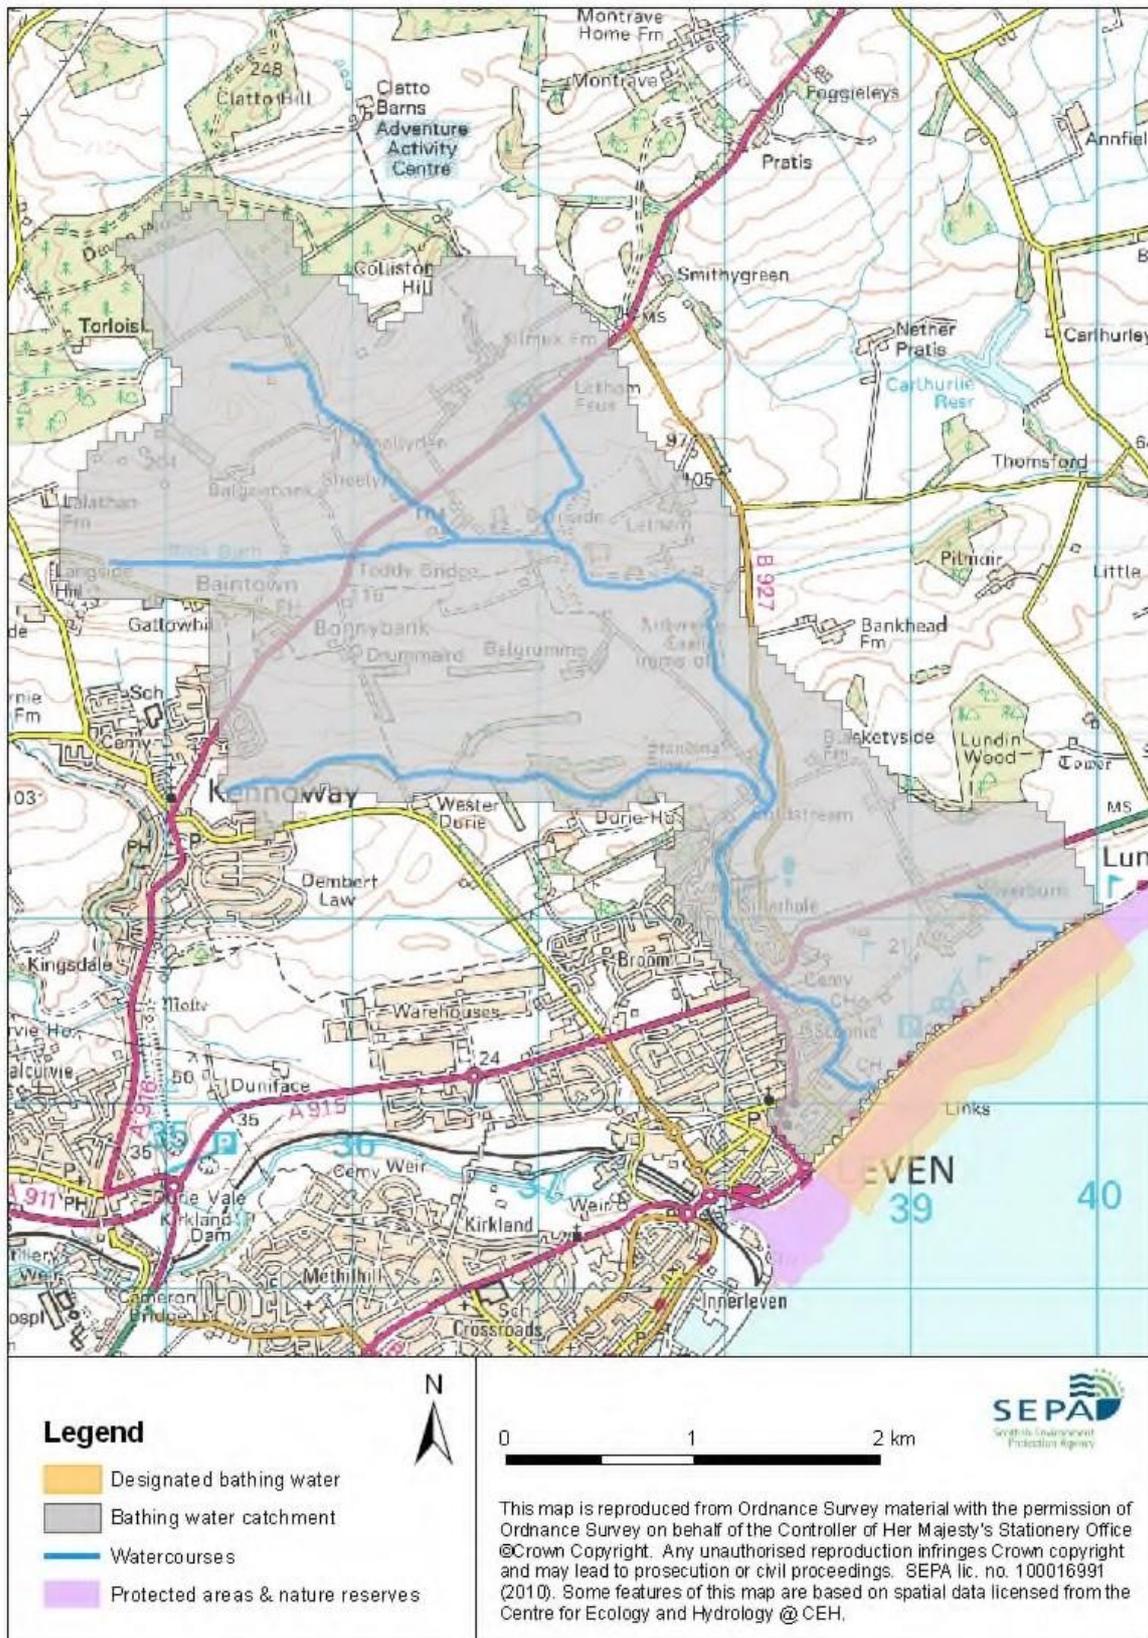
Map 2: Catchment draining into Leven bathing water

The catchment draining into the Leven bathing water extends to 11.5 km². The area is predominantly rural (94%) with arable agriculture the major land use. Approximately 6% of the bathing water catchment is urban. The main population centres within the catchment are Leven and Kennoway.

The main river in the bathing water catchment is the Scoonie Burn.

The principal risks and source of wet weather driven short term pollution at this bathing water arise from agricultural run-off and combined sewer overflows.
